HISTORIC DISTRICT COMMISSION APPLICATION FOR WORK APPROVAL

APPLICATION ID
HDC2026-00170

ADDRESS(ES): 4291 Cortland
HISTORIC DISTRICT: Russell Woods-Sullivan

4291 Cortland - Description of Existing Condition

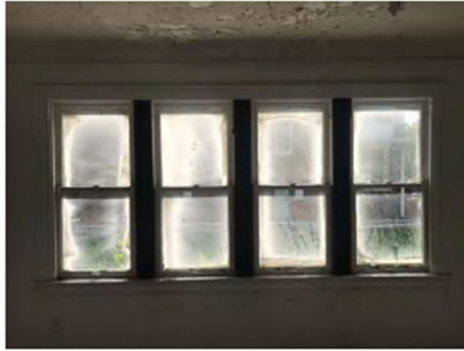
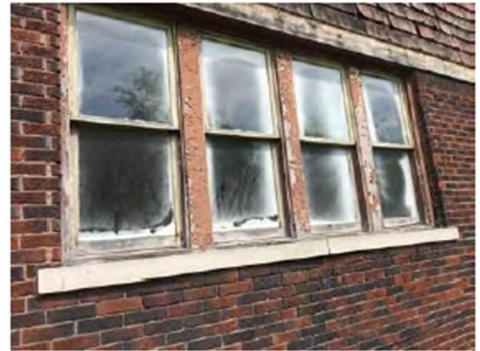
Window 4

Double Hung 1/1
4 Windows - 2'2" x 4'9" ea.
Repair - Assess for wood rot and replace rotted pieces in-kind, reglaze, repaint, hang weights as needed

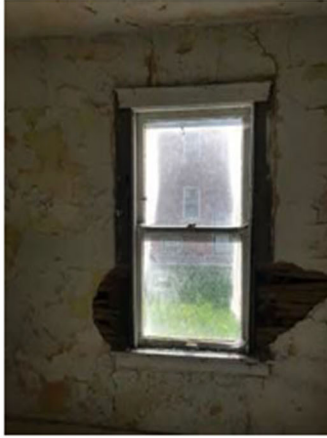
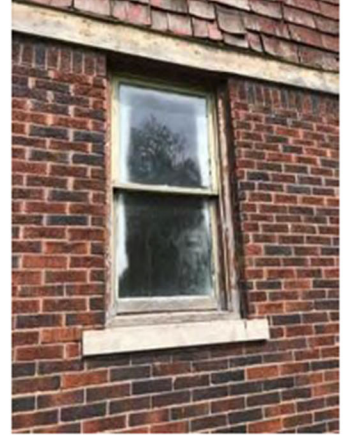
Window 5

Double Hung 1/1
2' 3"x 4'9"
Repair - Assess for wood rot and replace rotted pieces in-kind, reglaze, repaint, hang weights as needed, replace weights as needed based on damage to surrounding wall

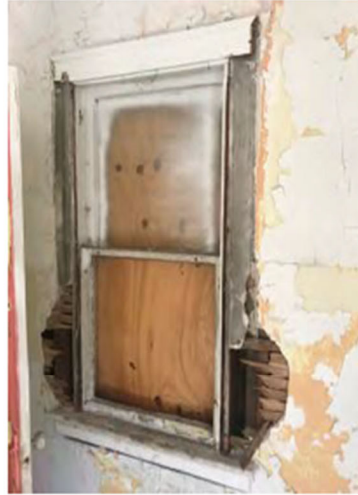
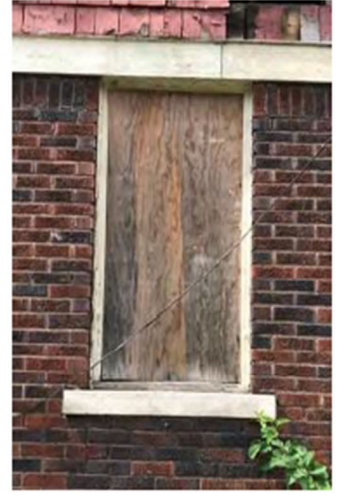
Window 6

Double Hung 1/1
2'3" x 4'9" ea.

Repair - Assess for wood rot and replace rotted pieces in-kind, reglaze, repaint, replace glass as needed, hang weights as needed, replace weights as needed based on damage to surrounding wall

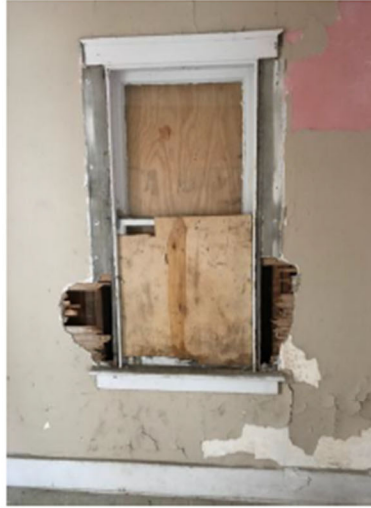
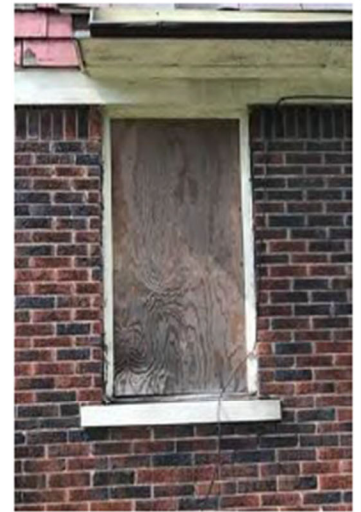
Window 7

Double Hung 1/1
2'3" x 4'9"

Repair - Assess for wood rot and replace rotted pieces in-kind, reglaze, repaint, replace glass as needed, hang weights as needed, replace weights as needed based on damage to surrounding wall

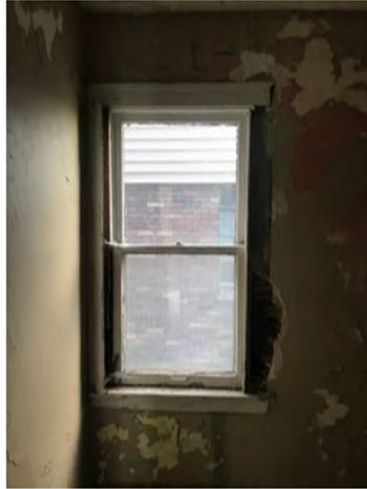
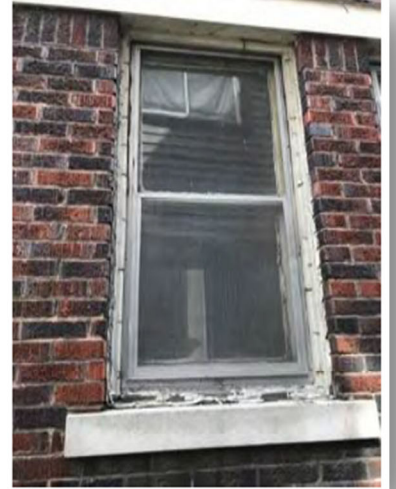
Window 8

Double Hung 1/1
2'3" x 4'9"

Repair - Assess for wood rot and replace rotted pieces in-kind, reglaze, repaint, replace glass as needed, hang weights as needed, replace weights as needed based on damage to surrounding wall

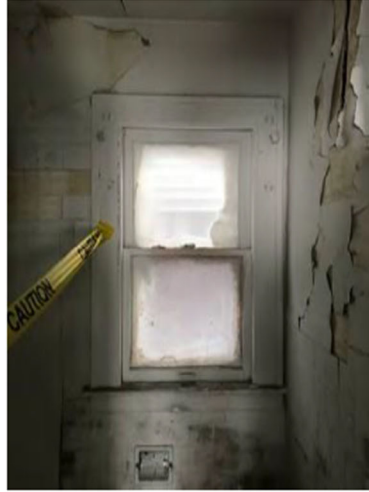
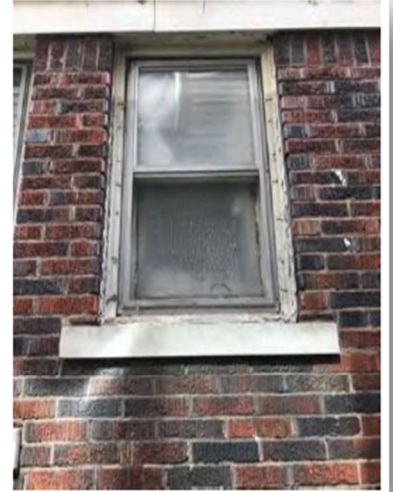
Window 9

Double Hung 1/1

1'11" x 3'10"

Repair - Assess for wood rot and replace rotted pieces in-kind, reglaze, repaint, replace glass as needed, hang weights as needed

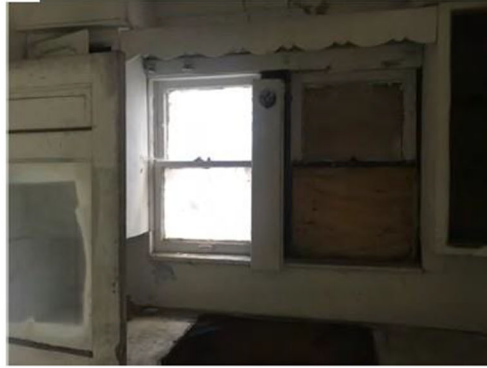
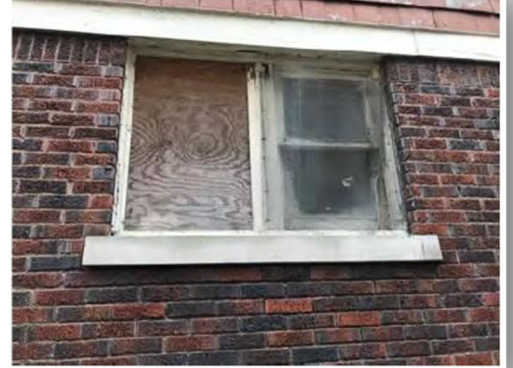
Window 10

10. Double Hung 1/1

2 Windows- 1'11" x 3'1" ea.

Repair - Assess for wood rot and replace rotted pieces in-kind, reglaze, repaint, replace glass as needed, hang weights as needed

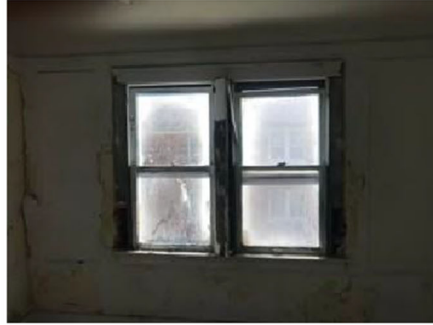
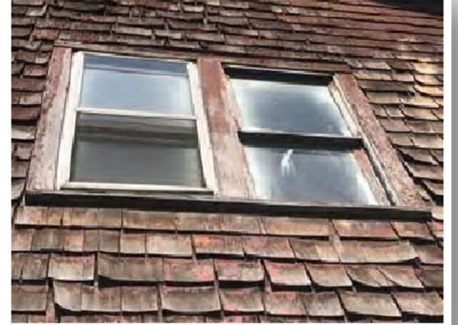
Window 15

Double Hung 1/1

2 Windows - 2'4" x 4'6" ea.
Repair - Assess for wood rot and replace rotted pieces in-kind, reglaze, repaint, replace glass as needed, hang weights as needed, replace weights as needed based on damage to surrounding wall

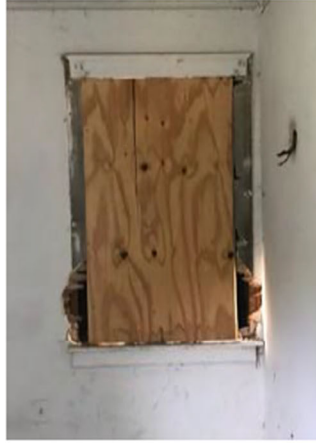
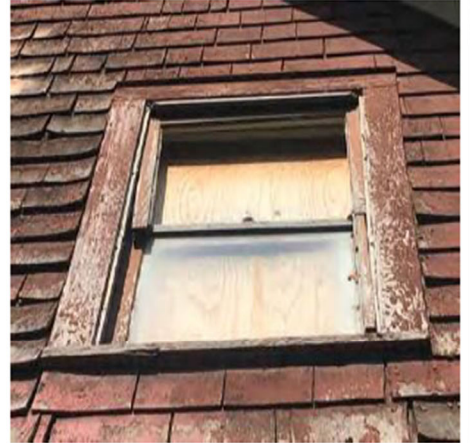
Window 16

Double Hung 1/1
2'4"x 4'6"

Repair - Assess for wood rot and replace rotted pieces in-kind, reglaze, repaint, replace glass as needed, hang weights as needed, replace weights as needed based on damage to surrounding wall

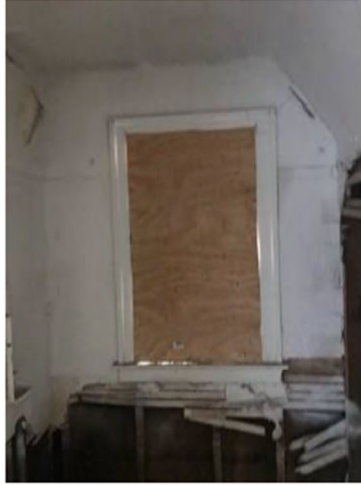
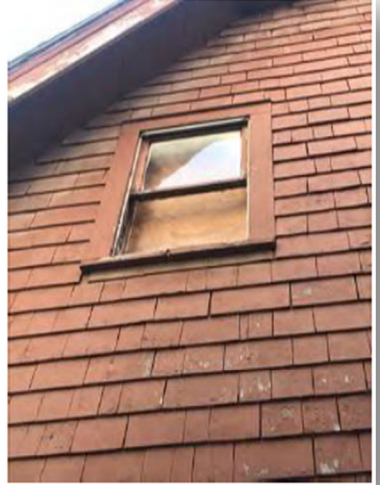
Window 17

Double Hung 1/1
2'x 3'10"

Repair - Assess for wood rot and replace rotted pieces in-kind, replace missing wood sash pieces in-kind, reglaze, repaint, replace glass as needed, hang weights as needed,

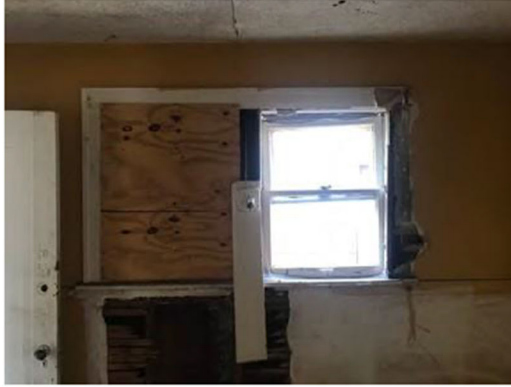
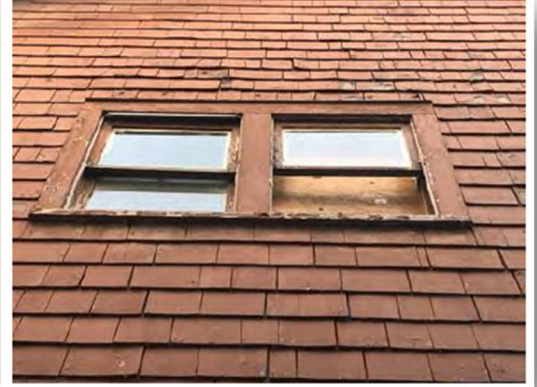
Window 18

Double Hung 1/1
2 Windows 2'4" x 3'1" ea.
Repair - Assess for wood rot and replace rotted pieces in-kind, reglaze, repaint, replace glass as needed, hang weights as needed, replace weights as needed based on damage to surrounding wall, rebuild lower sash on left window
