# HISTORIC DISTRICT COMMISSION APPLICATION FOR WORK APPROVAL

<b>APPLICATION ID</b>
HDC2026-00193

<b>ADDRESS(ES):</b> 892 W. Boston Boulevard
<b>HISTORIC DISTRICT:</b> Boston-Edison

EDWARD F. FISHER MANSION

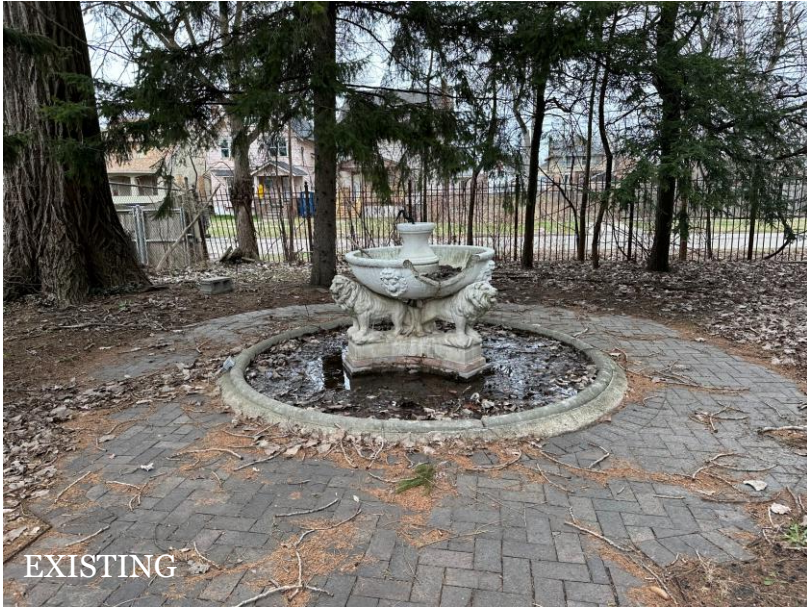
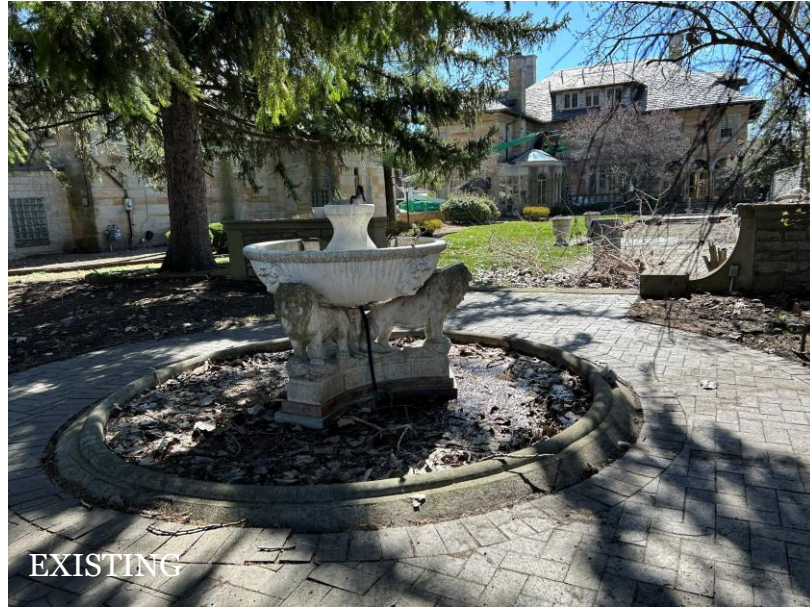
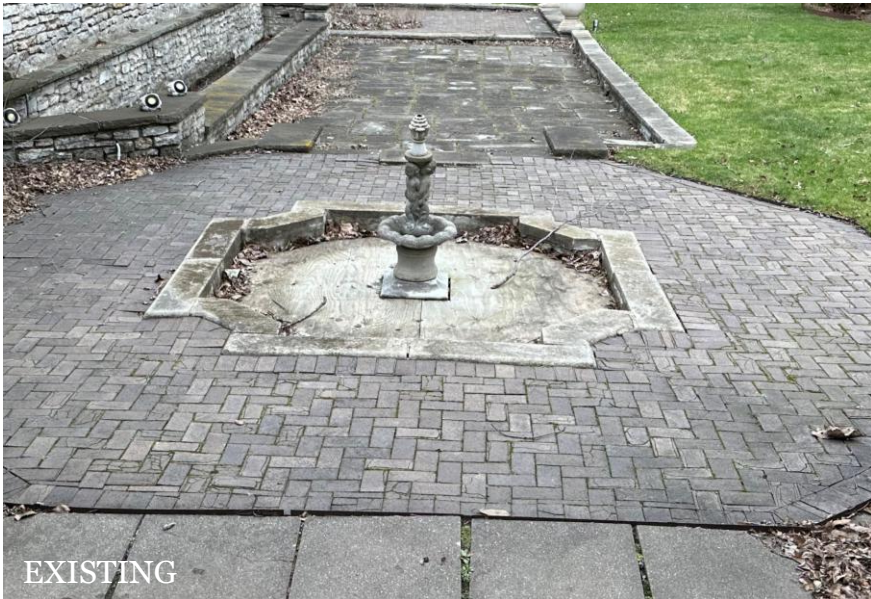
## Fountain

The existing fountains are concrete basins with non-historic water features controlled by a submersible pump. Deficiencies include cracked basin wall/floor, aged/non-functional submersible pump, deteriorated sealant at select joints and penetrations, failing non-historic water features.

Restore and repair existing elements with new plumbing and submersible pump.

The proposed repair will be completed by routing/widening cracks to create a clean bonding surface, fill with a polymer-modified cement mortar repair NSF-rated for submerged conditions, apply crystalline waterproofing system rated for constant water immersion (coating applied per manufacturer's thickness and curing requirements), install proposed water feature and submersible pump, pump connection to be performed by licensed electrician with watertight conduit fittings and junction boxes.

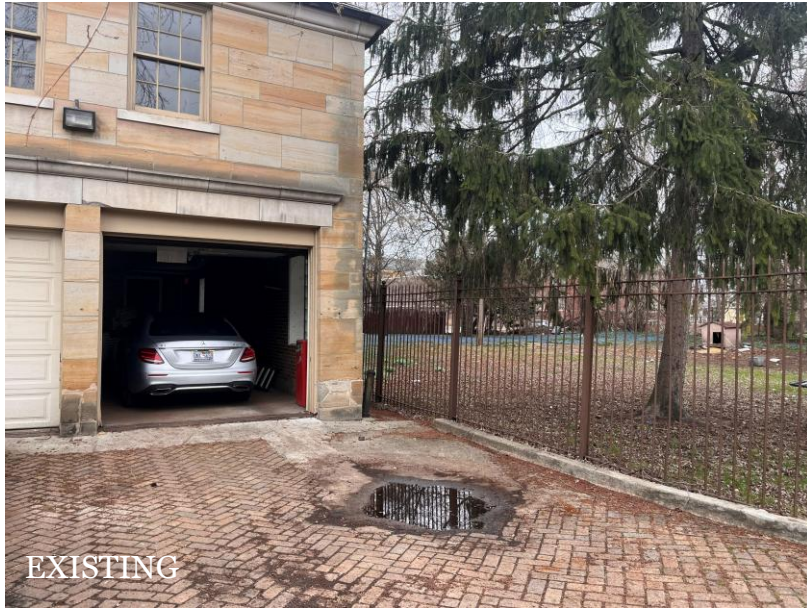
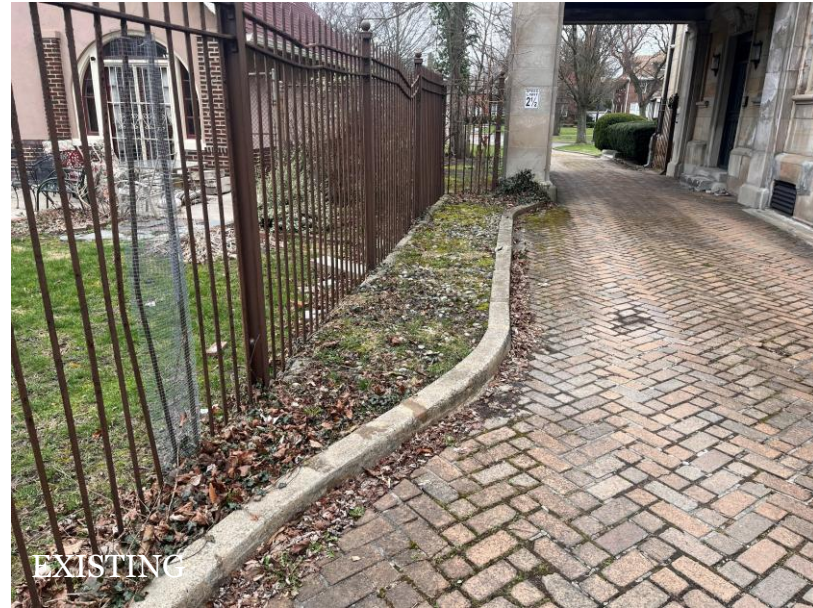
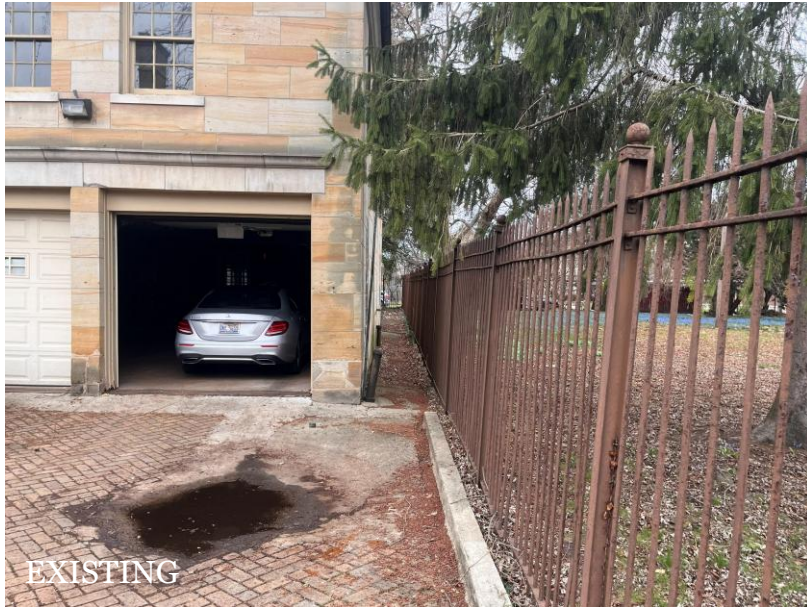
## Perimeter Fence

The perimeter fence is original and historic. Currently, sections of the fence are bent and broken due to fallen trees and damage throughout the years.

Weld and repair existing fence by bending and replacing broken pieces.

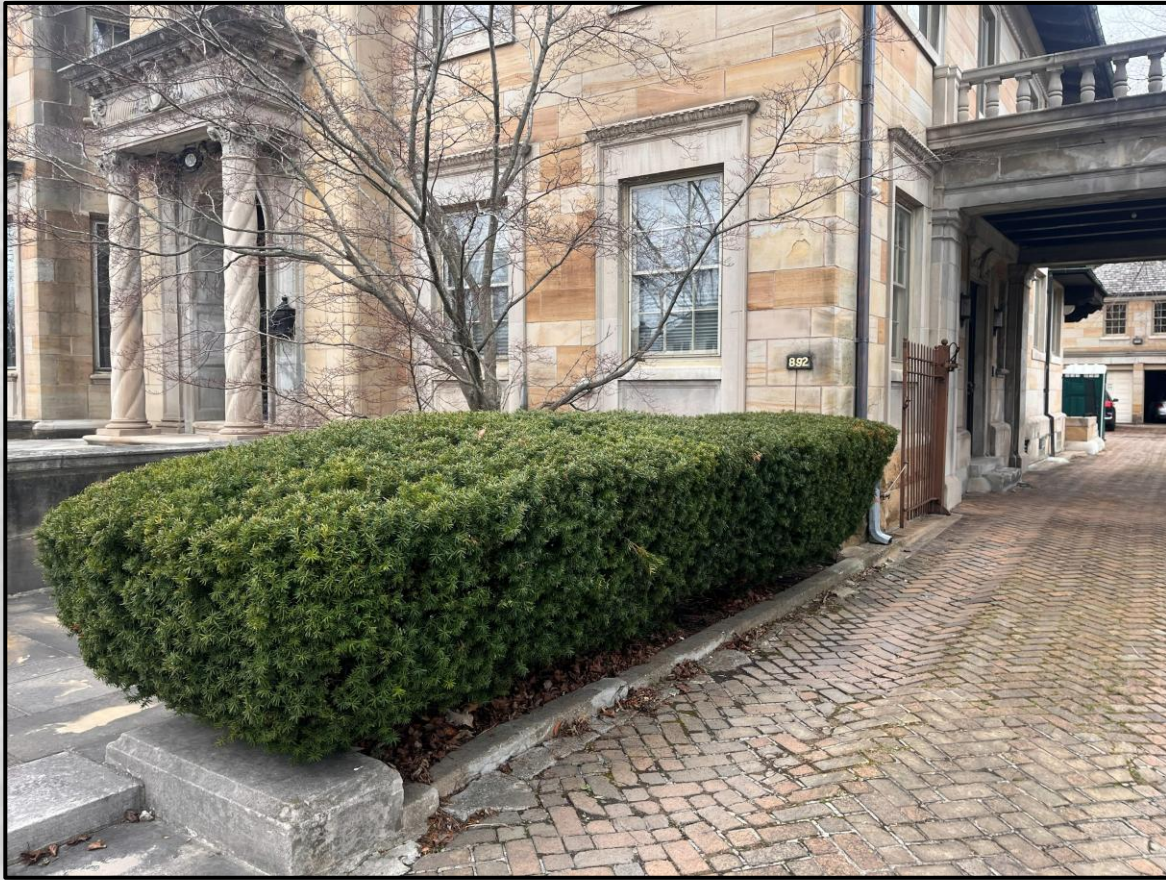
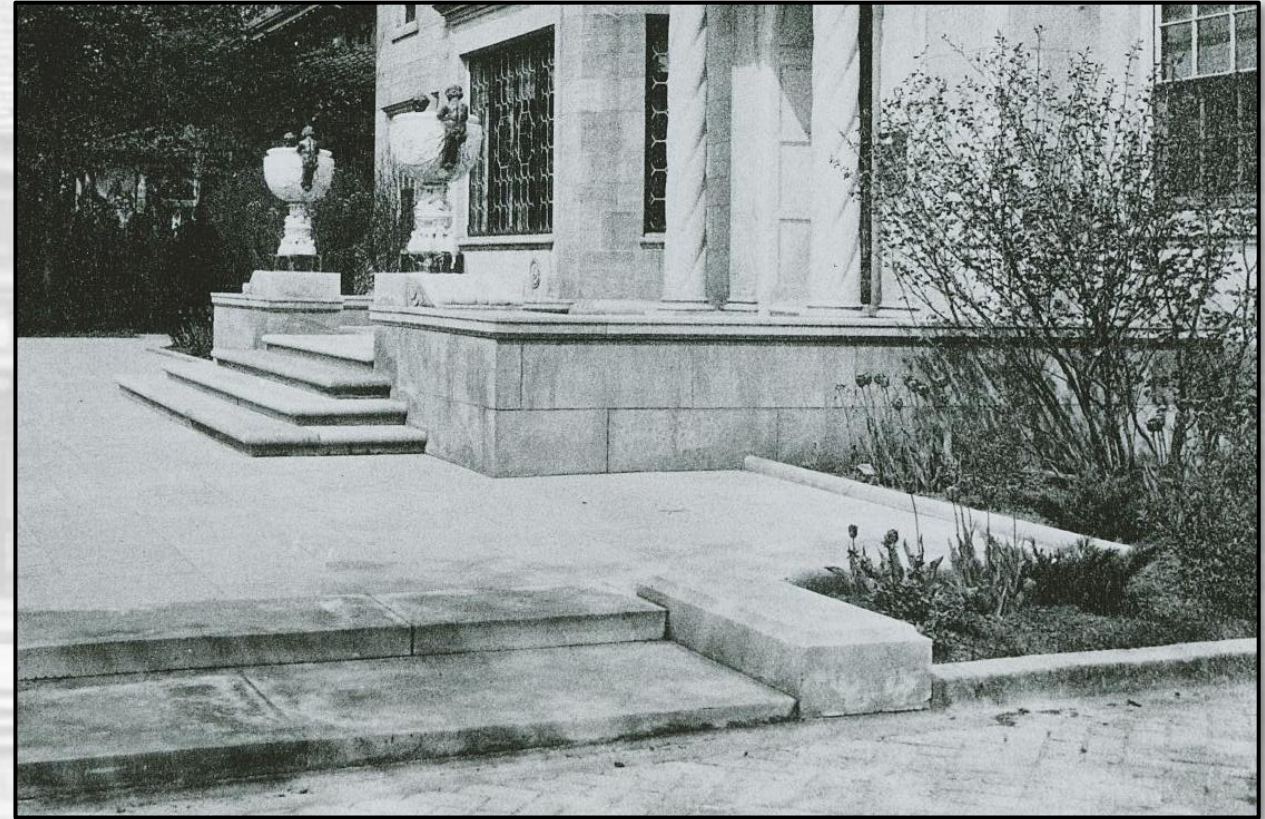
## Driveway Curb

Existing driveway curb failing. Over the years it has been patched in numerous locations at the wrong elevation leaving this element in disrepair.

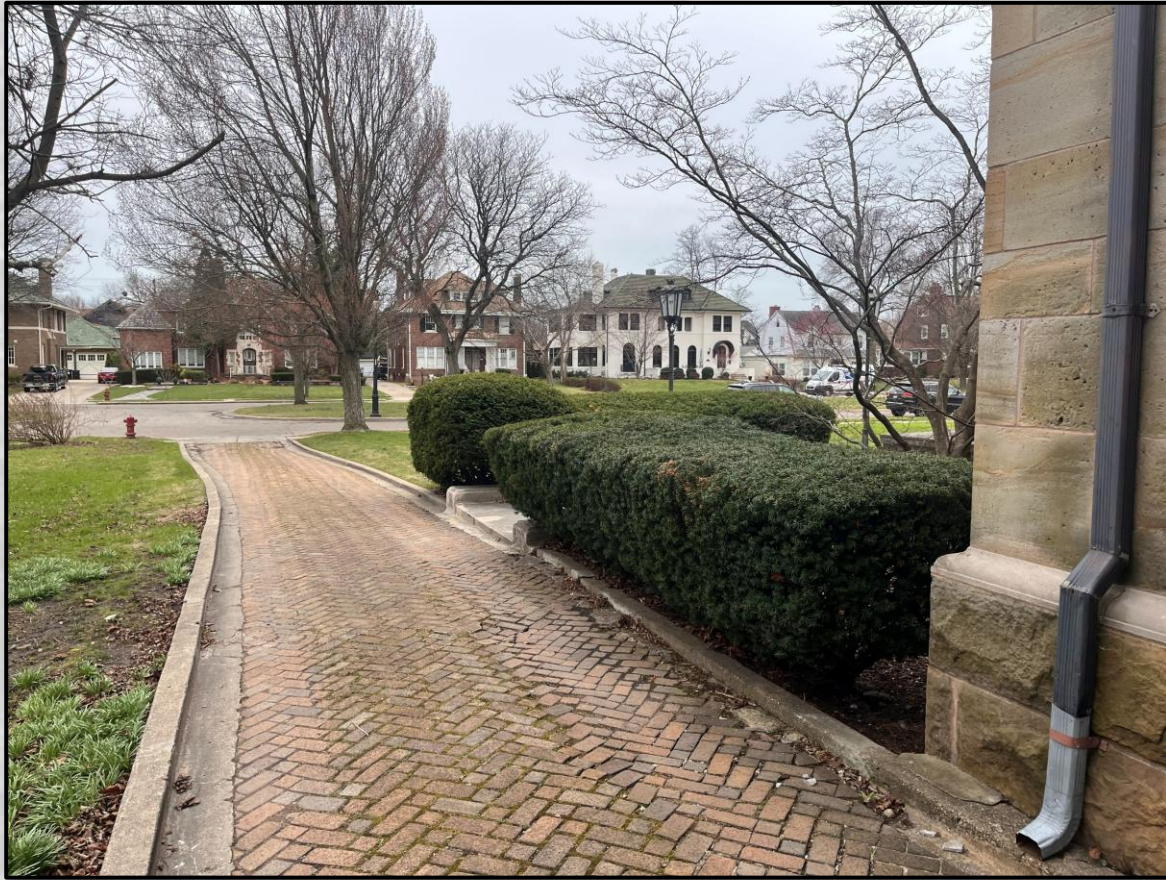
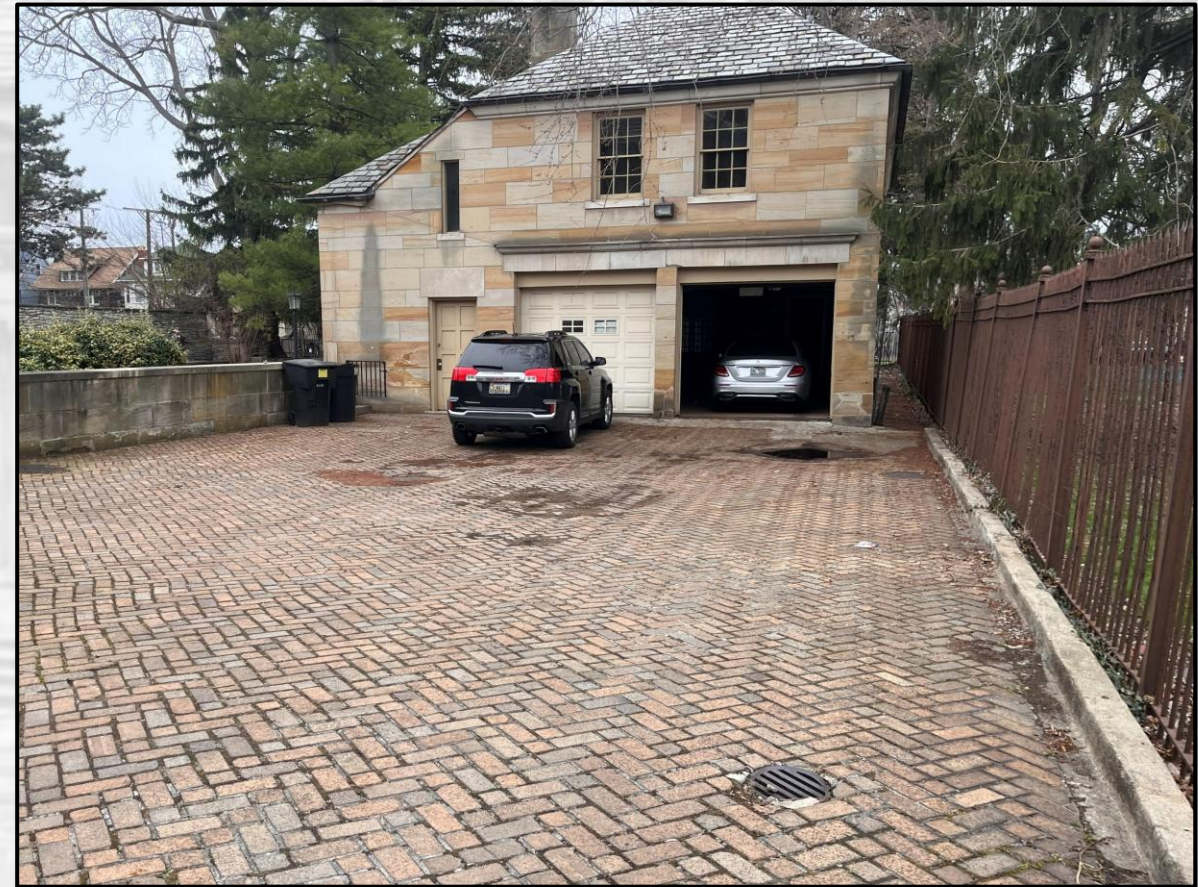
# Driveway

Existing driveway has cracked/broken pieces. The driveway subbase is failing due to compaction from vehicles over the years creating rutting.

Utilize existing brick and install on compacted aggregate base to address compaction issues. Widen to accept modern vehicles.

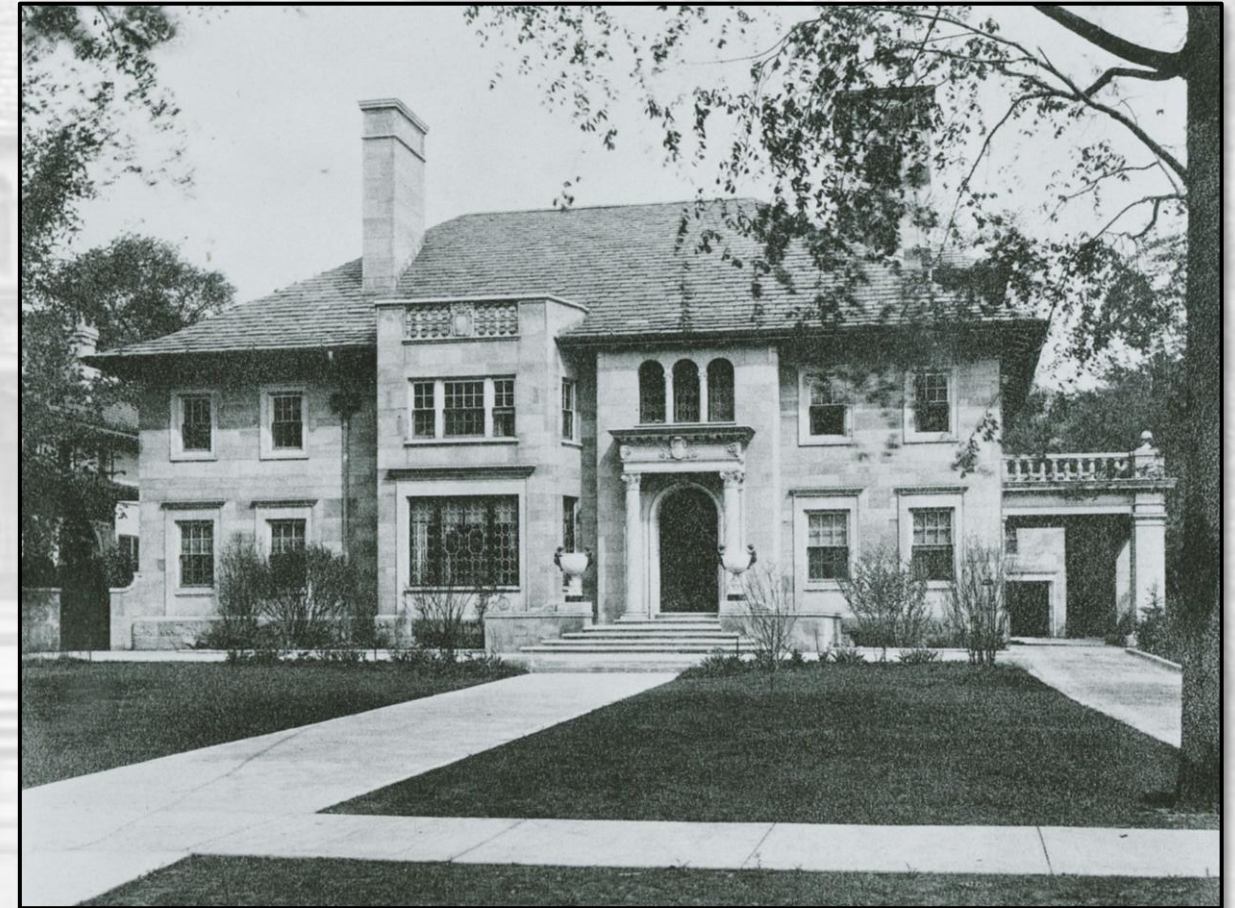
## Entry walk

Entry walk is not historic. Work done in the 90's included removing the original concrete walk and installing a died concrete with pieces of natural stone integrated into the flatwork. According to historical images, the width is the same.

Remove existing concrete entry walk and replace with new exposed aggregate concrete. Existing walkway footprint remains.

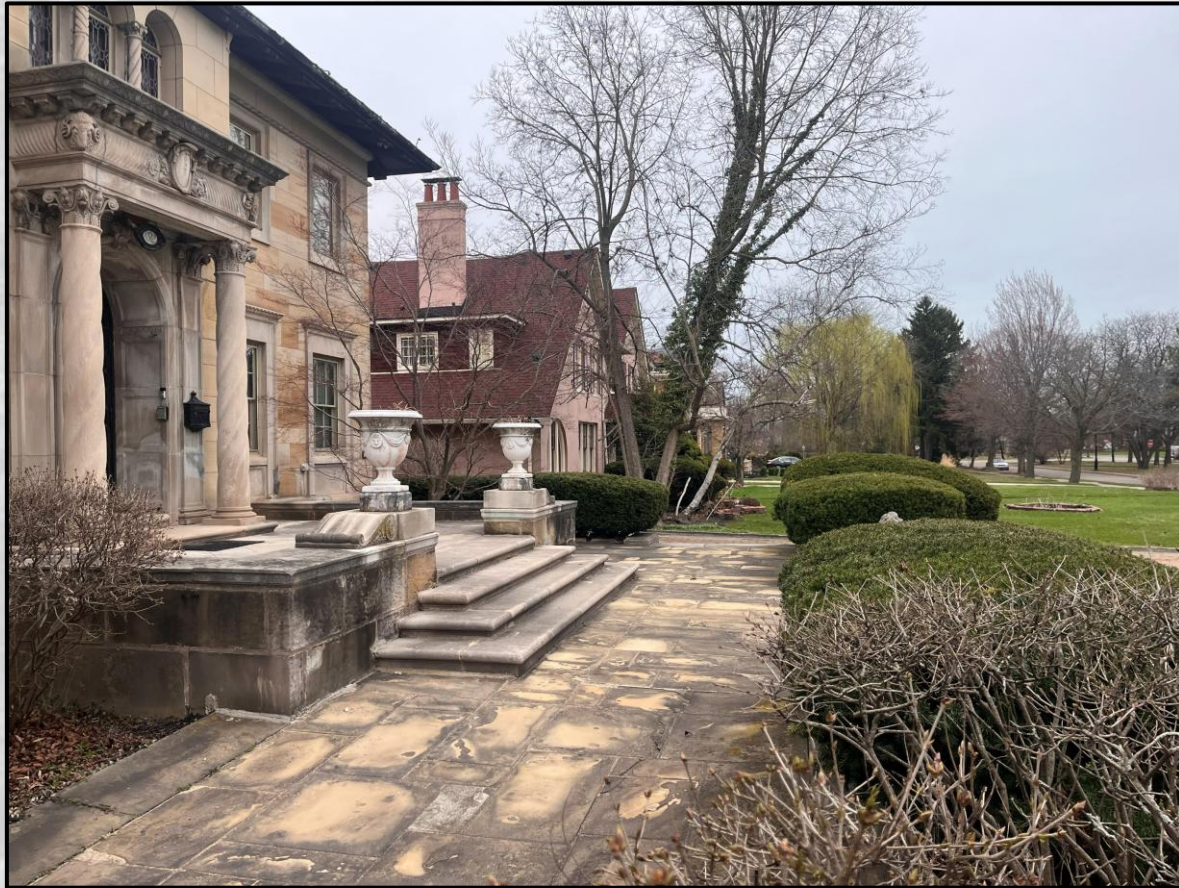
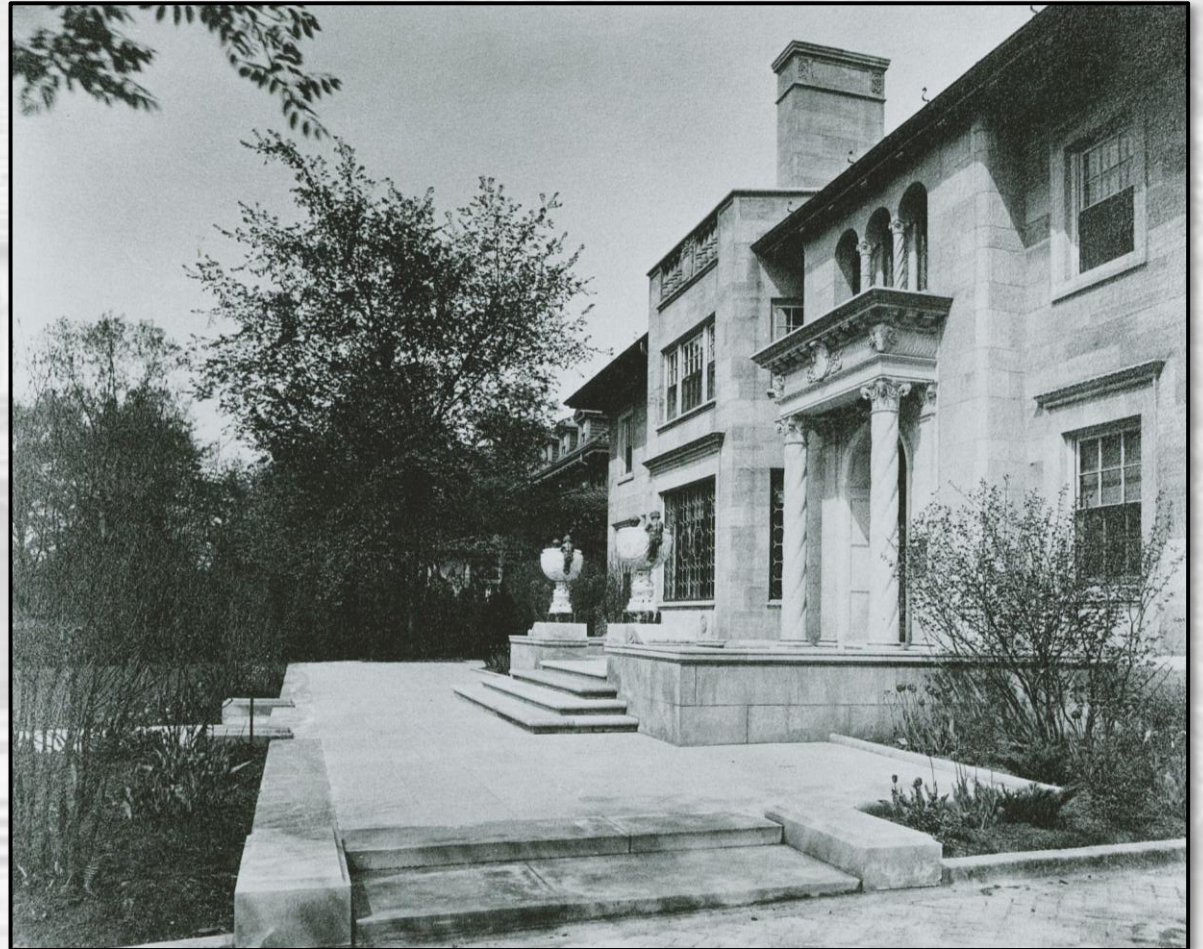
## Entry Plaza

Entry Plaza contains original natural stone paving. Areas have been patched with concrete, and the subbase is failing resulting in drainage pitching back towards the house.

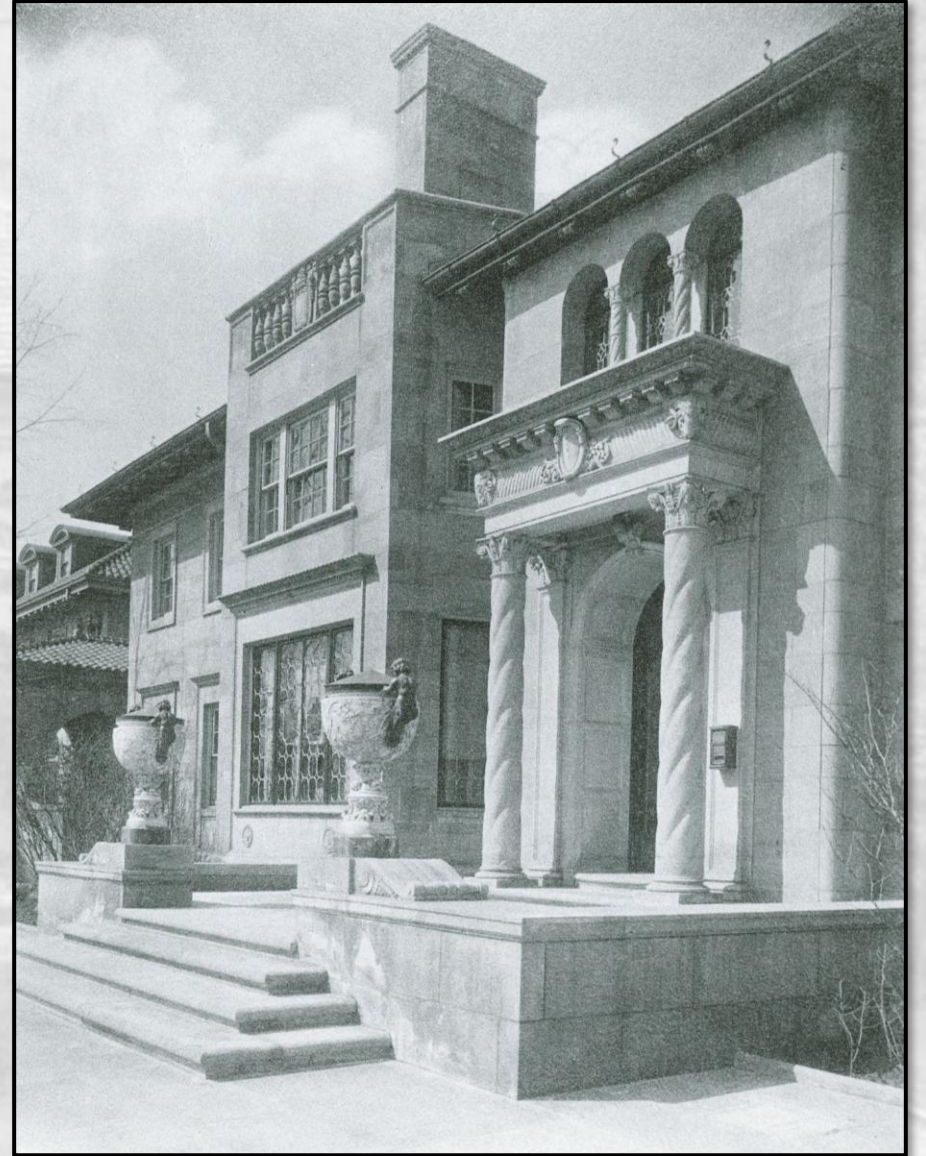
## Entry Porch

Entry Porch contains original natural stone paving with concrete patches.

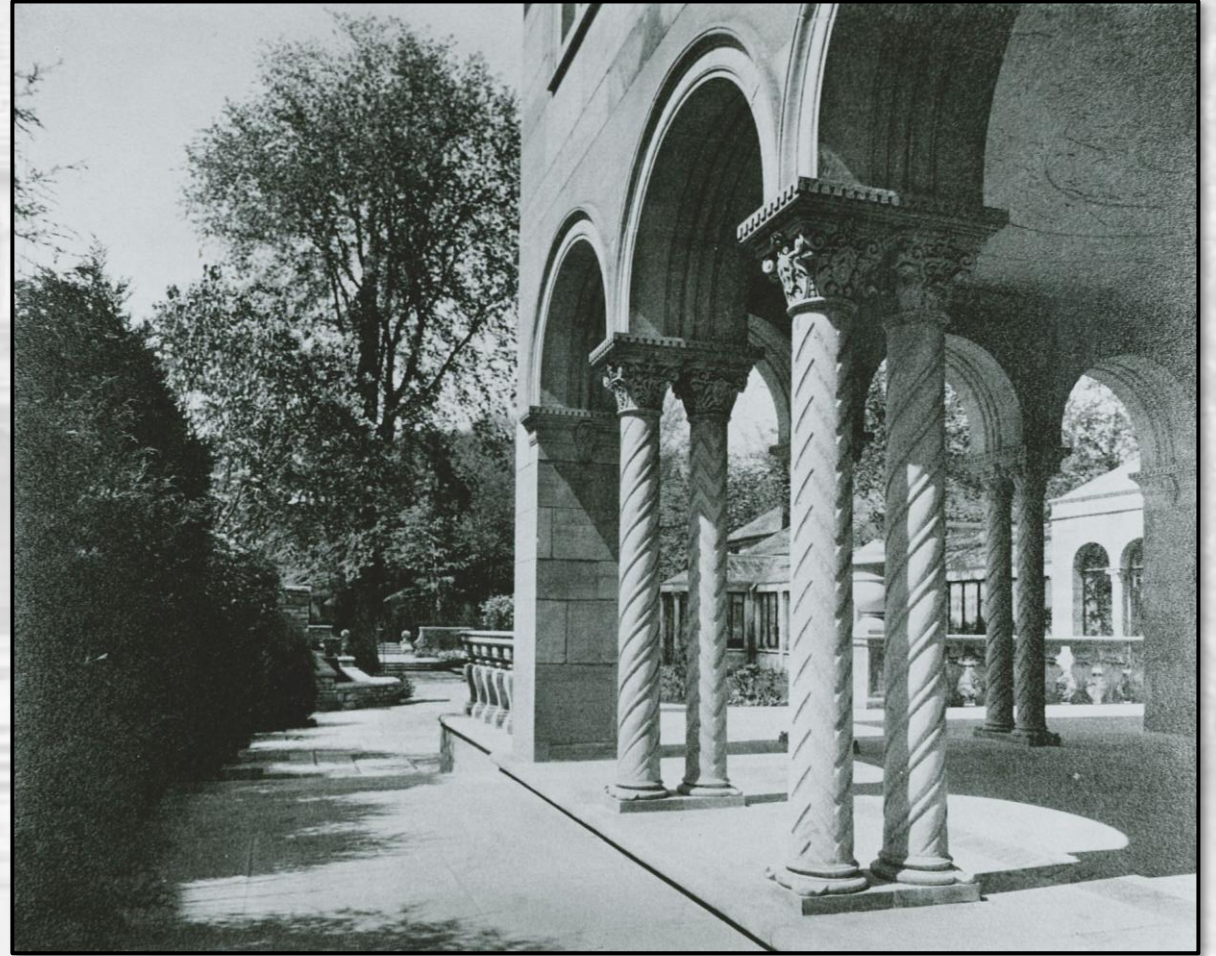
# West Side

West side is completely original.

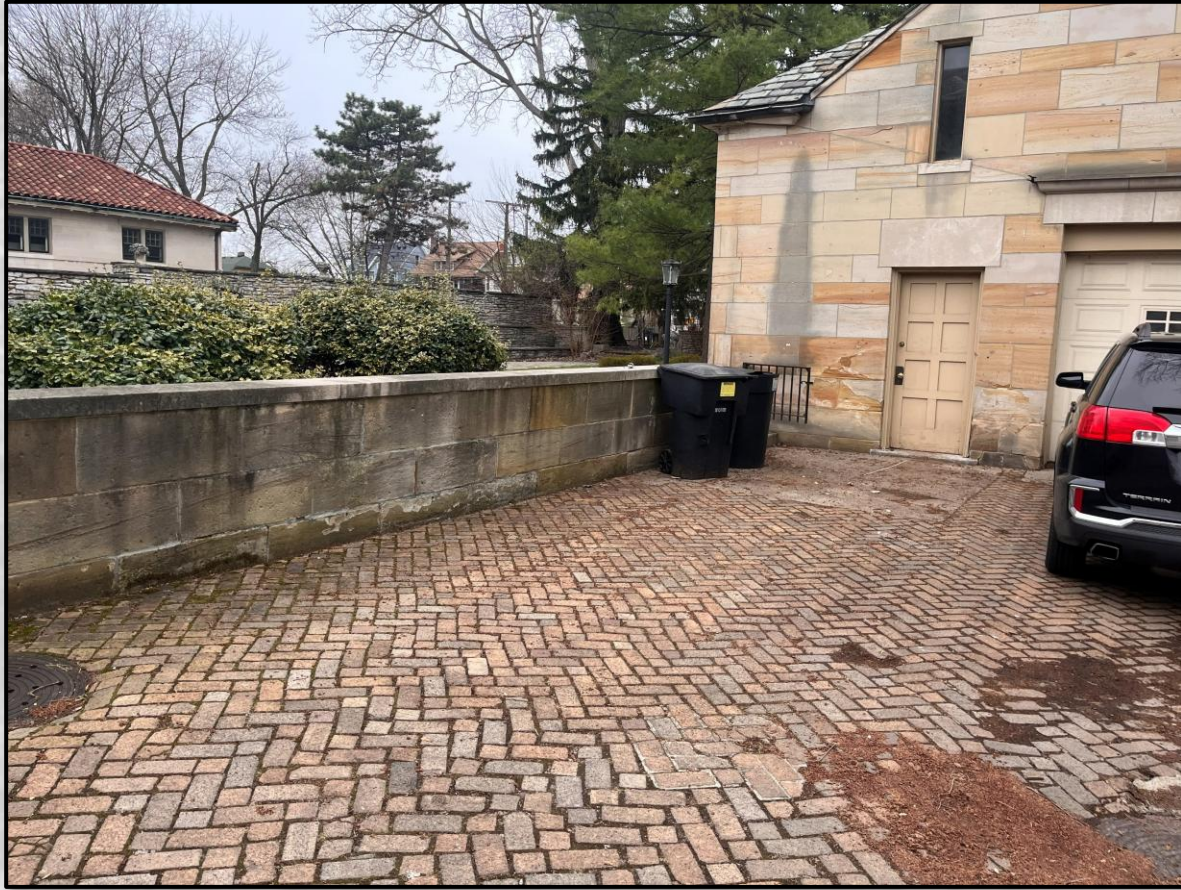
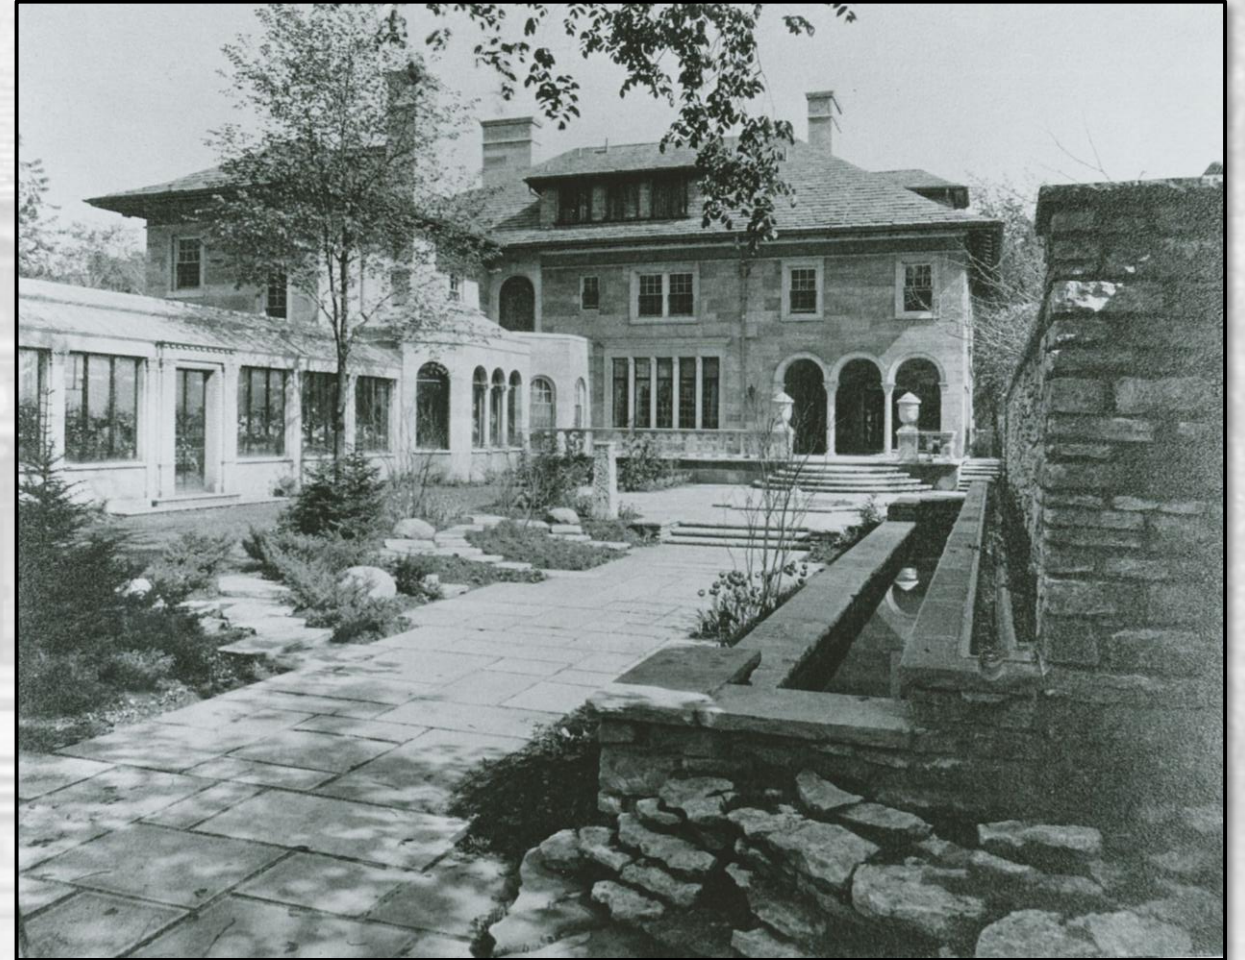
## Driveway wall

Driveway wall is not historic and replaced greenhouse. Historic materials were not used, and the wall is currently failing.

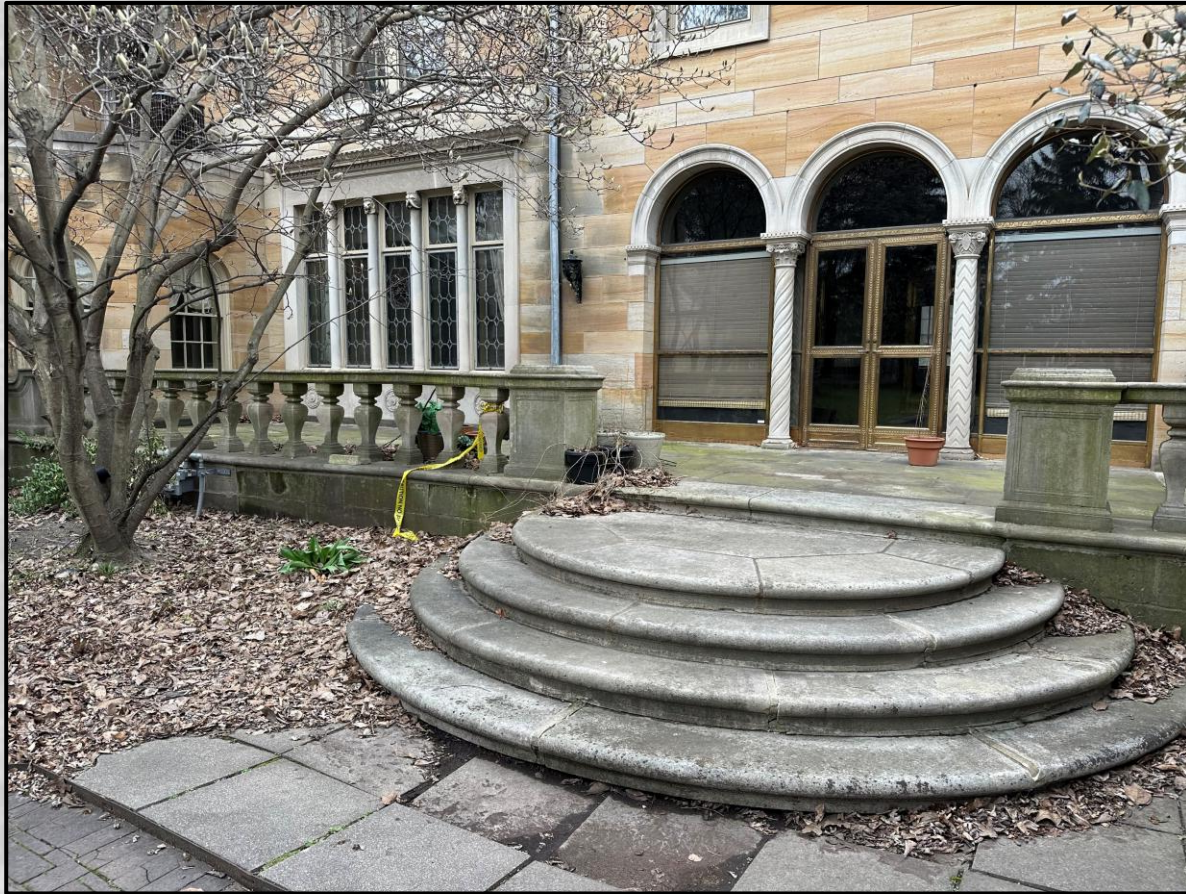
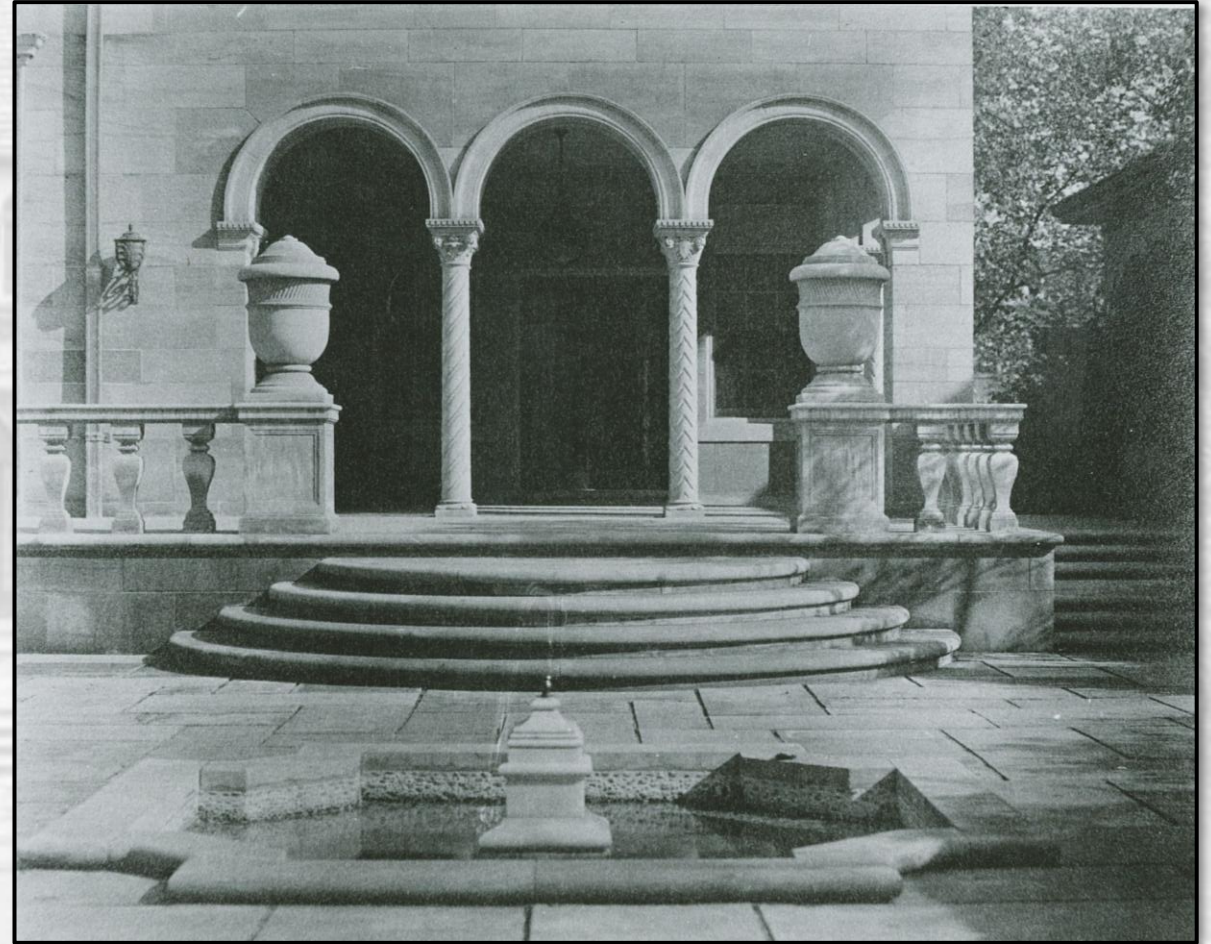
# Upper terrace

Upper terrace and staircase is original. There are some pieces that broke and replaced with concrete in flatwork areas.

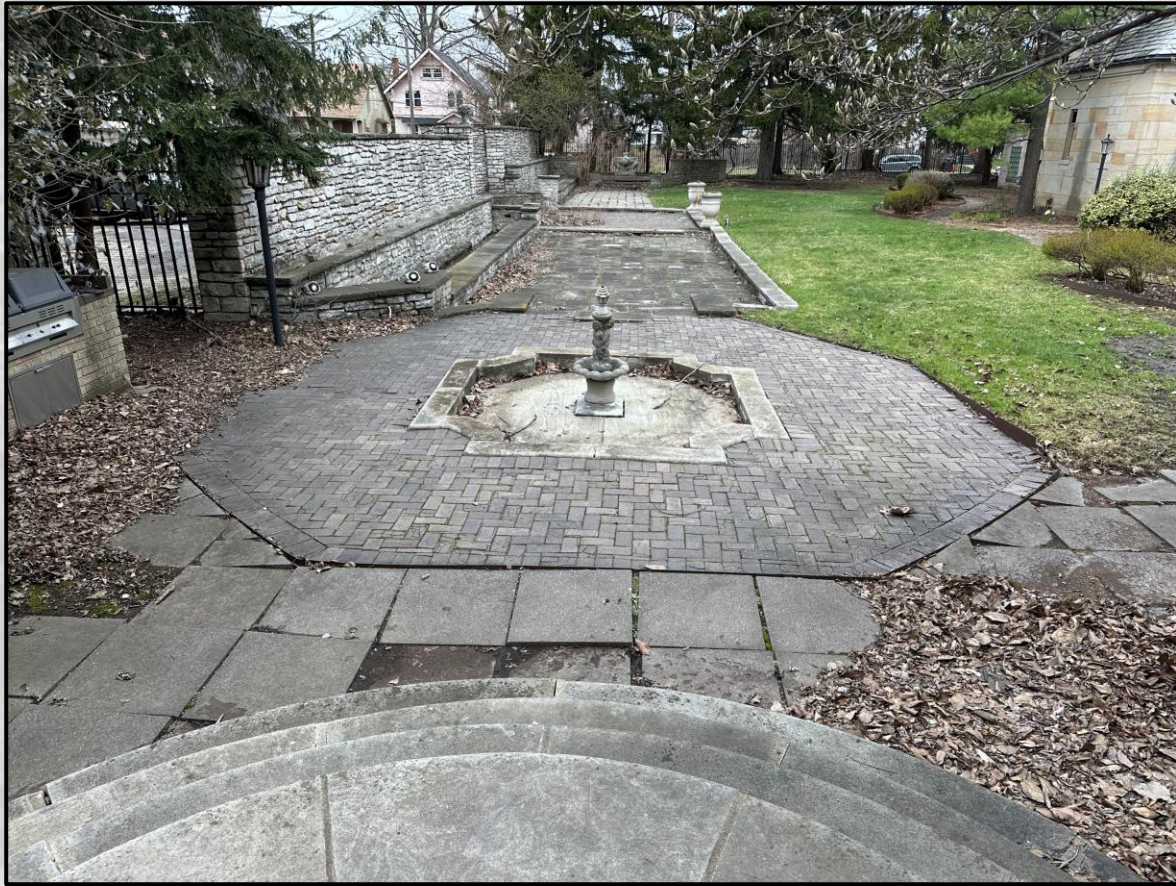
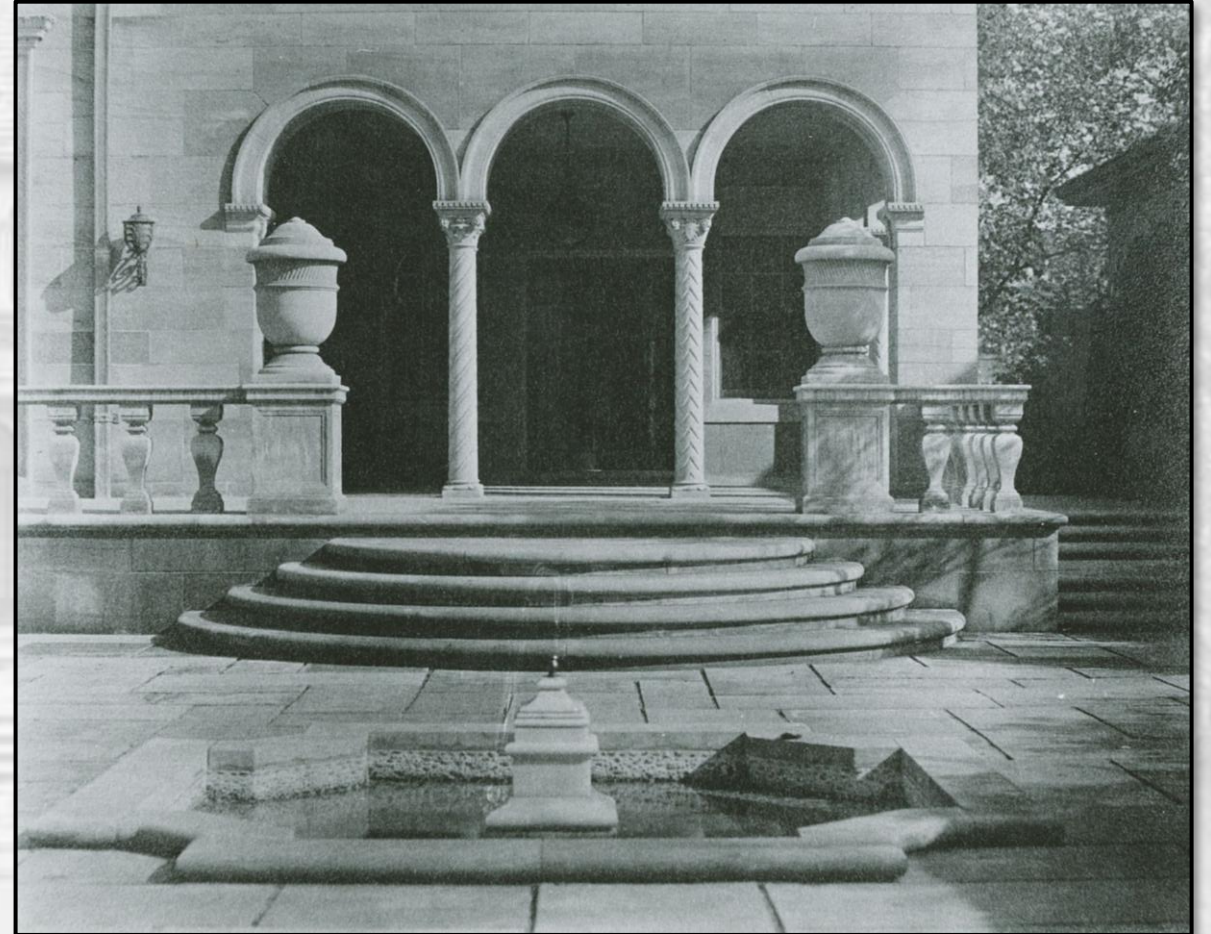
## Transition Terrace

Transition Terrace is not original and replaced with concrete unit pavers in the 90's. The non-historic flatwork is failing.

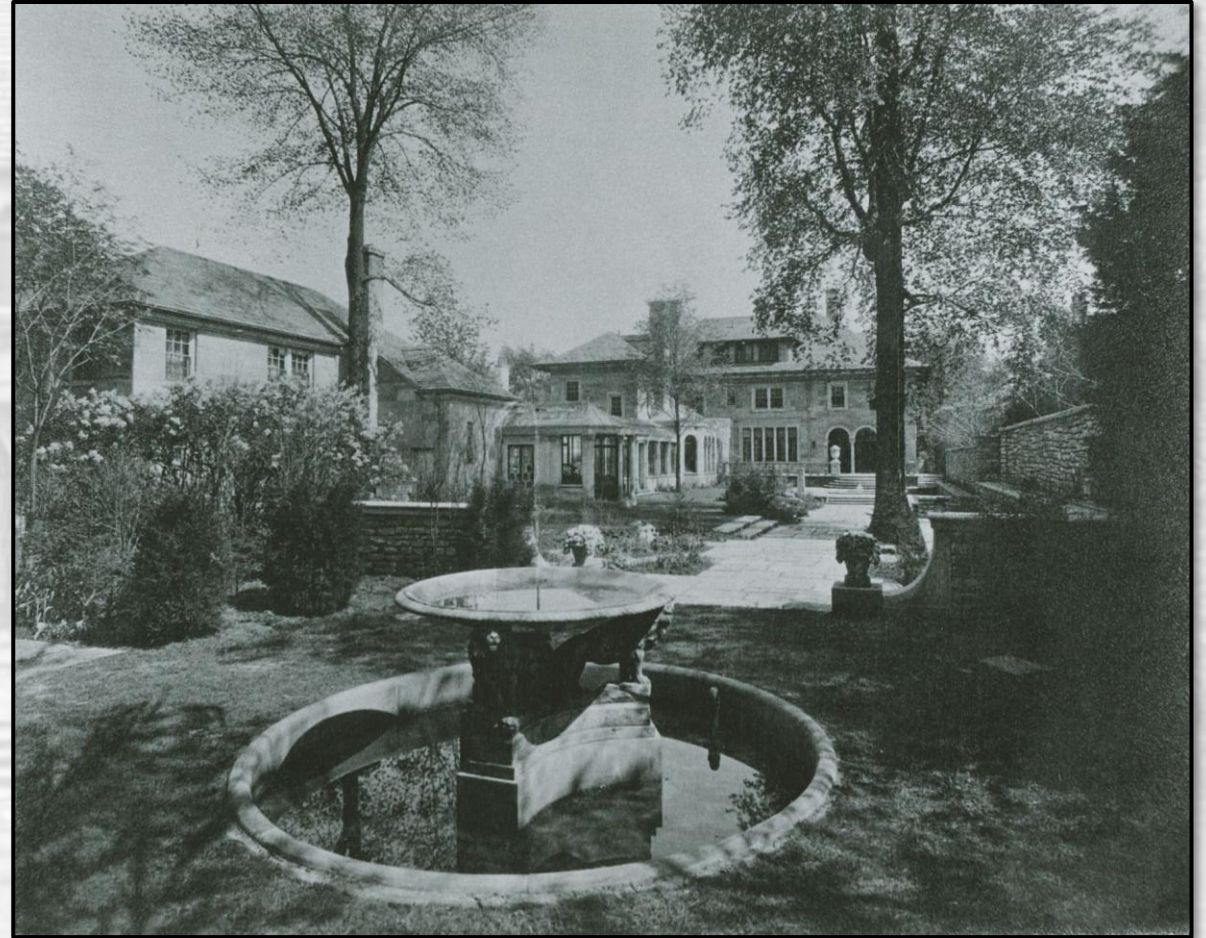
# North Fountain

North Fountain base is historic. The bowl is not historic. The basin is in disrepair.
