# HISTORIC DISTRICT COMMISSION APPLICATION FOR WORK APPROVAL

<b>APPLICATION ID</b>
HDC2026-00193

<b>ADDRESS(ES):</b> 892 W. Boston Boulevard
<b>HISTORIC DISTRICT:</b> Boston-Edison

EDWARD F. FISHER MANSION

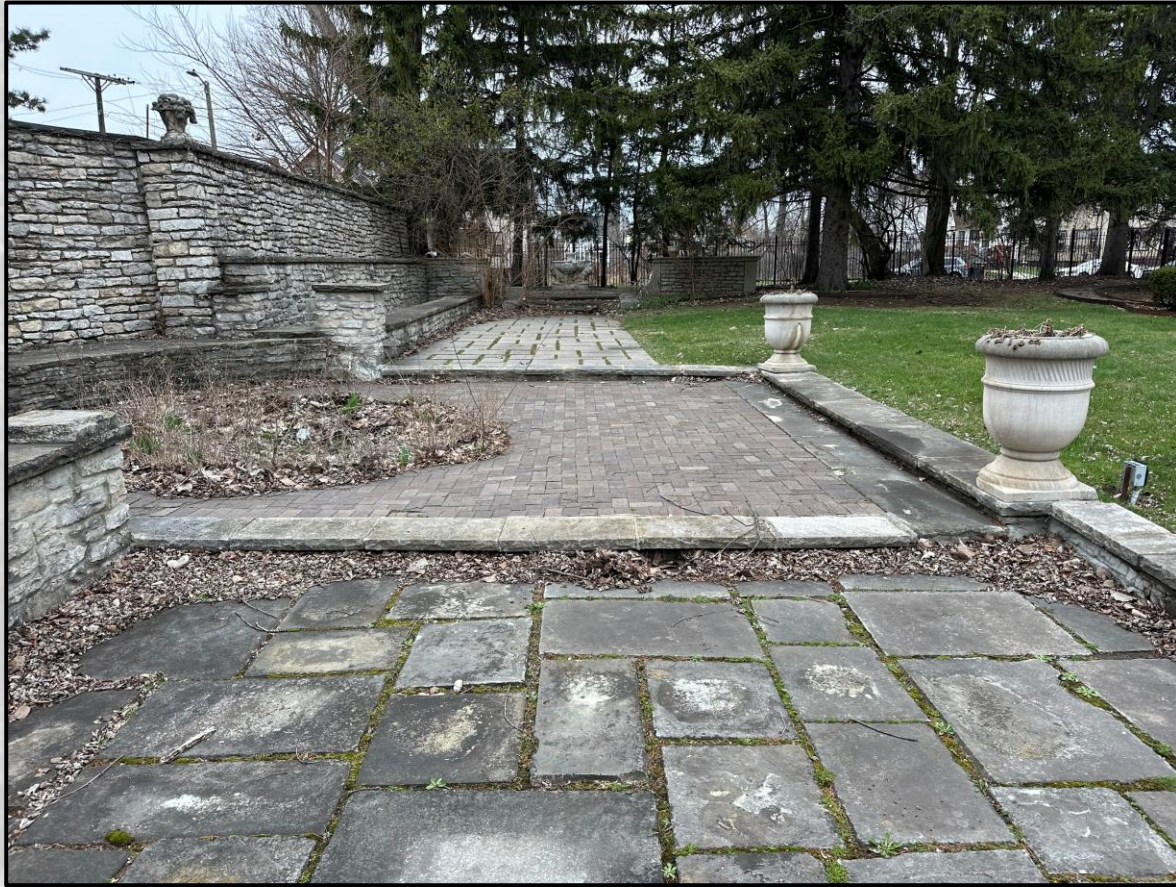
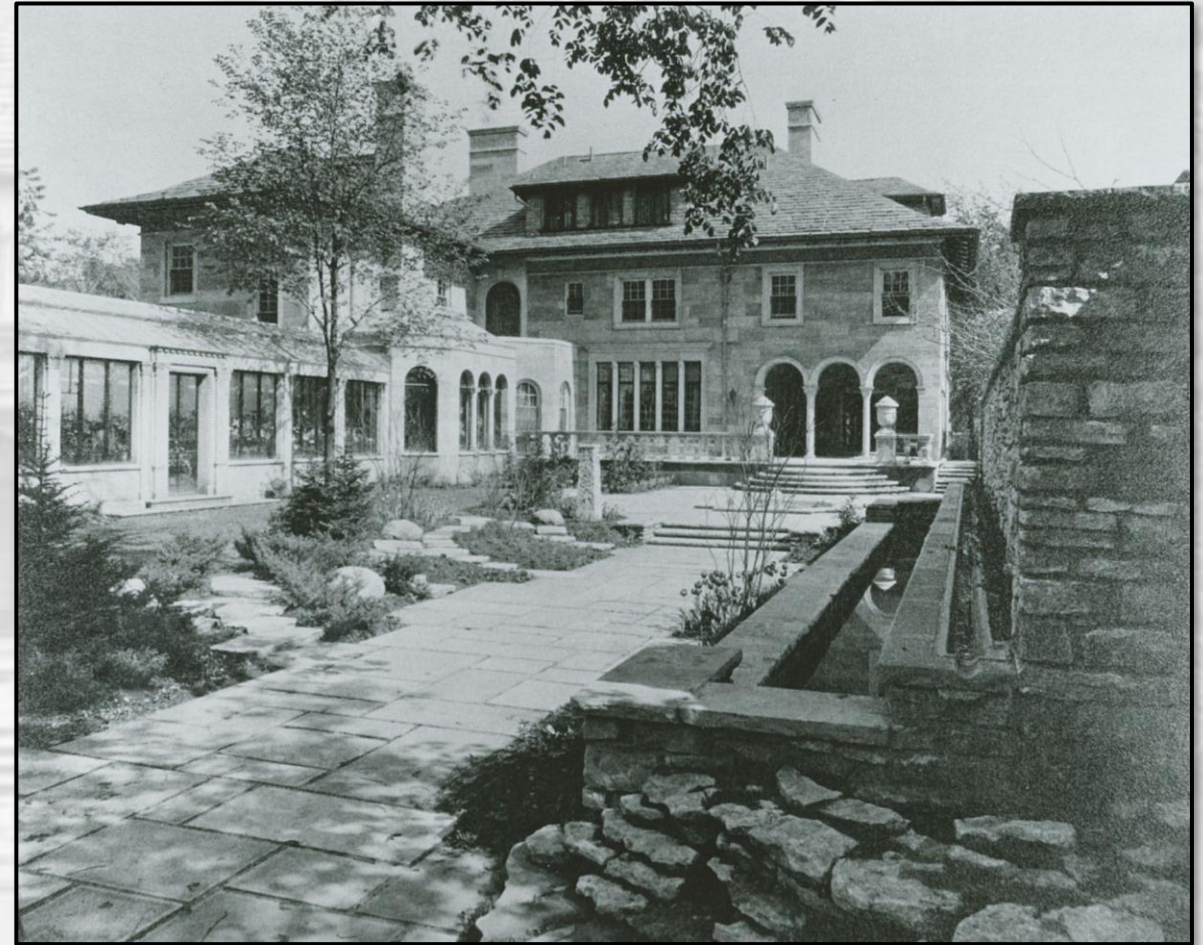
## Fountain Corridor

The Fountain Corridor is not original and replaced with concrete unit pavers during work in the 90's. The wall on the left is historic and original.

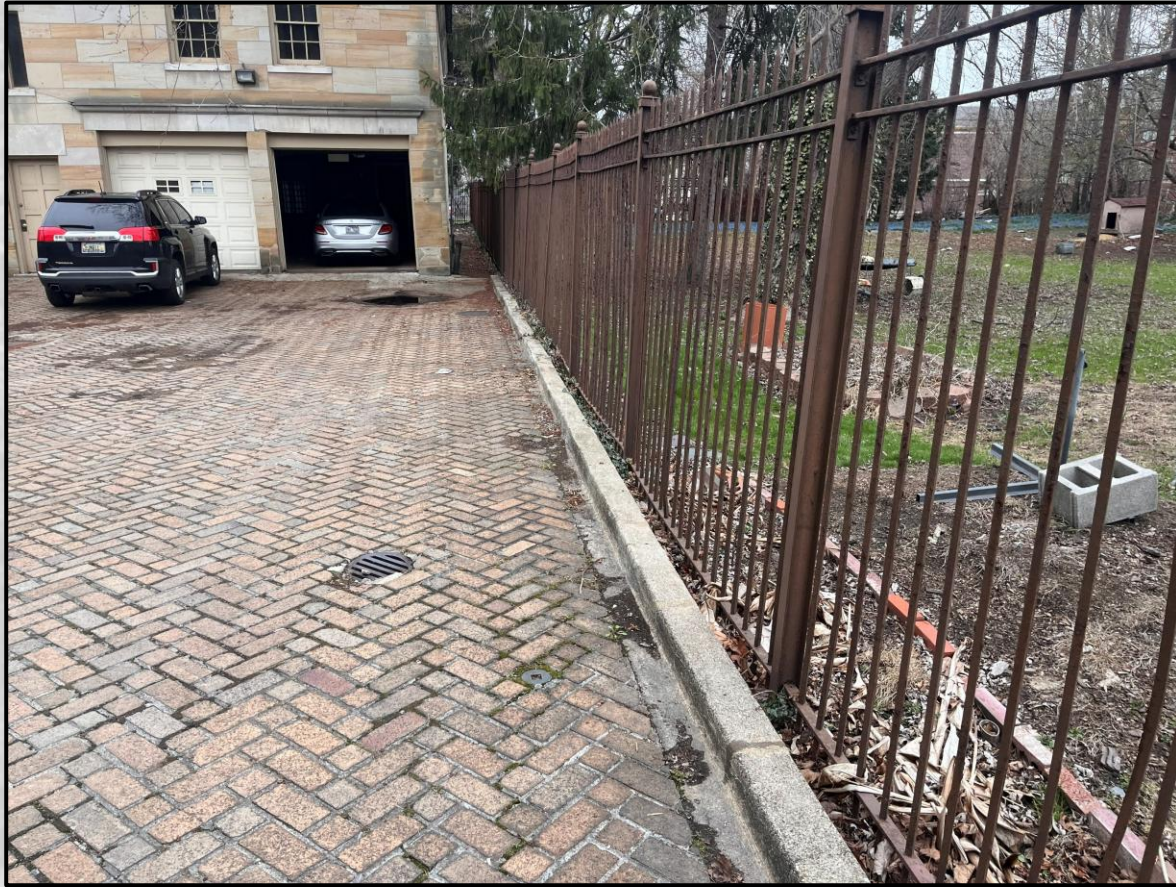
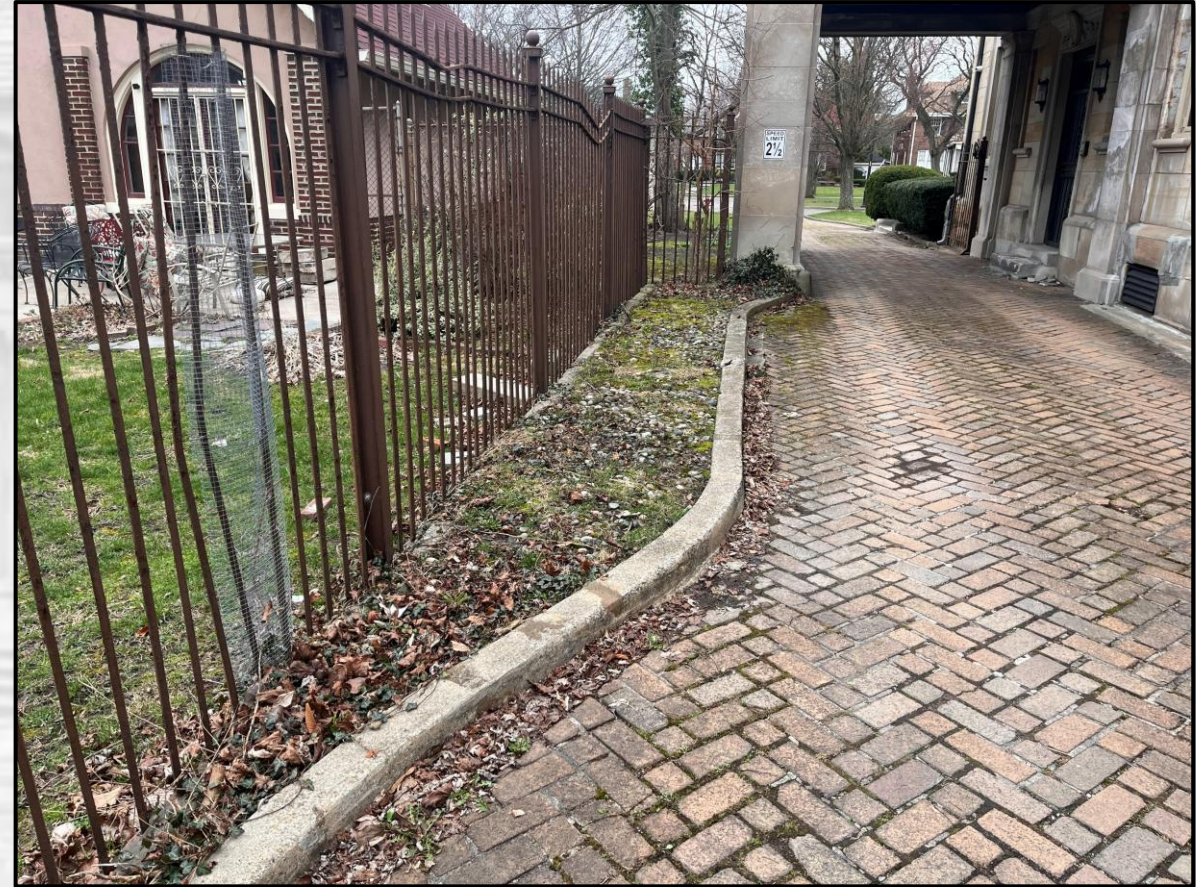
## Perimeter Fence

The perimeter fence is original and historic. Currently, sections of the fence are bent and broken due to fallen trees and damage throughout the years.

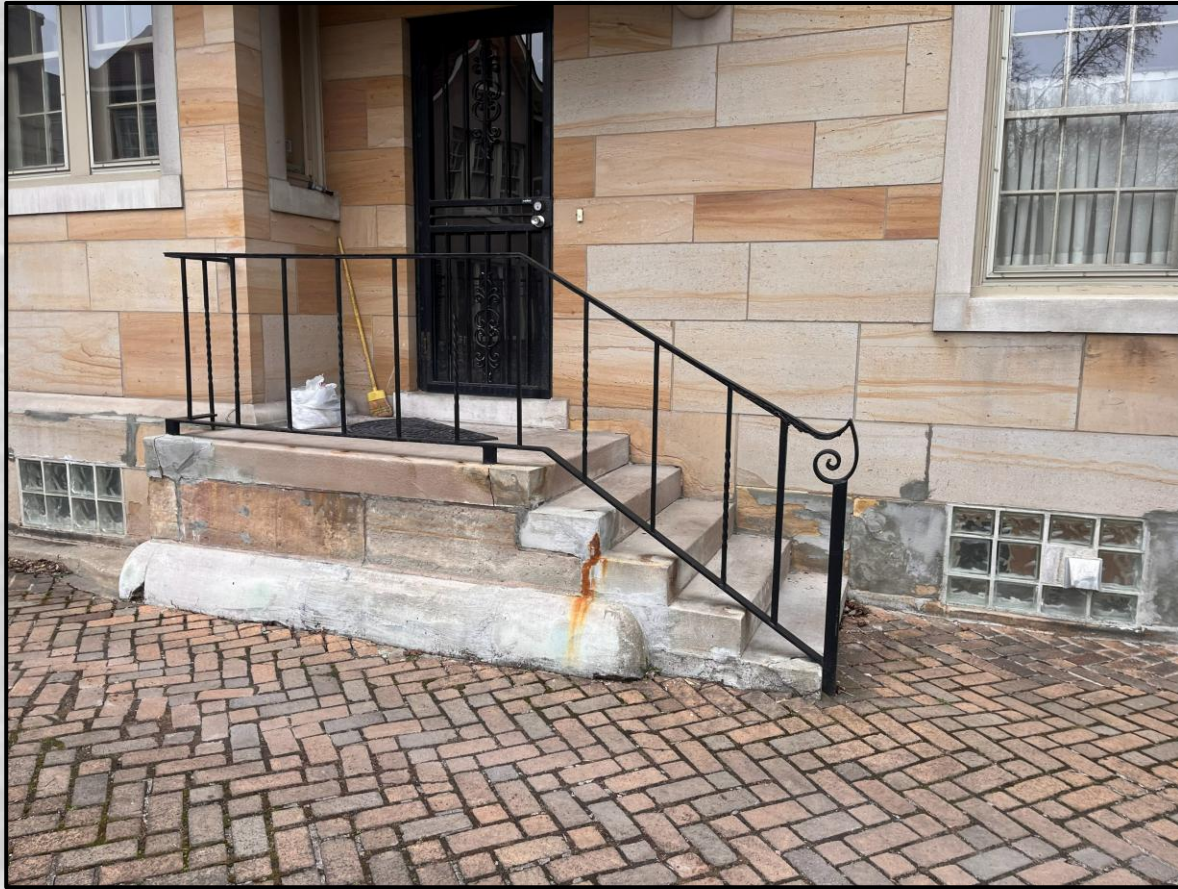
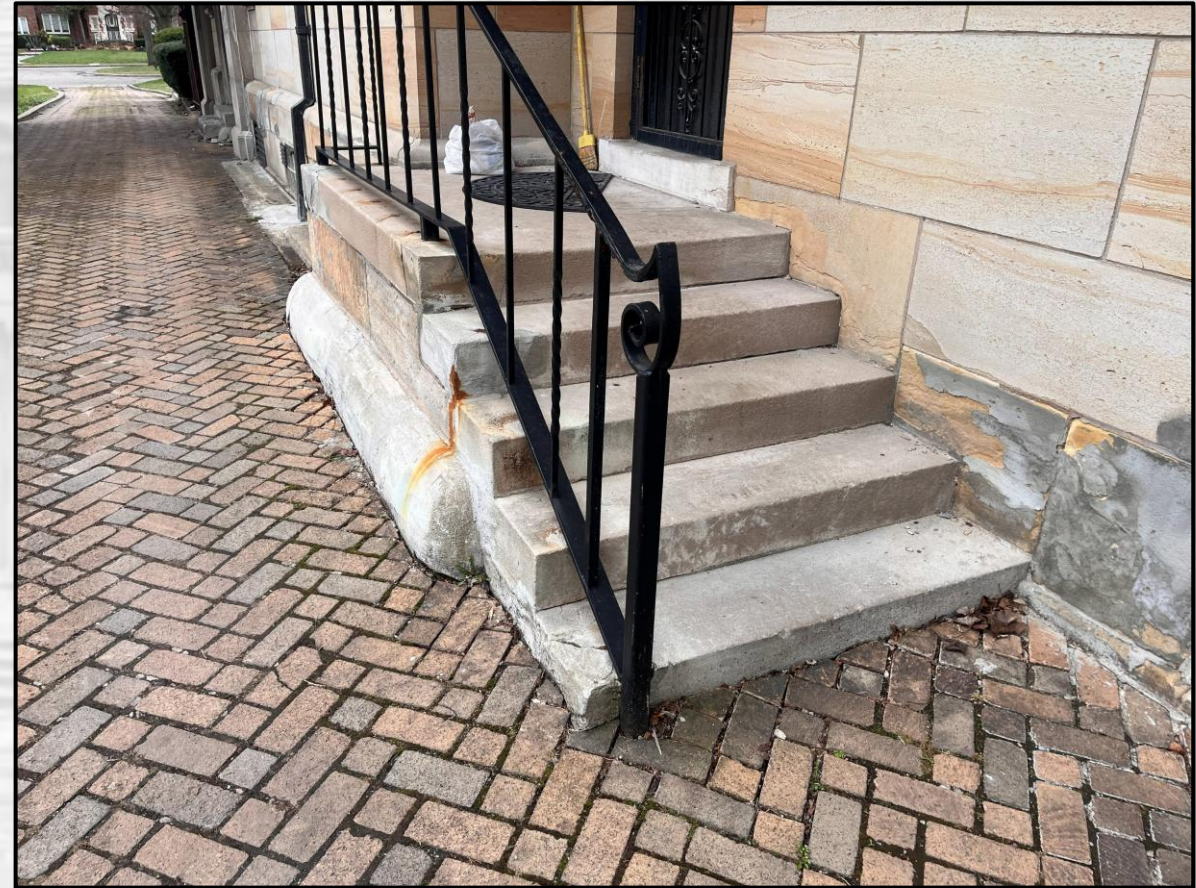
## Side Porch

The side porch and railing is historic. The concrete cap on the porch and steps is failing and in disrepair.
