HISTORIC DISTRICT COMMISSION APPLICATION FOR WORK APPROVAL

APPLICATION ID
HDC2026-00195

ADDRESS(ES): 1000 St Anne Street
HISTORIC DISTRICT: Ste. Anne's Parish Complex

Subject: HDC Application for Ste. Anne de Detroit: Exterior Restoration - Request for COA revision, Historic Wood Windows, Replacement Windows, and Basement Masonry Openings

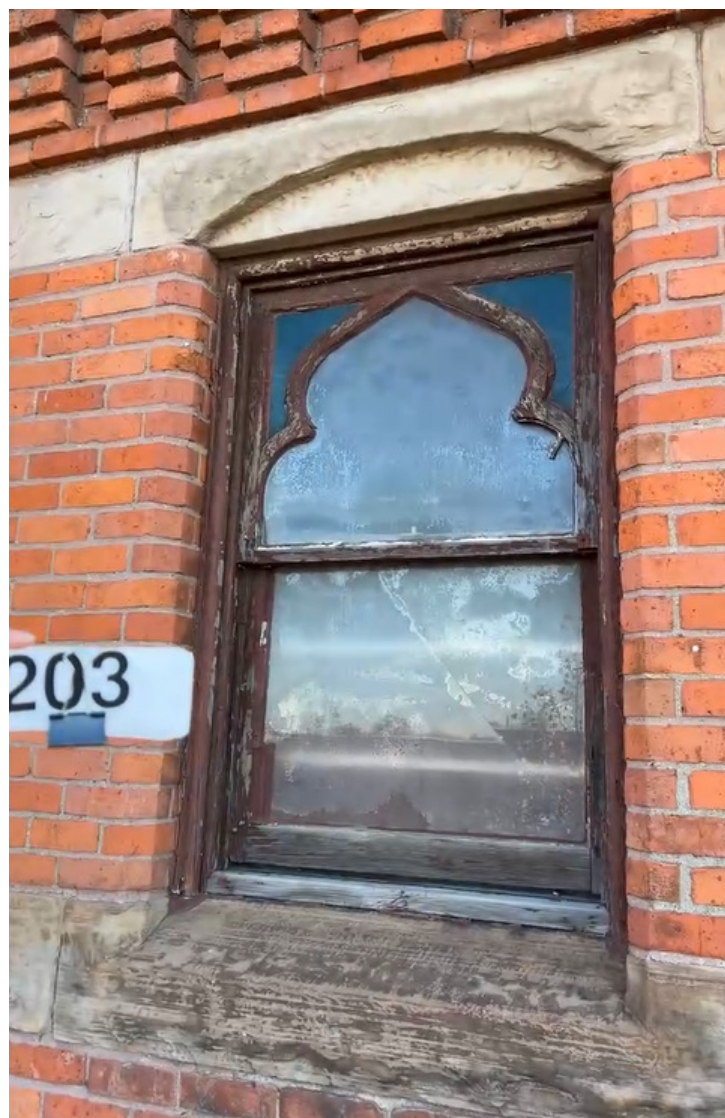
View of existing historic wood window #203 at Basilica (sacristy), 2nd floor, west elevation.

Windows #203, #204, and #205 are in very similar condition which is deteriorated beyond repair. The extent, depth and quantity of deterioration at each window is such that the quantity of dutchman and epoxy repairs would be so numerous that they are not likely to result in a sound functional window unit, and not likely to withstand the test of time. Also, while it may be possible to repair individual deteriorated window components, repair of deterioration beyond a certain level/extent - like that exhibited by these three windows - is not practical or reasonable. Replacement in kind, of an entire window that is too deteriorated to repair, using the physical evidence as a model for reproduction complies with the Secretary of the Interior's Standards and Guidelines.

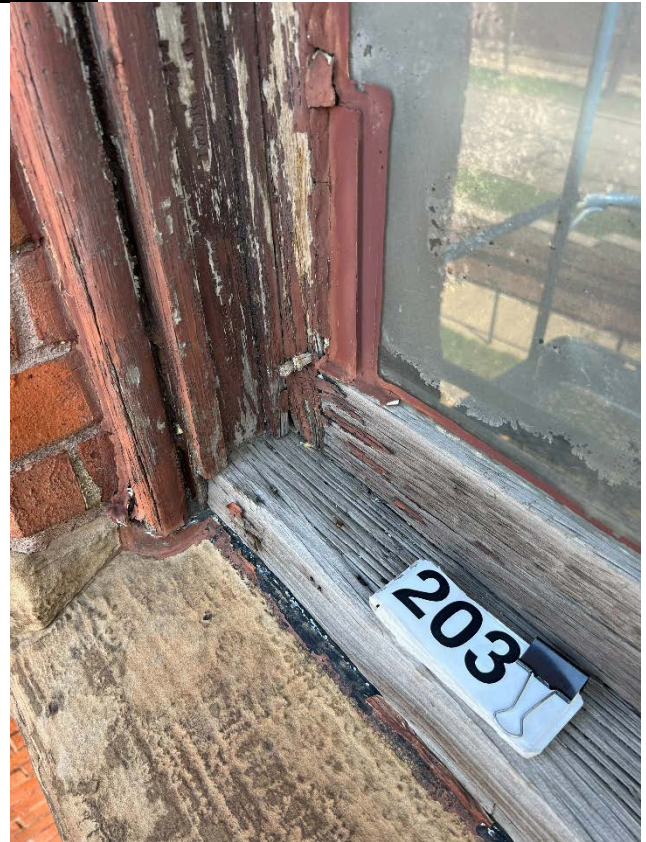
WINDOW #203 exterior elevation and detail views:

- Bottom 8" at both sides are split, rotted, and twisted from long-term moisture saturation. Dutchman repair is unlikely to result in sound functional frame; likely to impede sash operation.
- Parting stops, overall, are deeply checked, twisted, and have shrunk.
- Bottom 8" of brickmold at both sides are deeply checked and split.

- Meeting rail ends at both sides are deeply checked, rotted, and show evidence of shrinkage at joints which indicates breakdown of internal fiber structure. Structural integrity of joints has been lost.
- Side rail ends at both sides are deeply checked, split at joints with meeting rail, and are vertically displaced, resulting in failure. Structural integrity of joints has been lost.
- All wood tracery is deeply checked and dried out, extensive cracks exist parallel to grain, and the ends of tracery have shrunk away from the right-hand/south side rail.

- Deeply split/checked, as well as deep surface deterioration.

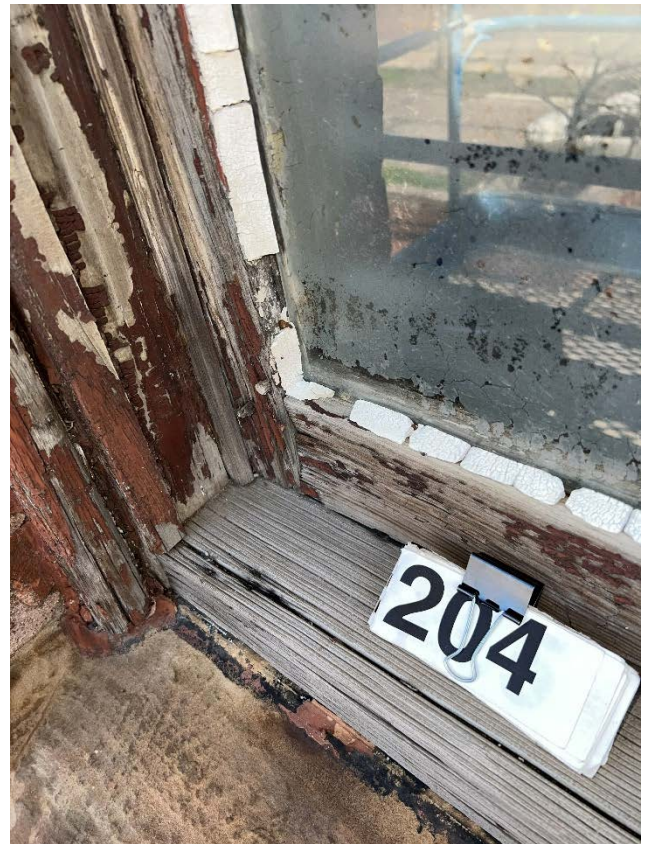
WINDOW #204 exterior elevation and detail views:

- Bottom 6" at both sides are split, rotted, and twisted from long-term moisture saturation. Dutchman repair is unlikely to result in sound functional frame; likely to impede sash operation.
- Parting stops, overall, are deeply checked, twisted, and have shrunk.
- Bottom 8"-12" of brickmold at both sides are deeply checked and split.

- Meeting rail is sagged at center which prevents proper locking.
- Meeting rail ends at both sides are checked and rotted. This checking extends to interior of component.
- Side rail ends at both sides are deeply checked, split at joints with meeting rail, and are vertically displaced, resulting in failure. Structural integrity of joints has been lost.
- All wood tracery is deeply checked and dried out, extensive cracks exist parallel to grain, pieces are missing, and ends of tracery have shrunk away from the side rails at both sides.

- Deeply split/checked, as well as deep surface deterioration.

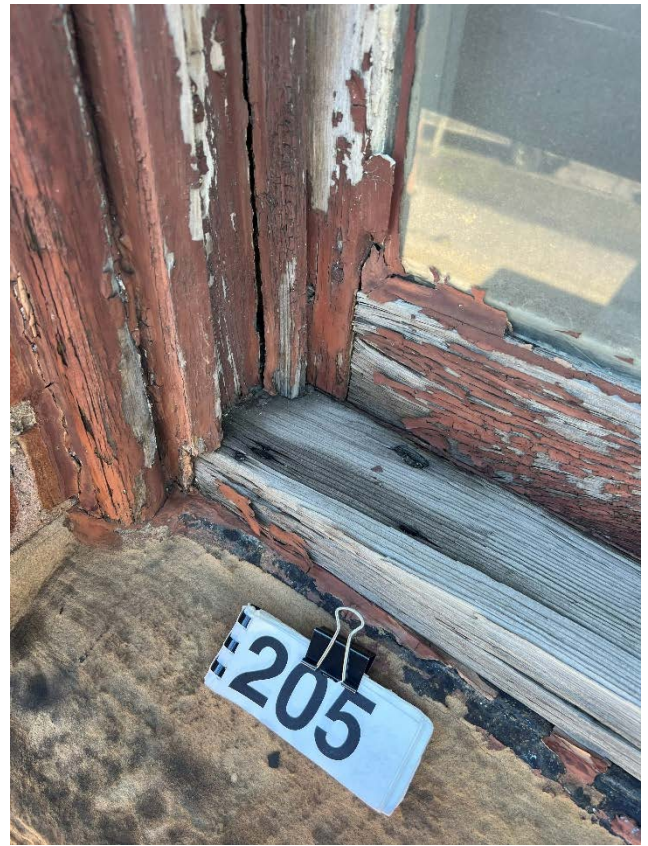
WINDOW #205 exterior elevation and detail views:

- Bottom 8" at both sides are split and rotted. Dutchman repair is unlikely to result in sound functional frame; likely to impede sash operation.
- Parting stops, overall, are deeply checked, twisted, and have shrunk.
- Bottom 2"-8" of brickmold at both sides are deeply checked and split.

- Meeting rail is sagged at center which prevents proper locking.
- Meeting rail ends at both sides are deeply checked, rotted, and show evidence of shrinkage at joints which indicates breakdown of internal fiber structure. Structural integrity of joints has been lost.
- Side rail ends at both sides are deeply checked, split at joints with meeting rail, and are vertically displaced, resulting in failure. Structural integrity of joints has been lost.
- All wood tracery is deeply checked and dried out, many cracks exist parallel to grain, and the ends of tracery have shrunk away from side rails on both sides.
