# HISTORIC DISTRICT COMMISSION APPLICATION FOR WORK APPROVAL

HDC2026-00439

**ADDRESS(ES):** 1459 Atkinson Street

**Siding & Windows Replacement**

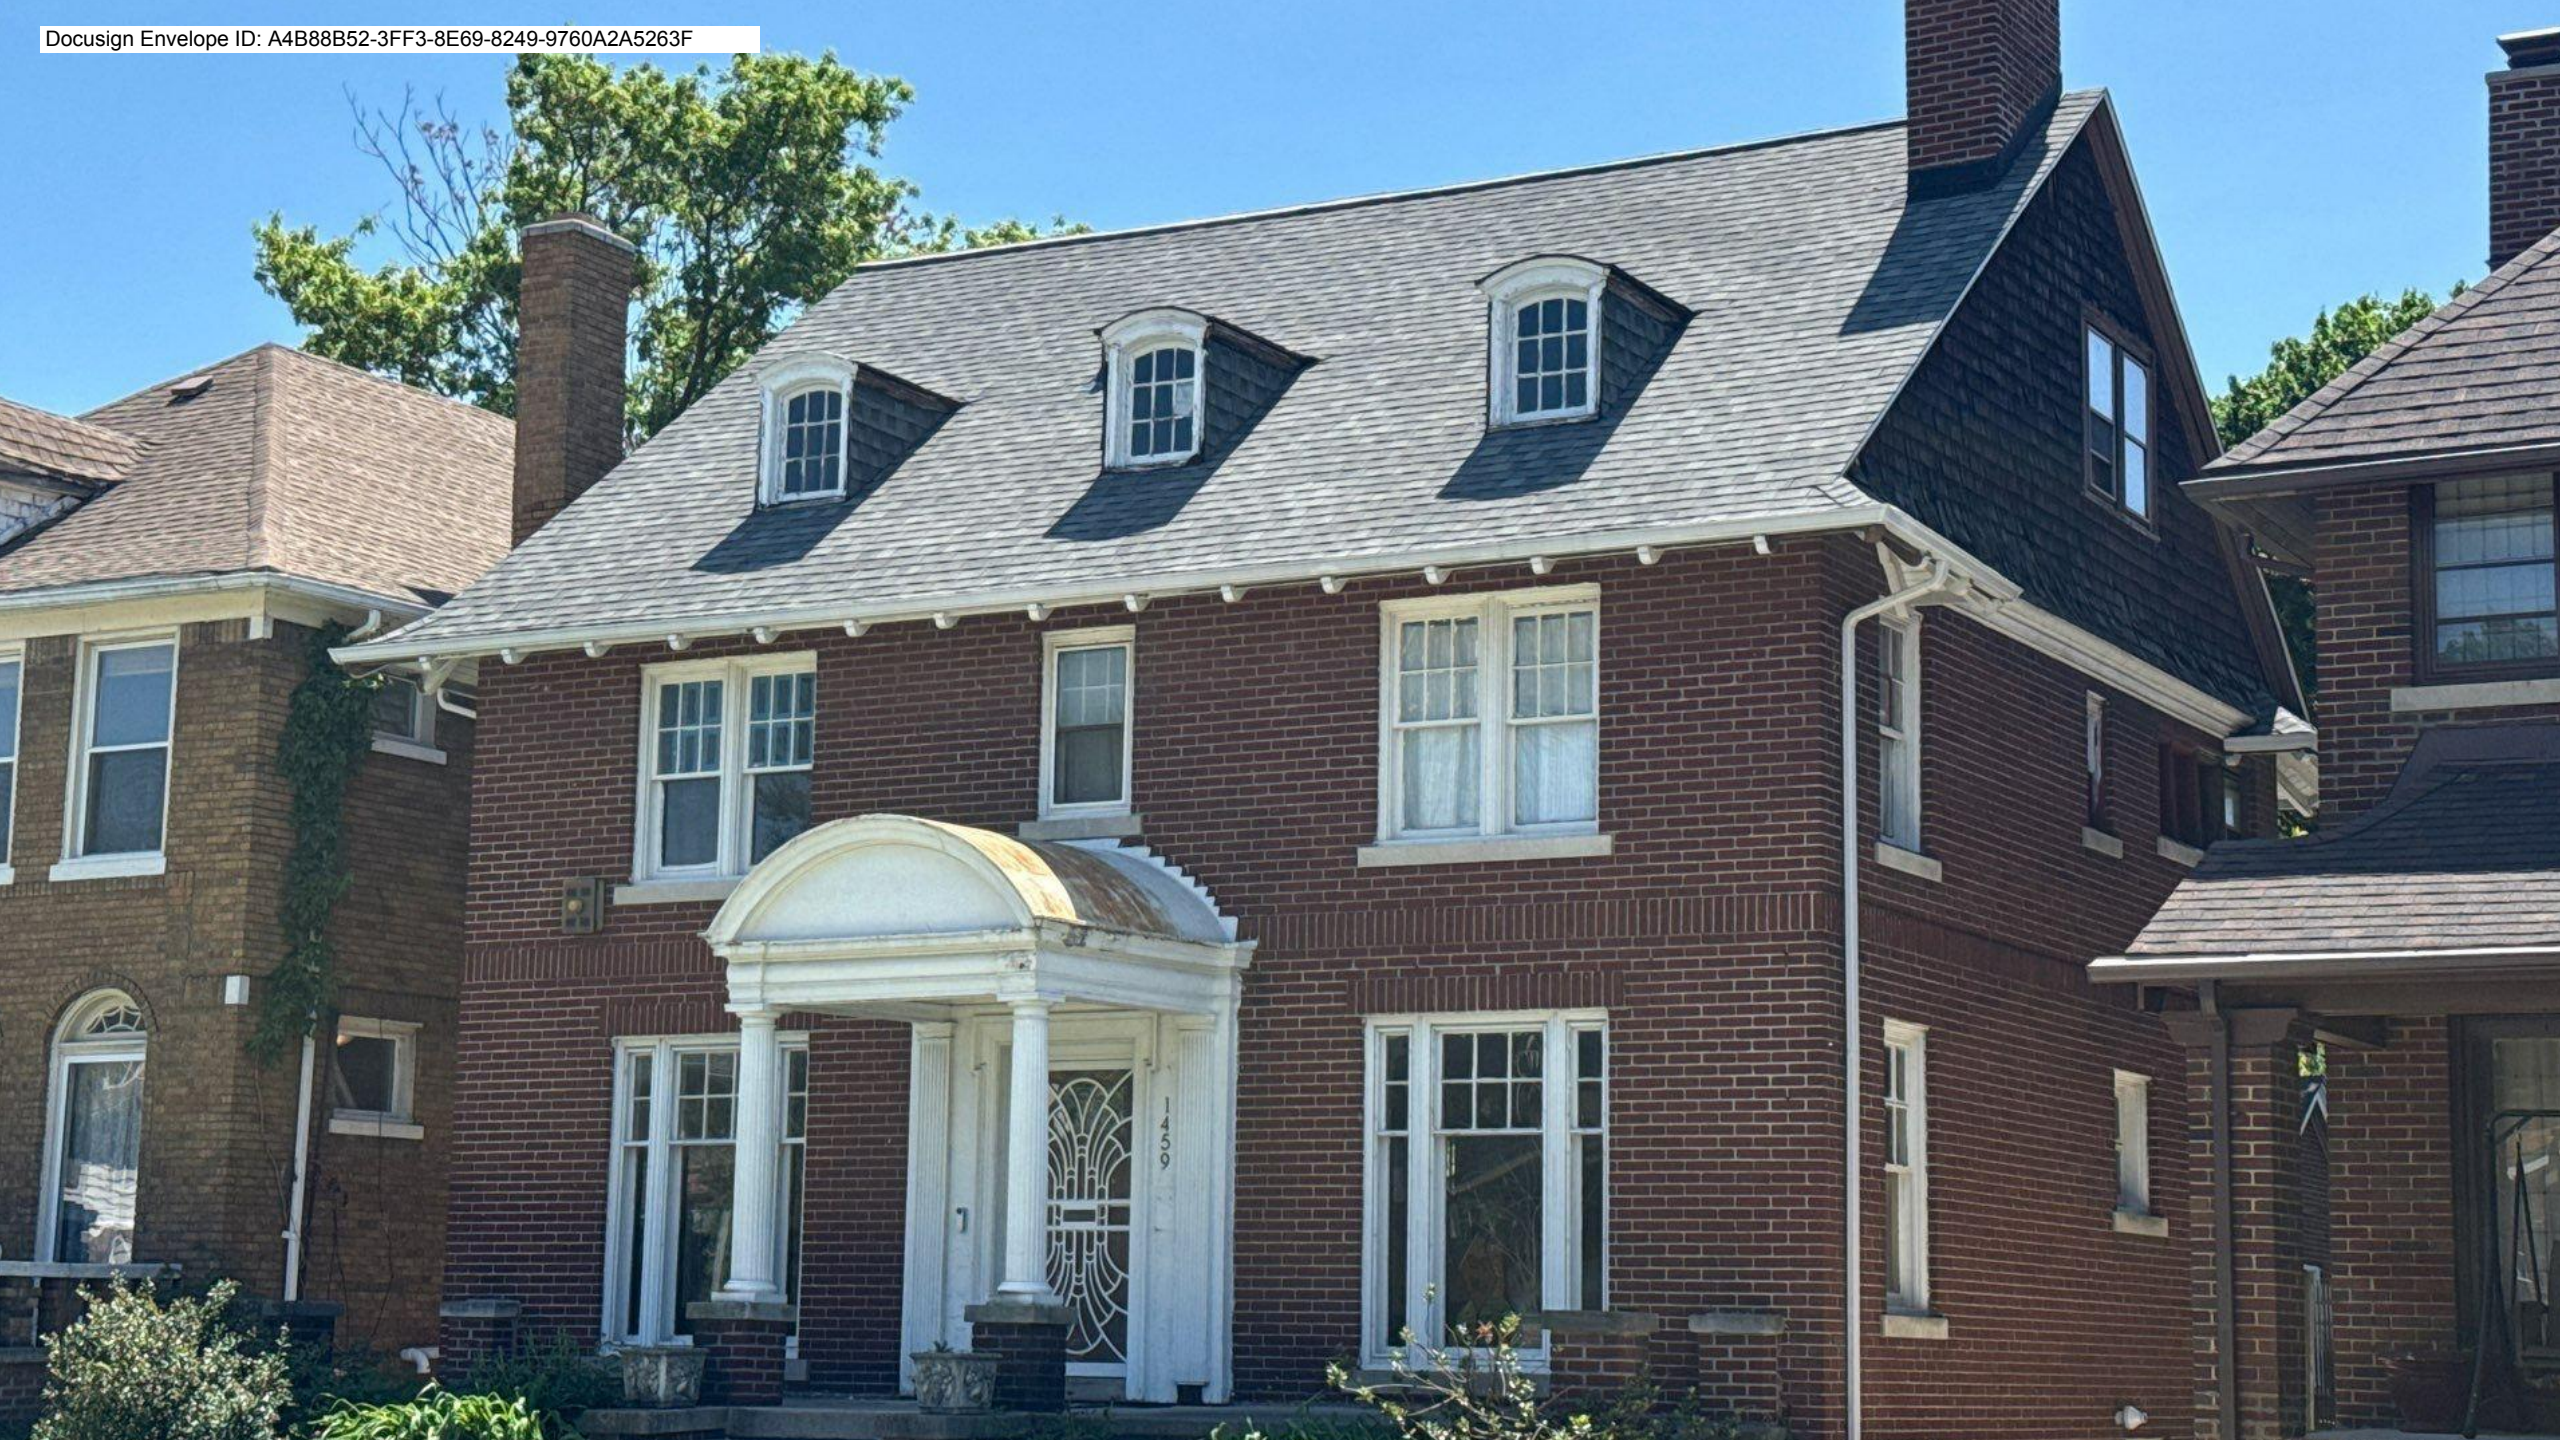
# Right Side Gable

- Rotting siding
- Missing pieces of siding
- Severe splitting
- Severe cupping

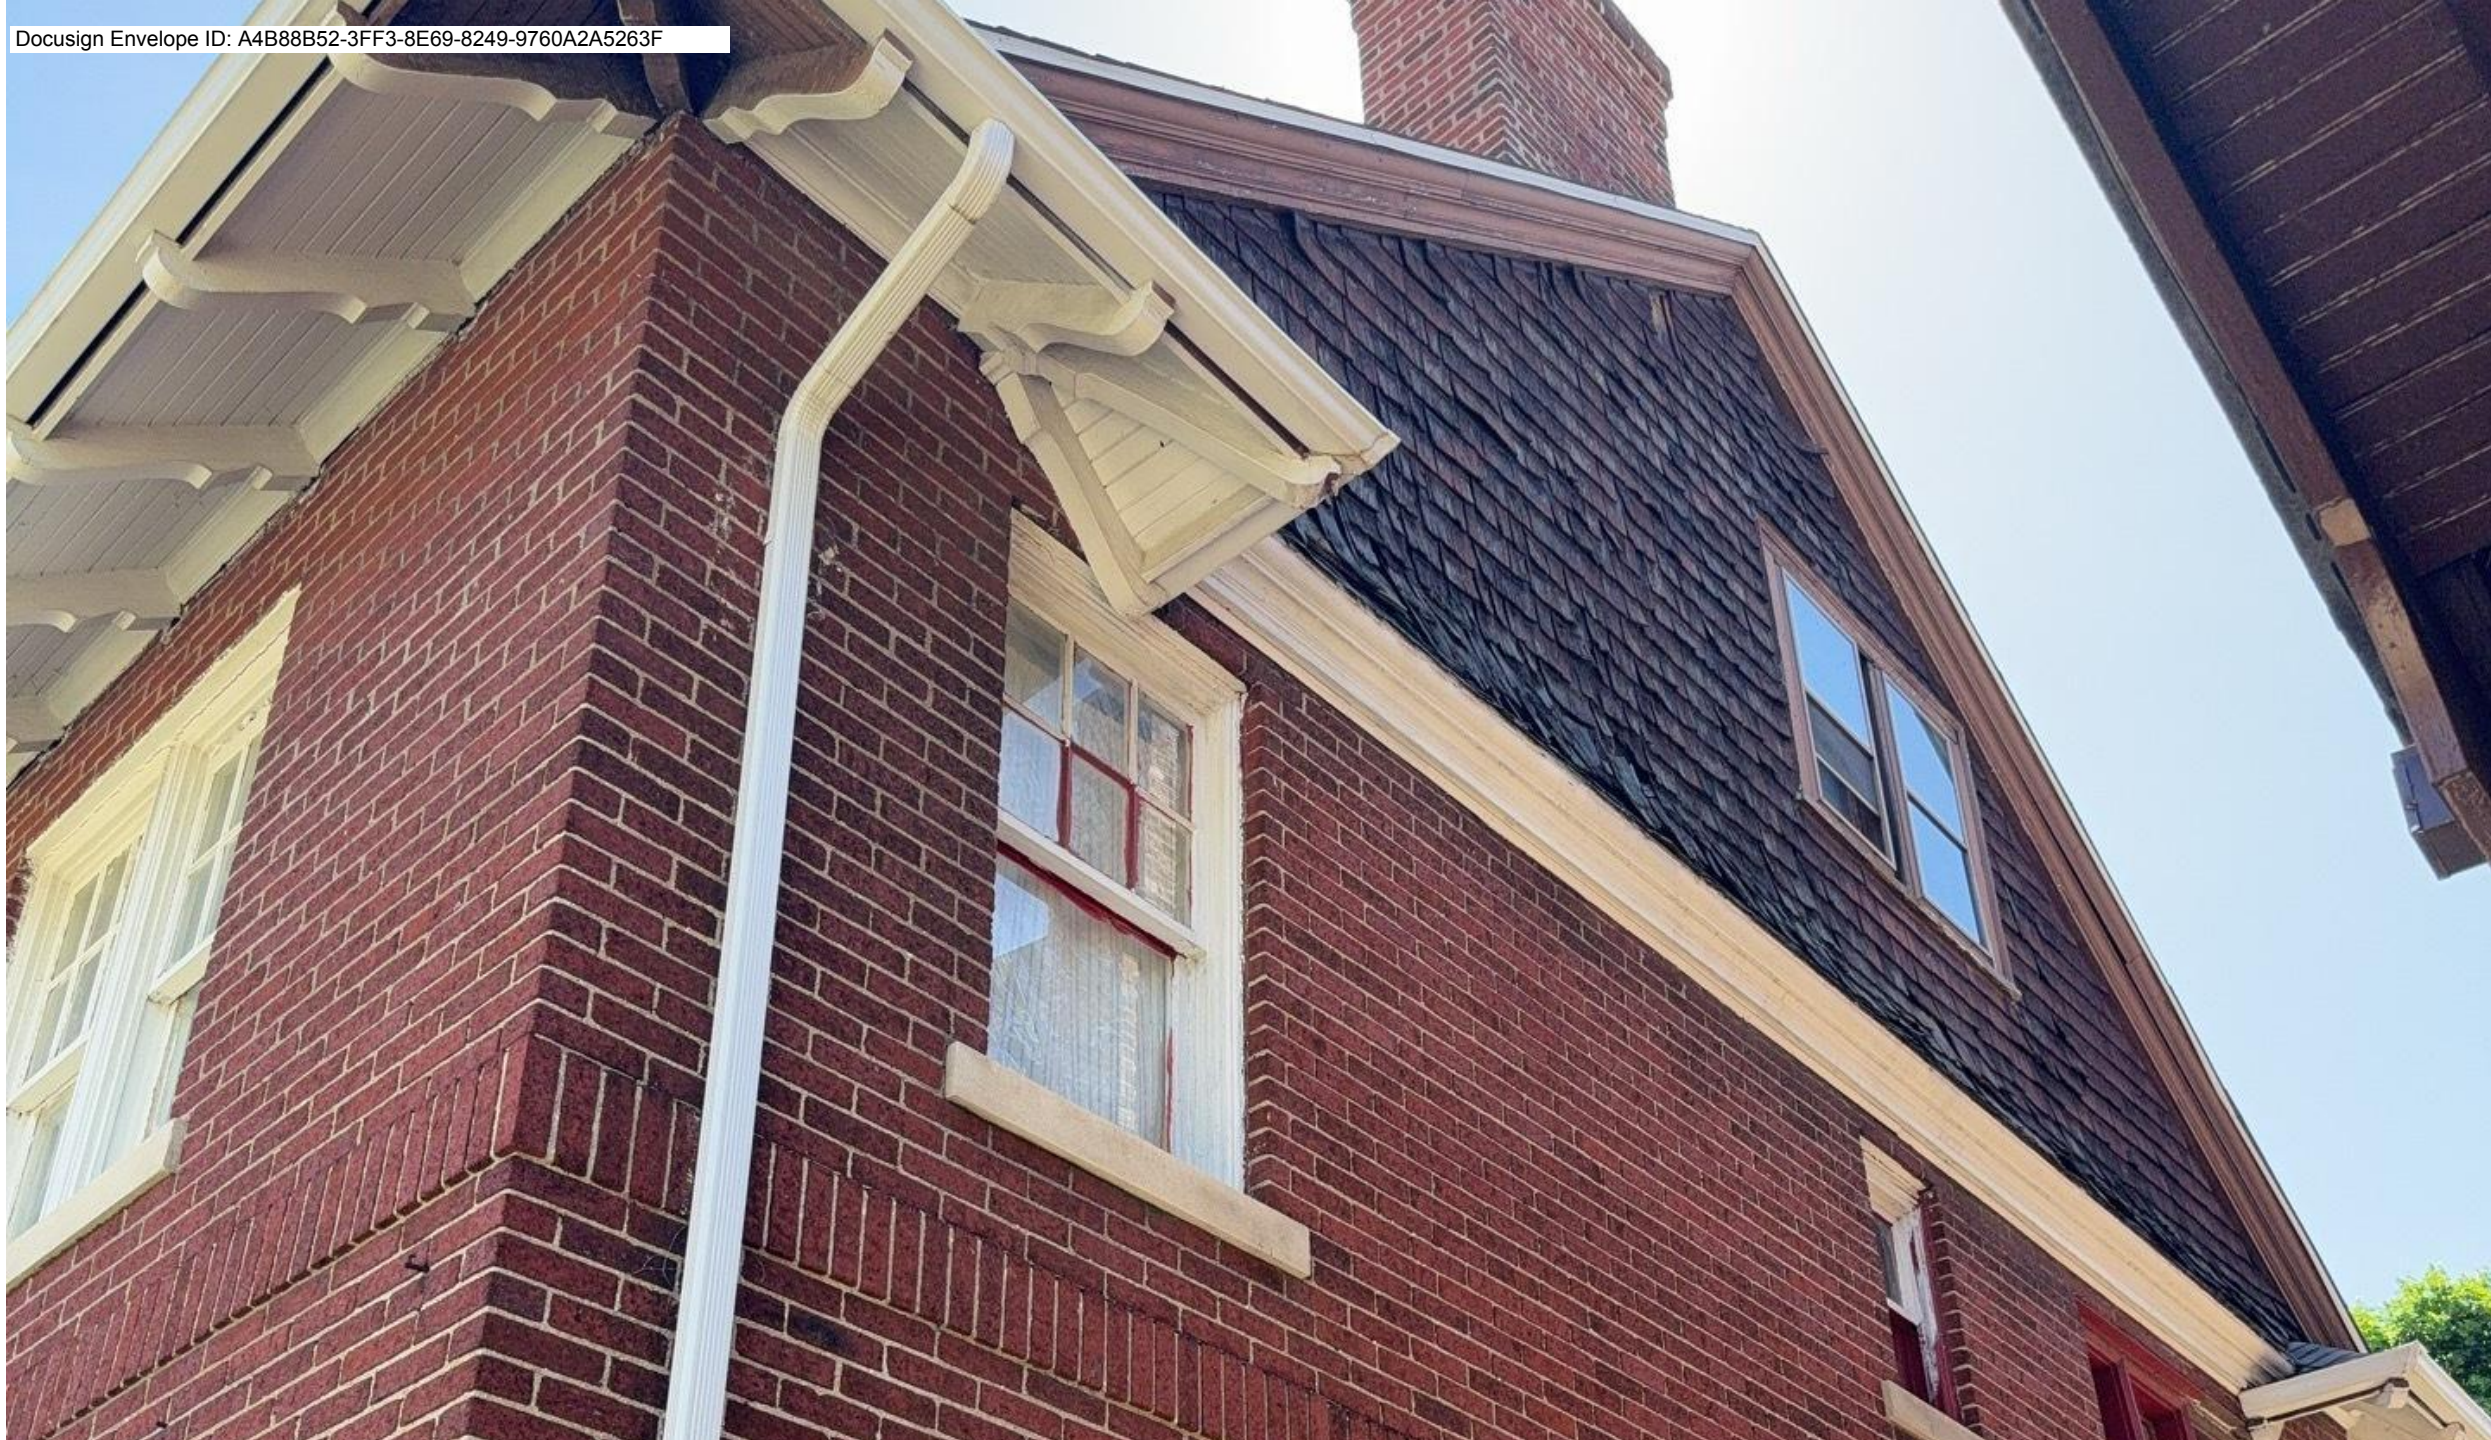
# Right Side Gable

- Deteriorating/Rotting siding (wood erosion)
- Missing pieces of siding
- Severe splitting
- Severe cupping

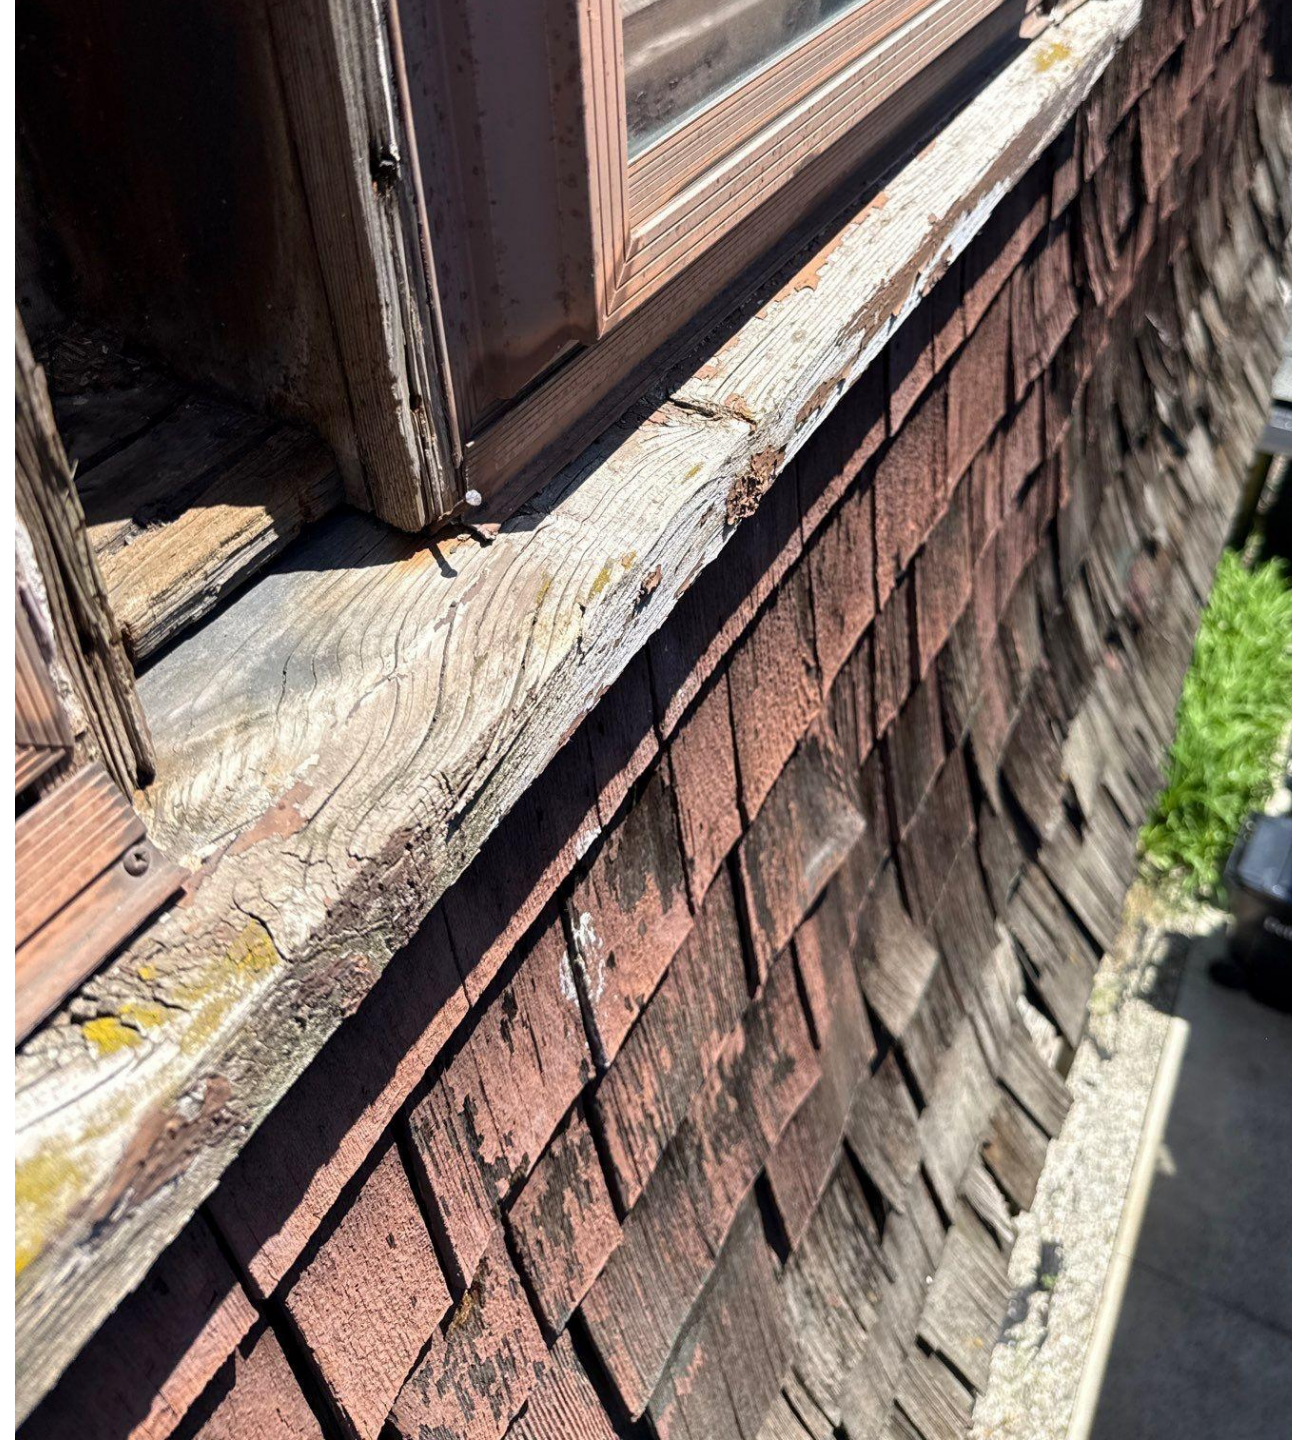
# Left Side Gable

- Rotting siding
- Missing pieces of siding
- Severe splitting
- Severe cupping

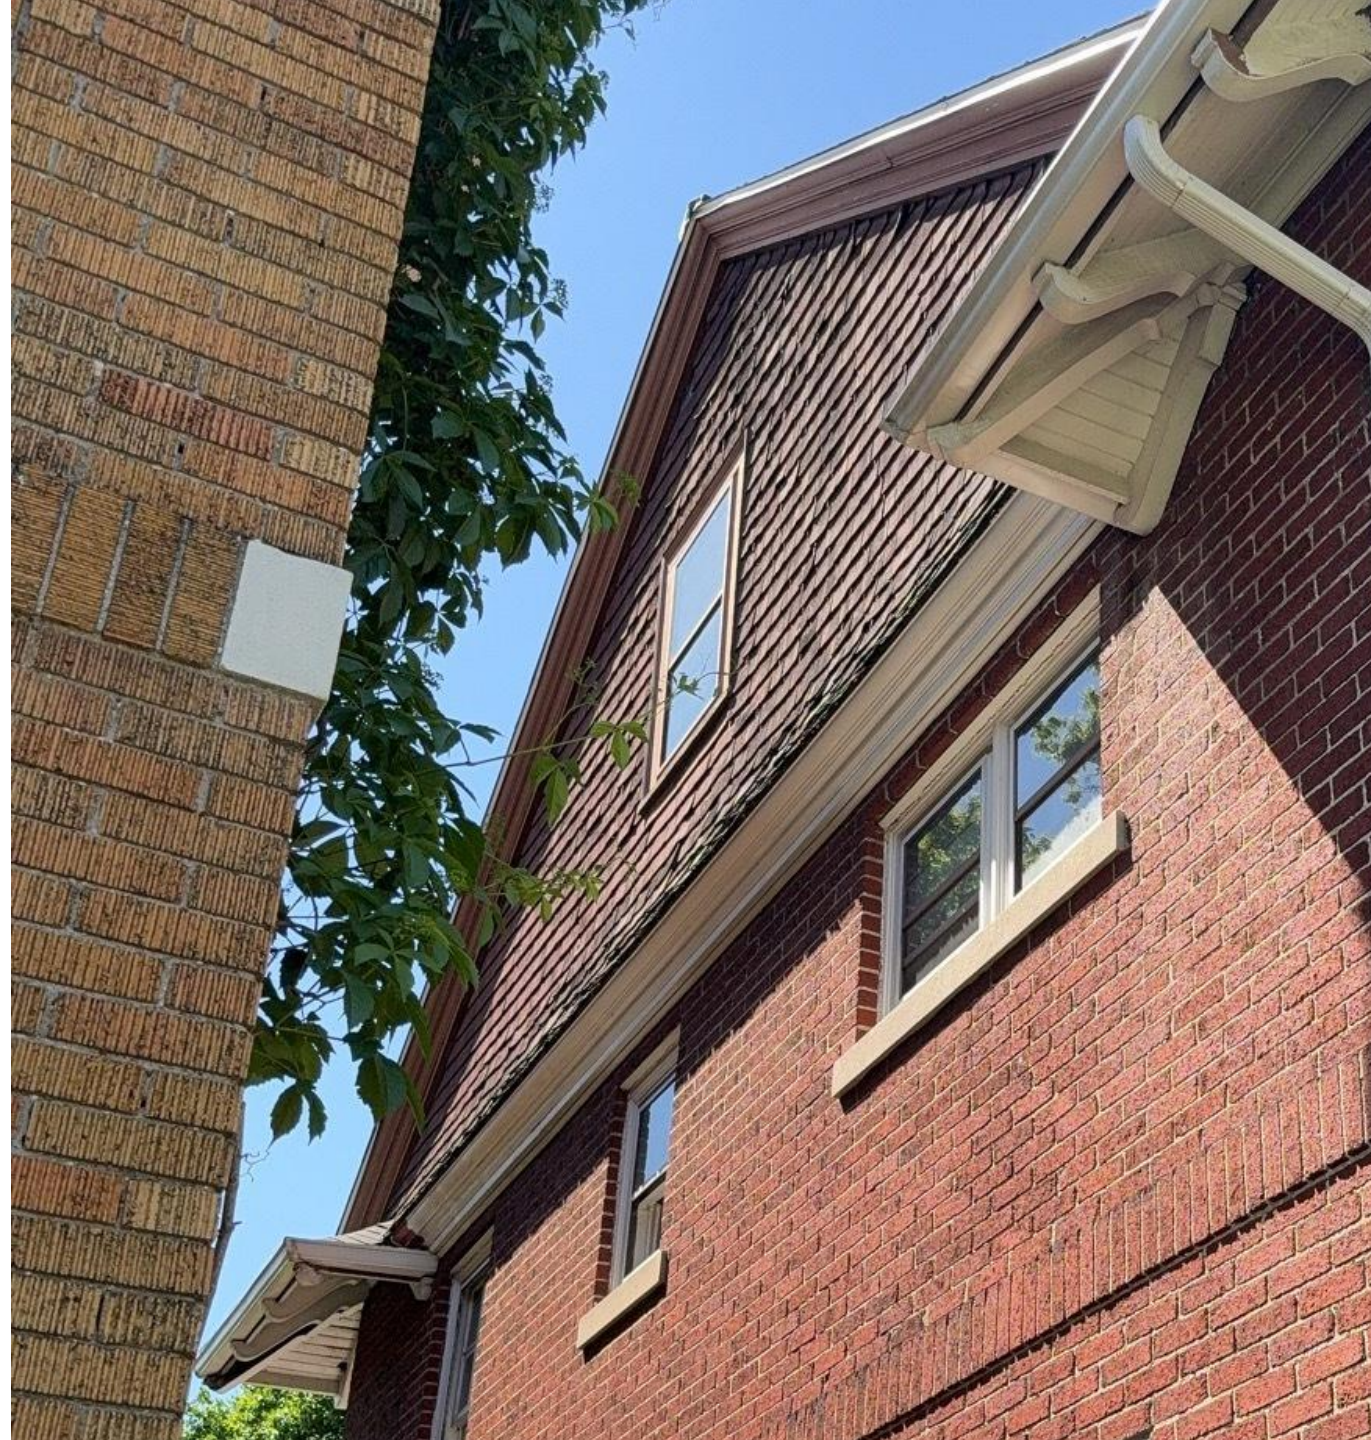
# Front Dormers #1-3

## Non-Compliant Condition:

Existing dormer wall surfaces do not comply with HDC guidelines regarding appropriate historic siding materials.

- Removal of non-historic alteration, installation of correct material (cedar shake siding):
  - Four (4) dormers currently feature asphalt roofing shingles applied vertically to the wall surfaces as a temporary siding substitute.
  - Dormer walls replaced with Common Natural Cedar Shake
  - This non-historic installation compromises the home's authentic architectural character and fails to comply with HDC guidelines.
  - Returning these dormer walls to natural wood Cedar Shake eliminates an improper material substitution and restores the home's historic rhythm and exterior integrity in full accordance with Standard 6.

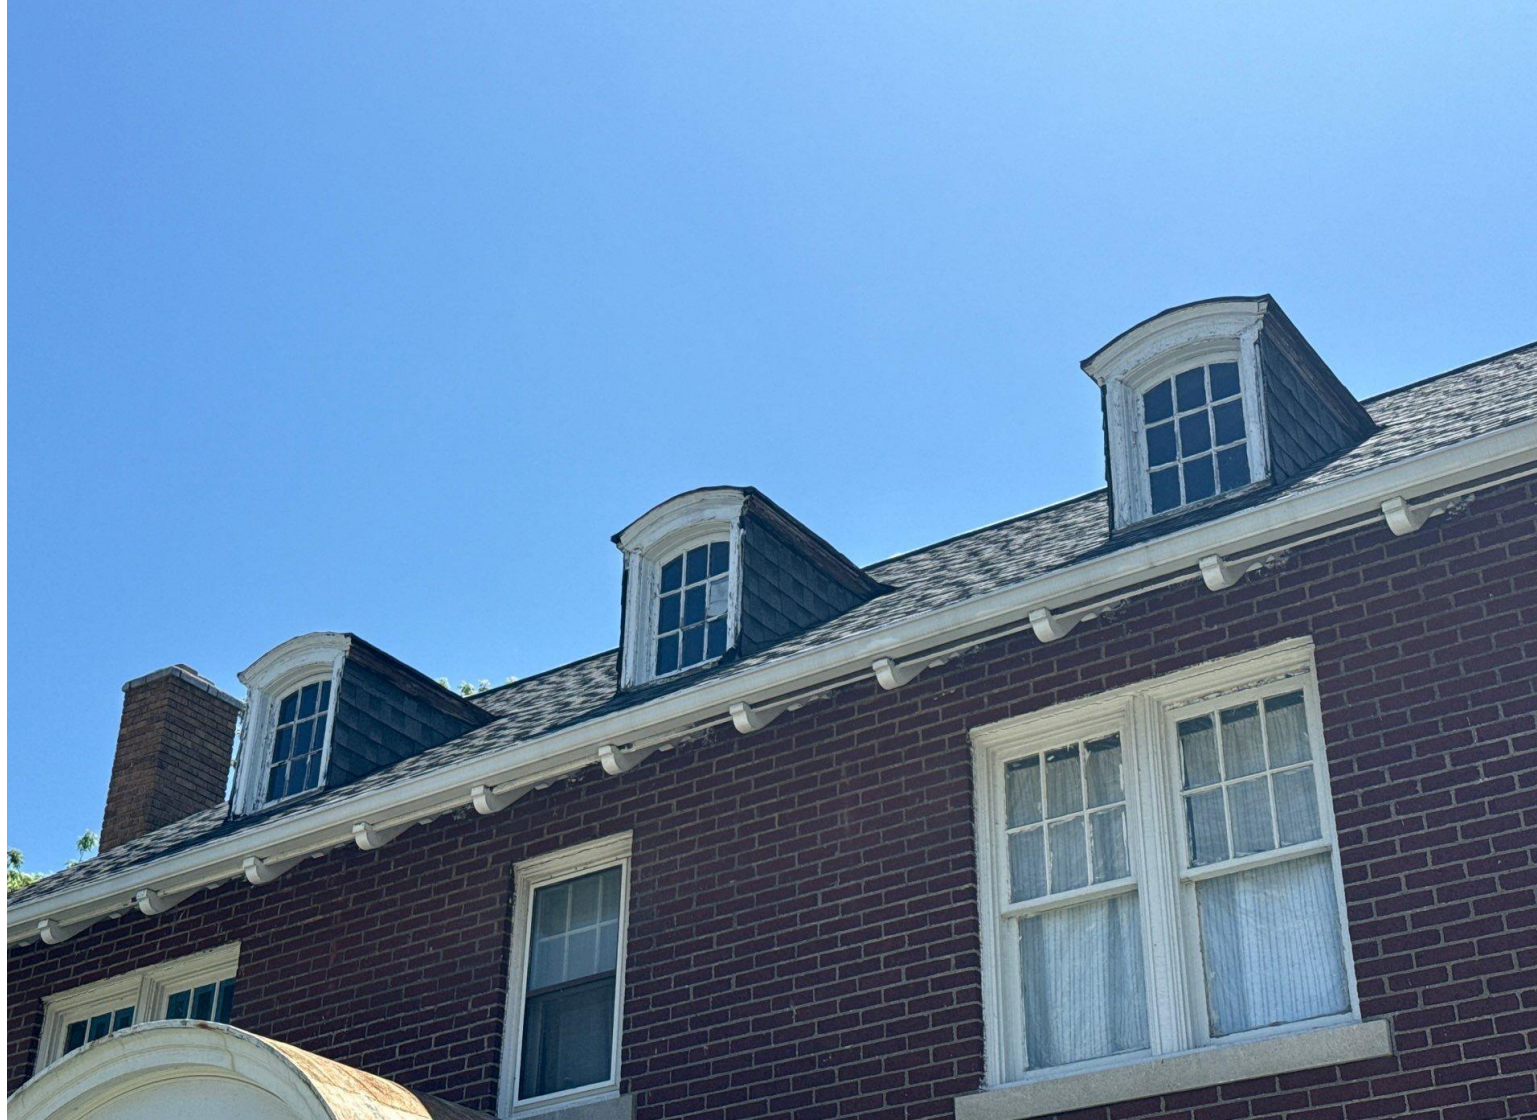
# Windows 1-3 (exterior)

Severe Structural Frame Deflection & Sagging Head Rails: High elevation exposure has caused significant downward deflection across all three arched heads, distorting the radii and creating visible perimeter air gaps along the dormer cheek intersections.

Widespread Paint Coating & Substrate Failure: Severe cracking, flaking paint, and bare, weathered timber across the curved head trim, casings, and sill assemblies expose critical joinery to uninhibited water entry.

Temporary Emergency Sealant Interventions (Center Unit): The center dormer shows clear interior/exterior emergency patching (plastic sheeting and tape visible through the lites) due to active envelope failure and shattered/separated glazing.

Technical Infeasibility of Restoration: High-elevation structural frame warping combined with deep substrate rot along the complex curved joinery renders spot repairs, scraping, or epoxy fills non-viable under Secretary of the Interior Standard 6.

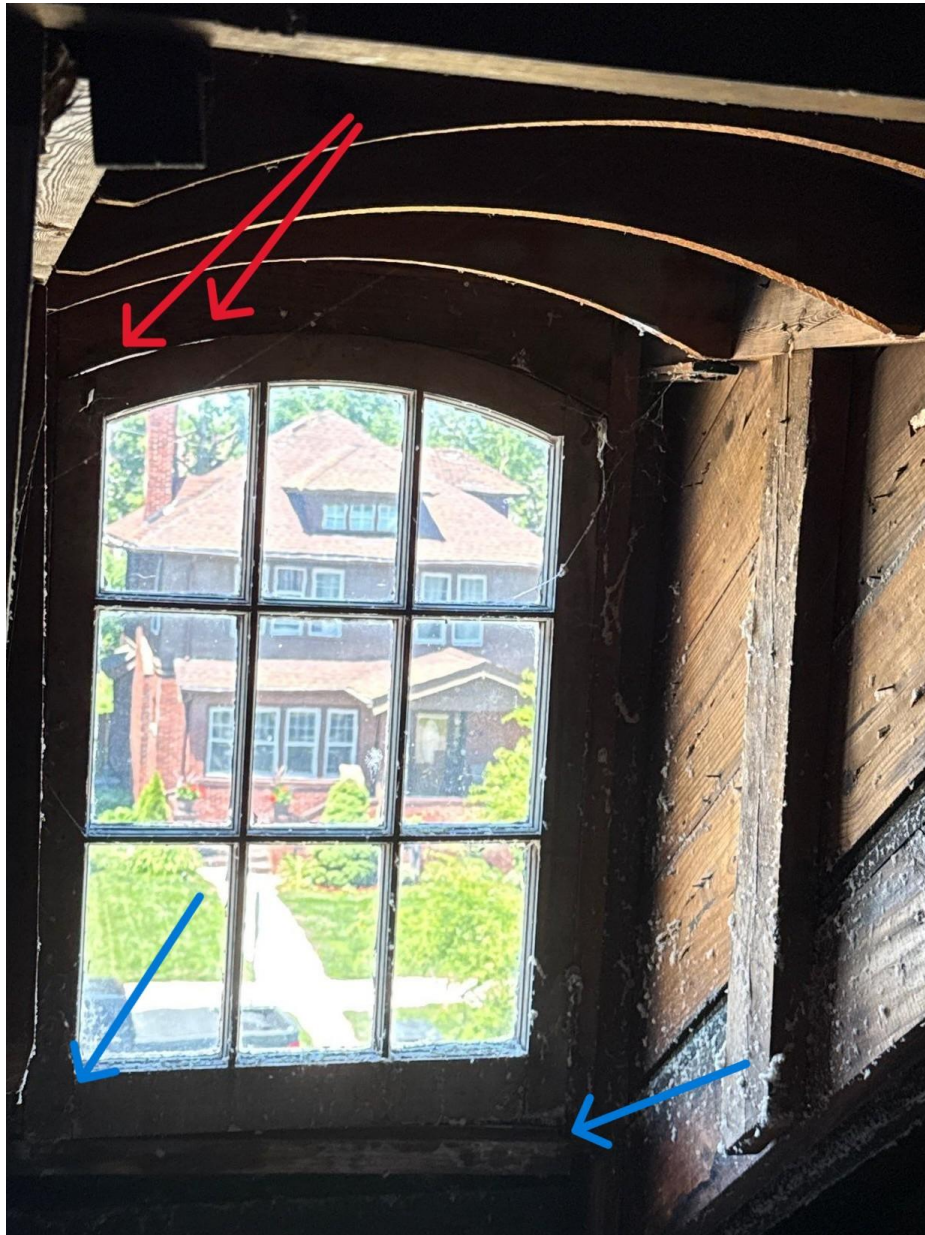
# Window 1

**Visible Envelope Failure (Red Arrows):** Direct daylight is visible along the upper arched head rail, demonstrating severe frame sagging and sash deflection over time.

**Inability to Weather-Seal:** The structural separation along the arched top rail creates an unsealable gap that permits continuous bulk water and air infiltration into the wall cavity and interior framing.

**Rotted Wood & Drainage Failure (Blue Arrows):** Severe timber decay and persistent moisture damage along the lower sash rail and sill assembly demonstrate improper water shed and irreparable wood rot.

**Technical Infeasibility of Repair:** Due to permanent warping of both the window frame and the arched top sash rail, weatherstripping or surface repairs cannot restore an airtight seal or structural integrity, rendering full restoration technically infeasible.

**Proposed Remediation:** Replacement with a custom-built, arched Sierra Pacific aluminum-clad wood window engineered to match the exact radius, glass plane depth, and 9-lite grid pattern (3V2H with radius top) of the original unit.

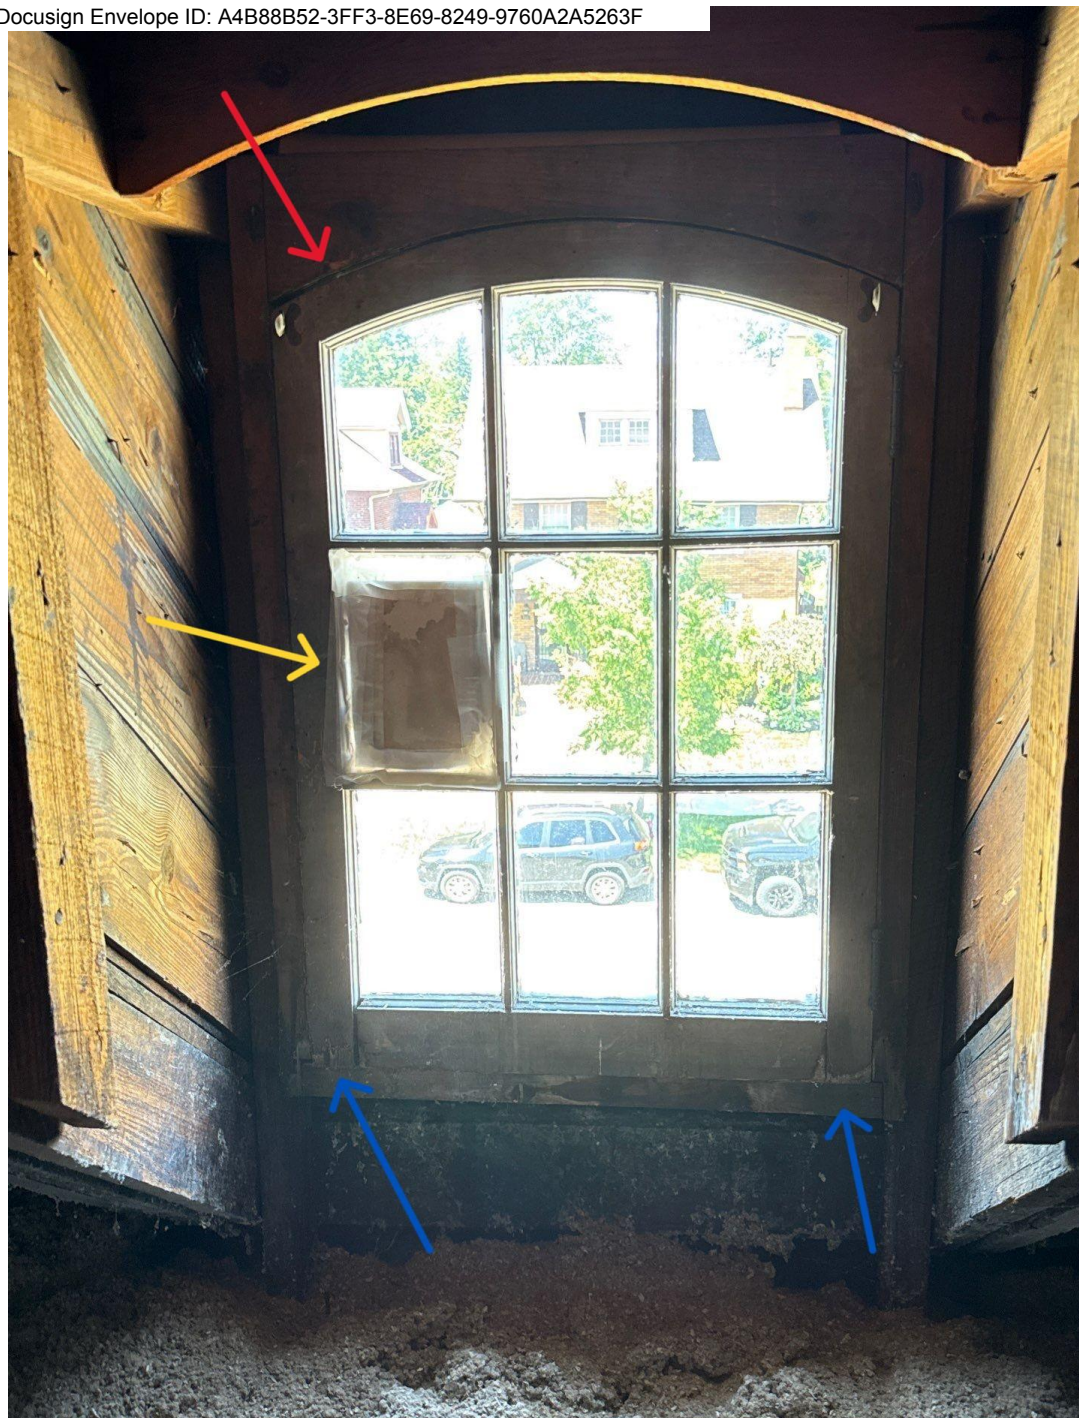
# Window 2

Red Arrow (Air Gap & Frame Deflection): Structural sagging along the arched head rail creates a continuous perimeter gap, permitting direct daylight and air infiltration into the building envelope.

Yellow Arrow (Temporary Seal & Glass Failure): Active envelope failure and draft leakage mandate temporary plastic sheeting over the pane to prevent moisture and cold air intrusion into the interior.

Blue Arrows (Rotted Wood & Drainage Failure): Severe timber decay and persistent moisture damage along the lower sash rail and sill assembly demonstrate improper water shed and irreparable wood rot.

Infeasibility of Repair: Advanced rot at the lower joinery combined with upper frame warping renders epoxy patching and weatherstripping technically non-viable under Standard 6.

In-Kind Replacement: Custom-built Sierra Pacific aluminum-clad wood unit strictly matching the original arched head radius, 9-lite grid configuration, and putty-profile SDLs.

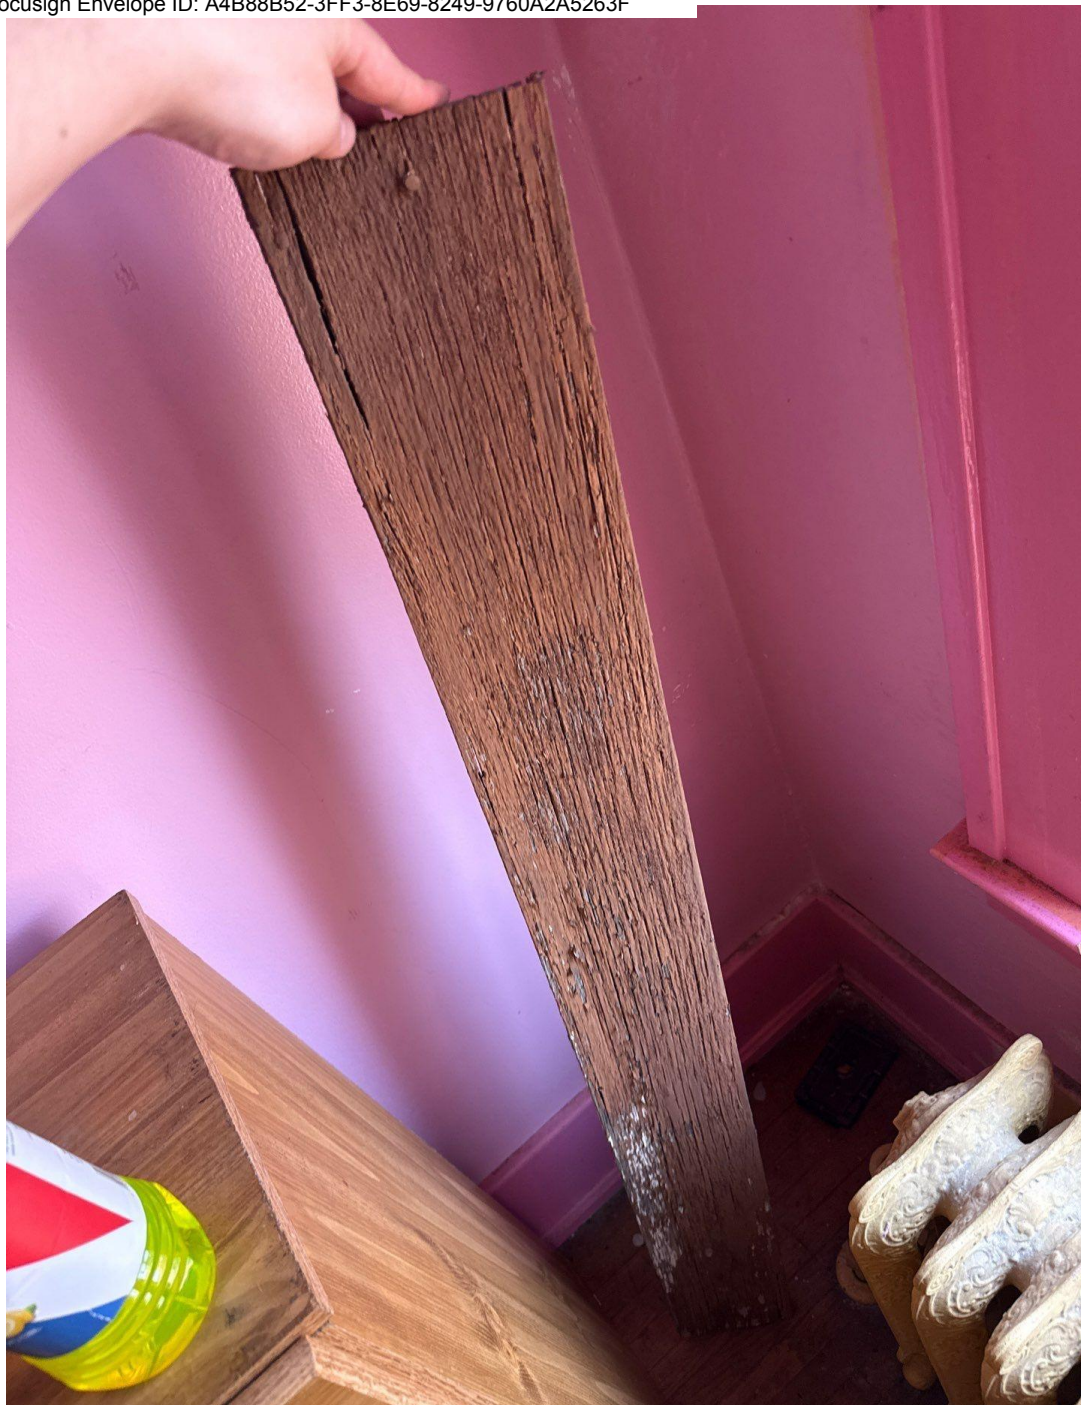
# Window 4/5

Material Failure & Separation: Original exterior window casing/trim has completely detached from the building facade due to fastener corrosion and substrate rot.

Loss of Weather Barrier: Complete absence of exterior trim leaves the window frame perimeter fully exposed to driving rain and bulk water infiltration into the wall assembly.

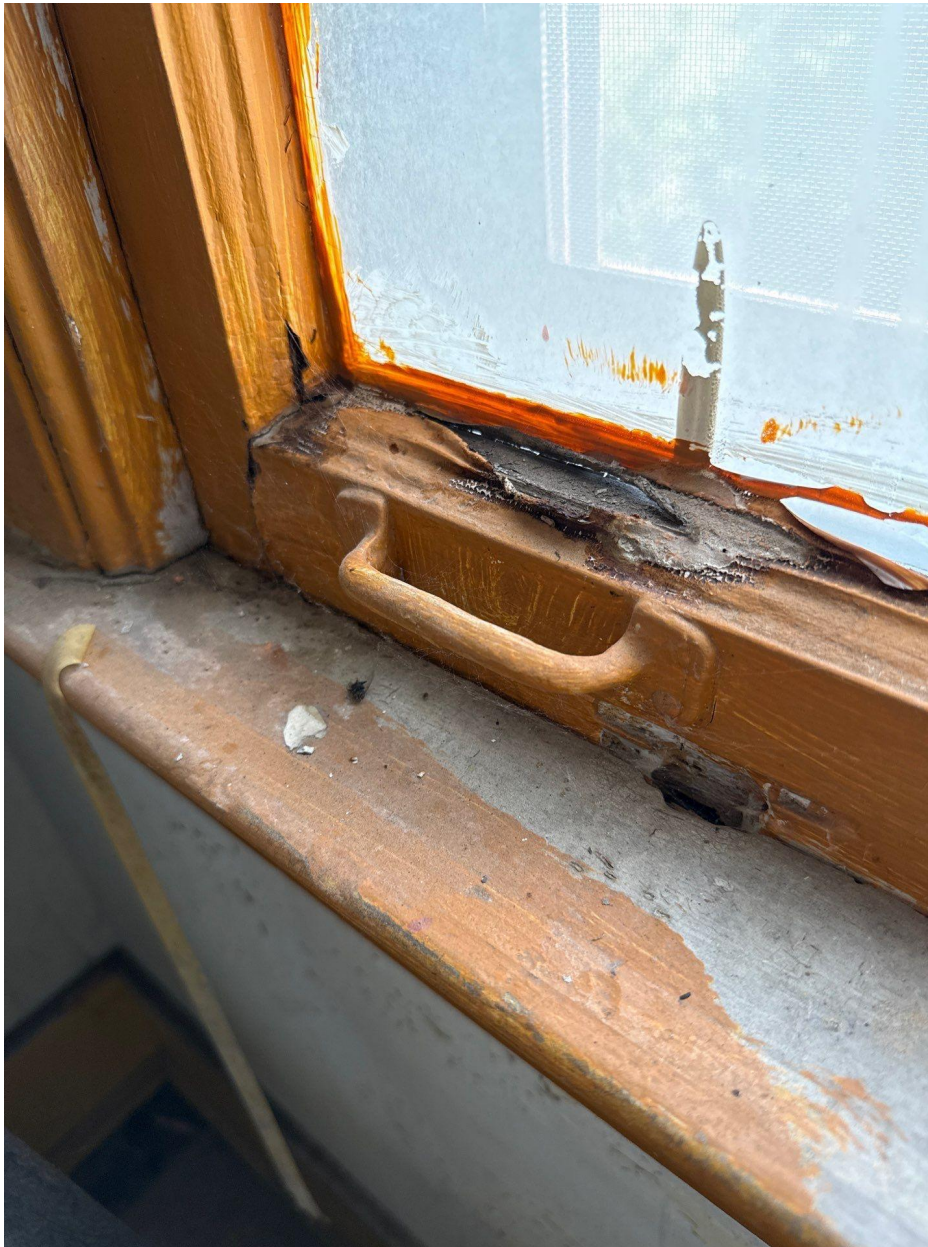
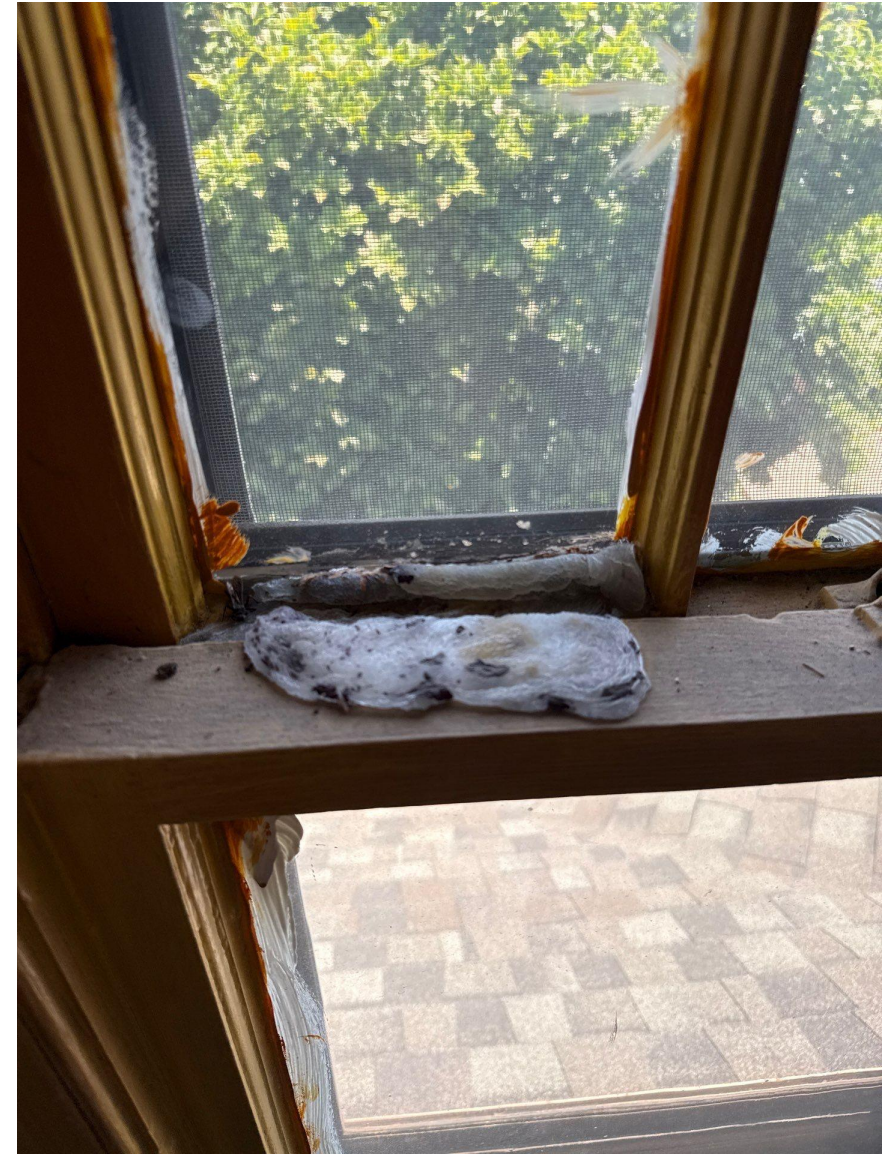
# Window 6/7

Severe Structural Wood Rot: Advanced rot, timber delamination, and dark decay along the lower bottom rail, stile joinery, and inner sill demonstrate complete material breakdown.

Operability & Egress Failure: The upper and lower sashes are permanently bound and seized shut due to severe structural frame racking and severe wood rot, eliminating required natural ventilation and emergency egress capability under local building safety codes.

Glazing Bed & Putty Failure: Complete failure and deterioration of original glazing putty around the bottom glass perimeter, exposing bare wood channels to continuous water trapping.

Ad-Hoc Weather Seal Interventions: Presence of makeshift sealant highlights active bulk water infiltration and severe envelope failure.

Infeasibility of Restoration: Extensive organic decay at critical structural joints renders epoxy consolidation non-viable under Secretary of the Interior Standard 6.

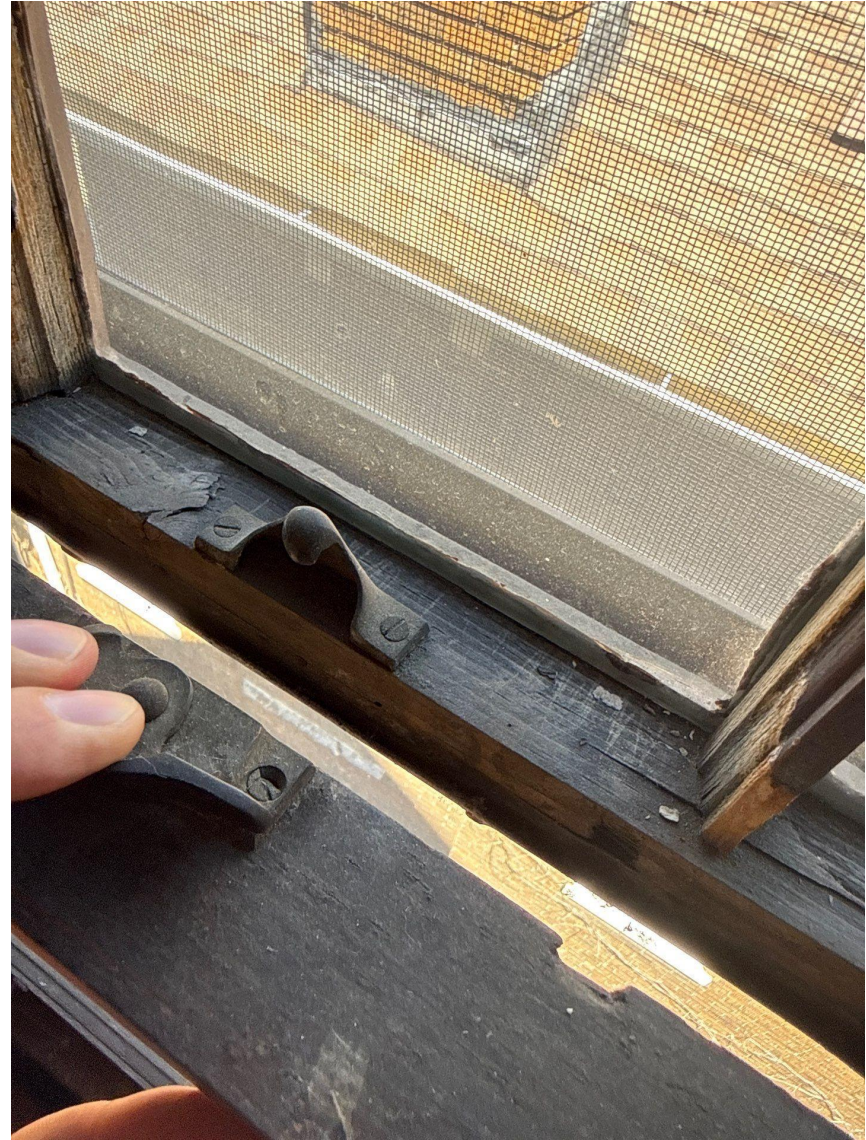
# Window 8

Complete Structural Fracture Due to Rot: Advanced timber decay has completely rotted through and fractured the bottom sash rail, severing the structural frame component and making sash alignment impossible.

Frame Deflection & Perimeter Air Gap: Severe frame out-of-square and sash deflection create a continuous vertical gap along the side jamb (held with tape), allowing direct draft and bulk water infiltration into the wall cavity.

Sash Stile Splitting & Wood Decay: Deep vertical grain checking and wood fiber loss along the sash stile compromise the structural integrity required to hold glass safely.

Sash Lock Alignment Failure: Because the rotted bottom rail can no longer support the sash structure, the meeting rail sweep lock cannot align or engage to secure the window shut.

Technical Infeasibility of Repair: Complete loss of structural wood density from rot renders epoxy consolidation or splicing non-viable under Secretary of the Interior Standard 6.
