# HISTORIC DISTRICT COMMISSION APPLICATION FOR WORK APPROVAL

HDC2026-00439

**ADDRESS(ES):** 1459 Atkinson Street

**Siding & Windows Replacement**

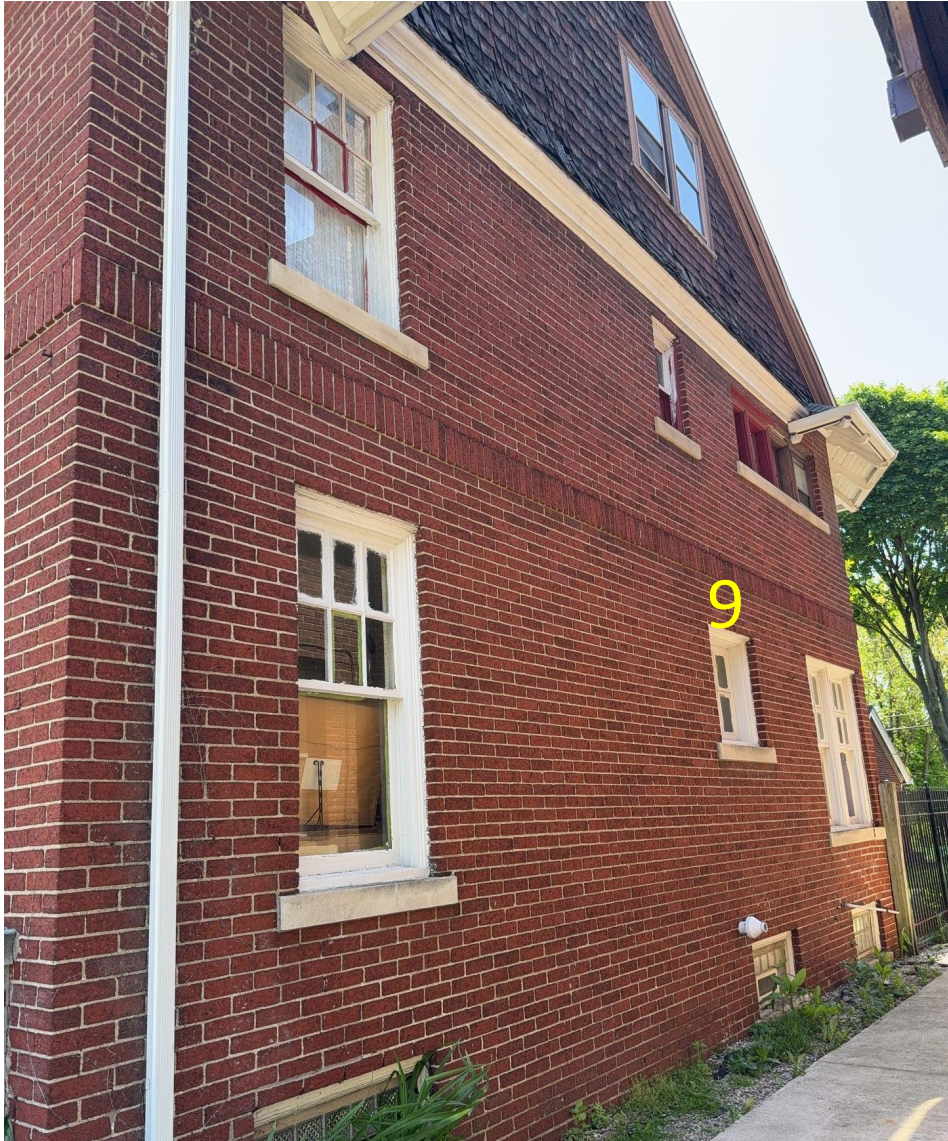
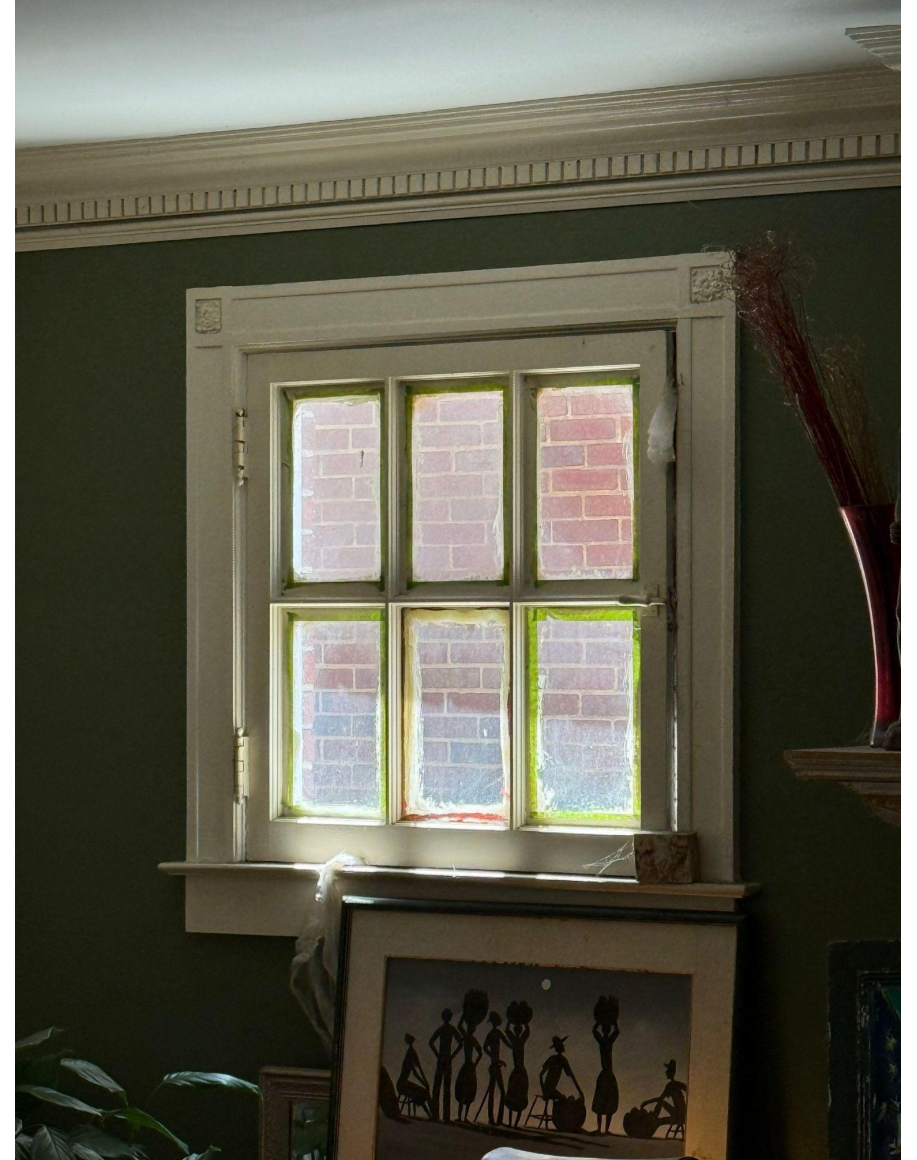
# Window 9

Located on right  
side of home, first  
story

- Severe Degradation: Existing single-pane, inswinging wood casement sash exhibits severe frame warping, joint separation, and air/water infiltration.
- Frame Warping: unable to functionally close due to swelling of rotted wood.
- Temporary Weatherization Failure: The unit currently requires plastic sheeting/temporary sealing to prevent active weather elements from entering the interior living space.
- Technical Infeasibility of Repair: Due to severe frame distortion and wood compromise, repairing or retrofitting weatherstripping to the historic sash is technically infeasible and economically unreasonable under Standard 6 guidelines.
- Proposed solution: to replace with a fixed or inswing casement window unit to match to the existing 6-lite configuration (Grids: 2V1H)
