CERTIFICATE OF APPROPRIATENESS

RE: Application Number 21-7584; 1315 Broadway, Broadway Historic District

1315 Broadway Concept Design September 27, 2021

1315 Broadway/Fire Escape Condition Assessment/RE#21209

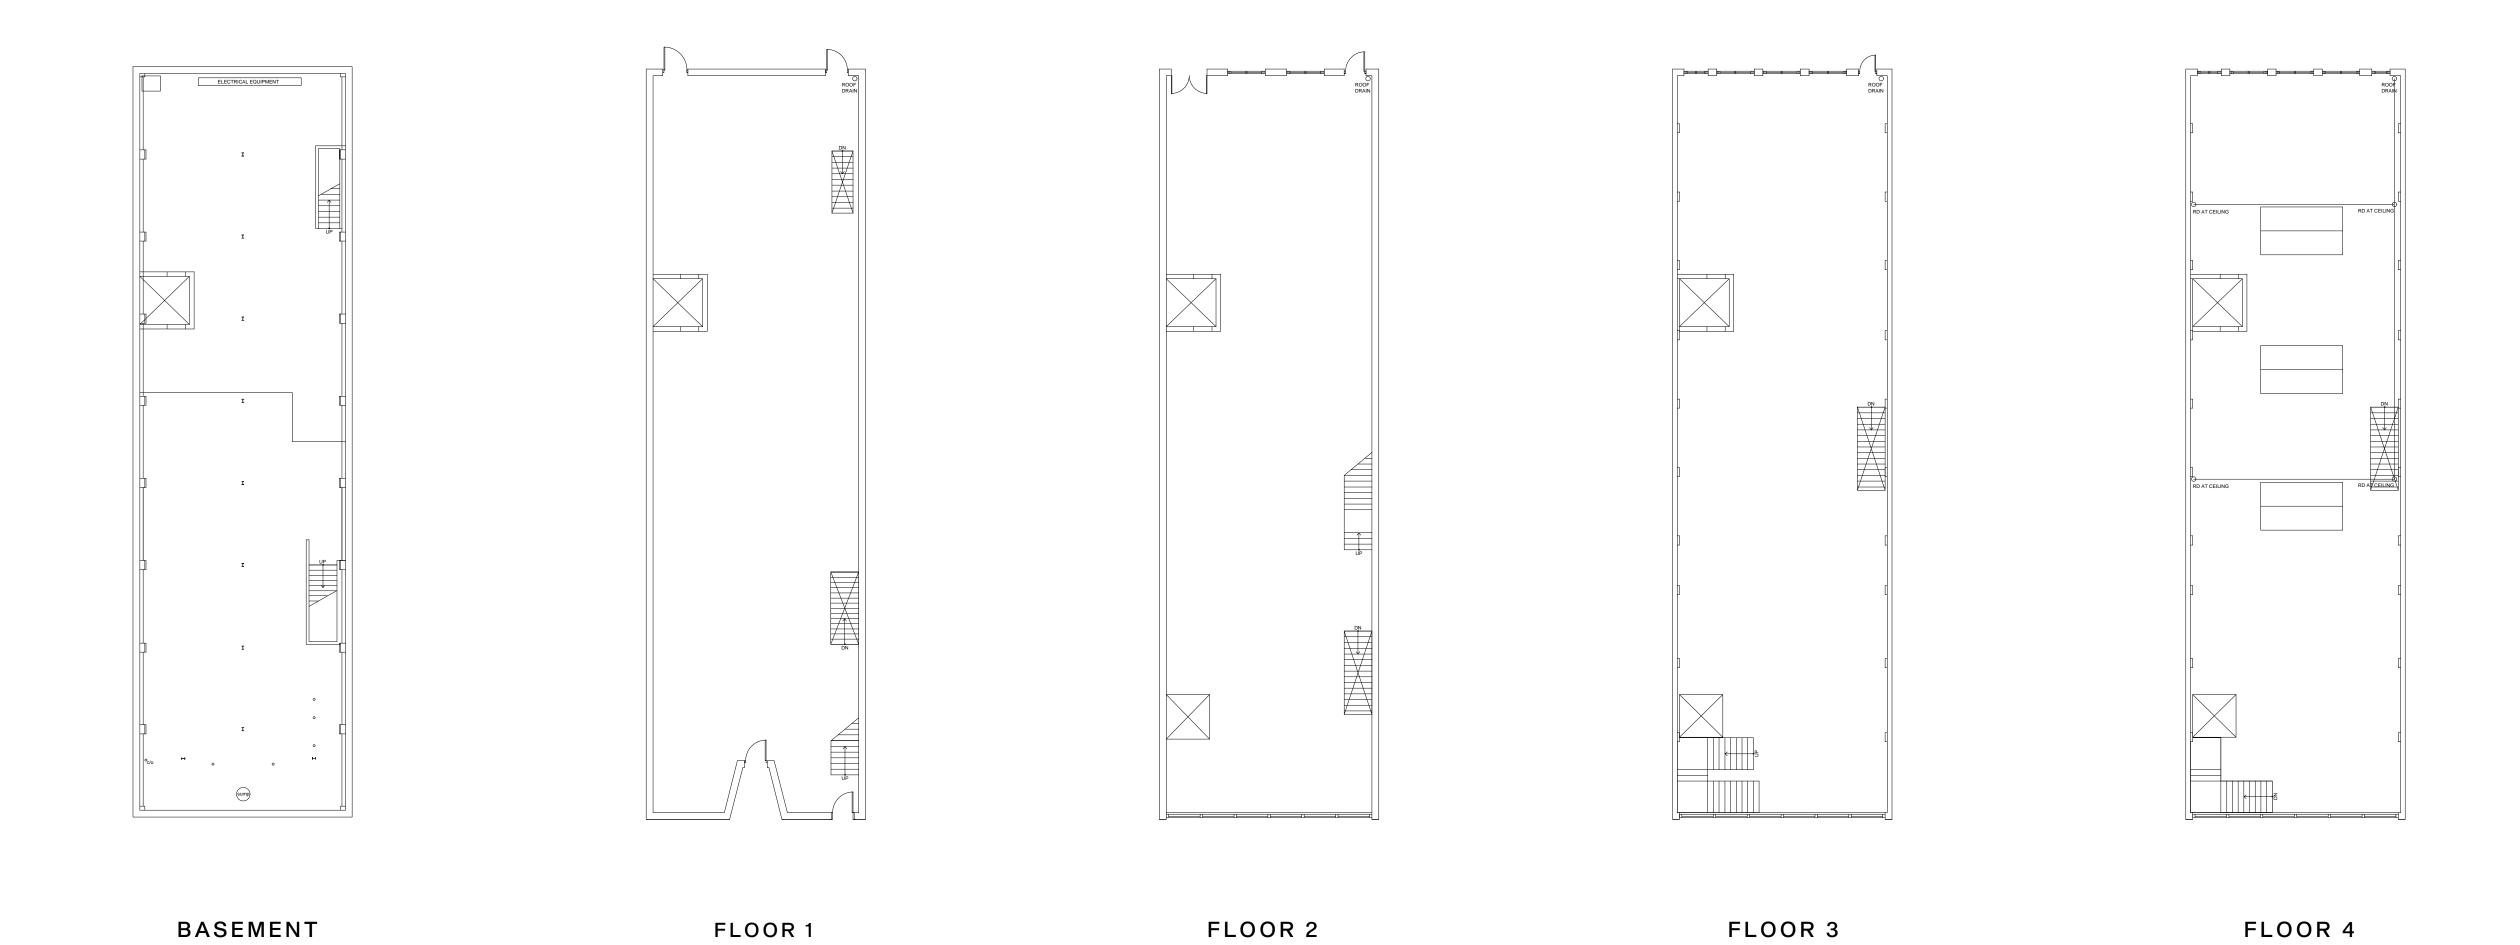
Floor Plans

- 1 WOOD FLOOR RESTORED/REPAIRED
- 2 HISTORIC STAIR RESTORED/REPAIRED

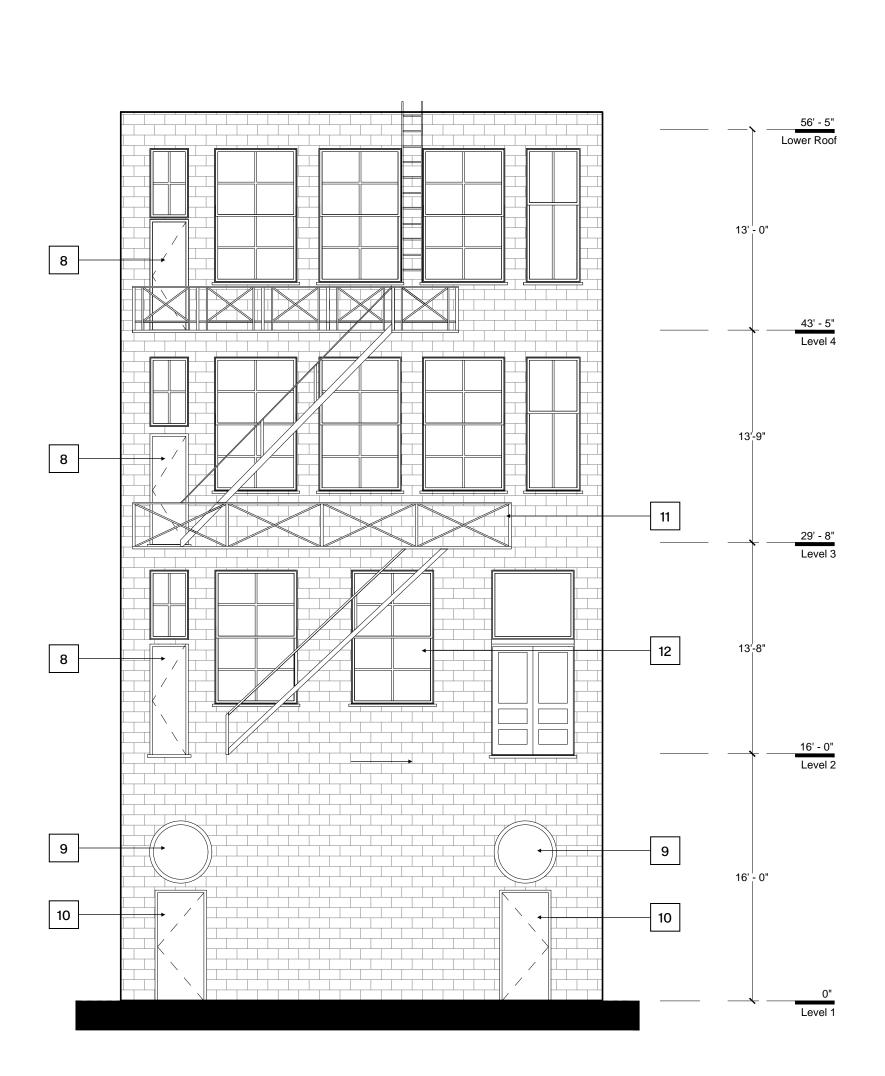
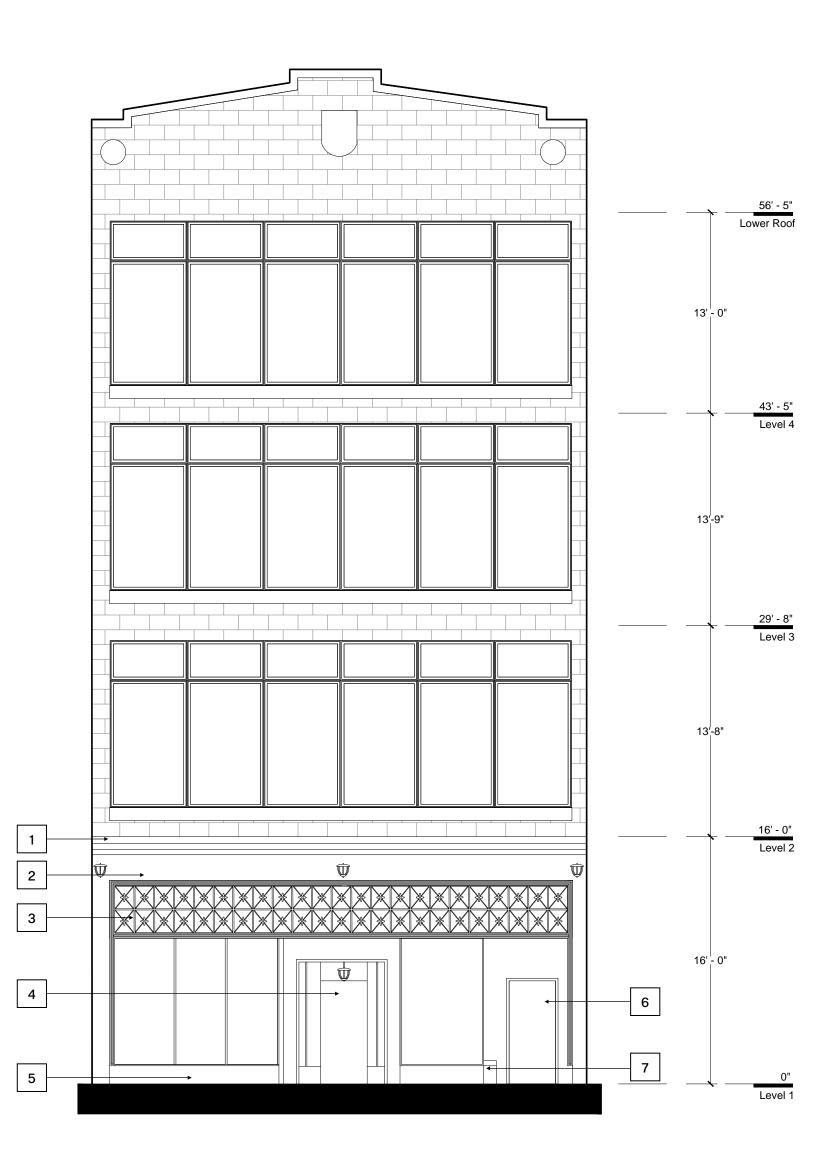
1315 BROADWAY - EXISTING EXTERIOR ELEVATIONS

- 1 REMOVE YELLOW METAL BAND ELEMENT
- 2 REMOVE PLYWOOD
- 3 REMOVE PLYWOOD BEHIND HISTORIC GRILLE WORK AND PREP FOR NEW GLAZING SYSTEM BEHIND. REMOVE AND COMPLETELY RESTORE GRILLE WORK FOR REINSTALLATION.

- 4 REMOVE NON-HISTORIC ENTRANCE DOOR AND STOREFRONT SYSTEM
- 5 REMOVE PLYWOOD COVERING HISTORIC GRANITE BASE
- 6 REMOVE EXISTING HOLLOW METAL DOOR THAT IS FLUSH WITH FRONT FACADE. THE ORIGINAL CONFIGURATION FOR THIS DOOR WAS IN AN ALCOVE, WHICH WILL BE RESTORED IN THE NEW WORK.

- 7 BASED ON FIELD OBSERVATIONS, THE EXISTING GRANITE STOPS AT
 THIS LOCATION. INSIDE THE BUILDING, THERE ARE REMNANTS OF
 TILED FLOOR AND TERRACOTTA ON THE SIDE WALL ADJACENT TO THE
 NEIGHBORING BUILDING, WHICH SUGGEST THAT THIS WAS ORIGINALLY
 AN ALCOVE

- 8 REMOVE HOLLOW METAL DOOR
- 9 REMOVE PLYWOOD AND EXHAUST COVERING ROUND OPENING
- 10 REMOVE HOLLOW METAL DOOR
- 11 STRUCTURAL ENGINEERING EVALUATION HAS RECOMMENDED THAT
 THE BRACKETS SUPPORTING THE EXISTING FIRE ESCAPE ARE
 STRUCTURALLY SOUND AND CAN BE REUSED, BUT THE FIRE
 ESCAPE ITSELF NEEDS TO BE REPLACED. SEE ATTACHED REPORT
 FOR REFERENCE.

- MUCH OF EXISTING WIRE GLASS IS COVERED IN GRAFFITI AND

CRACKED. WIRE GLASS CANNOT BE REPAIRED, AND IS NOT SAFETY

RATED. REMOVE GLASS, RESTORE AND PREP FRAMES TO BE REGLAZED.

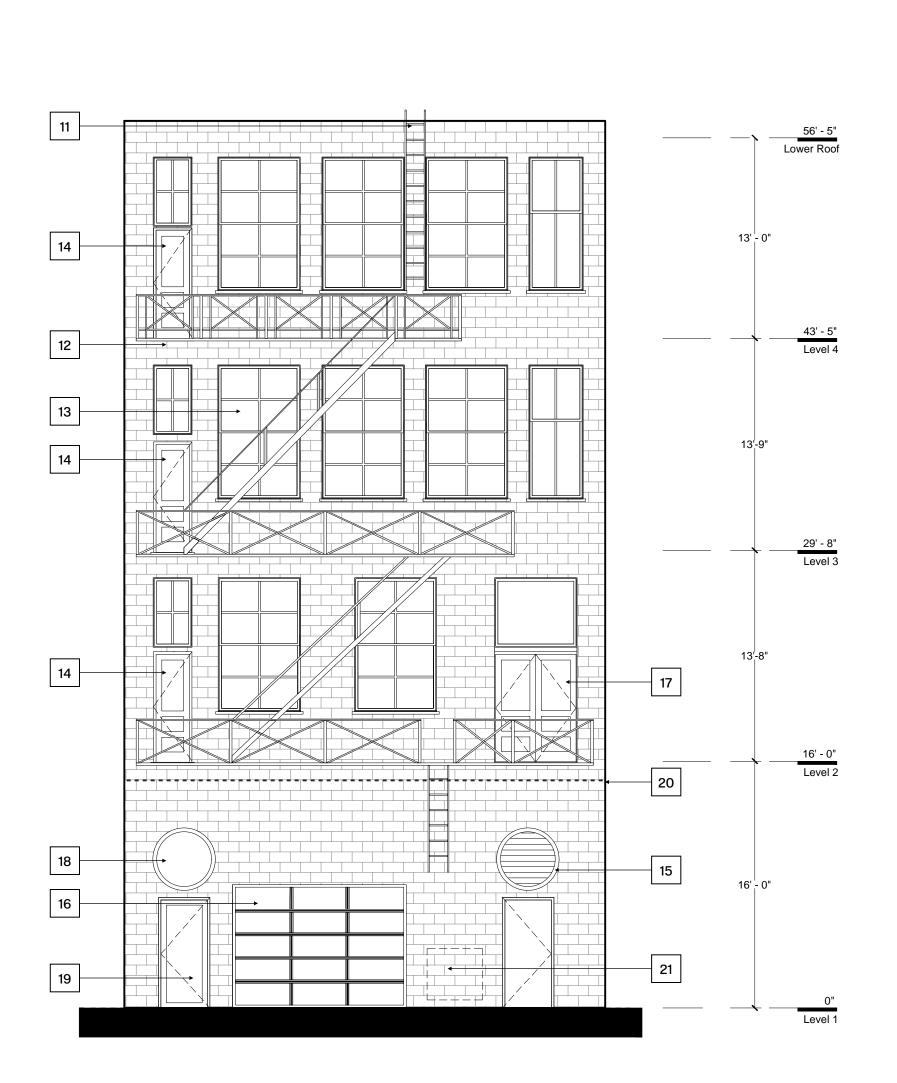
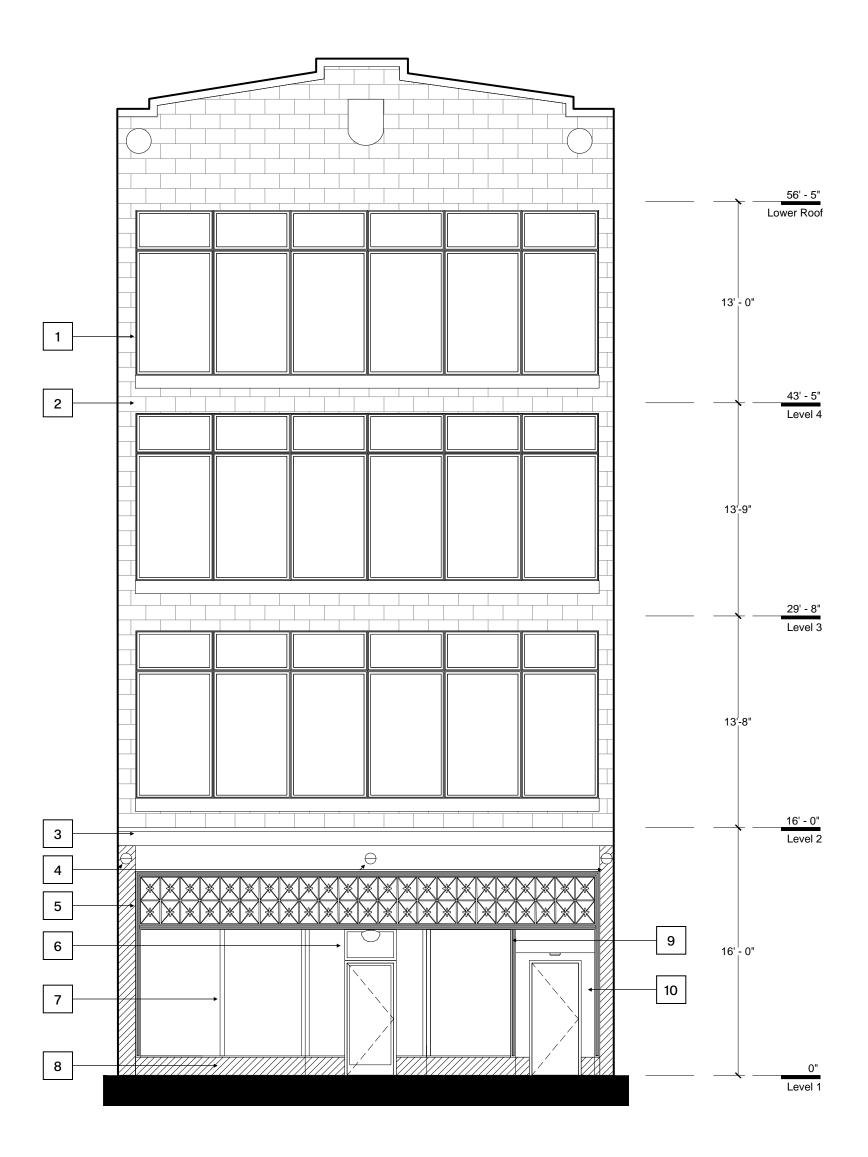
1315 BROADWAY - SUGGESTED EXTERIOR ELEVATIONS

- 1 EXISTING WINDOWS TO BE RESTORED, REPAIRED, PAINTED AND PINNED SHUT.
- 2 EXISTING TERRA-COTTA TO BE RESTORED/REPAIRED.
- 3 NEW METAL AWNING TO REPLACE ALUMINUM BAND.

- 4 | NEW SCONCES W/ HISTORIC PROFILE, SEE SPEC.
- 5 GRILLWORK TO BE SALVAGED AND PAINTED BLACK. MISSING DECORATIVE LEAVES TO BE PATTERNED AND REPLACED. DECORATIVE LEAVES TO BE PAINTED METALLIC BRASS COLOR. GLASS TRANSOM RESTORED BEHIND GRILLWORK.

- 6 NEW STOREFRONT SYSTEM, GLAZED ALUMINUM ENTRANCE DOOR,
 AND TRANSOM IN RECESSED CONFIGURATION.
- 7 NEW STOREFRONT. BASIS OF DESIGN: KAWNEER 451T.
- 8 BLACK GRANITE BASE AND SIDE COLUMNS TO BE RESTORED,
 REPAIRED, OR INFILLED WITH MATCHING GRANITE (WHERE MISSING).

- 9 FLUTED TRIM TO BE RESTORED AND REPAINTED.
- 10 RECESS NEW DOOR IN ALCOVE TO MATCH HISTORIC ALCOVE
 DIMENSIONS. SIDE WALLS AND ALCOVE WALL TO BE CLAD WITH
 BLACK BREAK METAL. INSTALL NEW FLUSH ALUMINUM DOOR.

- 11 ROOF LADDER TO BE RESTORED/REPAIRED.
- 12 NEW FIRE ESCAPE TO BE INSTALLED TO MATCH PROFILES,
 DIMENSIONS, AND CONFIGURATION OF EXISTING FIRE ESCAPE,
 UTILIZING EXISTING MOUNTING BRACKETS.

- THE EXISTING WIRED GLASS IS NOT SAFETY RATED. REMOVE

EXISTING GLASS, RESTORE STEEL FRAMES (SEE WINDOW REPORT)

AND PROVIDE NEW SAFETY AND 45 MINUTE FIRE RATED CLEAR GLASS

TO COMPLY WITH CODE REQUIREMENTS.

PAINT COLOR: BLACK.
- PATTERN OF EXISTING WOOD DOUBLE-DOOR REPLICATED FOR ALL REAR FIRE ESCAPE DOORS.
- 15 | LOUVRE VENT TO BE INSTALLED FOR FUTURE F&B TENANT.
- 16 NEW GLASS-FRONT GARAGE DOOR.
- 17 DOUBLE-DOOR TO BE RESTORED & SEALED SHUT.
- 18 ROUND WINDOW TO BE RESTORED & REPLACED.
- 19 NEW GLASS DOOR FOR OFFICE TENANT ENTRYWAY.
- 20 NEW GRAFFITI ART TO BE REPAINTED. TOP OF GRAFFITI SHALL NOT EXTEND BEYOND UPPER LIMIT OF EXISTING GRAFFITI.
- 21 ELECTRICAL METER BANK LOCATION

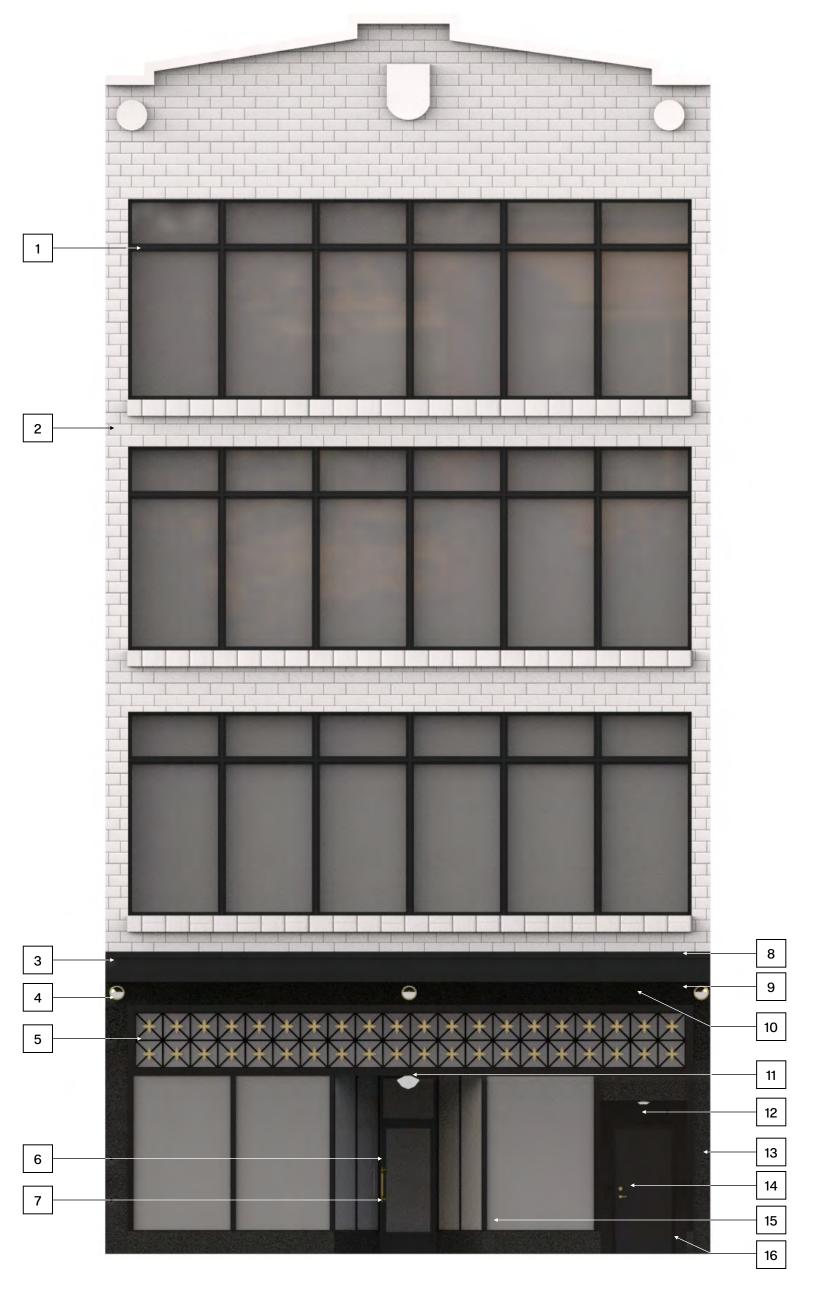
1315 BROADWAY - VIEW 1

- 1 EXISTING WINDOWS TO BE RESTORED, REPAIRED, PAINTED BLACK AND PINNED SHUT
- 2 EXISTING TERRA-COTTA TO BE RESTORED/REPAIRED
- 3 NEW METAL AWNING TO REPLACE ALUMINUM BAND

- 4 LT-01 THOMAS O'BRIAN PELHAM 10" WALL SCONCE IN
 HAND-RUBBED ANTIQUE BRONZE
- 5 GRILLWORK TO BE SALVAGED AND PAINTED BLACK. MISSING
 DECORATIVE LEAVES TO BE PATTERNED AND REPLACED.
 DECORATIVE LEAVES TO BE PAINTED METALLIC BRASS
 COLOR. GLASS TRANSOM RESTORED BEHIND GRILLWORK.

- 6 HW-01 EMTEK 18" CENTERS JASPER CONCEALED PULL
- 7 HW-02 EMTEK MODERN DISC SINGLE CYLINDER DEADBOLT
- 8 TYPICAL UP LIGHTING AND DOWN LIGHTING ON AWNING

- 9 AWNING CLAD WITH BLACK BRAKE METAL
- 10 FACADE TOP PANEL CLAD WITH BLACK BRAKE METAL.
- 11 LT-02 BARN LIGHT ELECTRIC CO. ACORN SCHOOLHOUSE SEMI-FLUSH.

- 12 LT-03 WAC LIGHTING YORK 12" WIDE LED DRUM
 CEILING FIXTURE.
- GRANITE FACADE TO BE RESTORED & REPLACED AT
 BASE AND LEFT AND RIGHT SIDE COLUMNS
- 14 FLUSH ALUMINUM ENTRANCE DOOR, BLACK. HW-03
 DETROIT ESCUTCHEON ENTRANCE SET

- 15 ST-01 NEW STOREFRONT SYSTEM, GLAZED ALUMINUM ENTRANCE DOOR, AND TRANSOM IN RECESSED CONFIGURATION.
- 16 ALCOVE WALLS AND CEILING CLAD WITH BLACK BREAK METAL

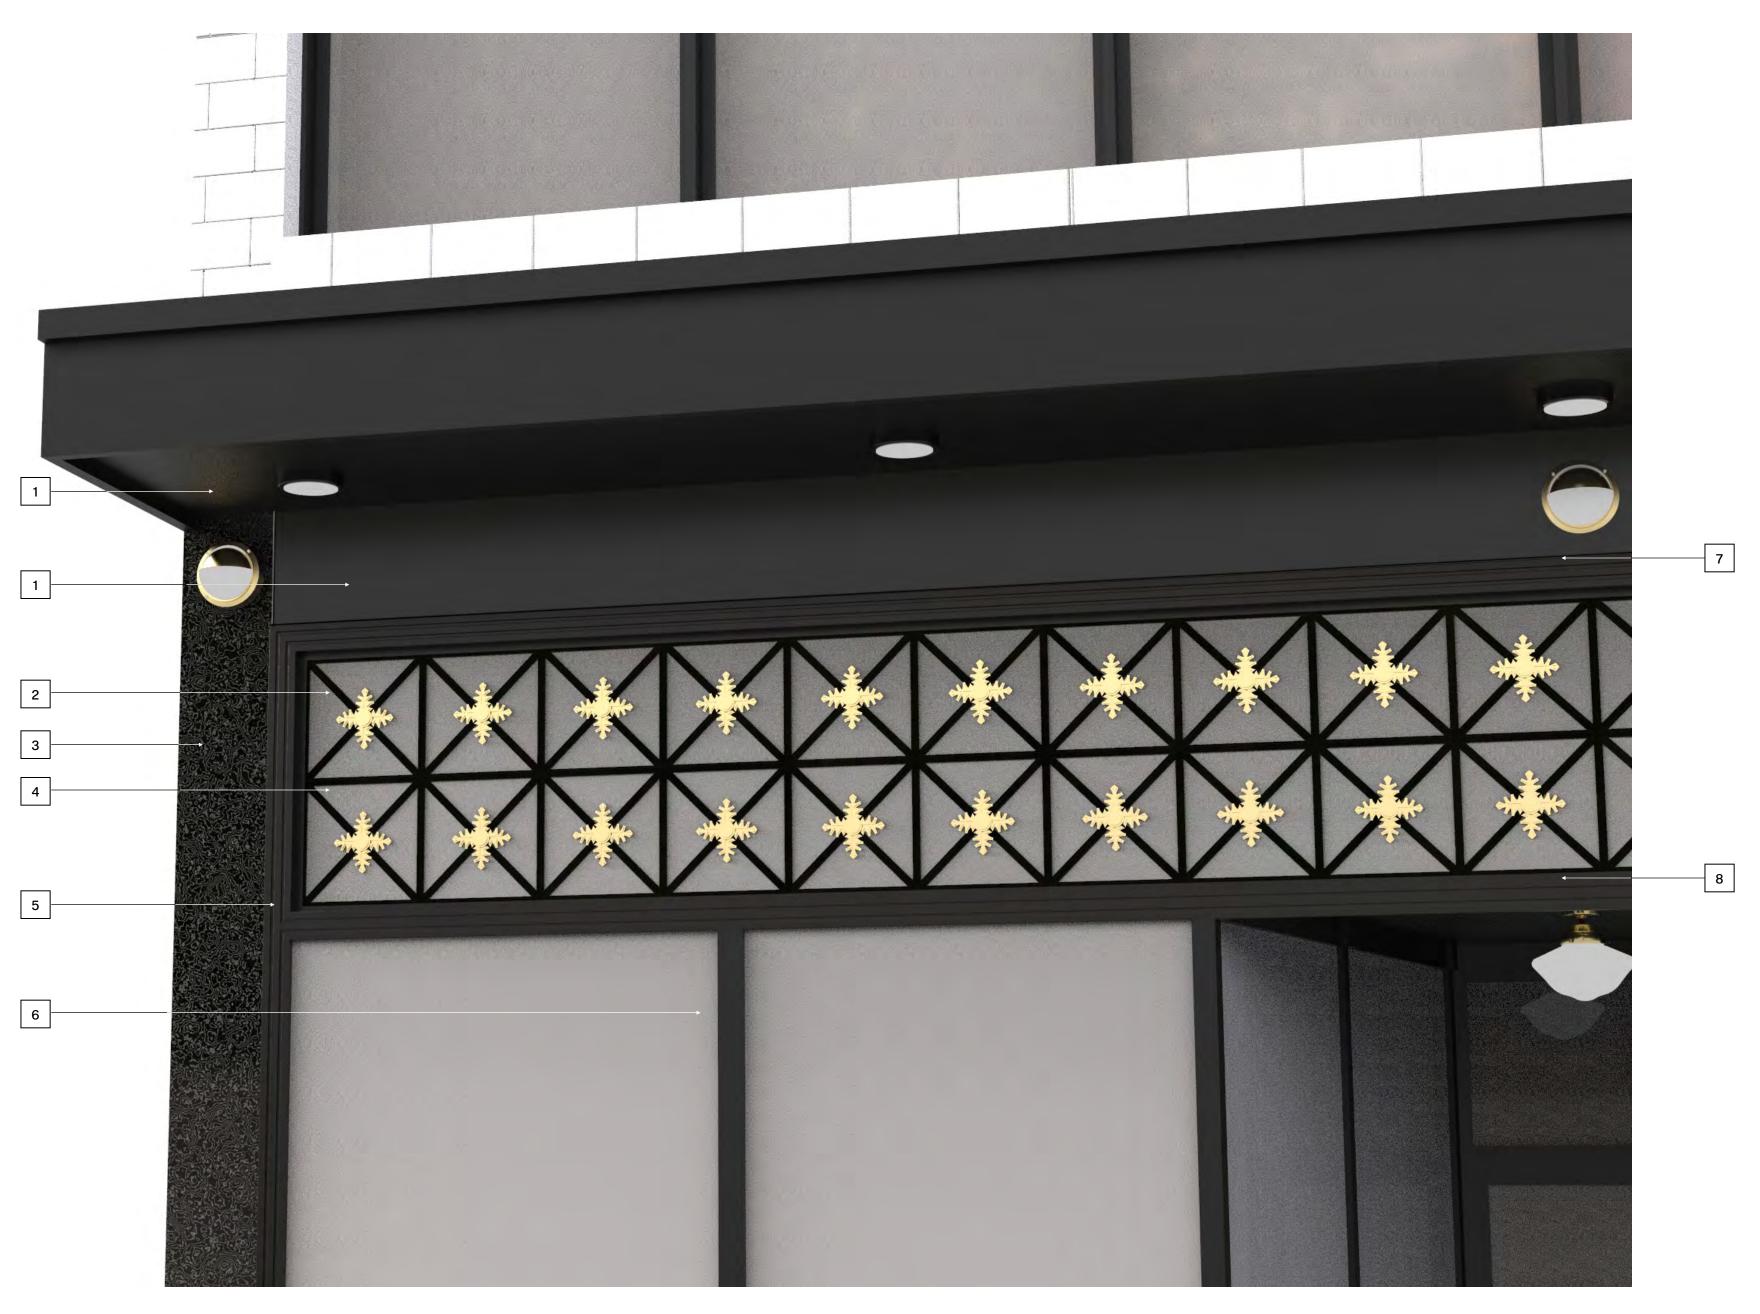
- 1 BLACK BRAKE METAL
- 2 RESTORE GRILLE WORK AND REPLACE MISSING LEAVES WITH NEW. PAINT LEAVES WITH SATIN BRASS METALLIC PAINT
- 3 BLACK GRANITE ON LEFT AND RIGHT COLUMNS
- 4 NEW TRANSLUCENT GLAZING SYSTEM BEHIND GRILLEWORK
- 5 EXISTING HISTORIC TRIM TO REMAIN. REPAINT (BLACK)
- 6 NEW STOREFRONT SYSTEM WITH CLEAR GLASS
- 7 EXISTING HISTORIC TRIM TO REMAIN. REPAINT (BLACK)
- 8 EXISTING HISTORIC TRIM TO REMAIN. REPAINT (BLACK)

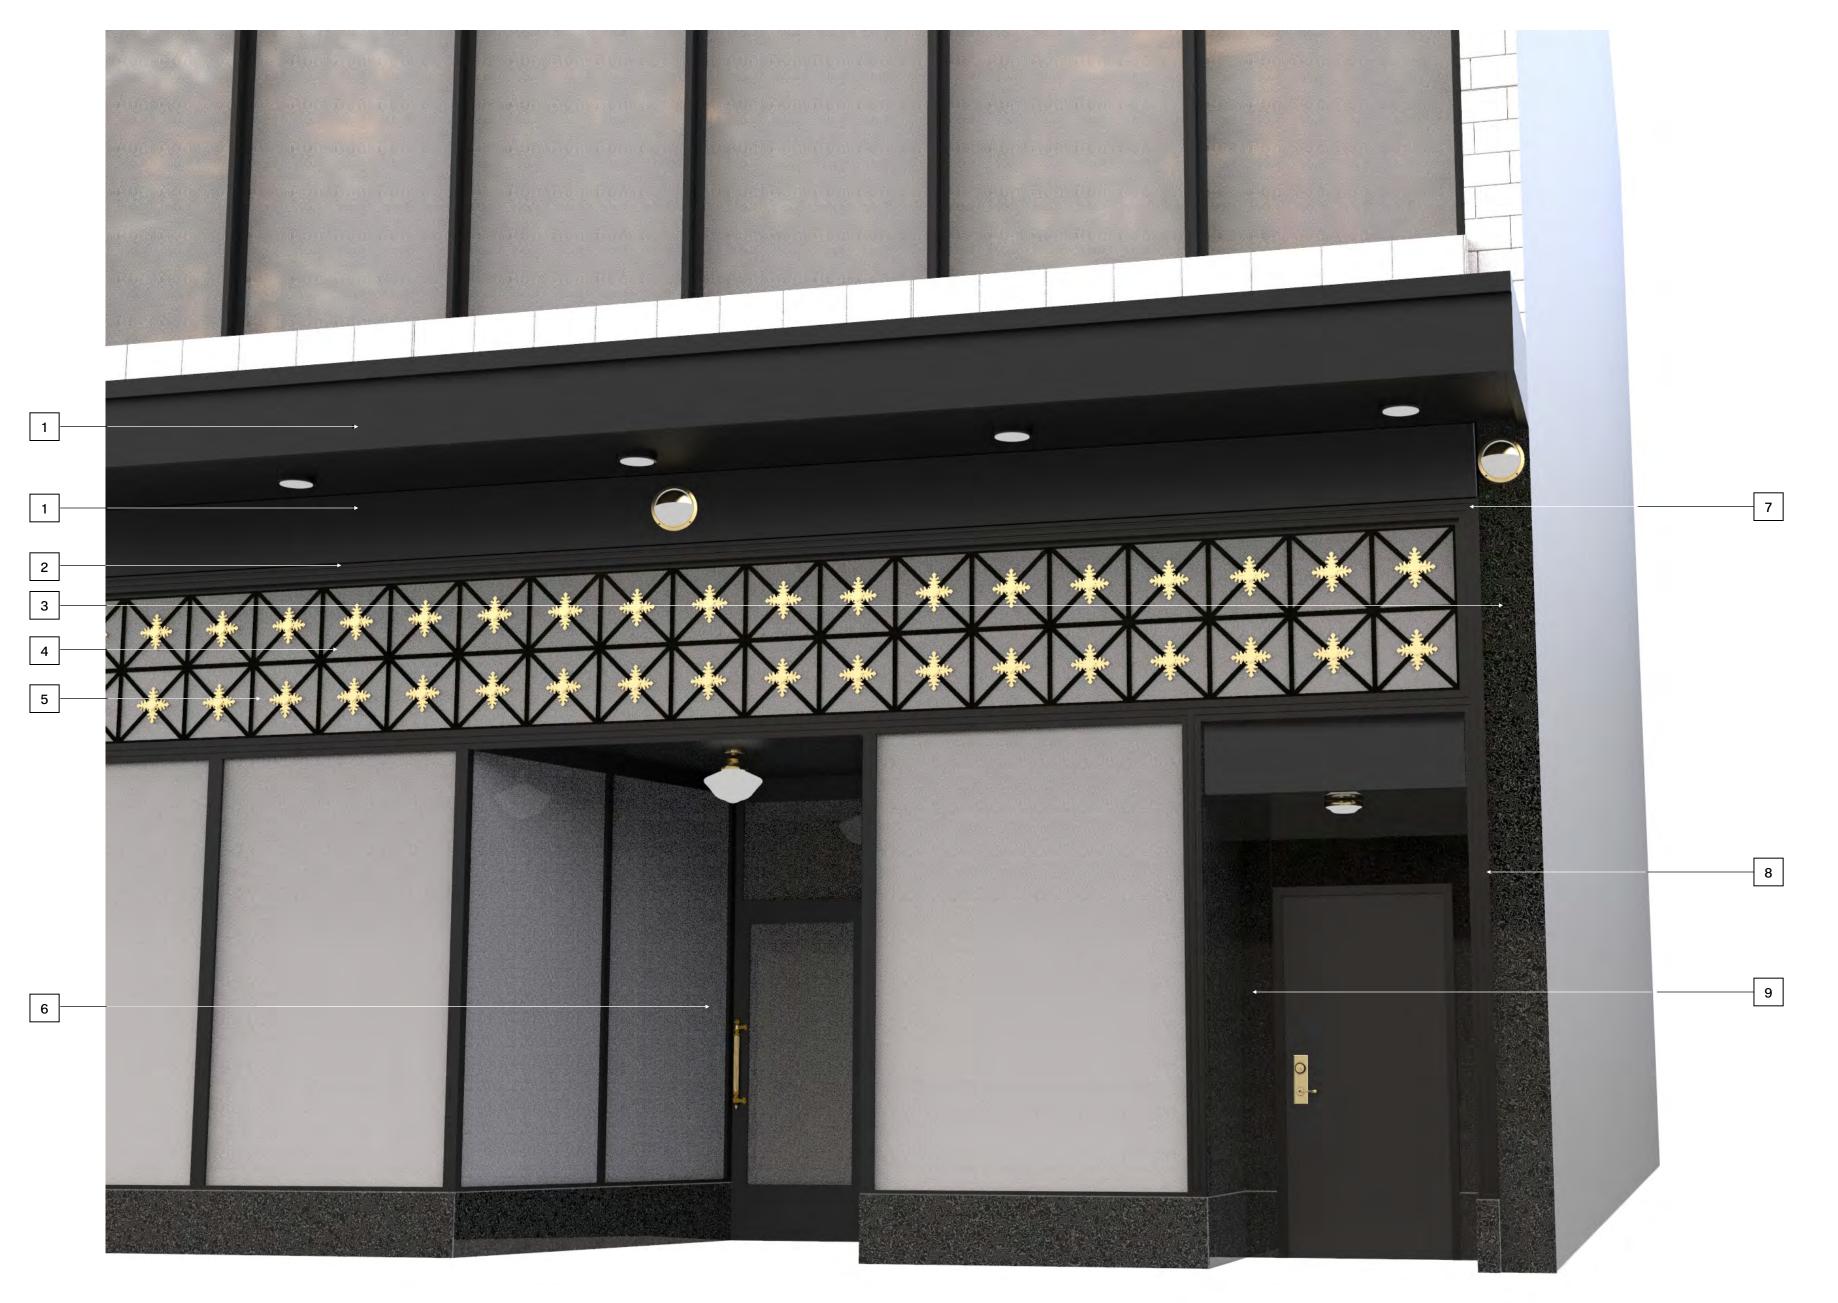
- 1 BLACK BRAKE METAL
- 2 RESTORE GRILLE WORK AND REPLACE MISSING LEAVES WITH NEW. PAINT LEAVES WITH SATIN BRASS METALLIC PAINT
- 3 BLACK GRANITE ON LEFT AND RIGHT COLUMNS
- 4 NEW TRANSLUCENT GLAZING SYSTEM BEHIND GRILLEWORK
- 5 EXISTING HISTORIC TRIM TO REMAIN. REPAINT (BLACK)
- 6 NEW STOREFRONT SYSTEM WITH CLEAR GLASS
- 7 EXISTING HISTORIC TRIM TO REMAIN. REPAINT (BLACK)
- 8 EXISTING HISTORIC TRIM TO REMAIN. REPAINT (BLACK)
- 9 INTERIOR ALCOVE TO BE BLACK BREAK METAL WITH
 GRANITE BASE

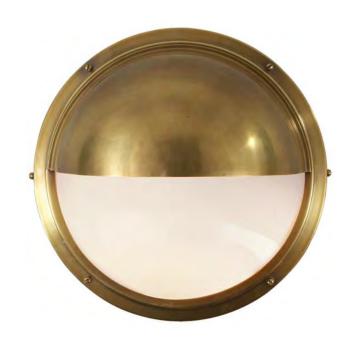
LT-01

EXTERIOR SCONCE

BRAND: THOMAS O'BRIEN

STYLE: PELHAM 10" WALL SCONCE

FINISH: HAND-RUBBED ANTIQUE BRASS

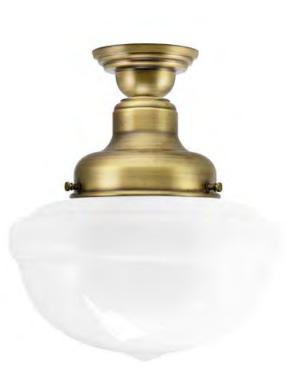
LT-02

EXTERIOR SEMI-FLUSH FIXTURE

BRAND: BARN LIGHT ELECTRIC CO.

STYLE: ACORN SCHOOLHOUSE SEMI-FLUSH

FINISH:OPAQUE GLASS / RAW BRASS

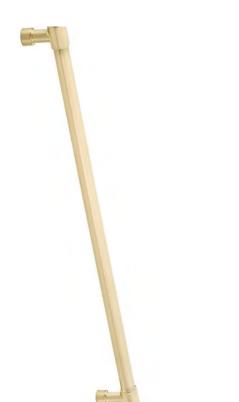
HW-01

EXTERIOR DOOR PULL
BRAND: EMTEK HARDWARE
STYLE: 18" CENTERS JASPER
CONCEALED PULL
FINISH: SATIN BRASS
#EMT-345973

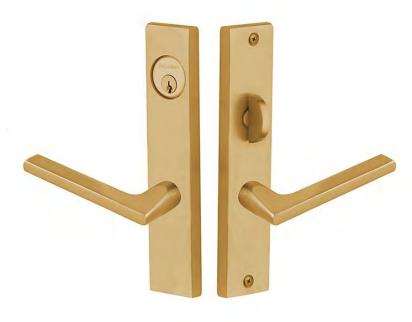
HW-03

EXTERIOR DOOR HARDWARE

BRAND: BALDWIN HARDWARE

STYLE: DETROIT ESCUTCHEON ENTRANCE SET

FINISH: VINTAGE BRASS

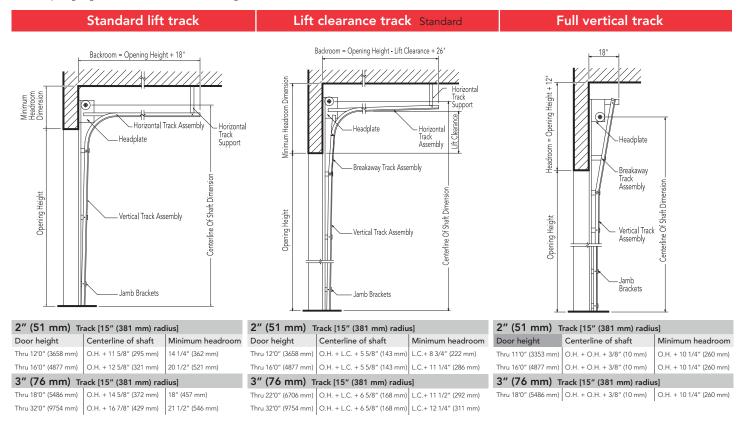
Track detail

Any of the following track configurations can be selected for 511, 521 and 522 Aluminum door models.

Low headroom track Springs to front

Low headroom track Springs to rear

2" (51 mm) Track [15" (381 mm) radius]			
Door height	Centerline of shaft	Minimum headroom	
Thru 12'0" (3658 mm)	D.H. + 8" (203 mm)	11 3/4" (299 mm)	
Thru 16'0" (4877 mm)	D.H. + 8" (203 mm)	12 1/2" (318 mm)	
3" (76 mm) Track [15" (381 mm) radius]			
Thru 12'0" (3658 mm)	D.H. + 9" (229 mm)	13" (330 mm)	
Thru 32'0" (5486 mm)	D.H. + 9" (229 mm)	13 3/4" (349 mm)

2" (51 mm) Track [15" (381 mm) radius]		
Door height	Centerline of shaft	Minimum headroom
Thru 12'0" (3658 mm)	O.H. + 2" (51 mm)	7 1/2" (191 mm)
Thru 16'0" (4866 mm)	O.H. 2" (51 mm)	8" (203 mm)
3" (76 mm) Track [15" (381 mm) radius]		
Thru 18'0" (5486 mm)	O.H. 6 3/4" (171 mm)	9 3/4" (248 mm)

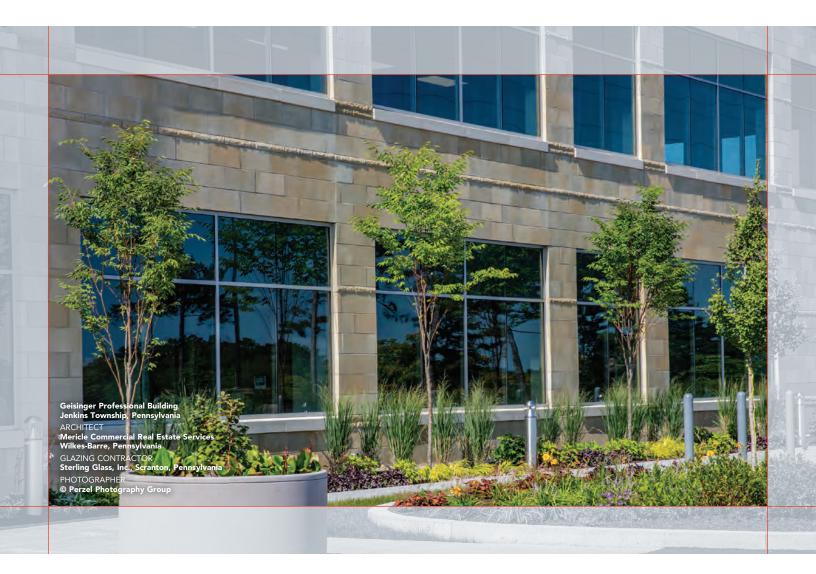
KAWNEER SYSTEM 451T FRONT SET, BLACK
