Voigt Park

Boston-Edison Historic District

Historic Landscape Report

Voigt Park Neighborhood Block Club

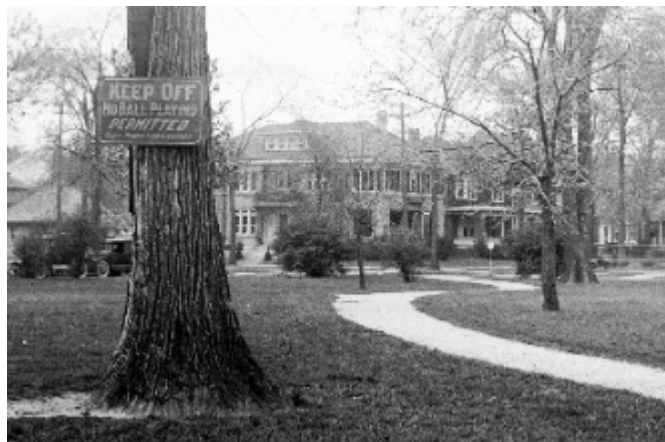
Figure 1 Historic Voigt Park Southwest View

The City honored this conveyance in practice and maintained Voigt Park as a decorative and passive landscape. The photo here looks toward the southwest corner of the park sometime during 1910-30, as suggested by the vintage of the cars in the background.

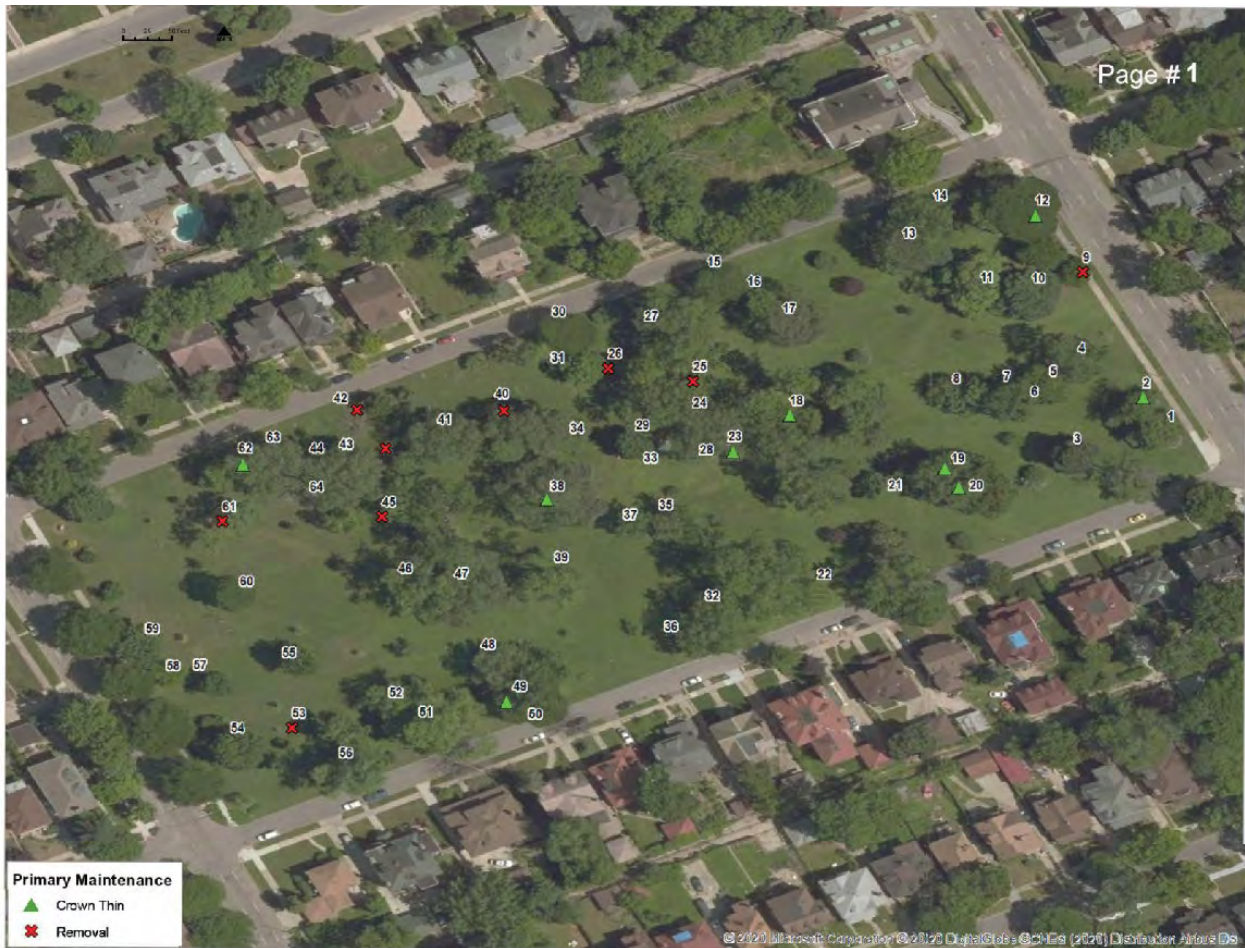
Figure 5 Voigt Park Tree Conditions Map 2020 Davey Survey

The Davey map is a summary of the trees that have defects. Trees that are in good condition are not indexed. The Davey survey found that 64 trees had defects that needed correction.

The specific species of each indexed tree and the defects found on that tree are listed in Appendix 2. Most of the defects are branches that need to be trimmed or removed.

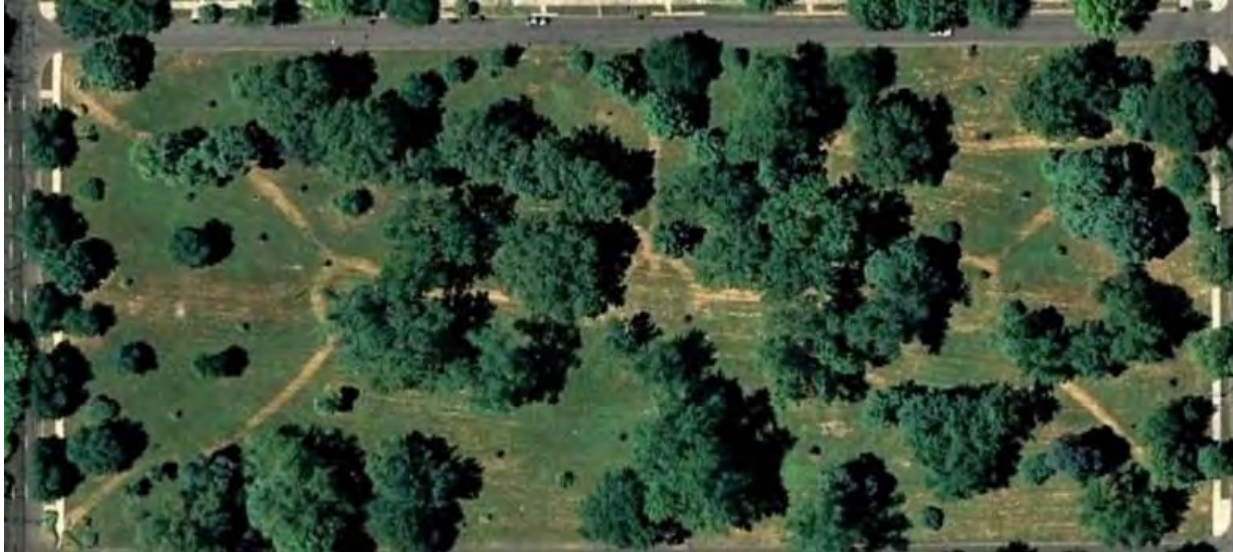
Figure 6 Historic Walkway Traces in Dry Period 2007

The original asphalt walkways, as shown in the 1928 map, have deteriorated, become covered by the growing lawn, and disappeared underground. As the original walkways disappeared, the City spread a layer of small gravel or slag over parts of them. This treatment did not entirely follow the original network pattern. Remnants of this secondary series of walkways were all that was present at the time that the Boston-Edison Historic District was designated in 1974. They persisted into the 1980's, until they gradually disappeared as well.

Faint surface traces of the historic walkways are discernible today under certain conditions. However, an aerial photograph of Voigt Park during a dry period in 2007 clearly shows that traces of the walkways are visible as discolorations in the park lawn.

The network of walkways is a *defining characteristic* of the *true* historic Voigt Park. The Voigt Park Neighborhood Block Club Vision is that replacement of walkways will use the locations of the historic walkways. If replacement has to occur in stages, the vision is that the historic network of walkways eventually will be restored.

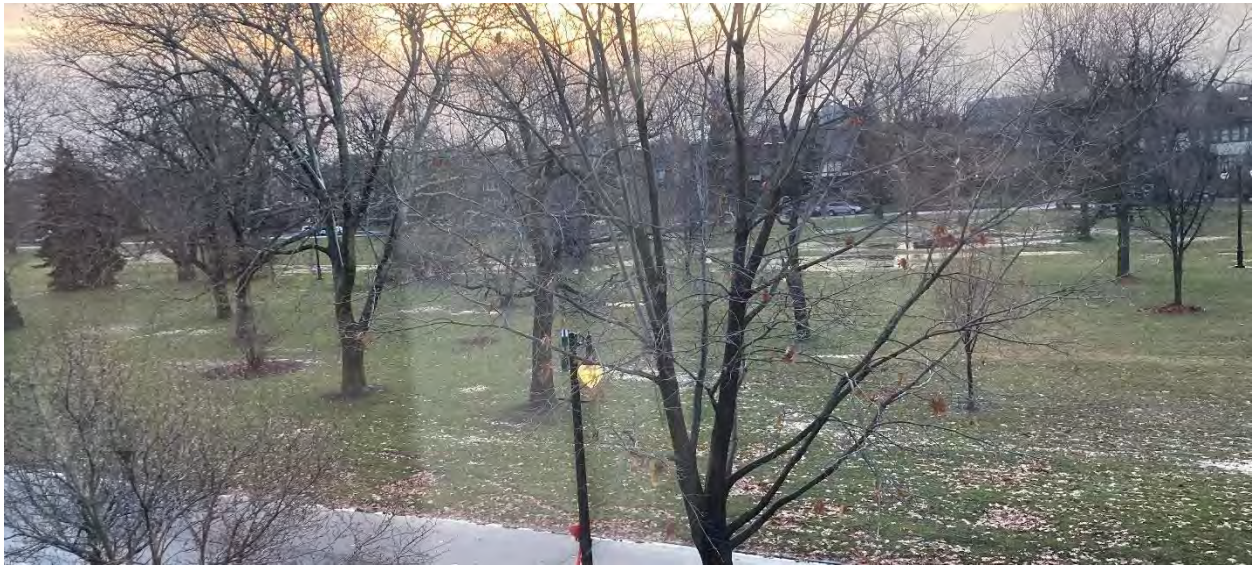
Figure 7 Extensive Ponding in Voigt Park

In many areas of the park, following snowmelt or heavy rain, water stands in ponds that create a swampy condition. Standing water makes these sections of the park unusable. Ponding can persist for some time.

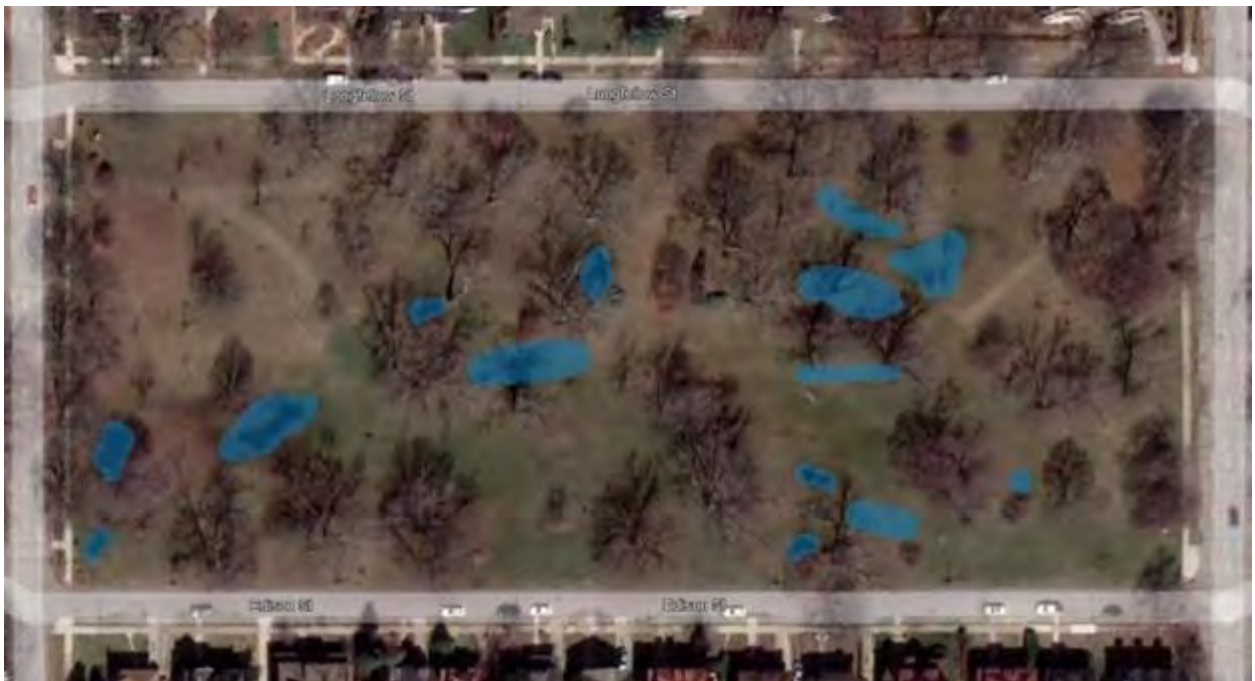
Figure 8 Extensive Ponding in Voigt Park Map

This map shows the areas of most extensive ponding. The ponding has become more extensive over time.

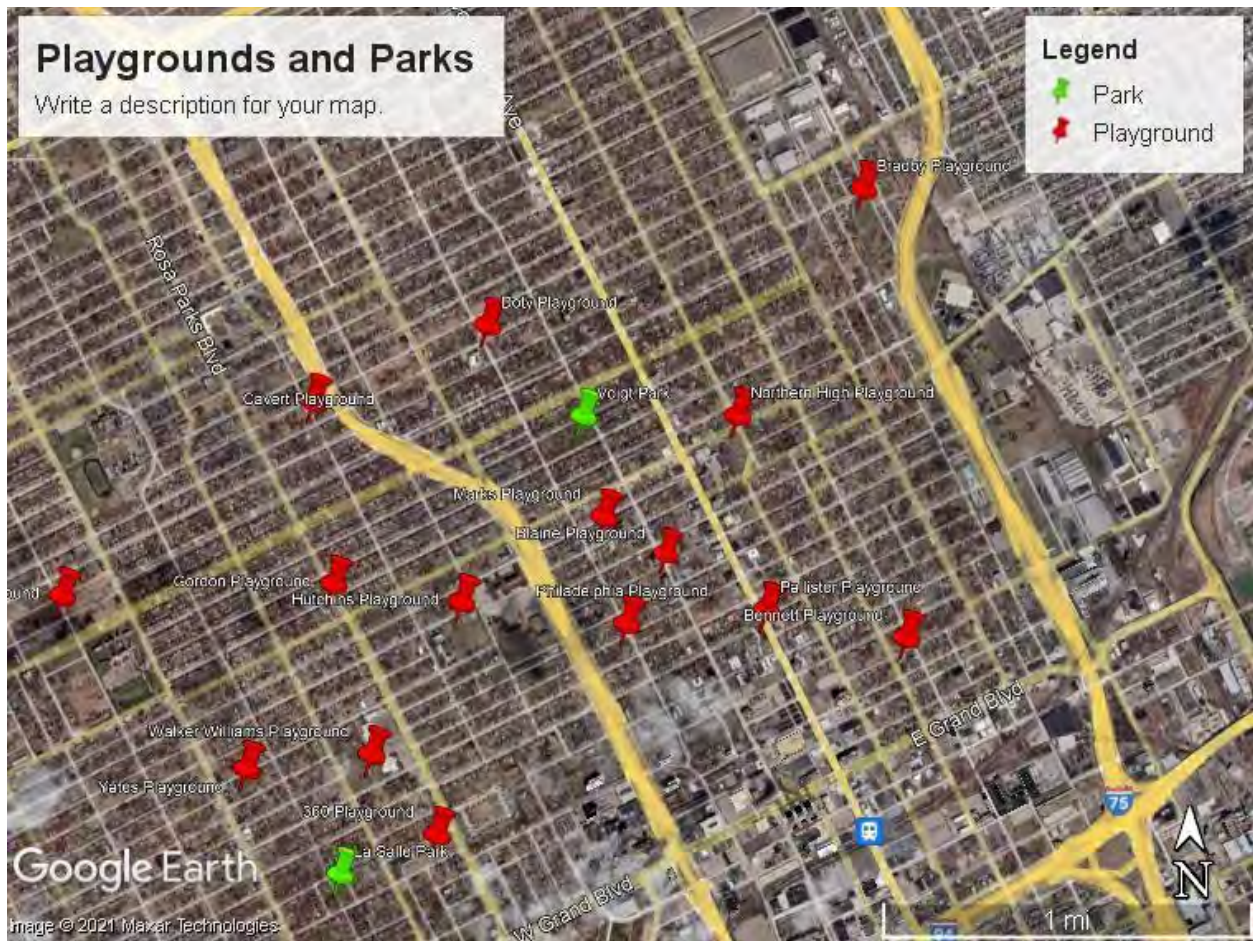
Figure 9 Parks and Playgrounds in Central Detroit

The place of Voigt Park in the City portfolio of parks is demonstrated by a map of the playgrounds and parks in the central part of the City. The map shows that Voigt Park is surrounded by parks that are programmed for activities: 15 of the 16 surrounding parks are programmed. Some of these parks are scheduled for rehabilitation, probably at an earlier date than for Voigt Park.

Keeping Voigt Park as it is with reference to the time of historic designation or rehabilitating the park to its character in the historic period would enhance the diversity in the City parks portfolio.

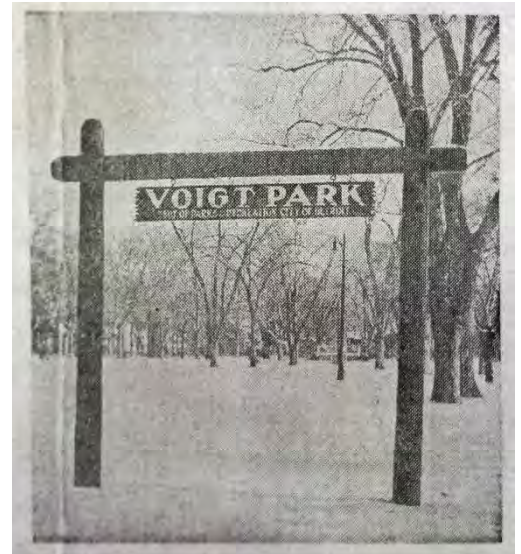
Figure 10 Historic Park Signage

The City had Voigt Park signs facing both Second and Third Avenues at the center of the blocks. The locations were roughly where the two planting beds are shown on the map. At the time of historic designation, these signs were simple horizontal wood signs on wood posts with no embellishments, as shown in the photo. They deteriorated and disappeared.

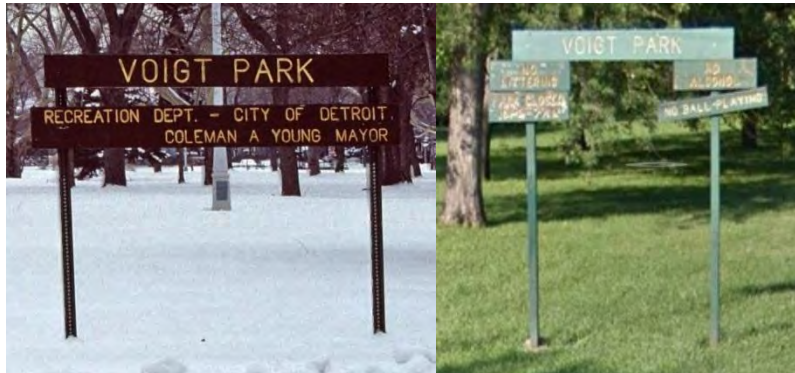
Figure 11 Modern Park Signage

Later signs on steel posts were installed. These also fell into ruin and have been removed.

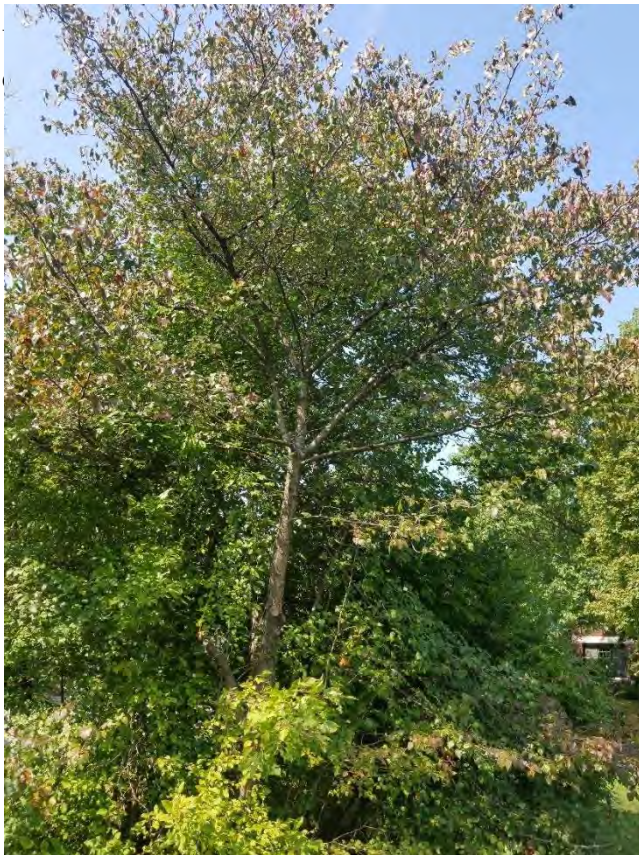
Cluster 1 (before, east view)

Much weedy material had grown in the bushes..

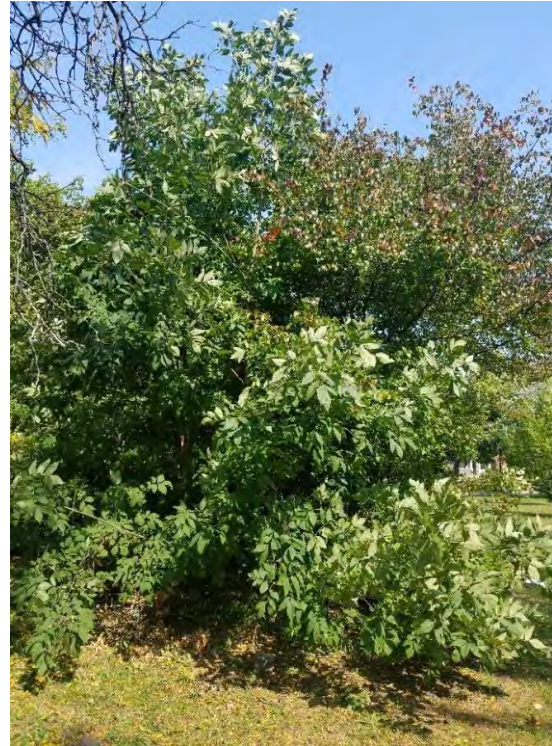
Cluster 1 (before, north view)

Hawthorn tree as an attractive element.

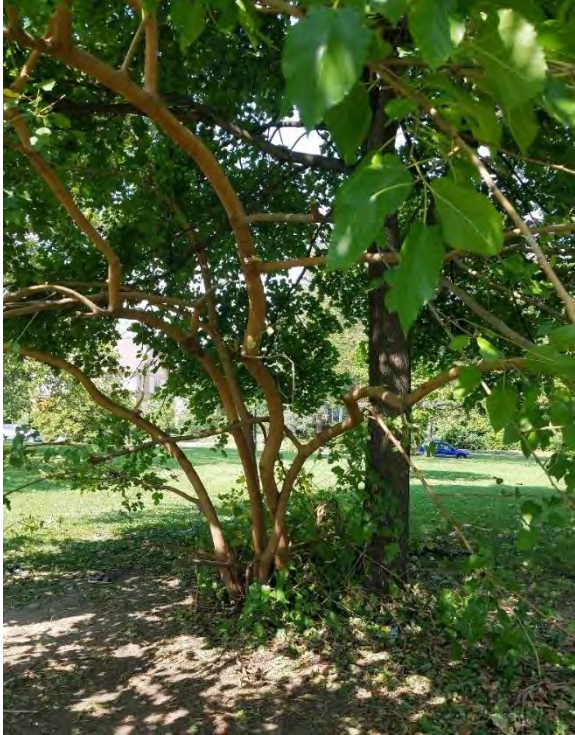
Cluster 4 (before)

A weedy mulberry cluster grew under a maple tree.

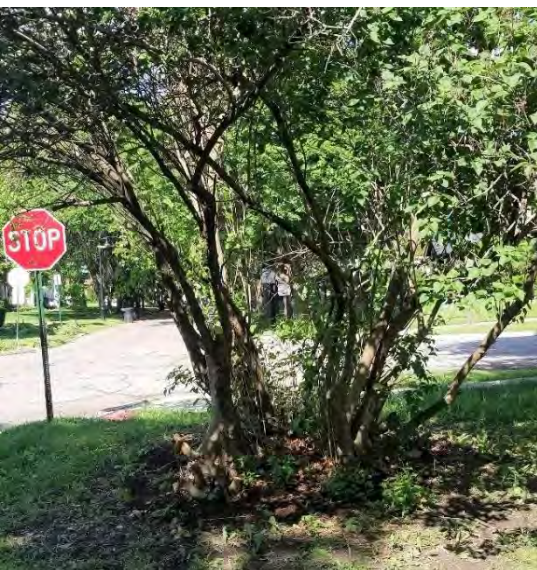
Cluster 8b (after)

The lilacs also were overgrown, nearly obscuring the stop sign. VPNBC trimmed the lilacs to give them more shape. Lilacs bloom on new growth, so the trimming will produce more flowering in the spring.

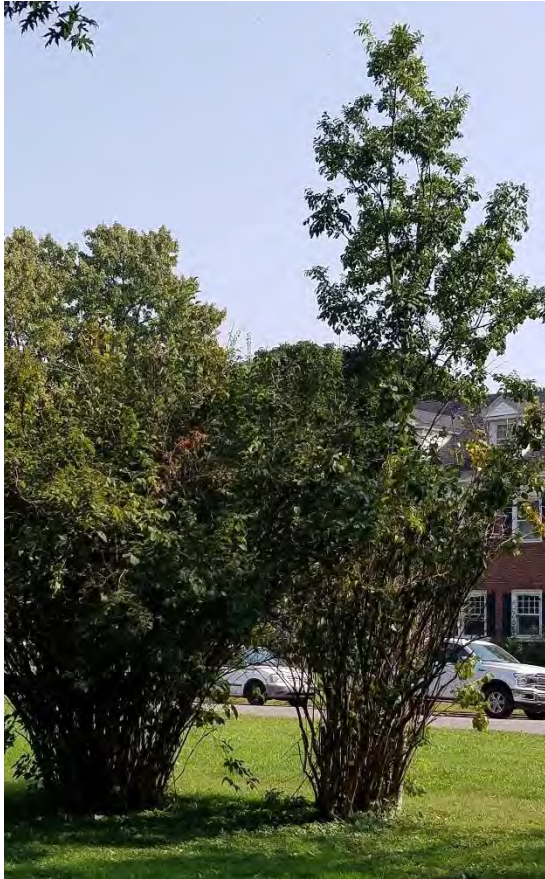
Cluster 12 (before)

A pair of Mock Orange bushes probably are original to the park landscape.

An ash tree was growing out of one of the bushes. The tree was not straight and lacked integrity.

Voigt Park Neighborhood Block Club removed the ash and restored the integrity of the original bush cluster.

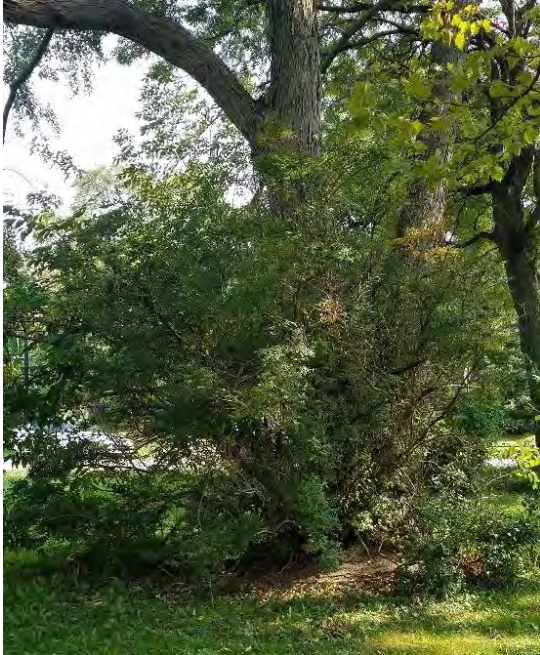
Cluster 16 (before)

Weedy growth around a large maple. VPNBC removed the weedy growths.

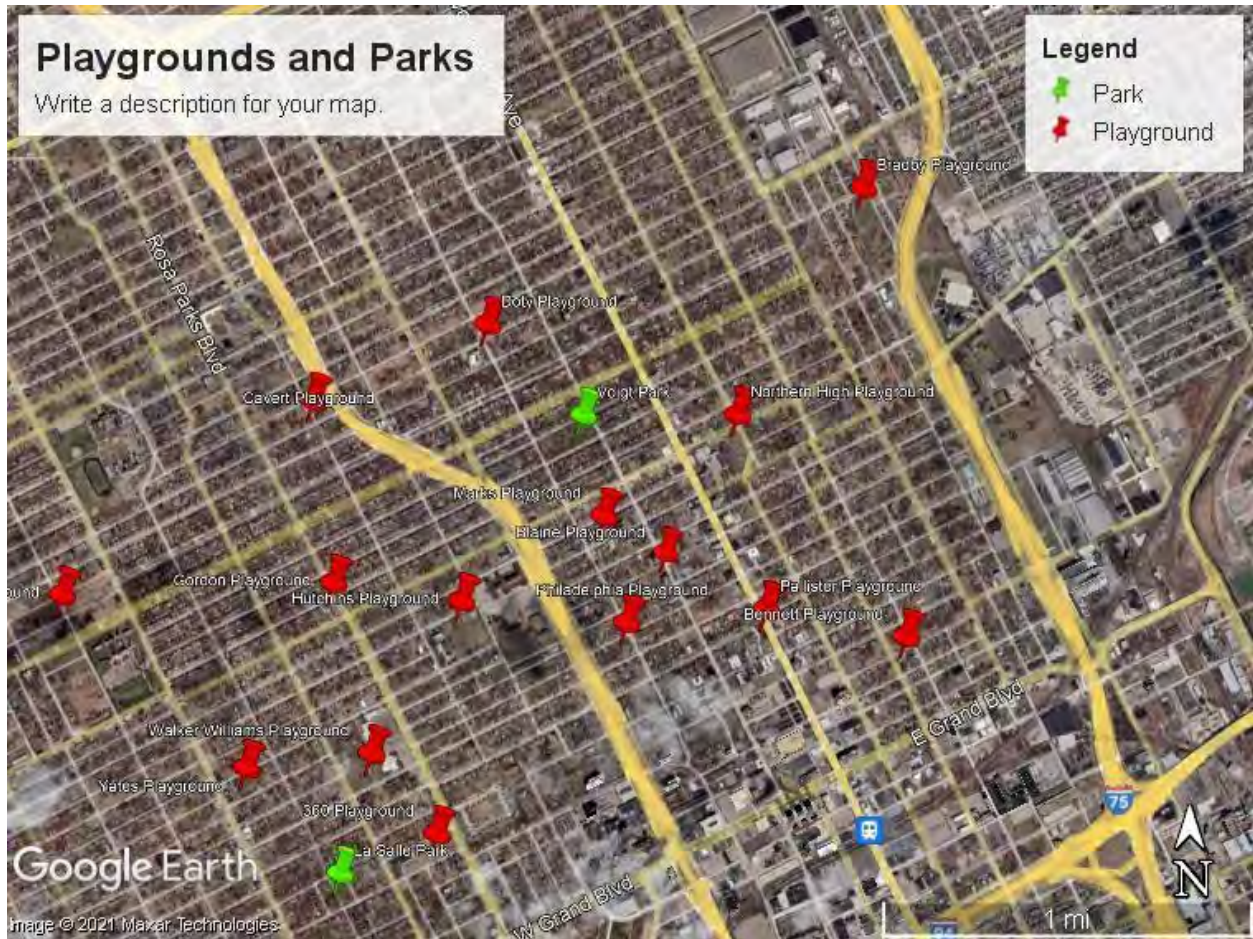
Map of Playgrounds and Parks in Central Detroit

- Calvert Playground (Calvert and Woodrow Wilson) is derelict and is a prime candidate for redevelopment to serve the area west of the Lodge.
- Keiden Playground (Rochester and Lawton) is underdeveloped and is a prime candidate for enhancement. This is a large space that has a basketball court. It could accommodate more basketball courts and tennis courts and similar facilities.
- Yates Playground (Linwood and Blaine) is large and has been recently redeveloped.
- Litsitz Memorial Playground (Linwood and both sides of Gladstone) (not shown on map) is a huge area that now is entirely undeveloped.
