**STAFF REPORT 2-10-2021 REGULAR MEETING**

**ADDRESSES:** 3664, 3690, 3700, 3708 TRUMBULL

**HISTORIC DISTRICT:** WOODBRIDGE FARM

**SCOPE:** ERECT NEW BUILDINGS, REHABILITATE EXISTING POWER HOUSE

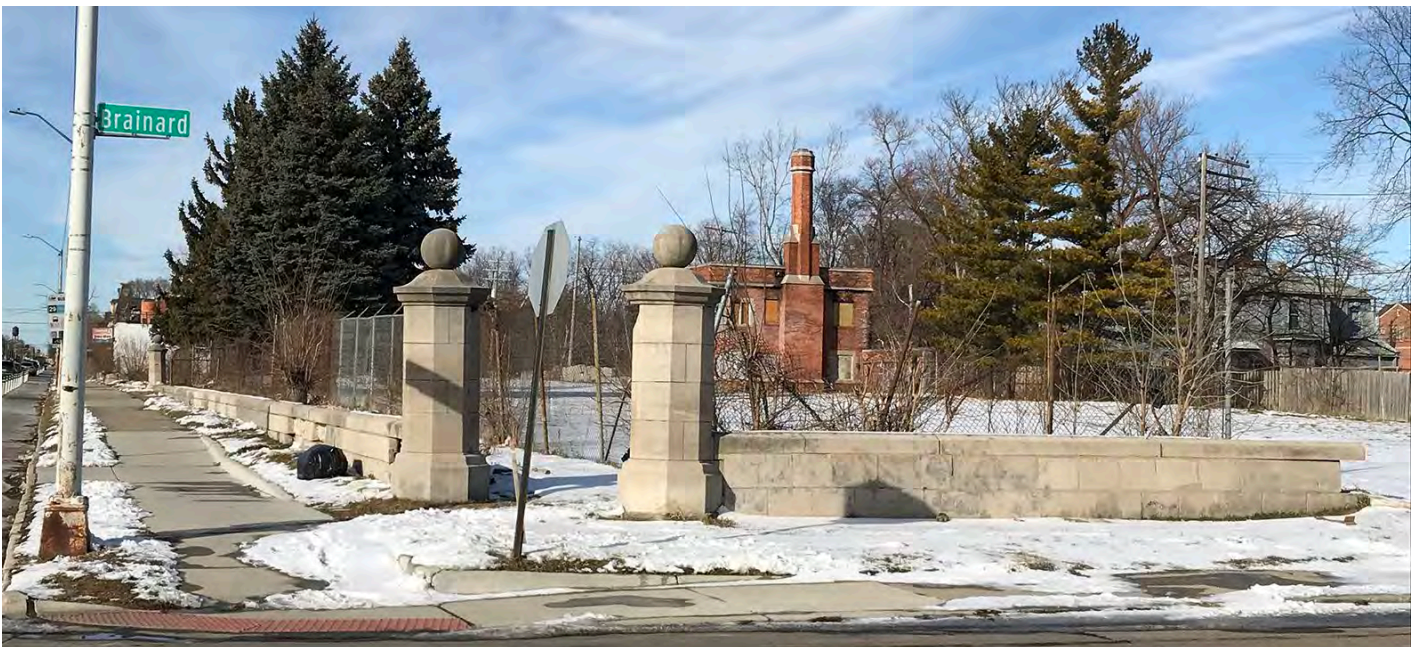
3664-3708 Trumbull. View from Brainard Street looking northeast. Photo taken by HDC staff, February 2, 2021

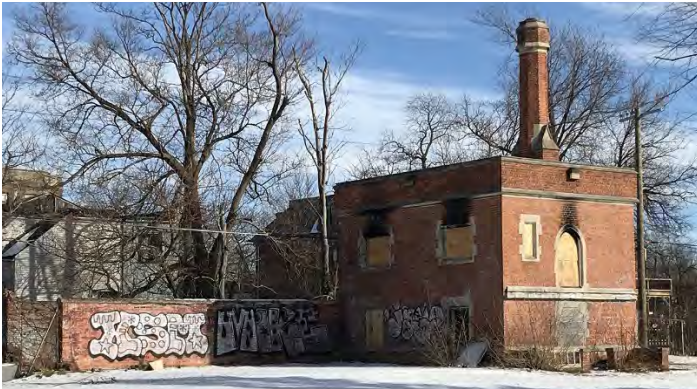
3664 Trumbull - Existing Masonry Power House. View from Trumbull looking southeast. Photo taken by HDC staff, February 2, 2021

Rehabilitate and convert existing 2-story brick Power House building into a detached residential condominium unit

- Demolish remaining portions of existing brick wall along alley adjacent to building. Salvage brick to be used as required for repair of building.
    - Demolish existing wood roof structure (destroyed in fire)

- Repair/repoint brick as required. Mortar mix to match existing color, composition, and texture.
    - Clean brick to remove soot stands and graffiti. Contractor to test least invasive (1) to more invasive (3) cleaning methods. 1 = power washing, 2 = acid/chemical cleaners, 3 = abrasives/media-blasting
    - Remove existing wood porch railing at north end of west facade of building and reconstruct wood porch rail in-kind and painted Yellowish White (C4).
    - Install new wood entry door centered on the west elevation. The replacement door is proposed to be a Craftsman 3 Panel 3 Light Premium Wood Pella Entry Door (stain color: Bordeaux)
    - Reconstruct damaged brick wall at northeast corner of building with salvaged brick from the demolition of the existing brick wall along the alley.

- Reopen the upper portion of the existing brick-infilled window opening at second floor of rear (east) elevation.
- Repair and replace existing wood header detail on front (west) façade above entry door.

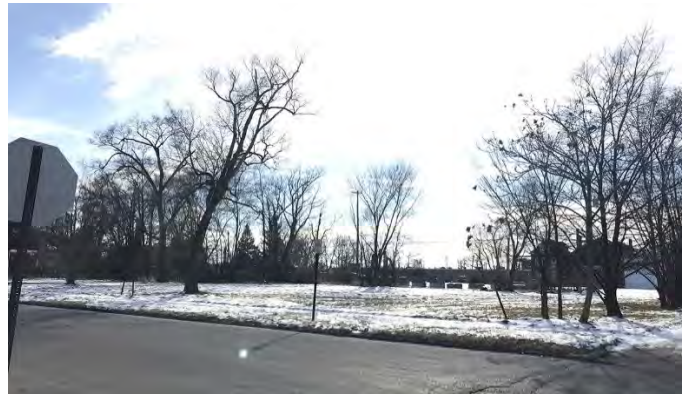
3689-3713 Lincoln. View from Selden Street looking southwest. Photo taken by HDC staff, February 2, 2021

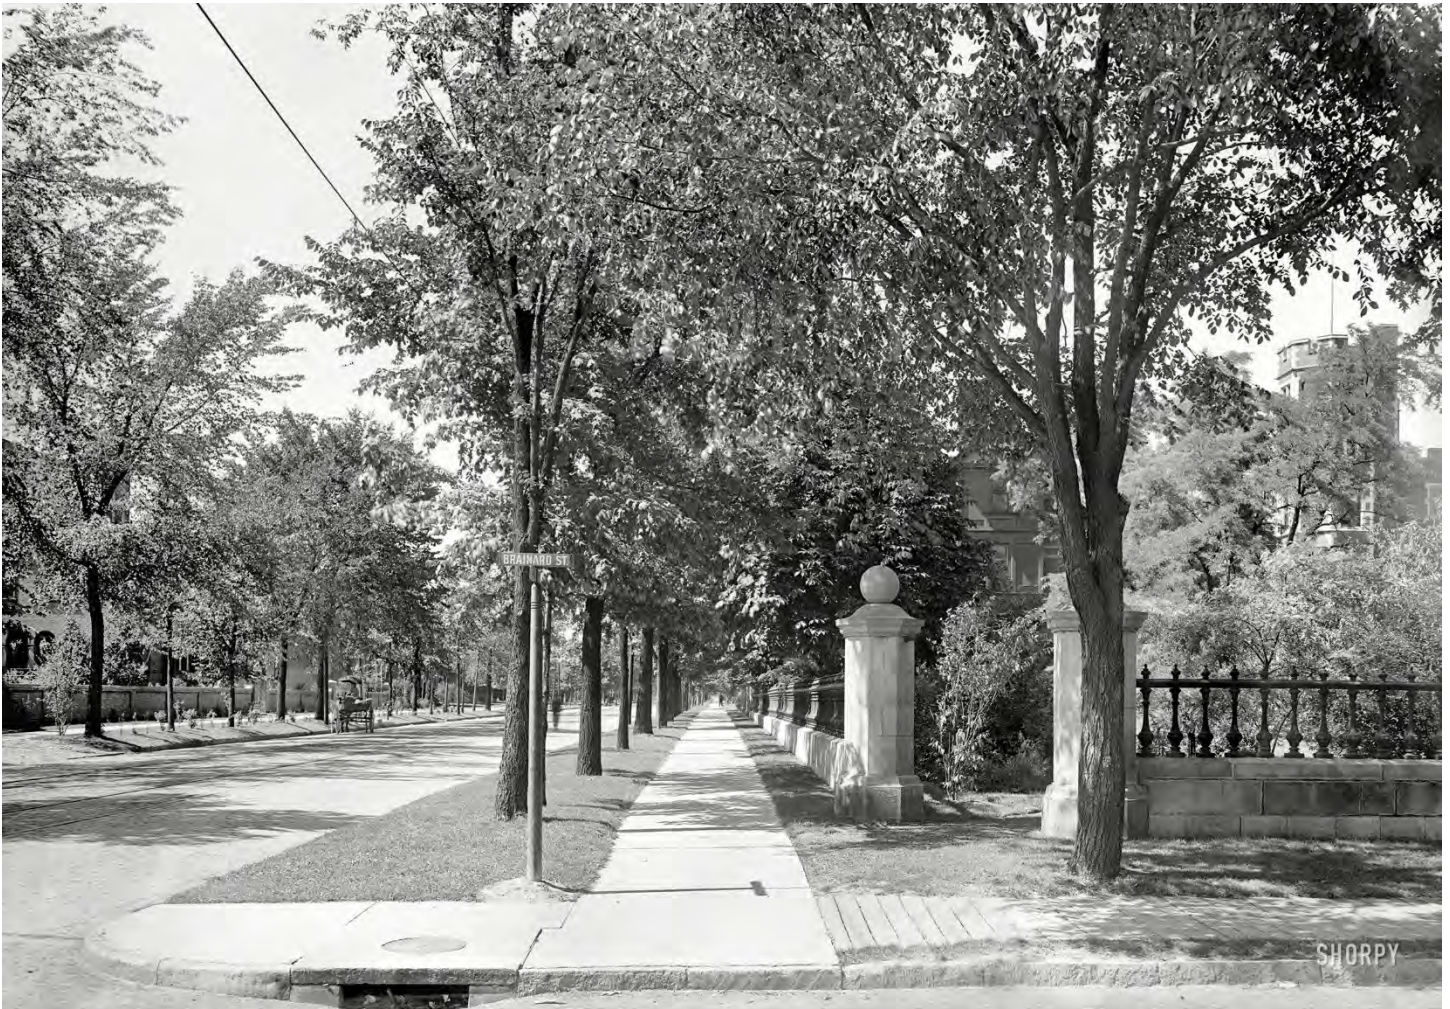
1910 Photo of Scripps Property taken from the corner of Brainard and Trumbull. **Note the perimeter garden wall base (cast iron pickets no longer intact) and stone columns at the corner.** – Source: <https://www.shorpy.com/files/images/SHORPY-4a20022a.jpg>

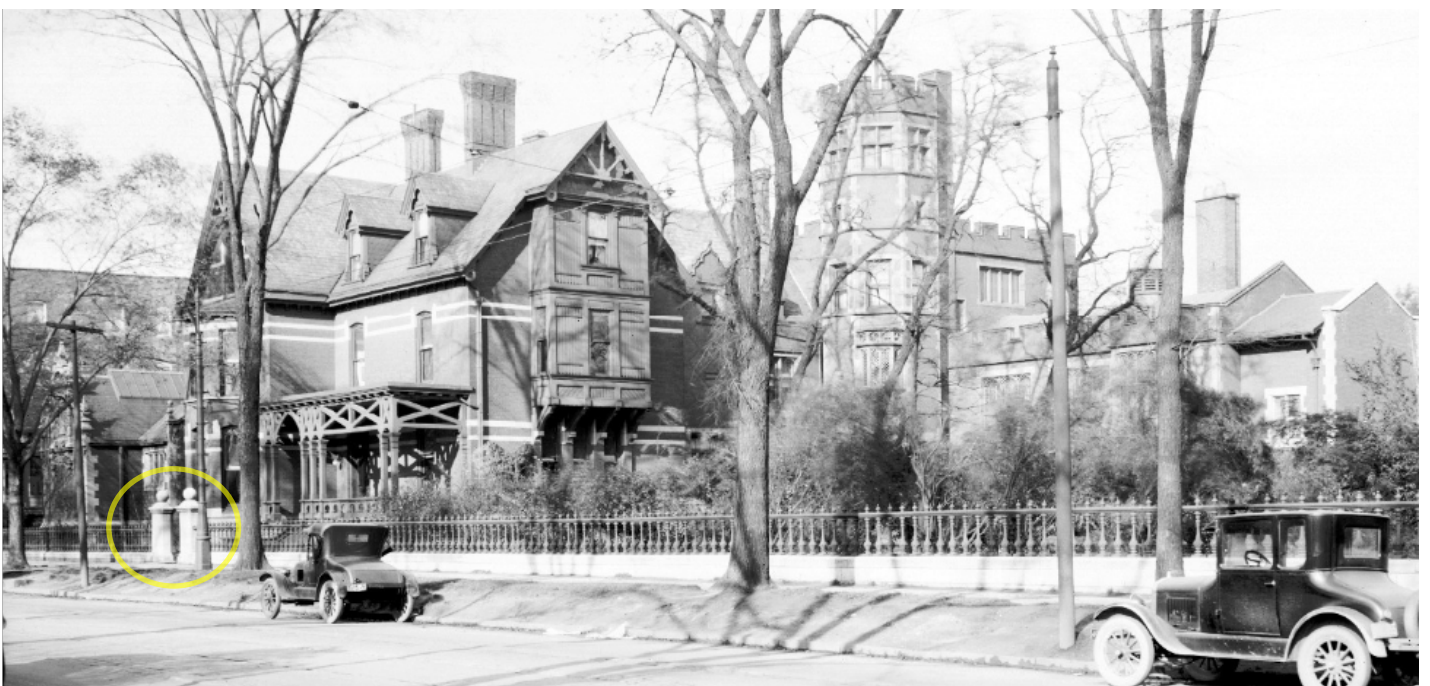
Photo of Scripps mansion (date unknown) taken from Trumbull looking northeast. **Note the perimeter garden wall base (cast iron pickets no longer intact) and stone columns at the central entrance to the site.** – Source: Wayne State University Digital Collections (Virtual Motor City Collection)

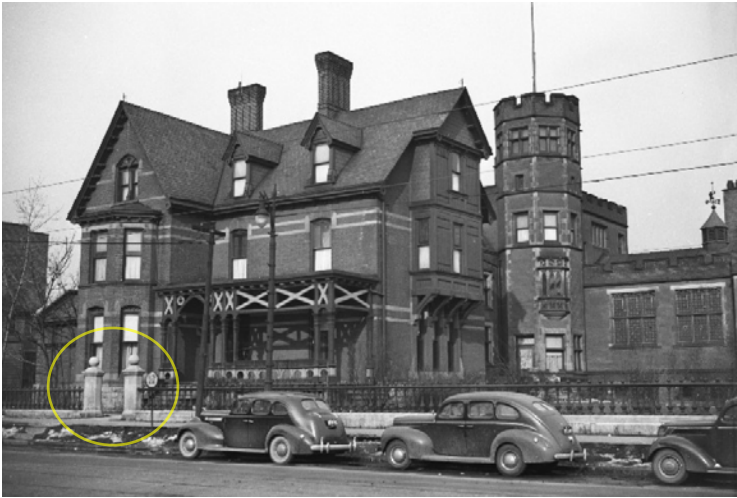
1940 Photo of Scripps mansion (date unknown) taken from Trumbull looking northeast. *Note the perimeter garden wall base (wrought iron pickets no longer intact) and stone columns at the central entrance to the site.*  
 Source: Wayne State University Digital Collections (Virtual Motor City Collection)

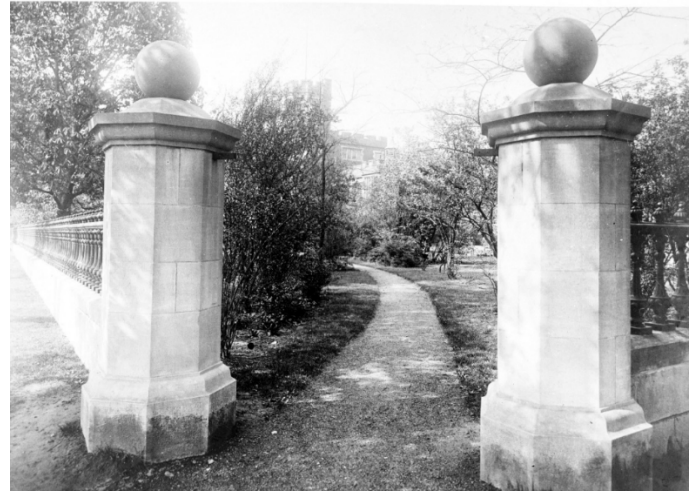
Photo of stone columns and perimeter garden wall (wrought iron pickets no longer intact) at the corner entrance to the property taken from the corner of Brainard and Trumbull.

- Demolish existing concrete barrier wall along north side of alley.
    - Demolish existing decorative stone wall at corner of Trumbull and Brainard in its entirety, including the lengths running along Trumbull and Brainard.
    - Demolish (2) two existing stone columns located along Trumbull mid-way through the site in their entirety.
    - Remove and salvage (2) existing decorative stone columns near corner of Trumbull and Brainard (to be relocated as part of development outdoor space).
    - Remove all existing trees on the site.

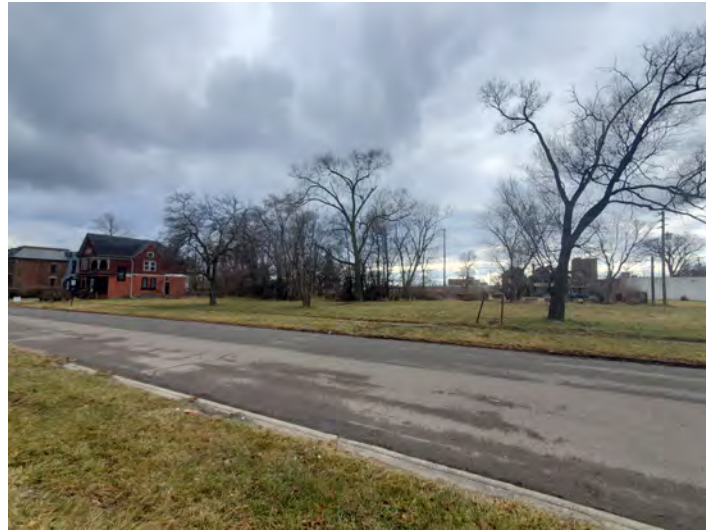
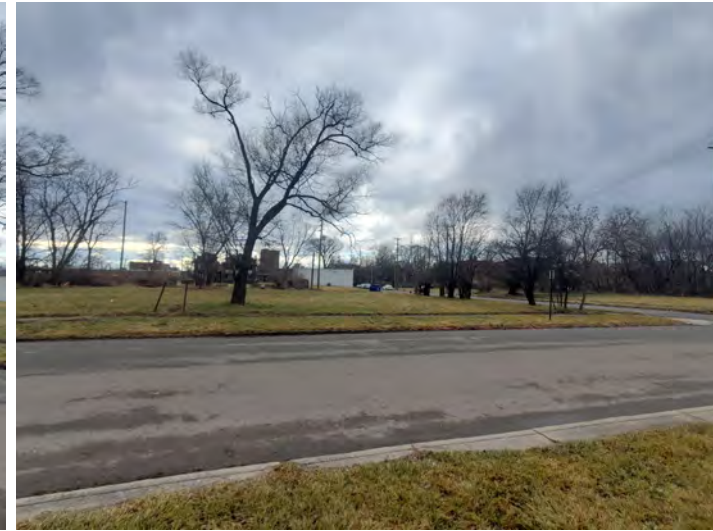
3689 - 3713 LINCOLN (LOOKING WEST)

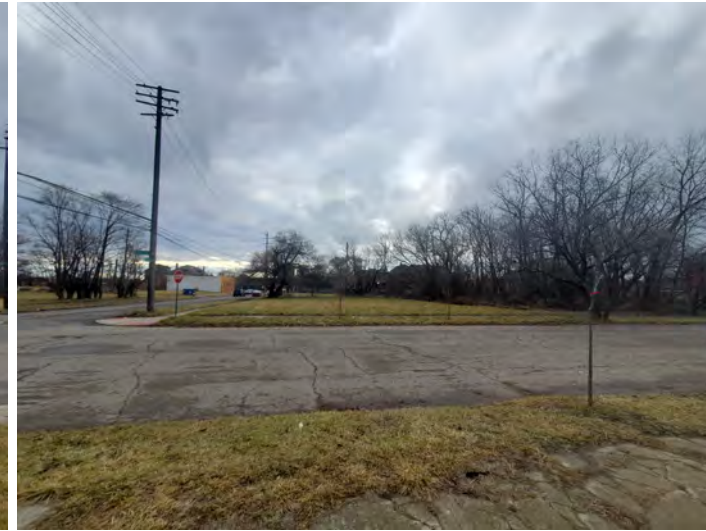
3907 - 3915 LINCOLN (LOOKING WEST)

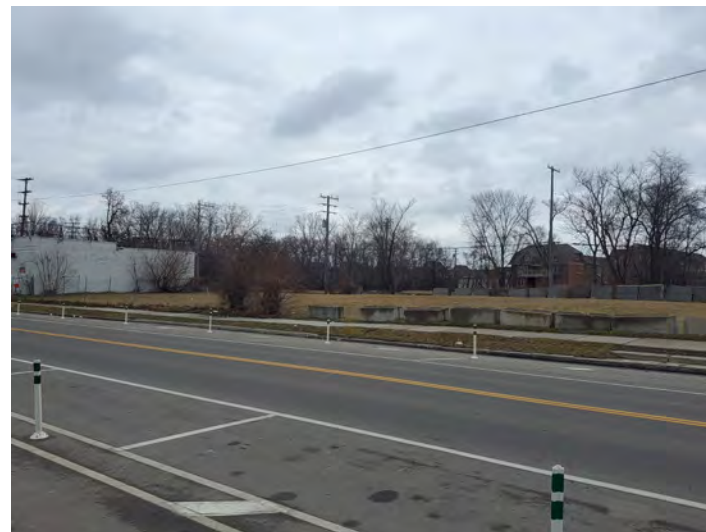
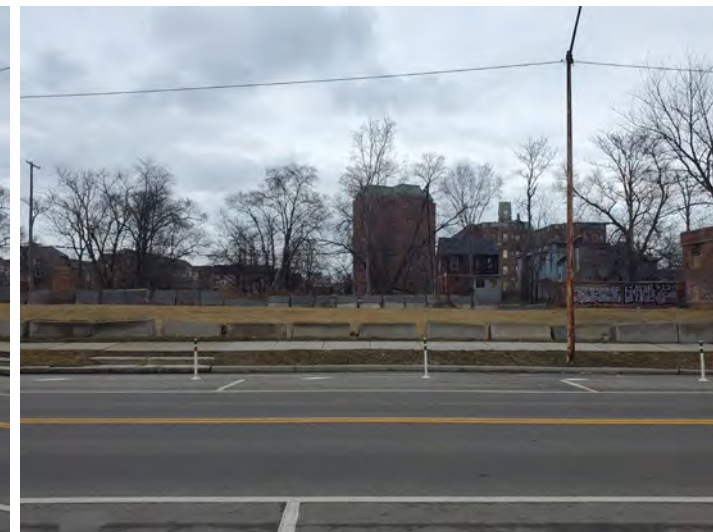
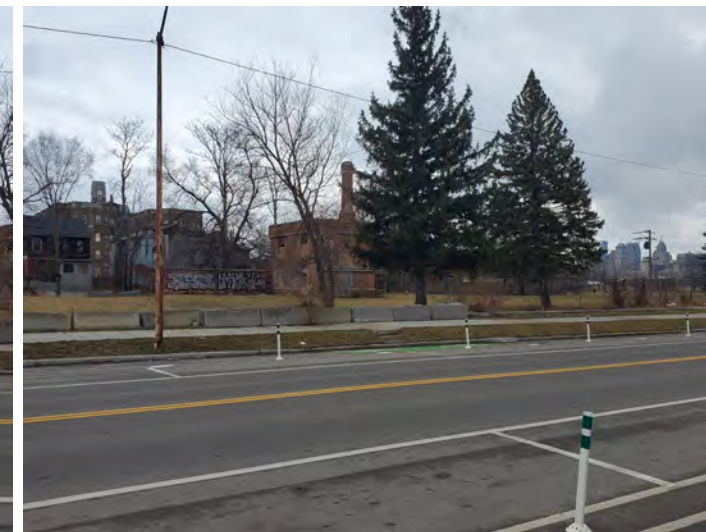
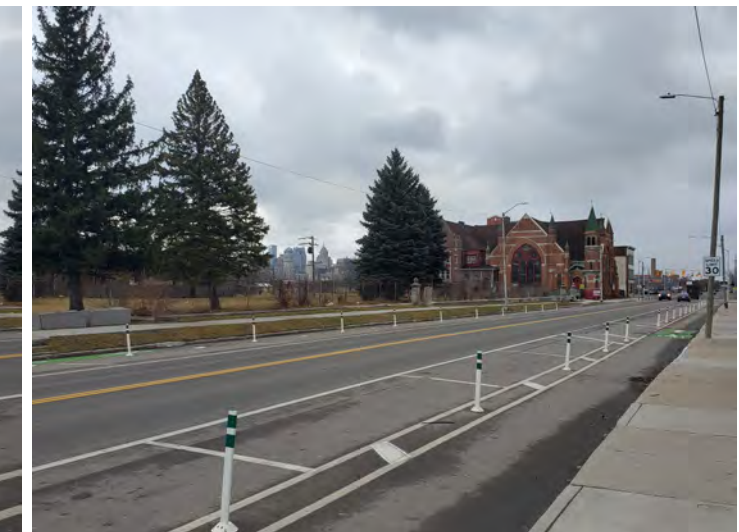
3664 - 3708 TRUMBULL (LOOKING EAST)

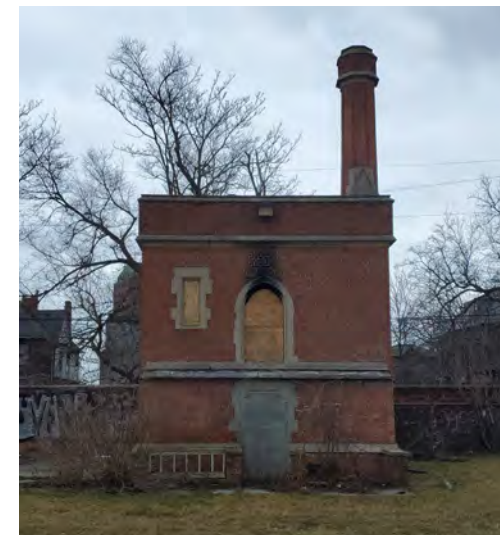
EXISTING POWERHOUSE

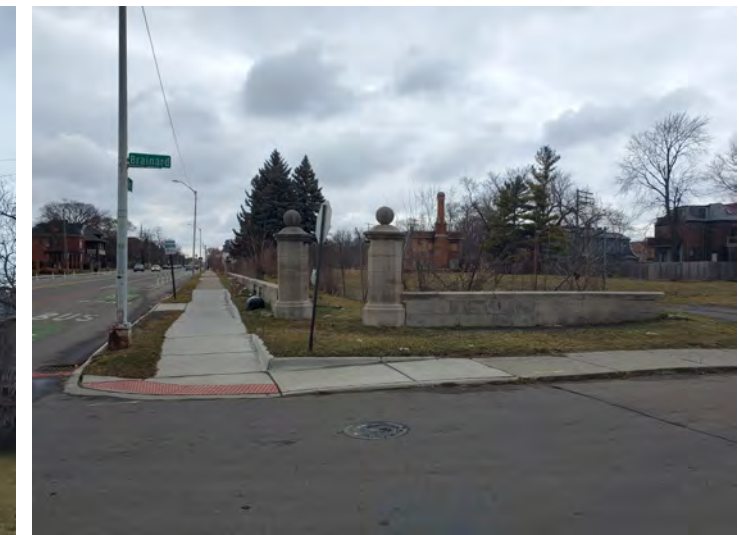
EXISTING STONE WALL AND DECORATIVE COLUMNS

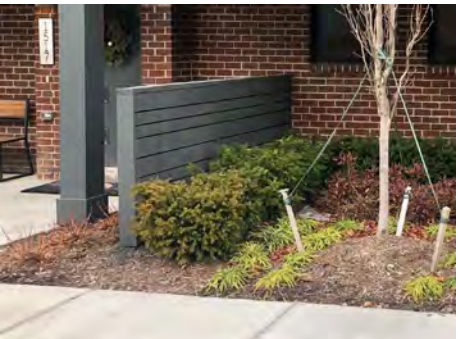
4' ht. Screen Fence - Color to match Architecture  
(For use between select buildings and as AC Unit screens)

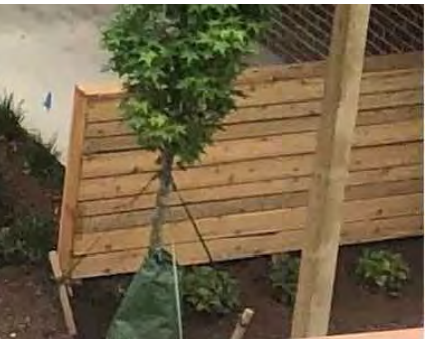
4' ht. Screen Fence - Alternate Natural Finish  
(For use between select buildings and as AC Unit screens)

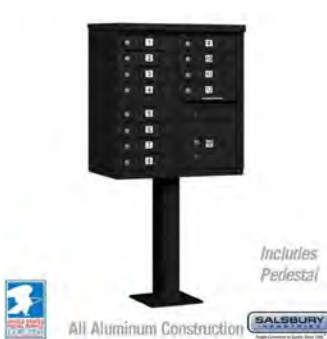
Mail Cluster Box Unit  
Includes Pedestal  
All Aluminum Construction  
SALSBURY

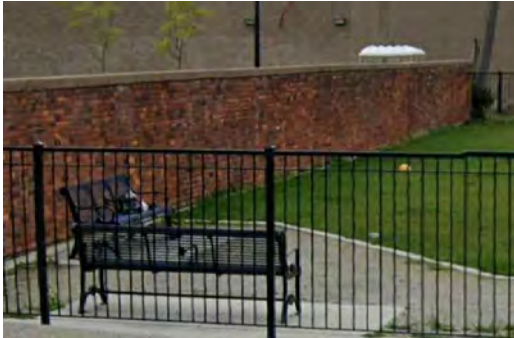
6' ht. Screen Wall - Brick to match Architecture

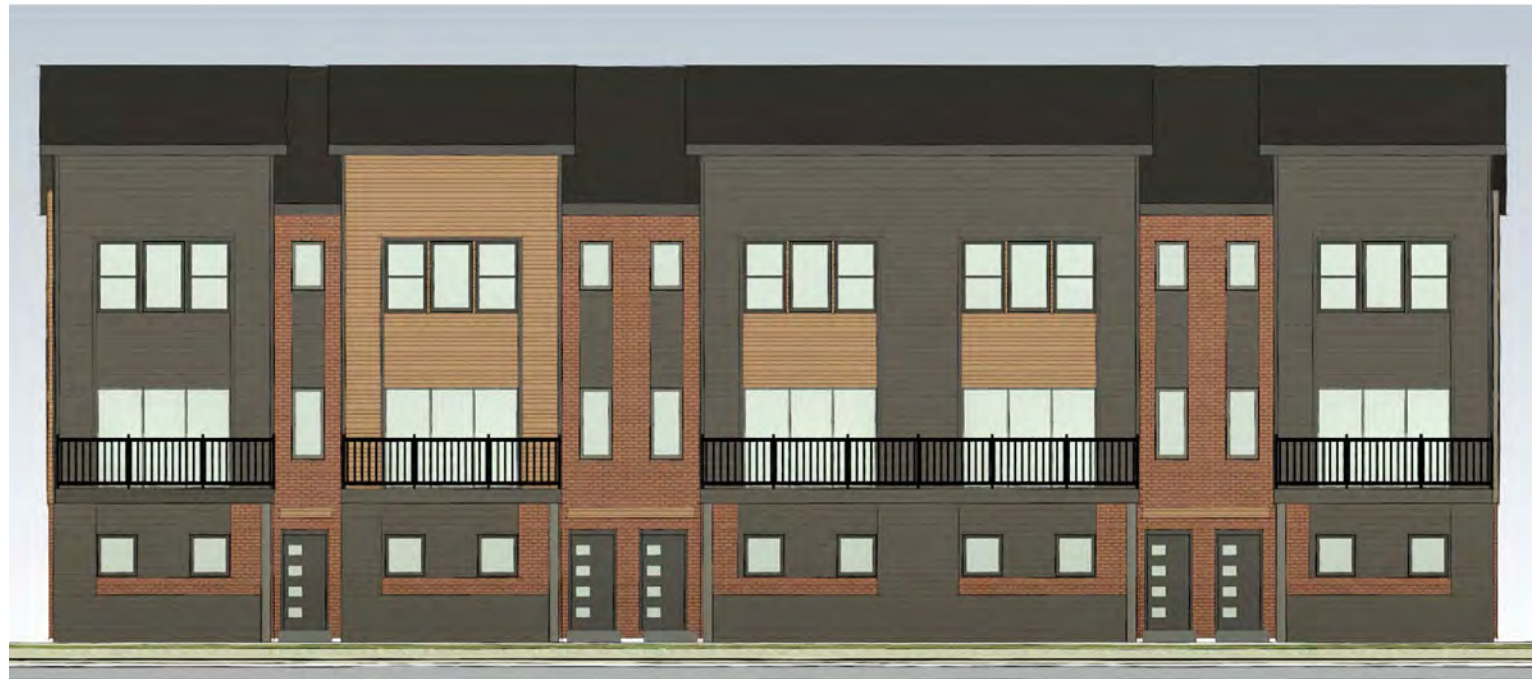
**FRONT ELEVATION**  
(20' WIDE UNIT - 5 UNIT BUILDING)

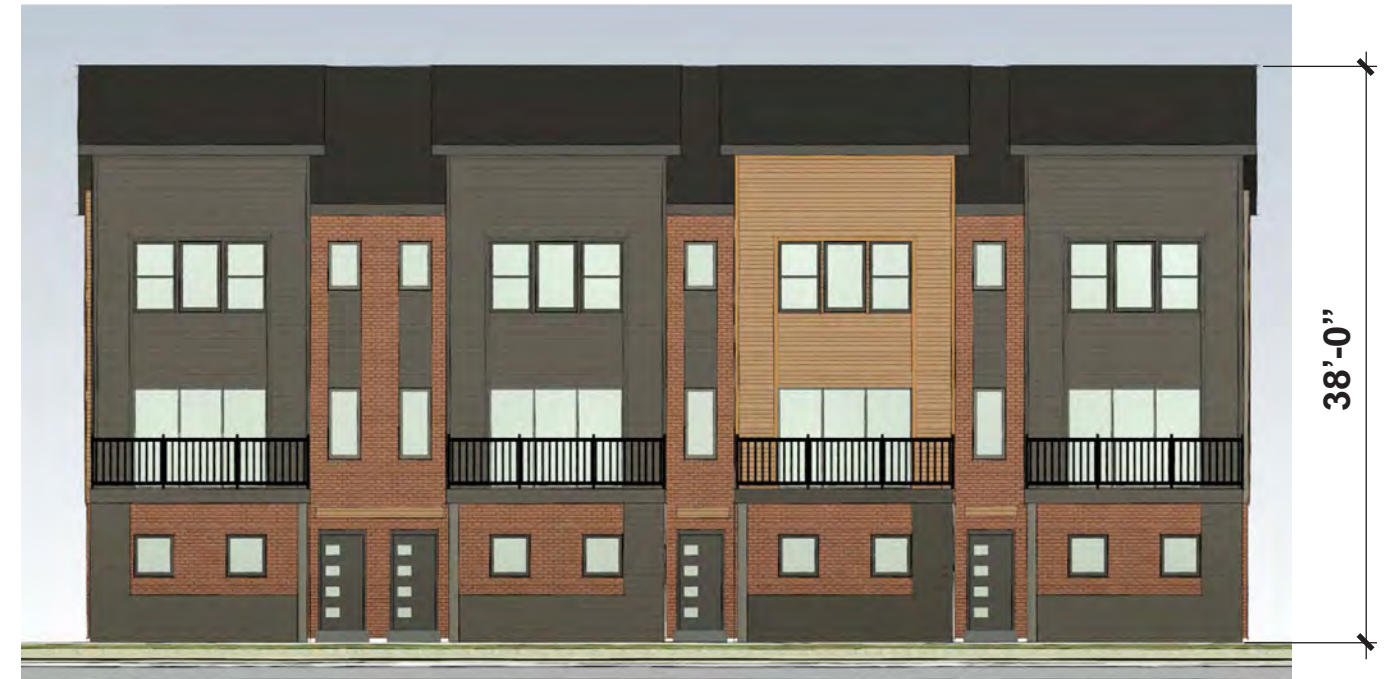
**FRONT ELEVATION**  
(20' WIDE UNIT - 4 UNIT BUILDING)

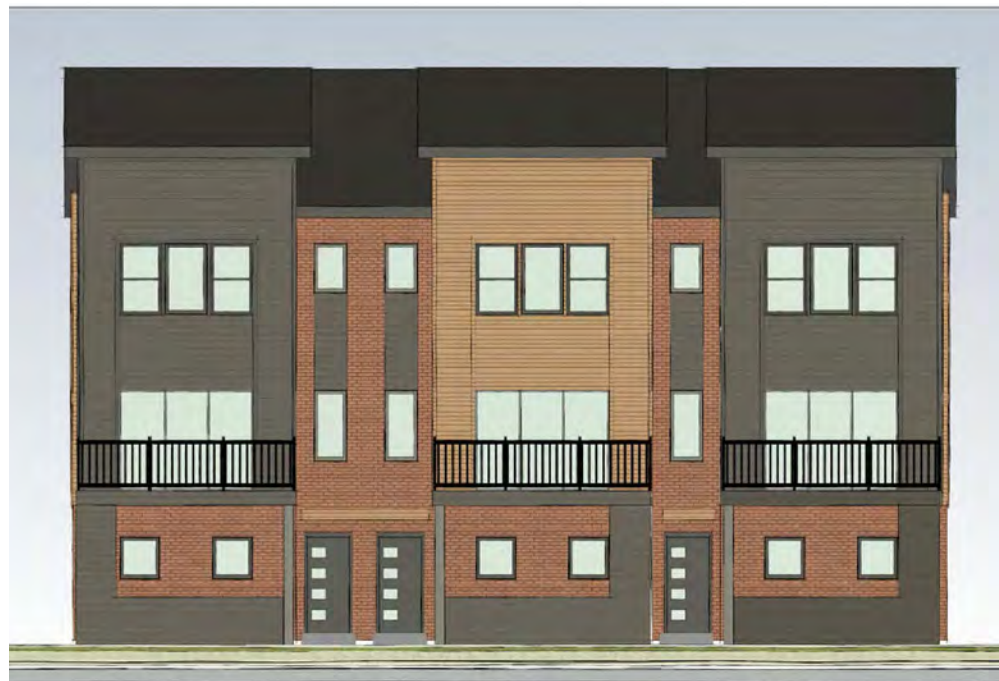
**FRONT ELEVATION**  
(20' WIDE UNIT - 3 UNIT BUILDING)

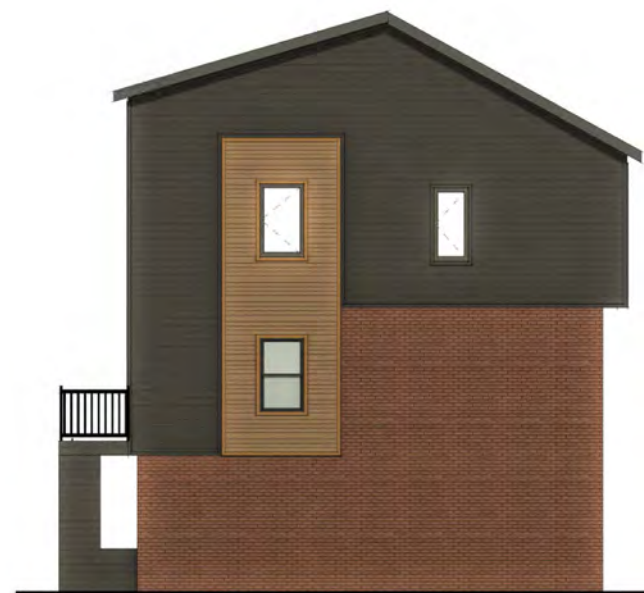
**TYP. SIDE ELEVATION**  
(20' WIDE UNIT)

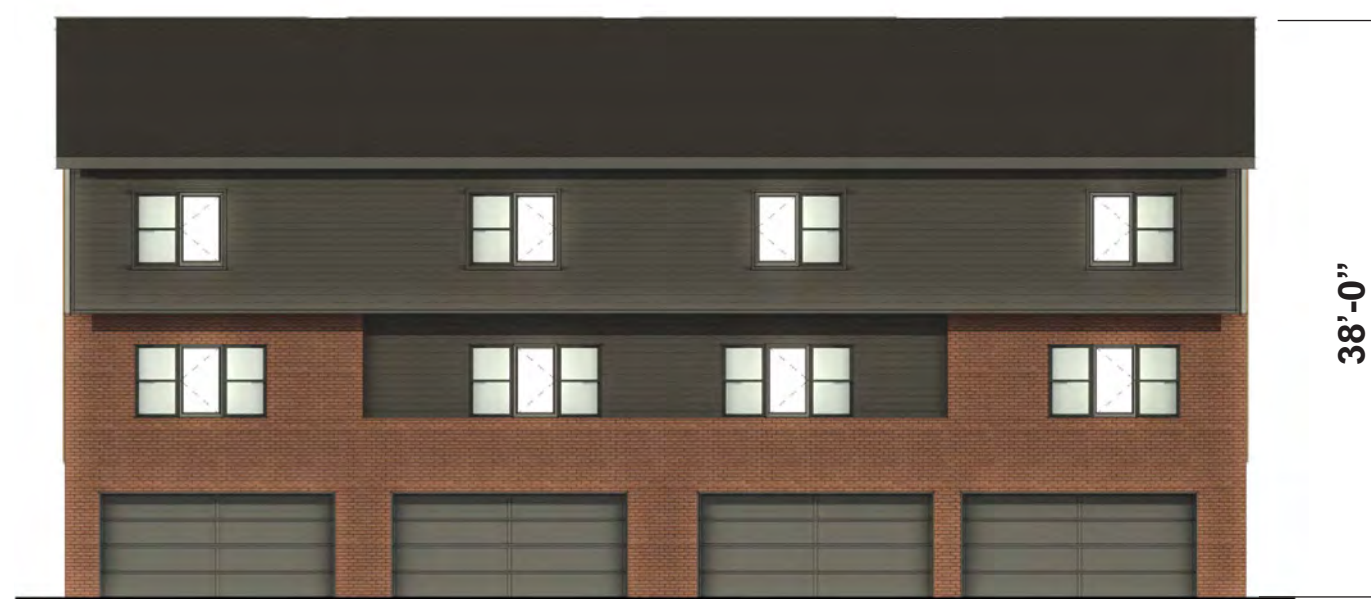
**TYP. REAR ELEVATION**  
(20' WIDE UNIT - 4 UNIT BUILDING SHOWN)

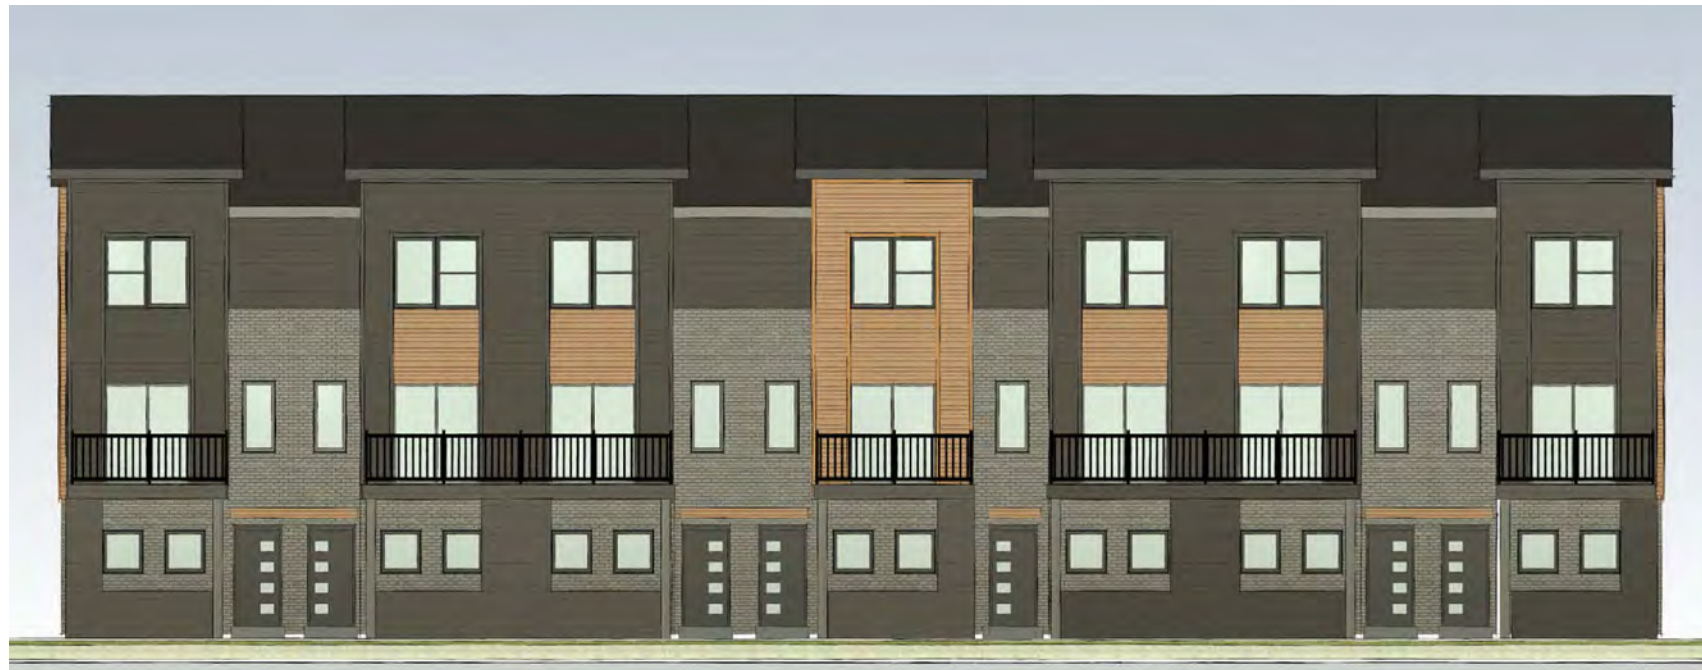
**FRONT ELEVATION**  
(16' WIDE UNIT - 7 UNIT BUILDING)

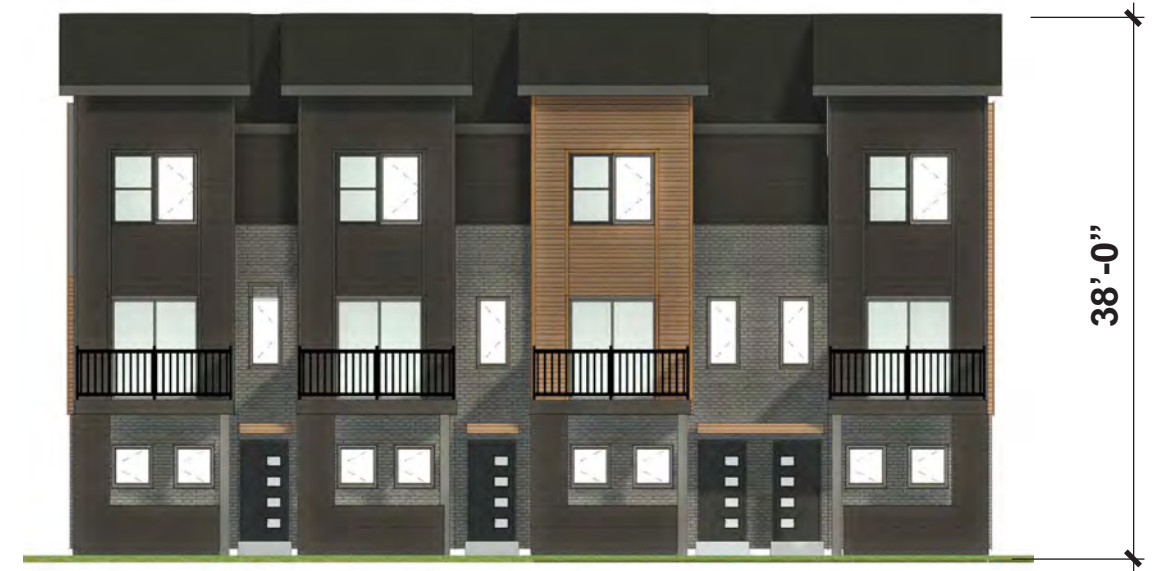
**FRONT ELEVATION**  
(16' WIDE UNIT - 4 UNIT BUILDING)

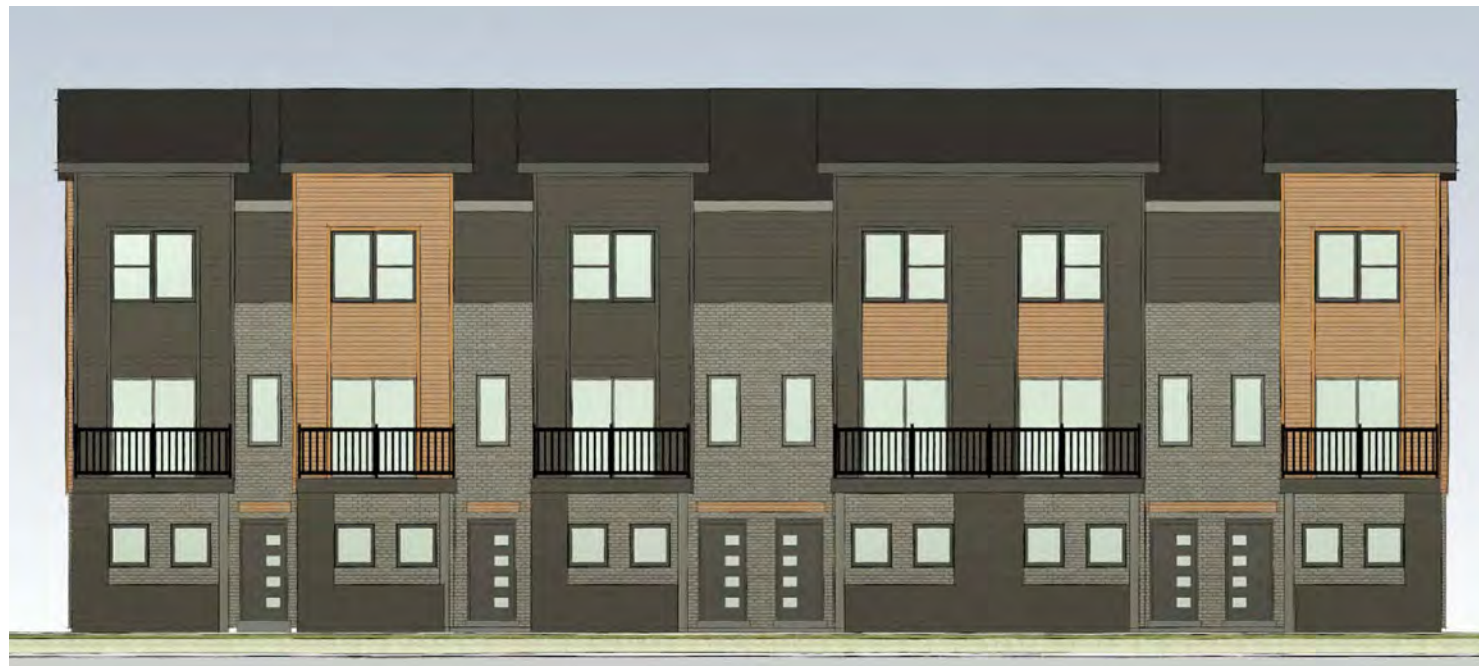
**FRONT ELEVATION**  
(16' WIDE UNIT - 6 UNIT BUILDING)

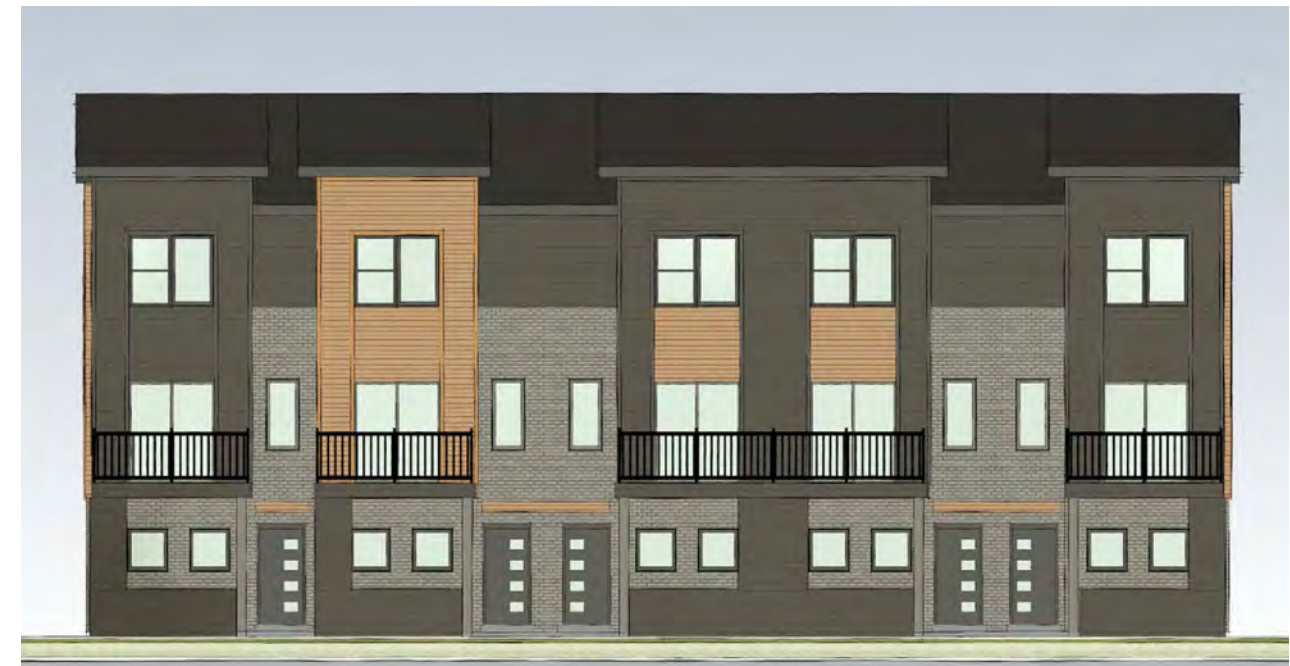
**FRONT ELEVATION**  
(16' WIDE UNIT - 5 UNIT BUILDING)

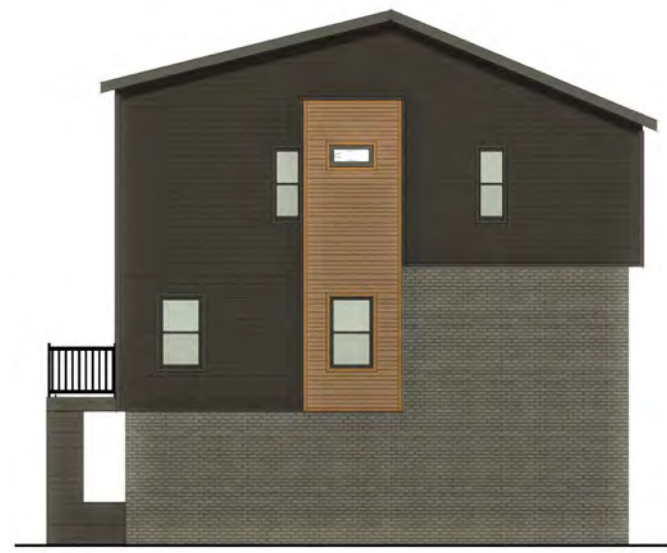
**TYP. SIDE ELEVATION**  
(16' WIDE UNIT)

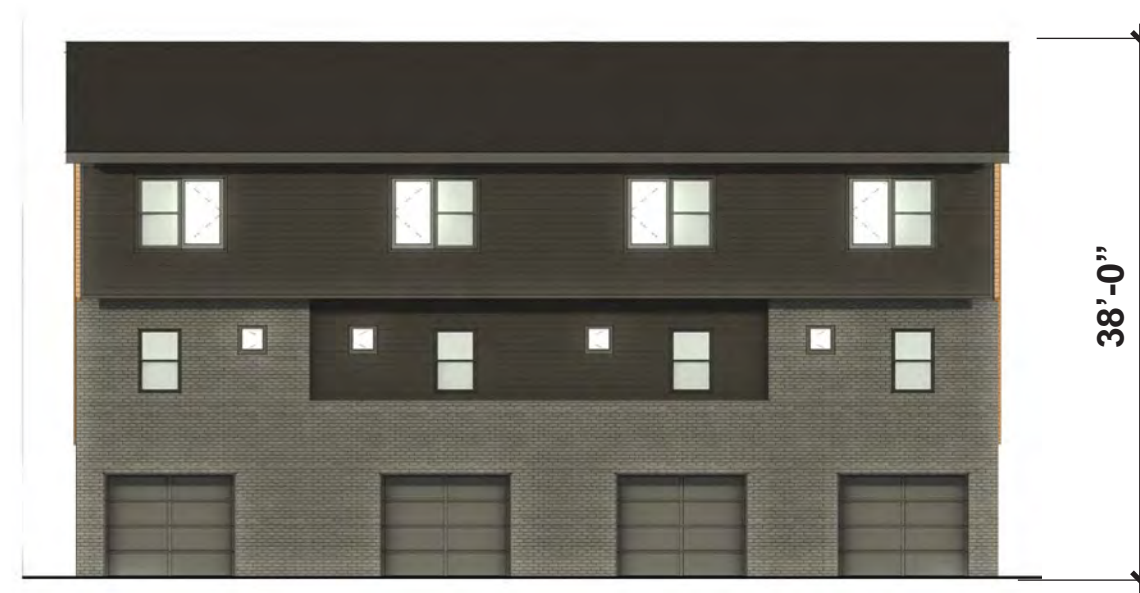
**TYP. REAR ELEVATION**  
(16' WIDE UNIT - 4 UNIT BUILDING SHOWN)

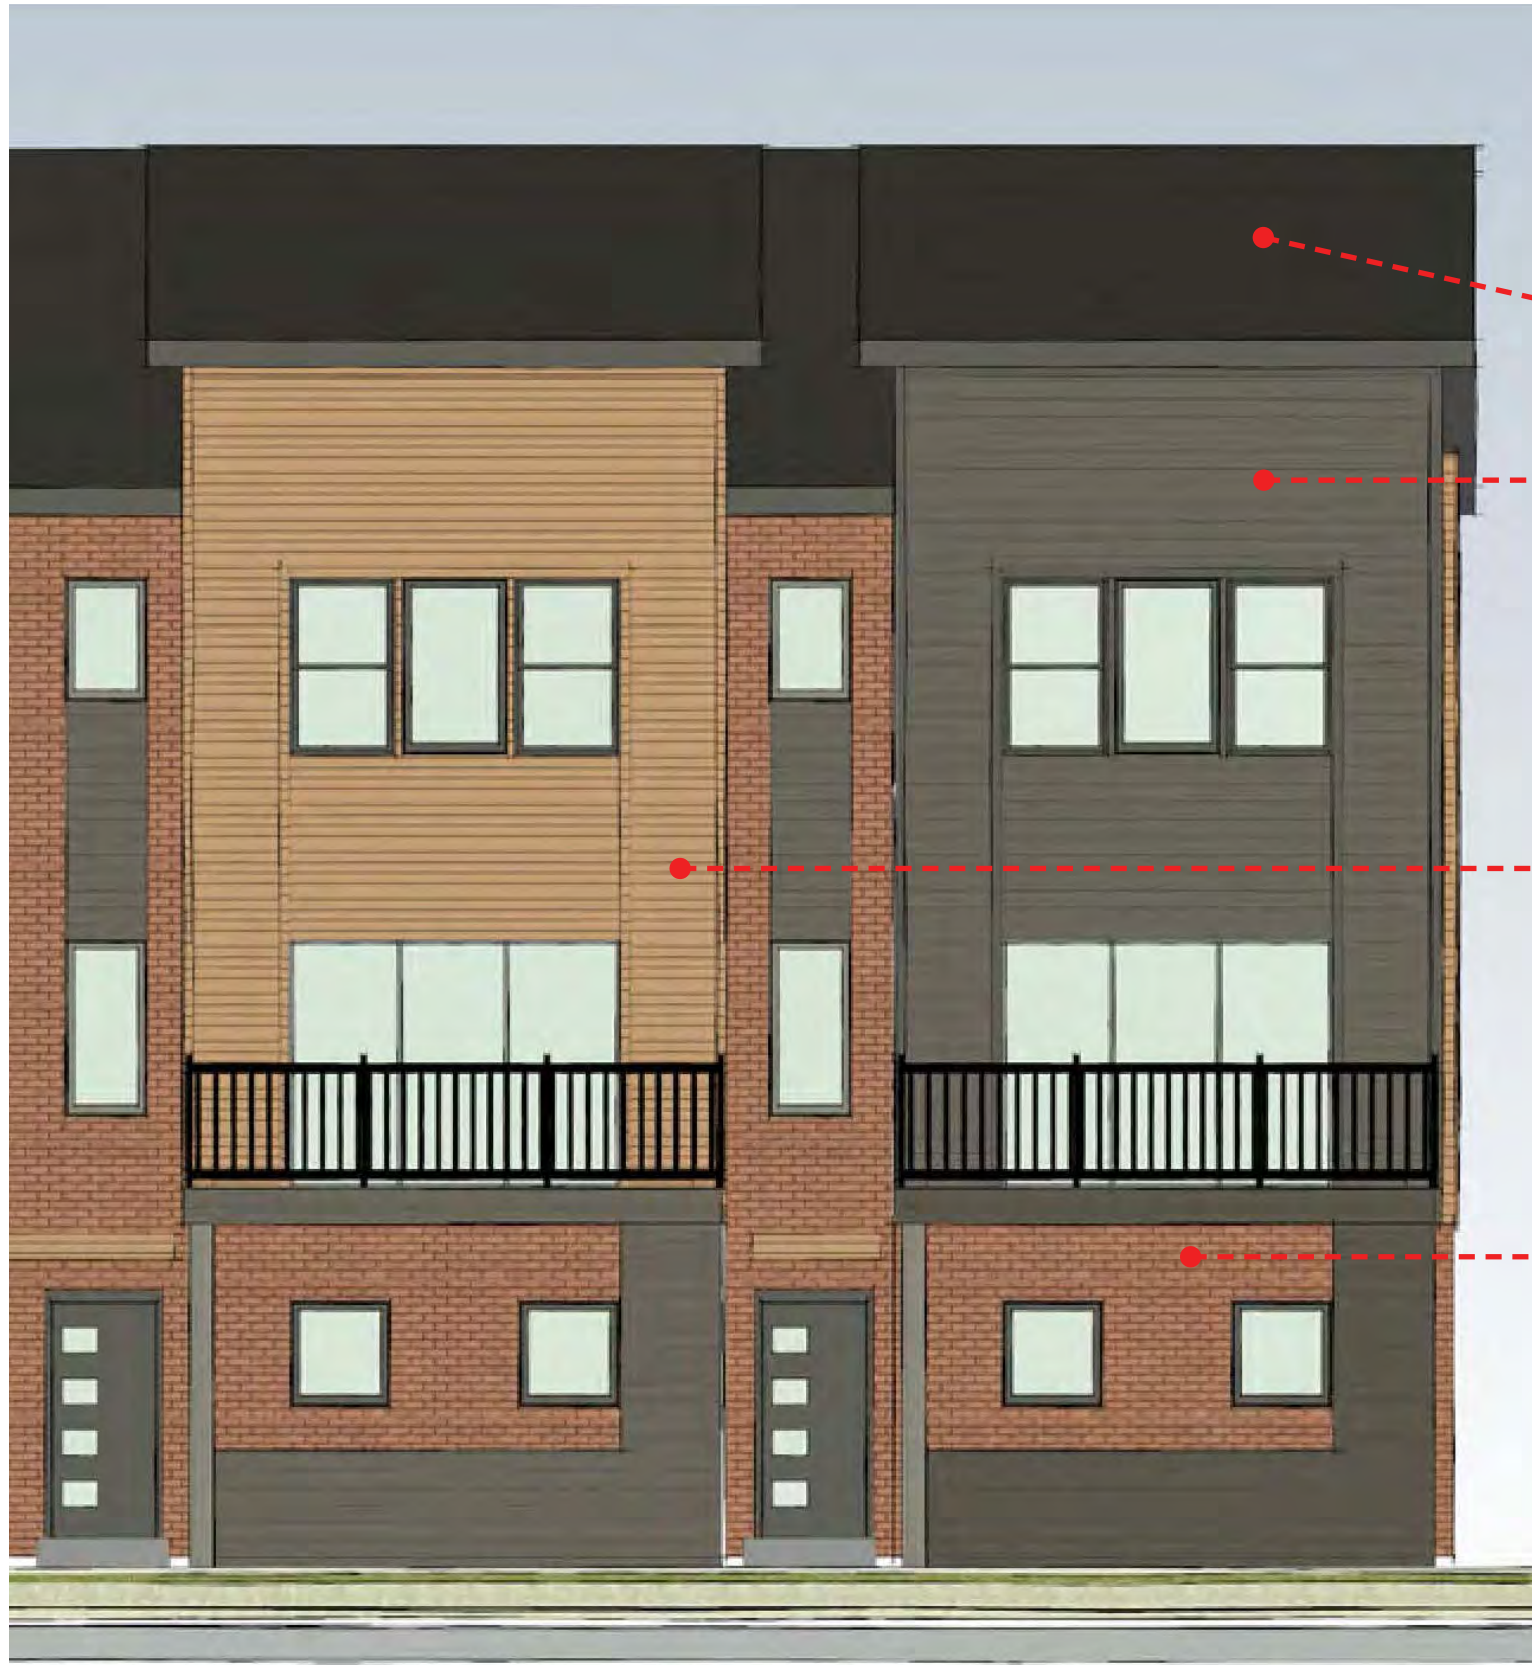
“RED” SCHEME

**BRICK:** MERIDIAN - GRAND RIVER QUEEN

**PAINTED SIDING:** JAMES HARDIE LAP SIDING, IRON GRAY, SMOOTH

**WOOD SIDING:** WOODTONE STAINED - SUMMER WHEAT
