**STAFF REPORT 2-10-2021 REGULAR MEETING**

**ADDRESSES:** 3664, 3690, 3700, 3708 TRUMBULL

**HISTORIC DISTRICT:** WOODBRIDGE FARM

**SCOPE:** ERECT NEW BUILDINGS, REHABILITATE EXISTING POWER HOUSE

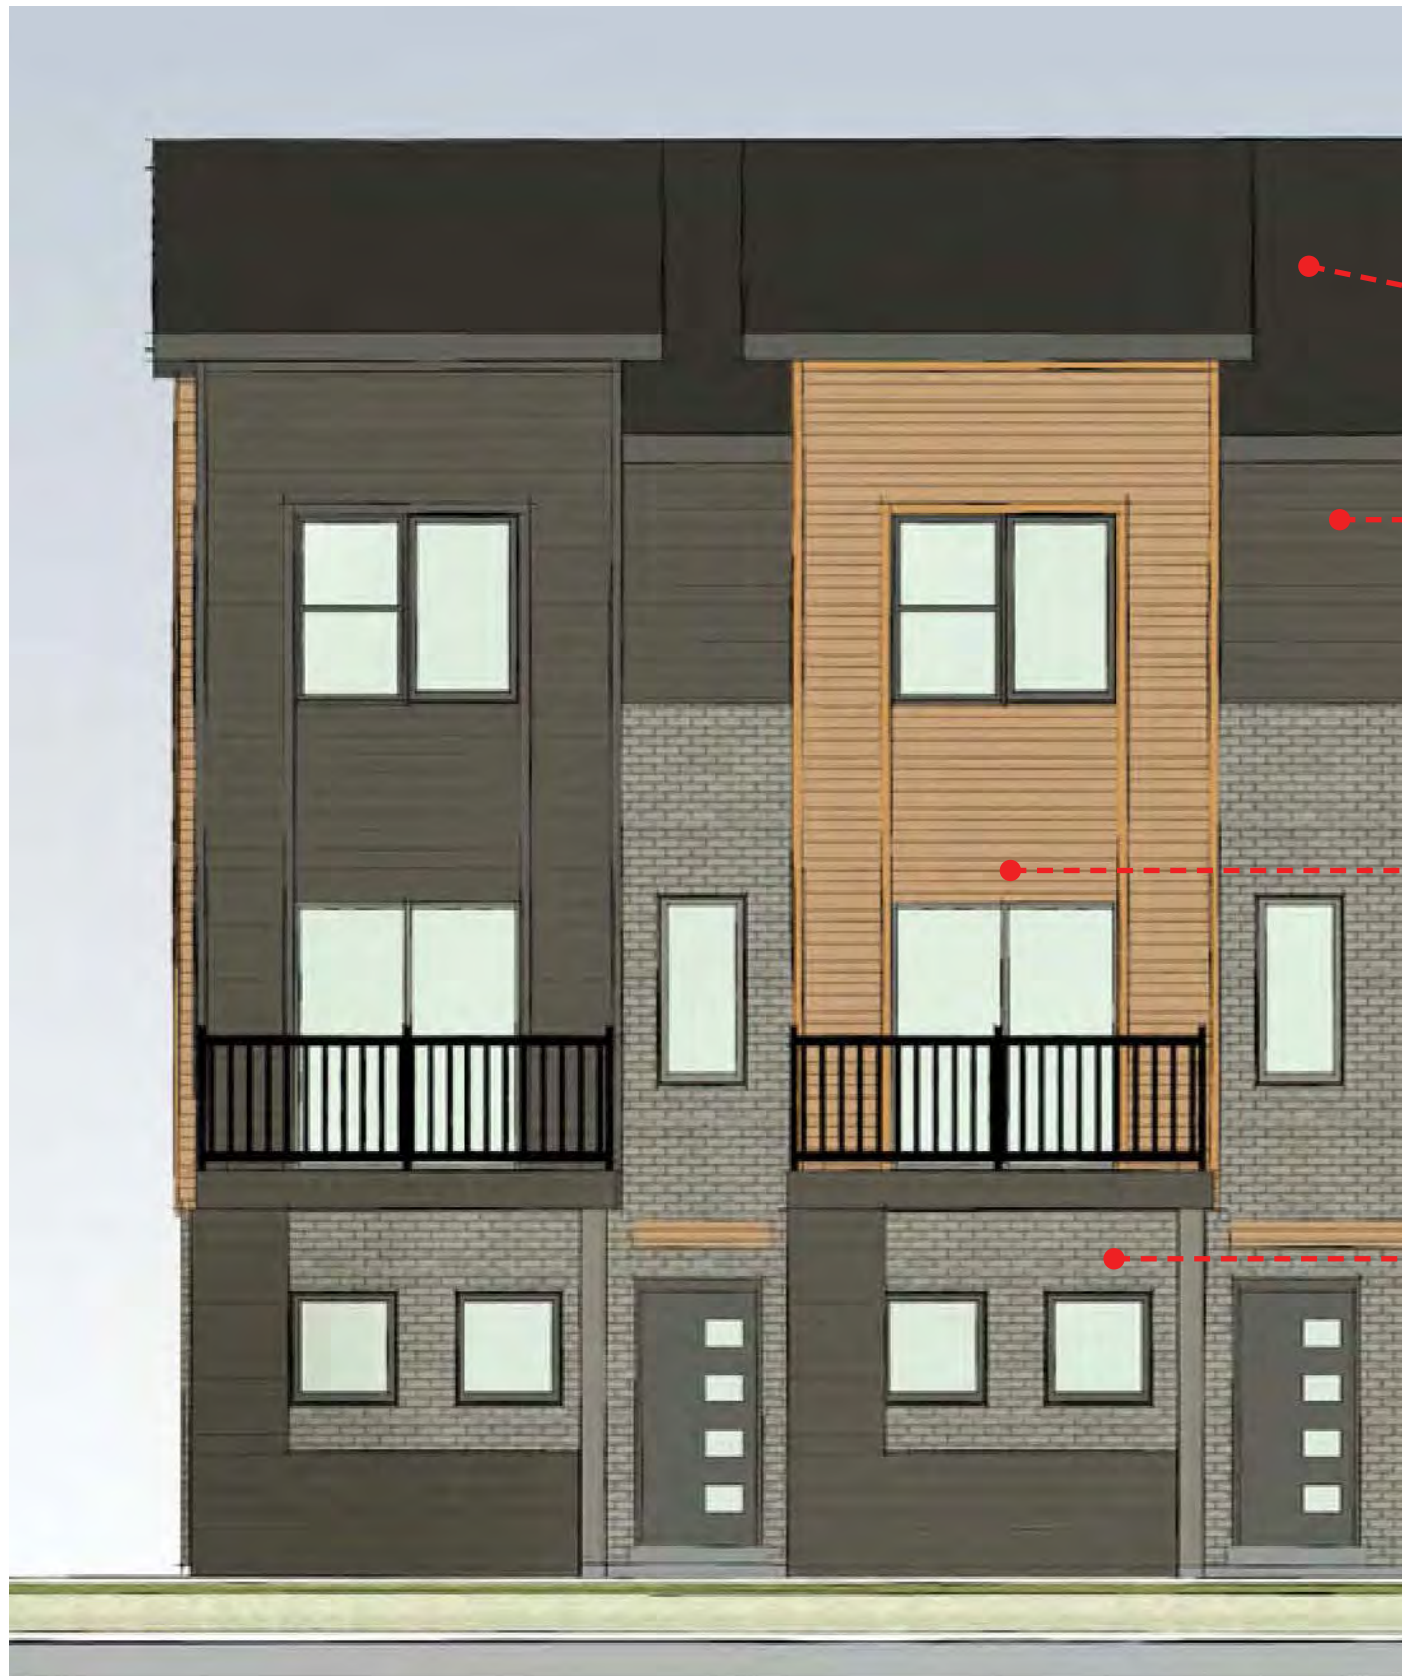
“GRAY” SCHEME

**BRICK:** BRICK CRAFT - CORAL BLEND QUEEN

**PAINTED SIDING:** JAMES HARDIE LAP SIDING, RICH ESPRESSO, SMOOTH

**WOOD SIDING:** WOODTONE STAINED - SUMMER WHEAT

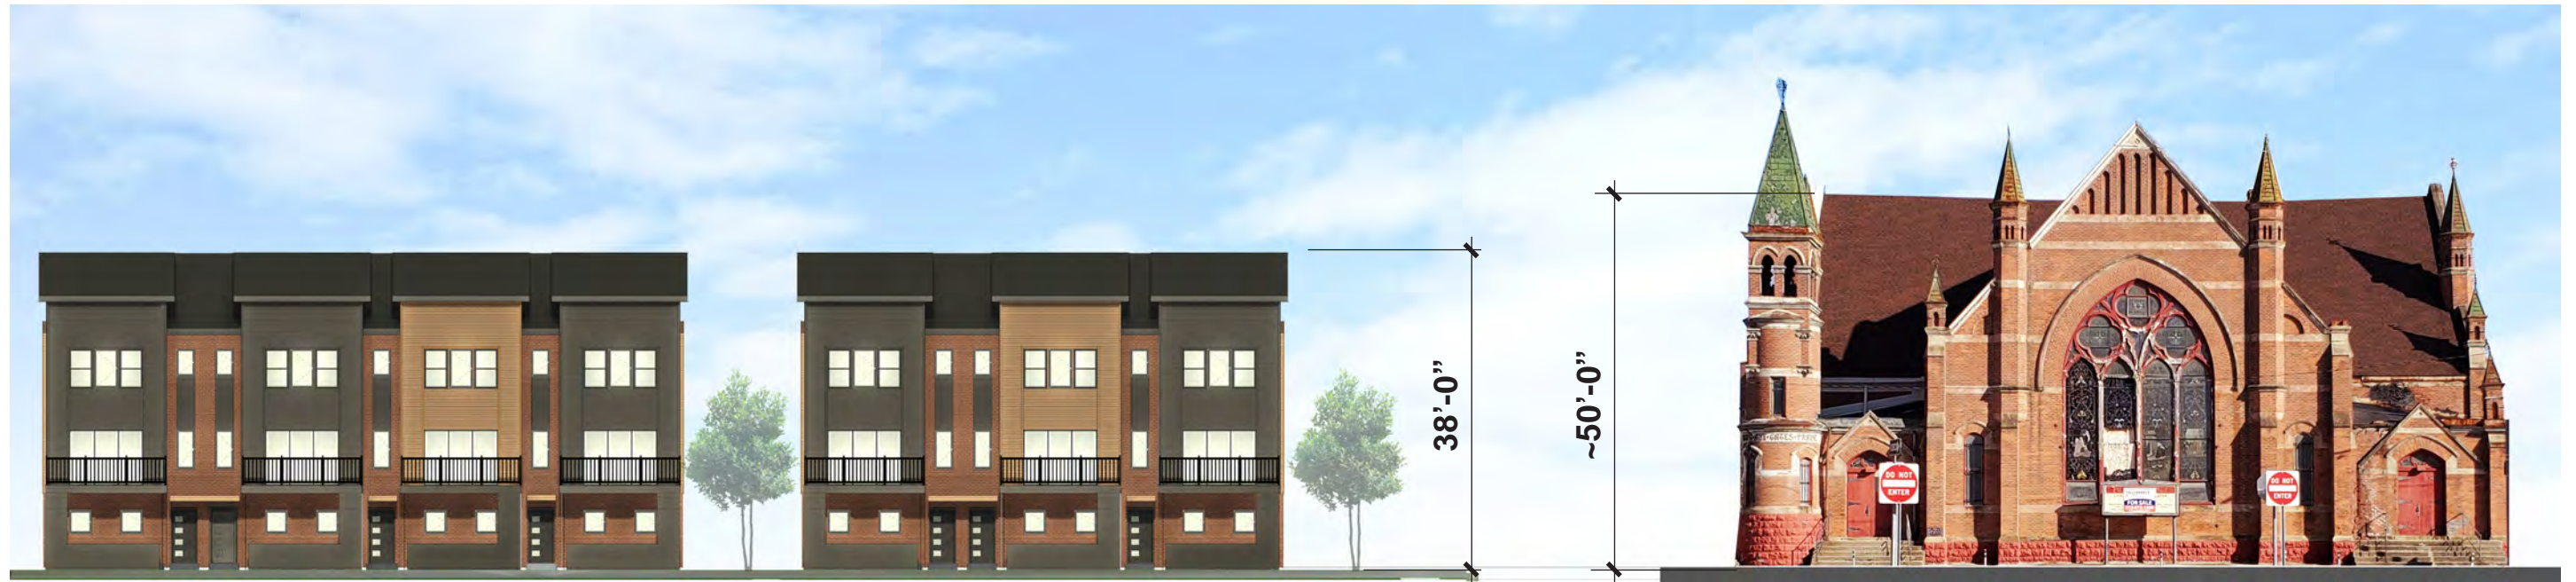
**TRUMBULL HISTORIC CONTEXT**  
SCALE: 1" = 10'-0"

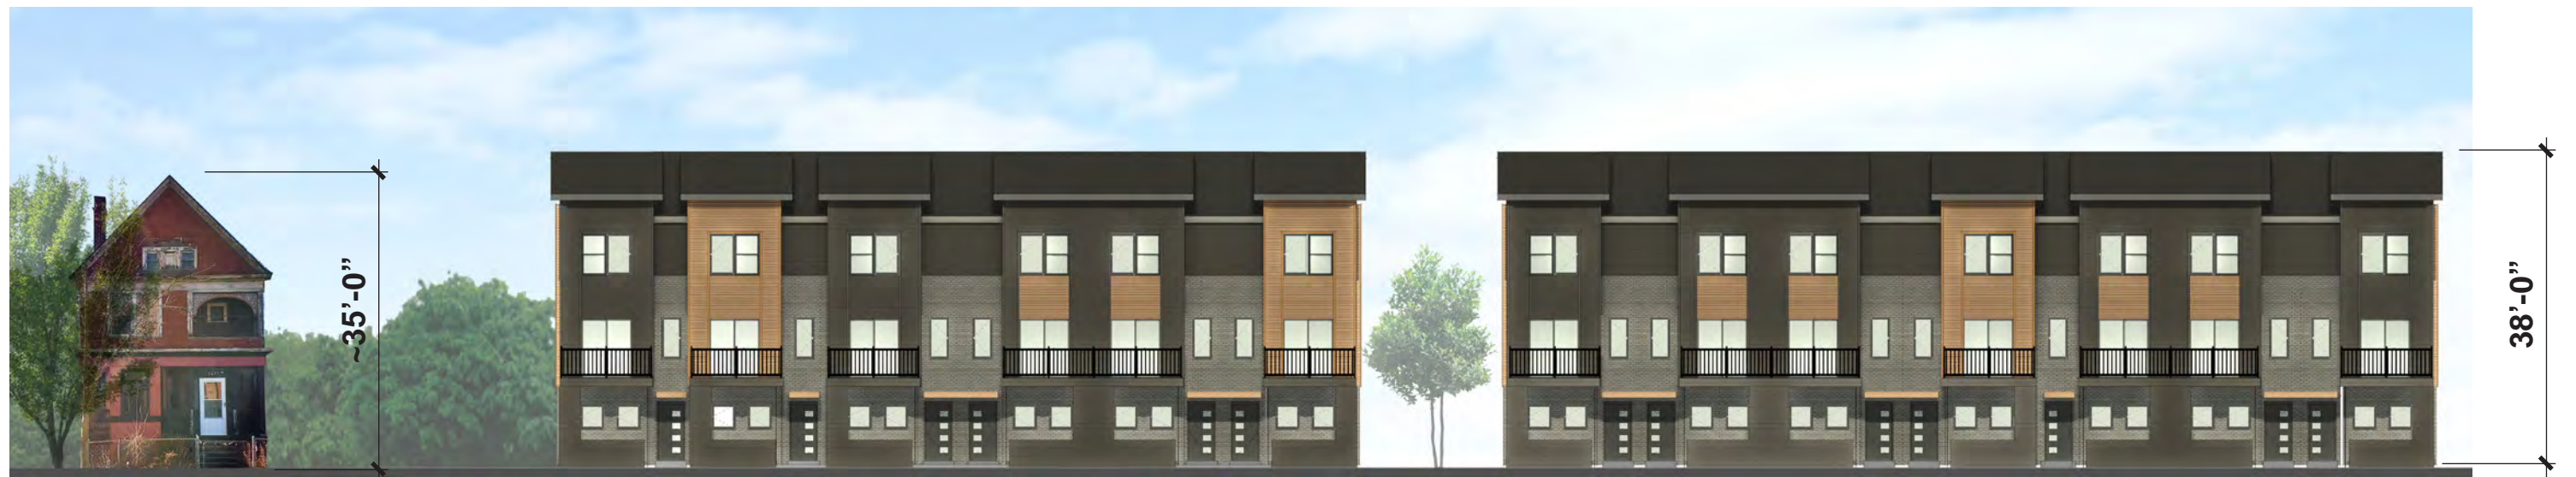
**LINCOLN HISTORIC CONTEXT**  
SCALE: 1" = 10'-0"

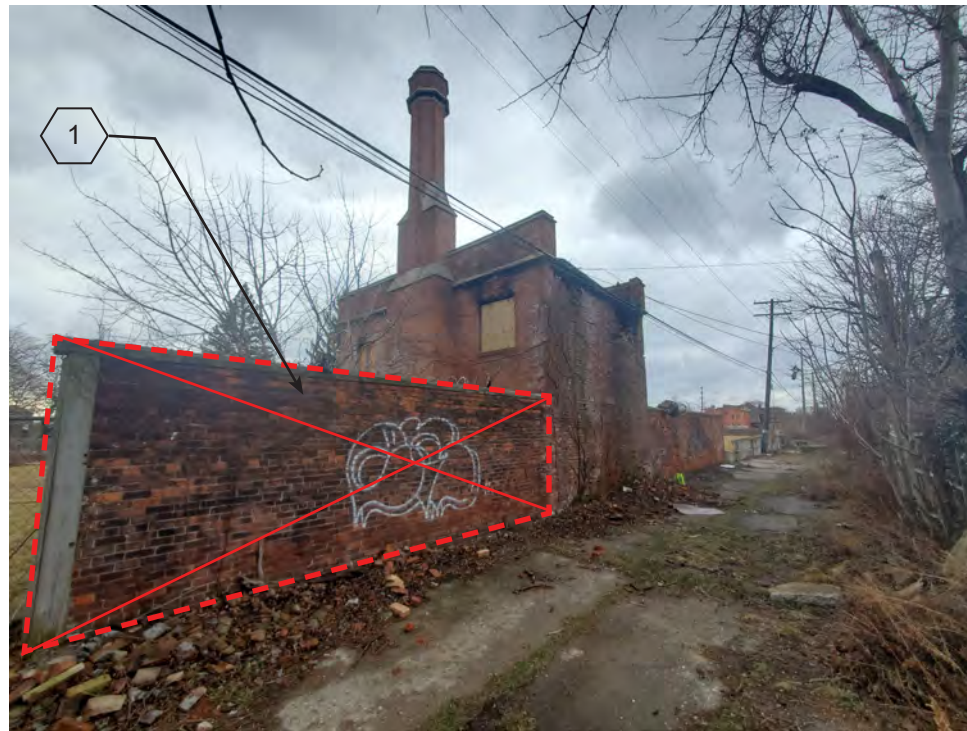
WINGWALL ELEVATION

- 1 DEMOLISH REMAINING BRICK FENCE/WALL. SALVAGE BRICK
- 2 DEMOLISH COLLAPSING REAR BRICK WALL. SALVAGE BRICK
- 3 REMOVE DAMAGED/ROTTED WOOD DETAILING. DOCUMENT PROFILES FOR IN-KIND REPLACEMENT

elements be evaluated for the current code required minimum design loads associated with the risk category related to the new use. The resulting wind speed of 115mph applied to the approximately 11ft tall freestanding masonry wall structure results in the existing east masonry wing walls to be overstressed and in an otherwise unsafe condition structurally.

Accordingly, it is our recommendation that the east elevation masonry wall be removed and replaced, and the east masonry wing walls be demolished.

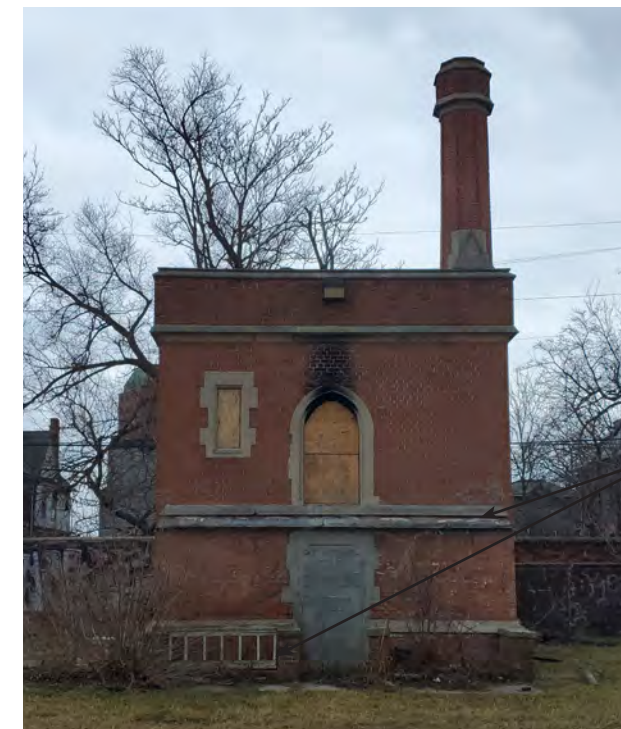
WEST ELEVATION

- 1 NEW ALUM CLAD WOOD WINDOWS. BASIS OF DESIGN: PELLA ARCHITECTURAL SERIES TRADITIONAL. EXTERIOR COLOR: BLACK
- 3 NEW FLOOR FINISH ON WOOD SUBFLOOR AND FRAMING. REPAIR, REPLACE, AND INFILL EXISTING FLOOR FRAMING AS REQUIRED.
- 4 NEW STAIR
- 7 RECONSTRUCT MASONRY WALL WITH SALVAGED BRICK
- 9 RAISE EXISTING SILL HEIGHT AS REQUIRED. INFILL OPENING BELOW NEW SILL WITH SALVAGED BRICK
- 10 NEW WINDOW IN EXISTING FRAMED OPENING (CURRENTLY BRICKED -IN)
- 11 NEW RAILING

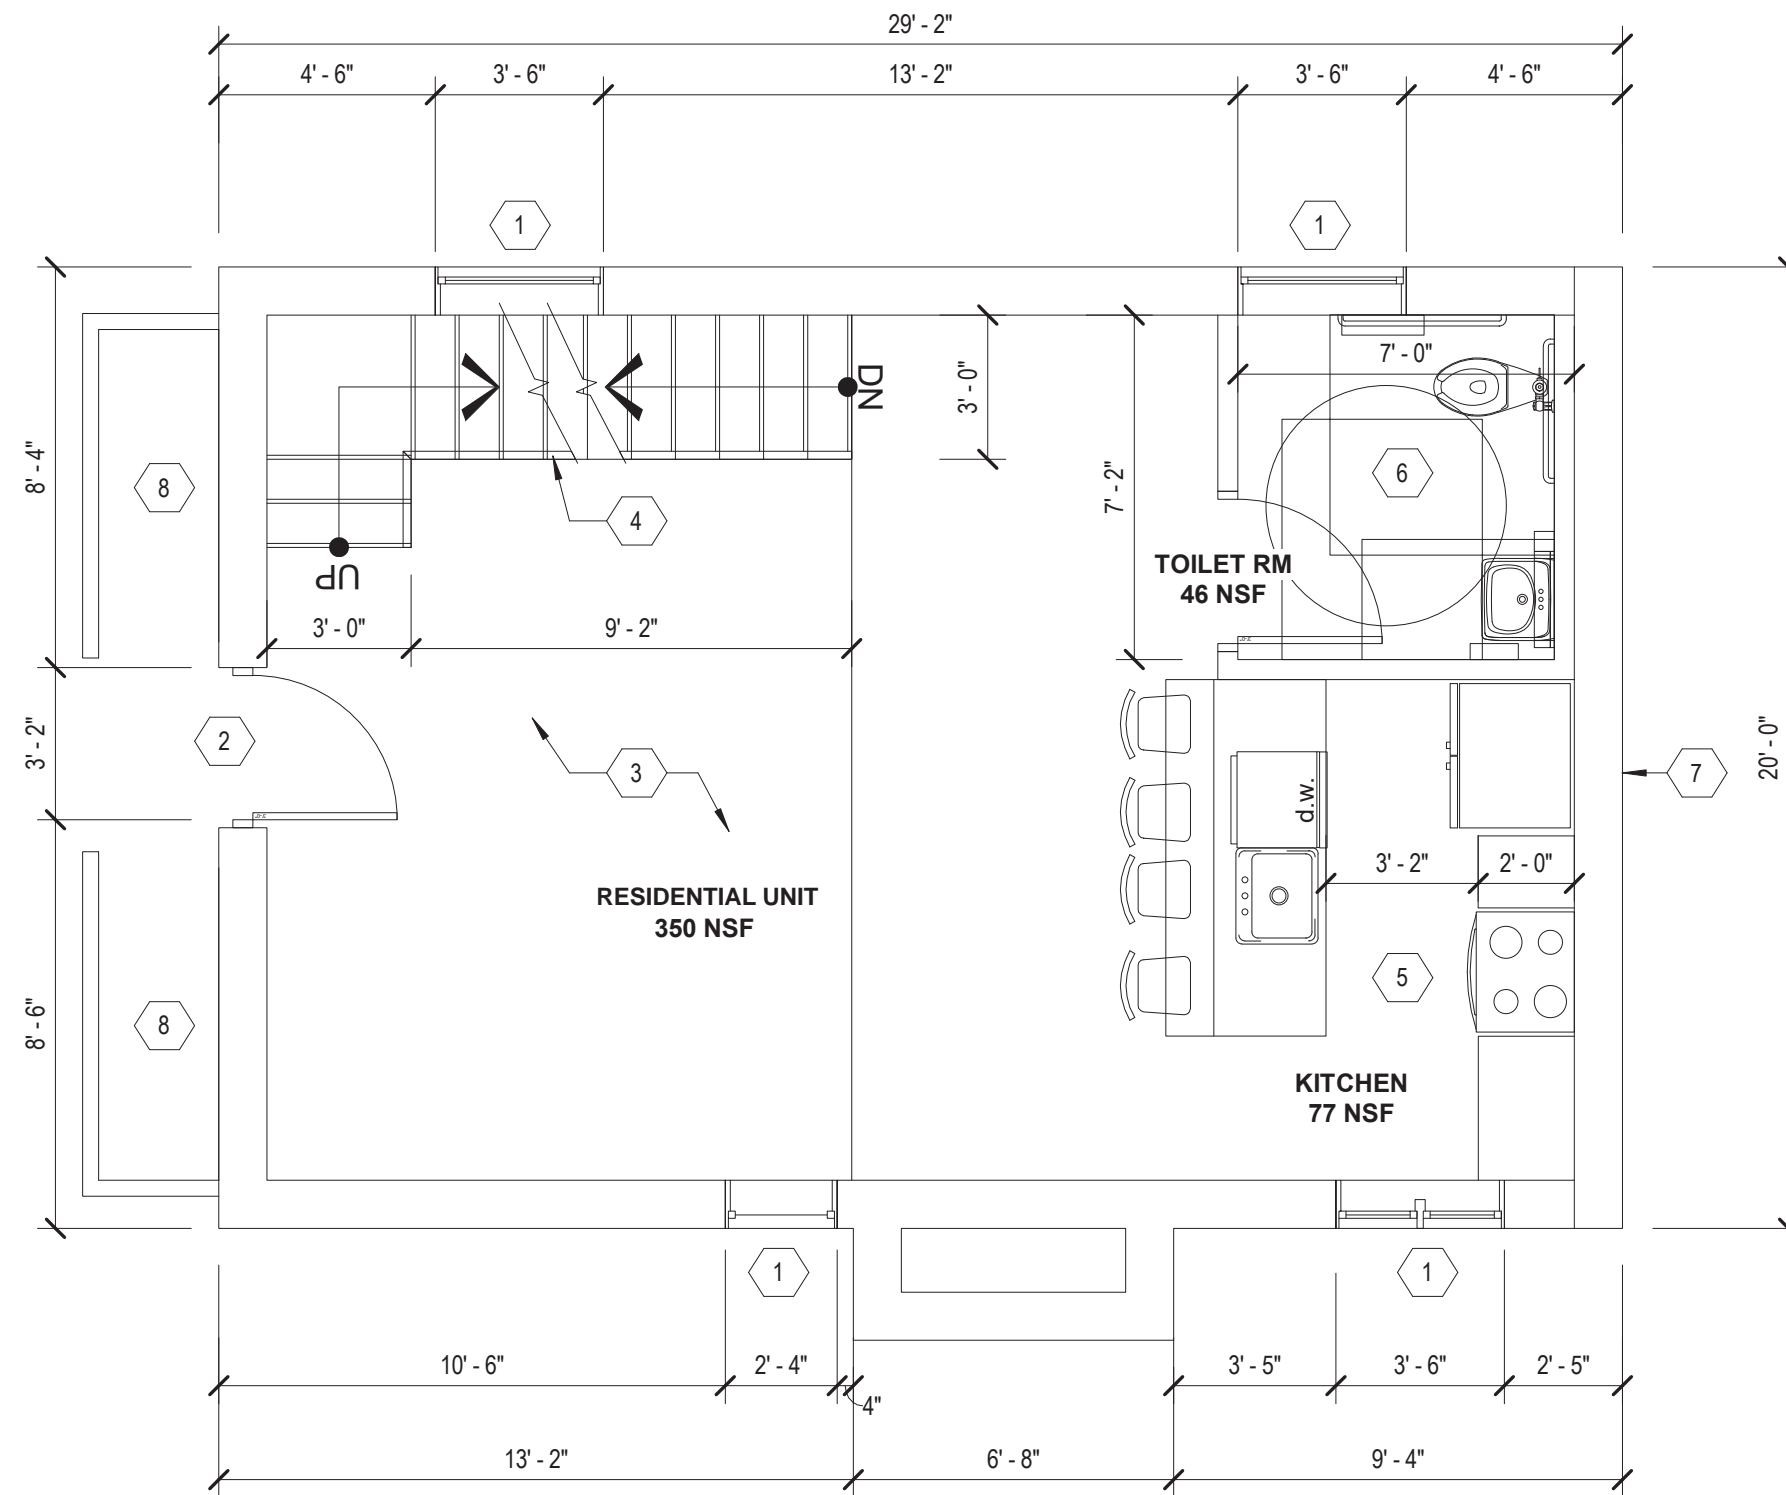
**GROUND FLOOR PLAN**

- 1 NEW ALUM CLAD WOOD WINDOWS. BASIS OF DESIGN: PELLA ARCHITECTURAL SERIES TRADITIONAL. EXTERIOR COLOR: BLACK
- 2 NEW WOOD ENTRY DOOR. SEE CUTSHEET FOR SELECTION
- 3 NEW FLOOR FINISH ON WOOD SUBFLOOR AND FRAMING. REPAIR, REPLACE, AND INFILL EXISTING FLOOR FRAMING AS REQUIRED.
- 4 NEW STAIR
- 5 INSTALL KITCHEN CABINETS, COUNTERTOPS, AND APPLIANCES. SELECTIONS TBD.
- 6 NEW TOILET ROOM INCLUDING TILE FLOOR FINISH, FIXTURES, AND ADA ACCESSORIES. SELECTIONS TBD.
- 7 RECONSTRUCT MASONRY WALL WITH SALVAGED BRICK
- 8 RECONSTRUCT WOOD PORCH RAIL DETAILING IN KIND. INTACT PORTION TO BE USED AS BASIS OF DESIGN

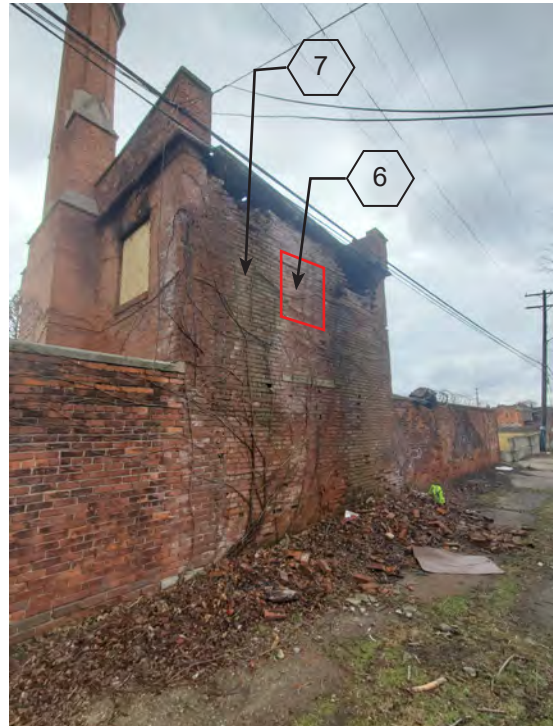
EAST ELEVATION

- 1 REPAIR/TUCKPOINT BRICK AS REQUIRED. MORTAR MIX TO MEET HDC STANDARDS
- 2 CLEAN BRICK TO REMOVE SOOT STAINS AND GRAFFITI. CONTRACTOR TO TEST LEAST INVASIVE METHODS
- 3 NEW ALUM. CLAD WOOD WINDOWS. REFER TO PLANS FOR BASIS OF DESIGN
- 4 NEW WOOD ENTRY DOOR. REFER TO CUT-SHEET FOR SELECTIONS
- 5 RECONSTRUCT DAMAGED BRICK WALL WITH SALVAGED BRICK
- 6 ADD NEW WINDOW OPENING WHERE EVIDENCE OF BRICKED-IN WINDOW OPENING EXISTS
- 7 RECONSTRUCT WOOD PORCH RAIL DETAIL IN-KIND
- 8 REPAIR/REPLACE WOOD HEADER DETAIL AS REQUIRED.
- 9 BRICK-IN OPENING AS REQUIRED TO RAISE SILL. USE SALVAGED BRICK

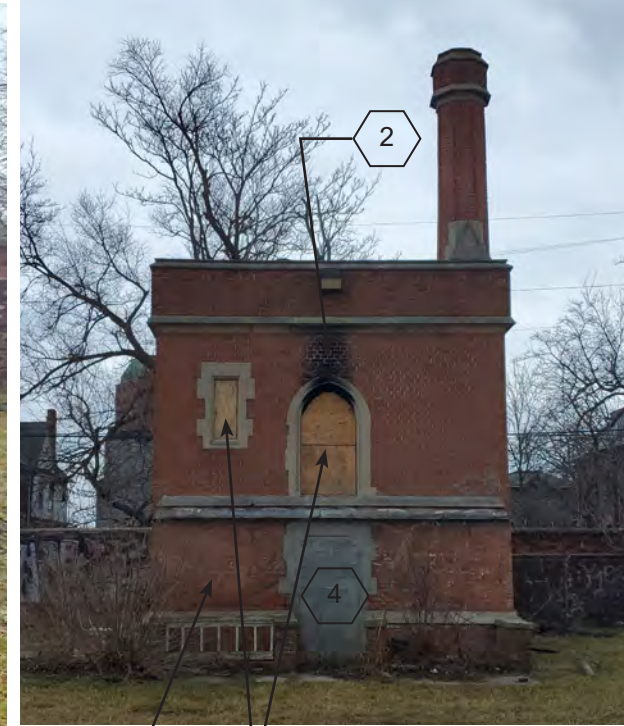
WEST ELEVATION

- 1 REPAIR/TUCKPOINT BRICK AS REQUIRED. MORTAR MIX TO MEET HDC STANDARDS
- 2 CLEAN BRICK TO REMOVE SOOT STAINS AND GRAFFITI. CONTRACTOR TO TEST LEAST INVASIVE METHODS
- 3 NEW ALUM. CLAD WOOD WINDOWS. REFER TO PLANS FOR BASIS OF DESIGN
- 4 NEW WOOD ENTRY DOOR. REFER TO CUT-SHEET FOR SELECTIONS
- 5 RECONSTRUCT DAMAGED BRICK WALL WITH SALVAGED BRICK
- 6 ADD NEW WINDOW OPENING WHERE EVIDENCE OF BRICKED-IN WINDOW OPENING EXISTS
- 7 RECONSTRUCT WOOD PORCH RAIL DETAIL IN-KIND
- 8 REPAIR/REPLACE WOOD HEADER DETAIL AS REQUIRED.
- 9 BRICK-IN OPENING AS REQUIRED TO RAISE SILL. USE SALVAGED BRICK
- 10 TREX DECKING ON WOOD SLEEPERS ON EPDM ROOFING MEMBRANE AND 5/8" COVER-BOARD OVER NEW WOOD ROOF JOISTS. SEE CUTSHEETS FOR SELECTIONS.
- 11 PAINTED ALUM RAIL. SEE CUTSHEET FOR SELECTION. COLOR: BLACK
- 12 CONTINUOUS ALUM GUTTER AND DOWN-SPOUT

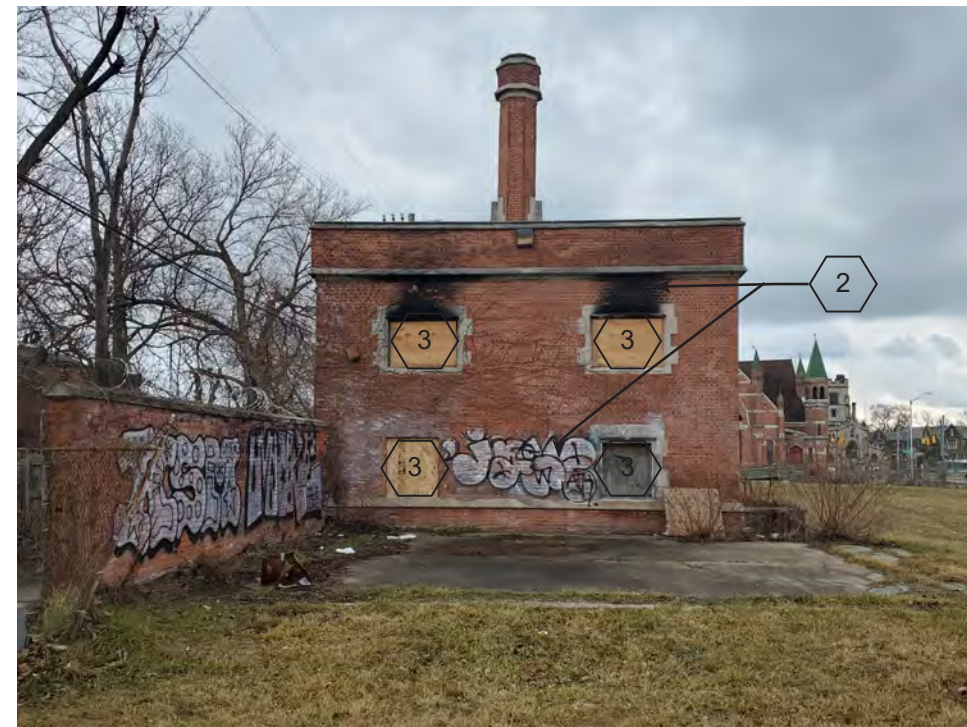
NORTH ELEVATION

- 1 REPAIR/TUCKPOINT BRICK AS REQUIRED. MORTAR MIX TO MEET HDC STANDARDS
- 2 CLEAN BRICK TO REMOVE SOOT STAINS AND GRAFFITI. CONTRACTOR TO TEST LEAST INVASIVE METHODS
- 3 NEW ALUM. CLAD WOOD WINDOWS. REFER TO PLANS FOR BASIS OF DESIGN
- 4 NEW WOOD ENTRY DOOR. REFER TO CUT-SHEET FOR SELECTIONS
- 5 RECONSTRUCT DAMAGED BRICK WALL WITH SALVAGED BRICK
- 6 ADD NEW WINDOW OPENING WHERE EVIDENCE OF BRICKED-IN WINDOW OPENING EXISTS
- 7 RECONSTRUCT WOOD PORCH RAIL DETAIL IN-KIND
- 8 REPAIR/REPLACE WOOD HEADER DETAIL AS REQUIRED.
- 9 BRICK-IN OPENING AS REQUIRED TO RAISE SILL. USE SALVAGED BRICK
- 10 TREX DECKING ON WOOD SLEEPERS ON EPDM ROOFING MEMBRANE AND 5/8" COVER-BOARD OVER NEW WOOD ROOF JOISTS. SEE CUTSHEETS FOR SELECTIONS.
- 11 PAINTED ALUM RAIL. SEE CUTSHEET FOR SELECTION. COLOR: BLACK
- 12 CONTINUOUS ALUM GUTTER AND DOWN-SPOUT

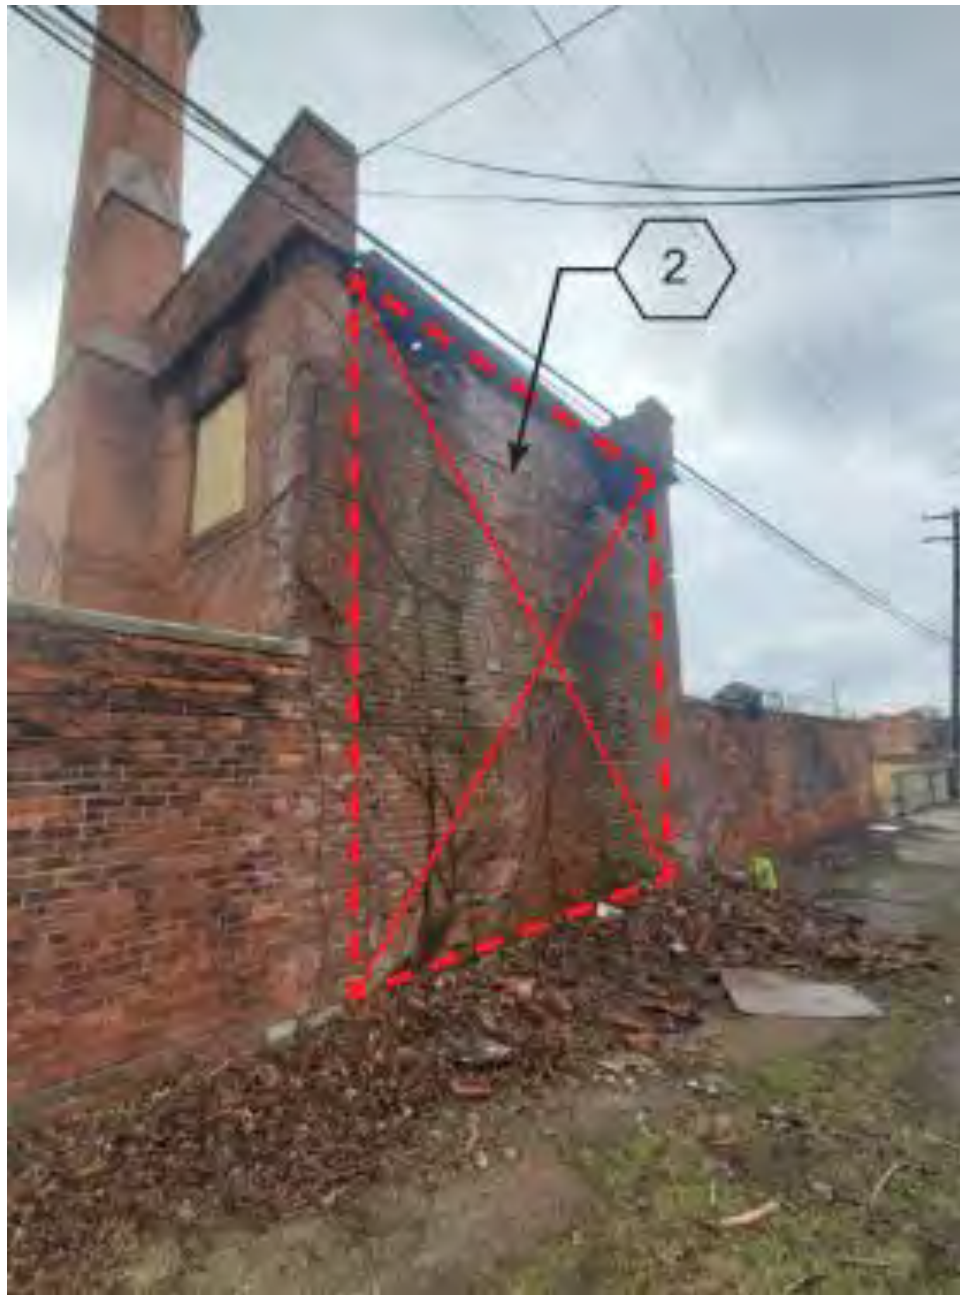
Photograph 1: East Elevation Masonry Wall

The east elevation masonry wall is shown in Photograph 1. The wall is constructed of brick masonry units set in hydraulic sand-lime mortar. Both the masonry units and the mortar joints are in an advanced state of deterioration. A significant number of masonry units have begun to spall and the mortar joints have softened such that a masonry rubble pile has formed at the base of the wall. Further, the wall has been exposed to a fire at the second level, and numerous unabated freeze thaw cycles as a result of water penetrating the damaged building envelope. Aside from those sources of deterioration, calcification and efflorescence was observed covering more than 50% of the surface area of the east elevation, indicating that the masonry material itself has reached its serviceable life and will no longer meet the durability requirements specified in ACI 318.

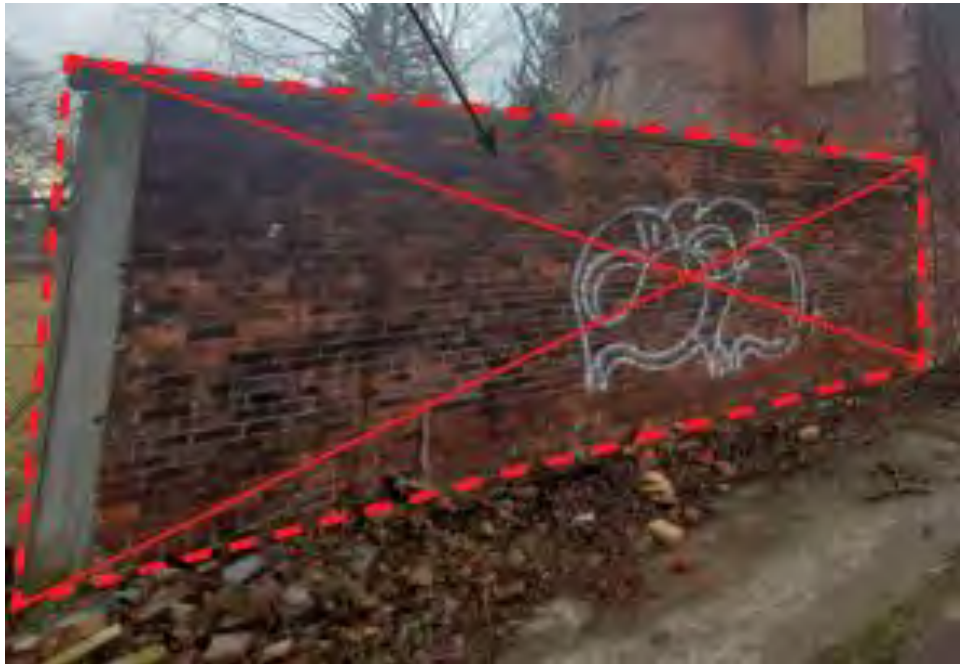
Photograph 2: East Masonry Wing Wall – South

The east masonry wing walls are shown in Photograph 2 and Photograph 3. The walls are constructed of brick masonry units set in hydraulic sand-lime mortar and are approximately 11ft tall by 12in thick. The masonry units and mortar joints are experiencing similar spall, softening, calcification, and efflorescence as the east elevation masonry wall identified in Photograph 1. The level of deterioration is not as advanced as the east elevation masonry wall, however, it has progressed to the point where the masonry materials will no longer meet the durability requirements specified in ACI 318.

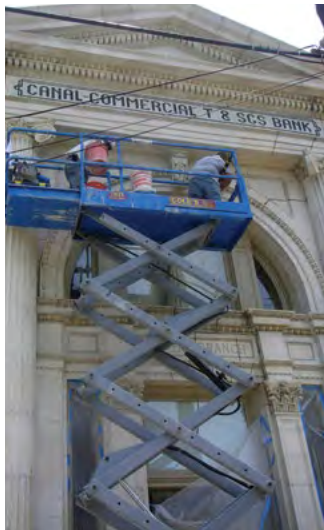
[1] An alkaline-based product is appropriate to use to clean historic marble because it will not damage the marble, which is acid sensitive.

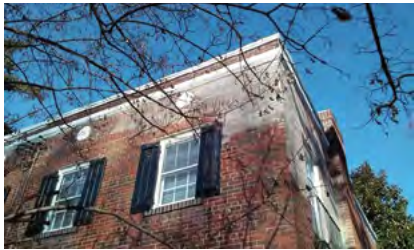
**[3] Not Recommended:**  
The white film on the upper corner of this historic brick row house is the result of using a scrub or slurry coating, rather than traditional repointing by hand, which is the recommended method.

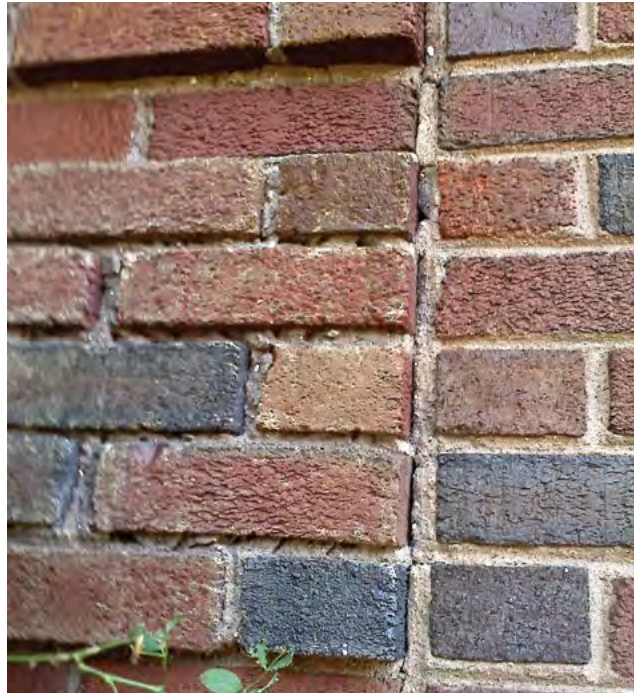
**[4] Not Recommended:**  
The quoins on the left side of the photo show that high-pressure abrasive blasting used to remove paint can damage even early 20th-century, hard-baked, textured brick and erode the mortar, whereas the same brick on the right, which was not abrasively cleaned, is undamaged.

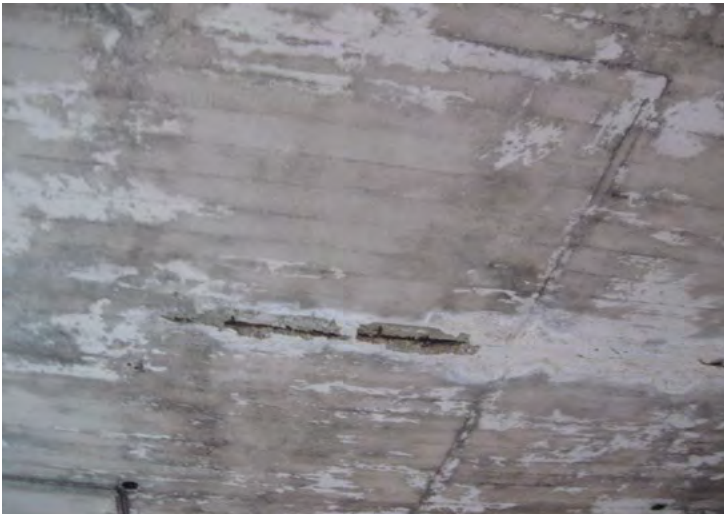
[5] Rebars in the reinforced concrete ceiling have rusted, causing the concrete to spall. The rebars must be cleaned of rust before the concrete can be patched.

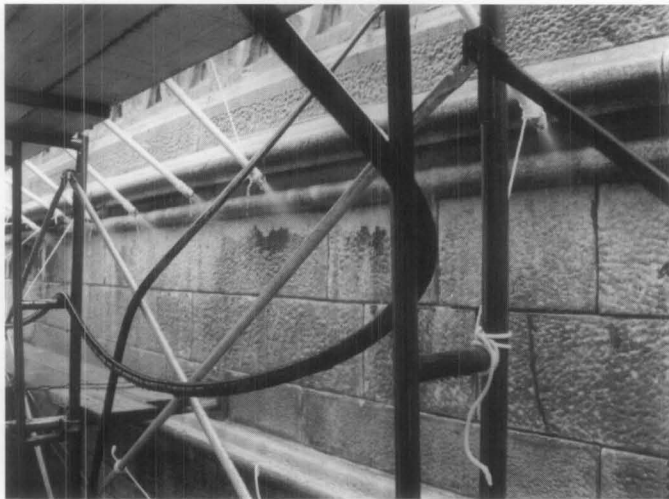
Figure 6. Timed water soaking can be very effective for cleaning limestone and marble as shown here at the Marble Collegiate Church in New York City. In this case, a twelve-hour water soak using a multi-nozzle manifold was followed by a final water rinse. Photo: Diane S. Kaese, Wiss, Janney, Elstner Associates, Inc., N.Y., N.Y.

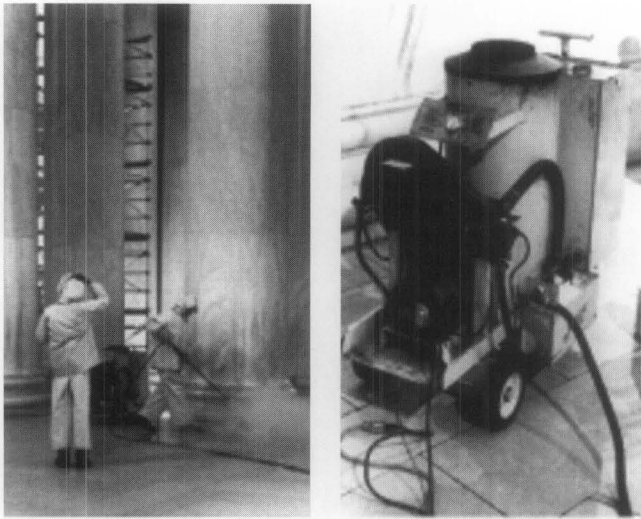
Figure 8. (Left) Low-pressure (under 100 psi) steam cleaning (hot-pressurized water washing), is part of the regular maintenance program at the Jefferson Memorial, Washington, D.C. The white marble interior of this open structure is subject to constant soiling by birds, insects and visitors. (Right) This portable steam cleaner enables prompt cleanup when necessary. Photos: National Park Service Files.

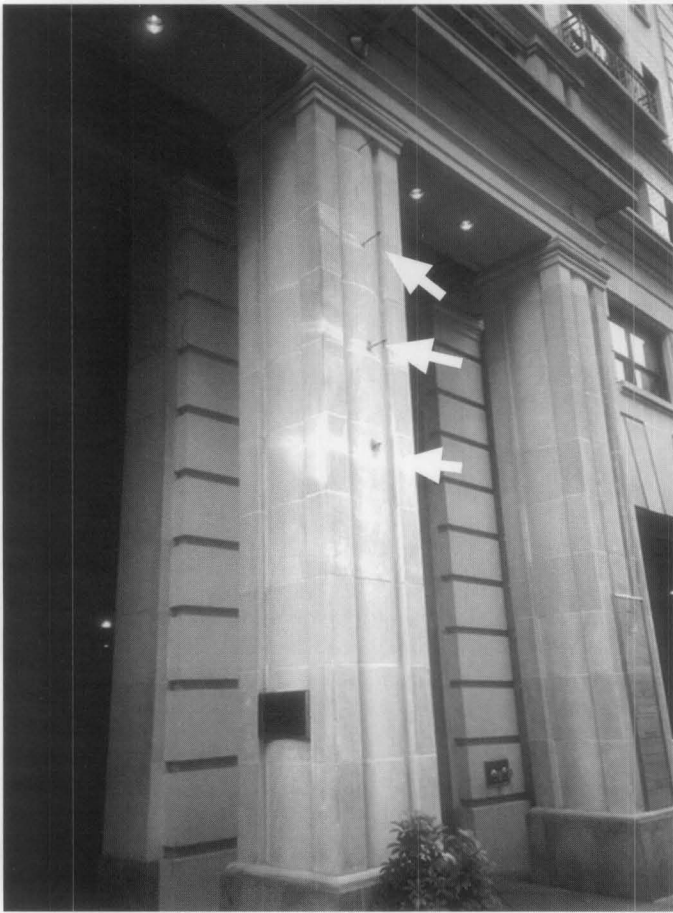
Figure 10. High-pressure water washing too close to the surface has abraded and, consequently, marred the limestone on this early-20th century building.

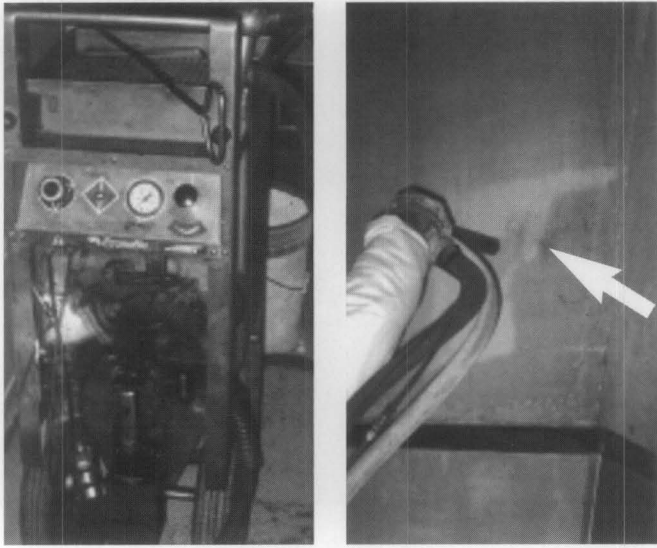
Figure 21. Low-pressure blasting with ice pellets or ice crystals (left) is an abrasive cleaning method that is sometimes recommended for use on interior masonry because it does not involve large amounts of water. However, like other abrasive materials, ice crystals "clean" by removing a portion of the masonry surface with the dirt, and may not remove some stains that have penetrated into the masonry without causing further abrasion (right). Photos: Audrey T. Tepper.

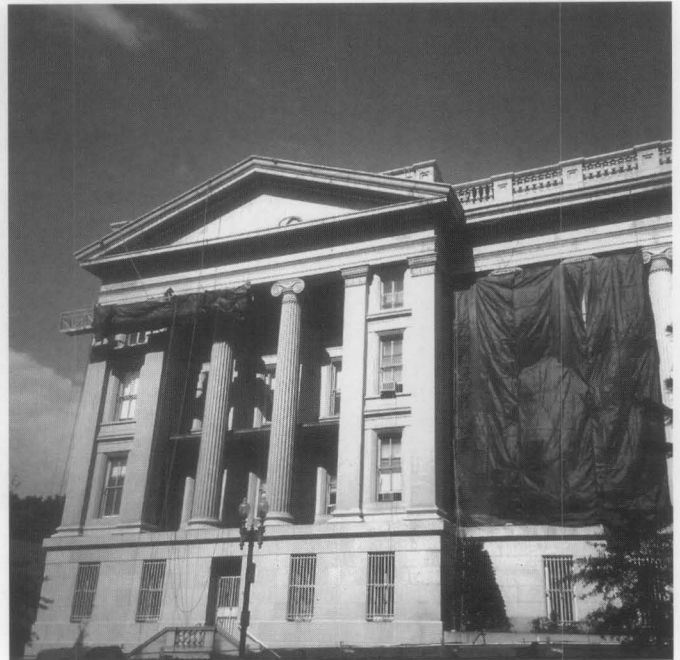
Figure 23. A tarpaulin protects and shields pedestrians from potentially harmful spray while chemical cleaning is underway on the granite exterior of the U.S. Treasury Building, Washington, D.C.

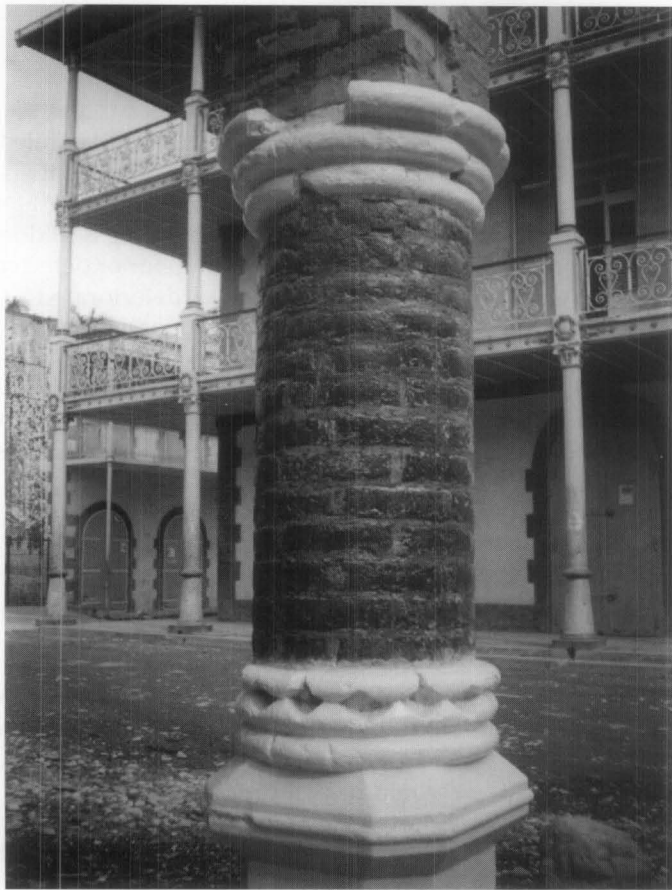
Figure 24. Although the application of a water-repellent coating was probably not needed on either of these buildings, the coating on the brick building (above), is not visible and has not changed the character of the brick. But the coating on the brick column (below), has a high gloss that is incompatible with the historic character of the masonry.

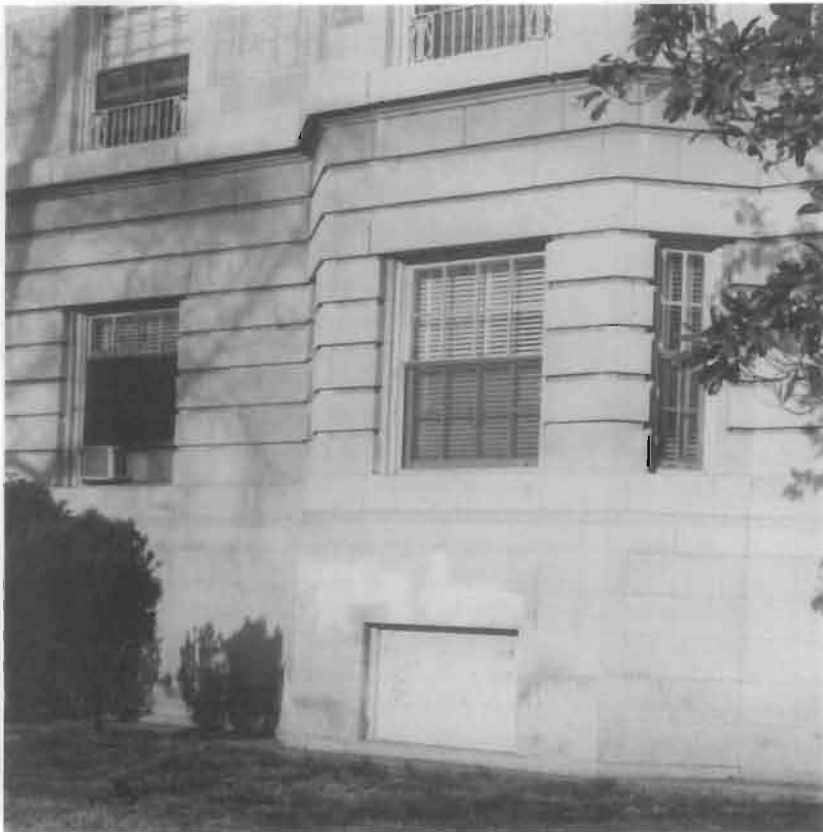
*Figure 1. When an inappropriate chemical cleaner was used to remove graffiti, it resulted in permanently bleaching the limestone foundation, and left a mark as unsightly as the graffiti.*

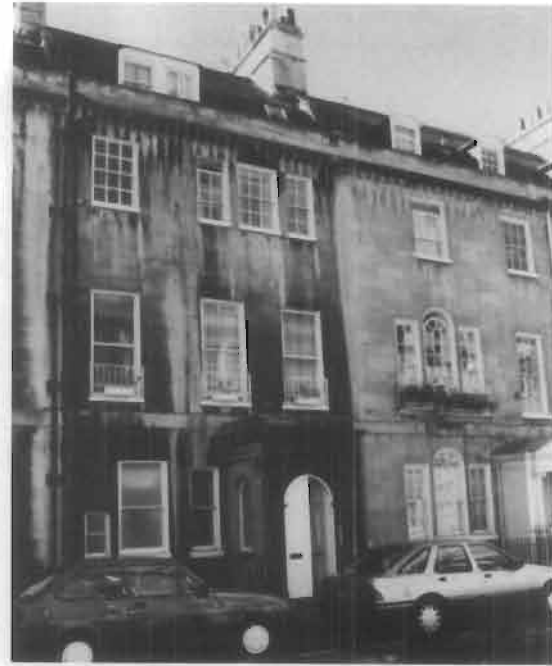
*Figure 2. The building on the left is an obvious candidate for cleaning, as the heavy black crust may be concealing or contributing to deterioration of the stone. Despite its more recent cleaning, the stone facade of the house on the right exhibits the same distinctive, and hard-to-eliminate rainwater wash patterns under the eaves and window sills, as its unwashed neighbor.*

The strongest practical argument in support of masonry cleaning is that it may slow the processes of deterioration and decay. Heavy layers of dirt not only interfere with natural weathering and washing patterns, but also obscure deterioration (figure 2). Cleaning is often necessary to help the architect or building conservator detect problems, and correctly interpret them, in order to take corrective measures, and to prepare a regular maintenance schedule for the building. The cleaning process itself, as well as the close-range view of historic masonry afforded by the scaffolding or other access equipment, also provides an important opportunity to evaluate the condition of the building. Once rid of dirt and pollutant crusts, the condition of the masonry will be more clearly revealed.

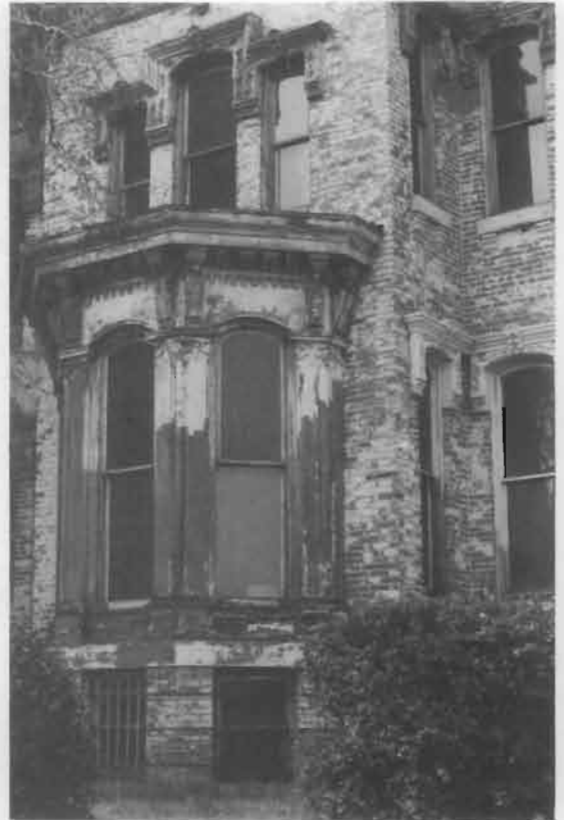
*Figure 3. Know what you are cleaning. If the painted surfaces of the projecting bay window on this once elegant Second Empire brick mansion were still intact, it would not be easy to identify the beltcourse as sandstone, the windows and window frames as wood, and the cornice and all of the window hoods as pressed metal. Cleaning so many different building materials may require a variety of techniques and treatments.*

Indeed, some parts of a building, particularly decorative features, may not be masonry at all (figure 3). Frequently, such features as window hoods, cornices and balustrades may be metal, such as cast iron, galvanized sheet iron or zinc. When painted, they give an intentional appearance of masonry. Some features may have been fabricated of wood, then coated with a sanded paint to give the illusion of sandstone. Thus, the need to correctly identify the type of masonry, or other non-masonry materials on a building cannot be over-emphasized when planning a cleaning project.

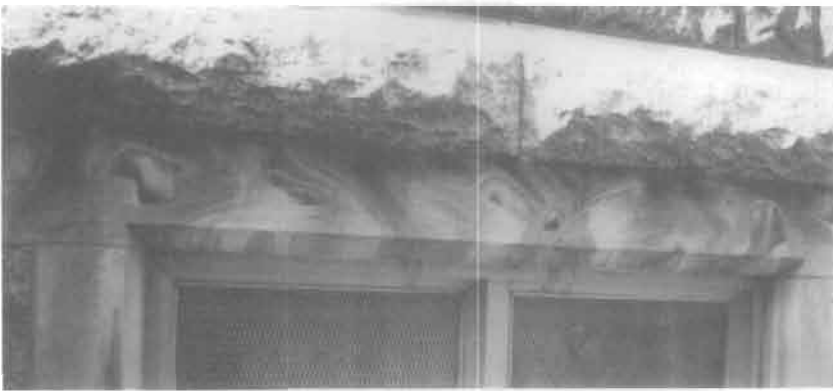
*Figures 4a-4b. Decorative architectural features that project from a wall surface, such as this granite belt course above an intricately-tooled limestone lintel, and this sandstone pinnacle topping a limestone buttress, may shield or protect masonry surfaces beneath them. But they are also responsible for creating unusual "wash" patterns and black crusts that form underneath them, further complicating cleaning projects.*

Dirt or soiling may include disfiguring pollutant or sulfate crusts, which usually build up in sheltered or protected areas not regularly washed by the natural action of rain. It is particularly common under cornices, window sills, or other projecting decorative features (figures 4a - 4b). Some pollutant crusts resulting from a chemical reaction of stone to airborne particulate matter, or particles in which cementing material of the stone has actually incorporated itself, indicate the beginning of dissolution of the stone and incipient decay. Removing these crusts will necessarily involve a loss of a small amount of stone (figure 5). While removal is generally recommended because pollutant crusts hasten stone dissolution, extreme care must nonetheless be exercised to ensure that loss of the stone is minimized.

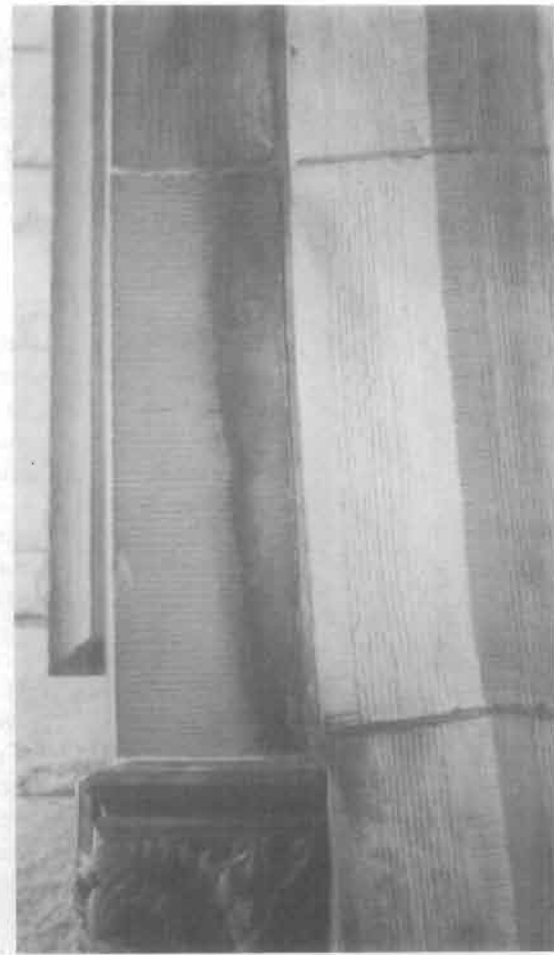
*Figure 5. It is unlikely that this blackened crust can be removed without some loss of the tooled sandstone surface, because the sulfate crust has become integral with the stone.*

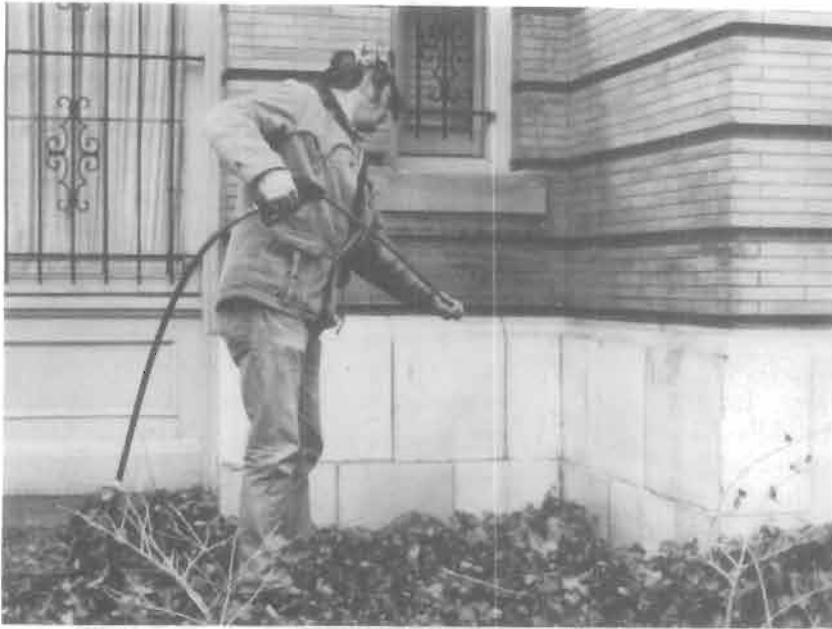
Figure 7. A contractor prepares equipment before testing a low-pressure water wash on a Roman brick and terra cotta building. Photograph: Sharon C. Park, AIA

Because of the wide variety of unforeseeable factors, the cleaning method or methods should always be tested on an inconspicuous area of the building and preferably in more than one location (figure 7). Such tests must be carried out before attempting any large-scale masonry cleaning project. Failure to do so may have disastrous consequences for the outcome of the cleaning as well as the long-term preservation of the historic building material. Testing should be carried out by the consultant or conservation specialist, or by the contractor, under the consul-
