**STAFF REPORT 2-10-2021 REGULAR MEETING**

**ADDRESSES:** 3664, 3690, 3700, 3708 TRUMBULL

**HISTORIC DISTRICT:** WOODBRIDGE FARM

**SCOPE:** ERECT NEW BUILDINGS, REHABILITATE EXISTING POWER HOUSE

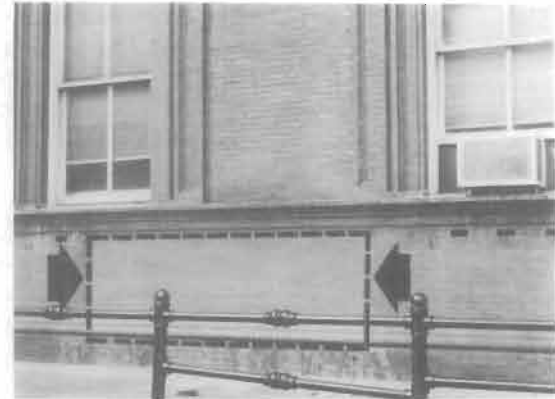
Figure 9. A test patch on brick to remove a century of dirt reveals only a slight difference in appearance between the cleaned and the uncleaned brick. The hard-baked outer skin of the brick provides a surface that is not only impervious to dirt penetration, but resists dirt accumulation. Photograph: Christina Henry

tant's careful supervision. Carefully controlled testing is probably the only reliable way to determine the best or most appropriate cleaning techniques and pressures to be used in a particular project (figures 8-9).

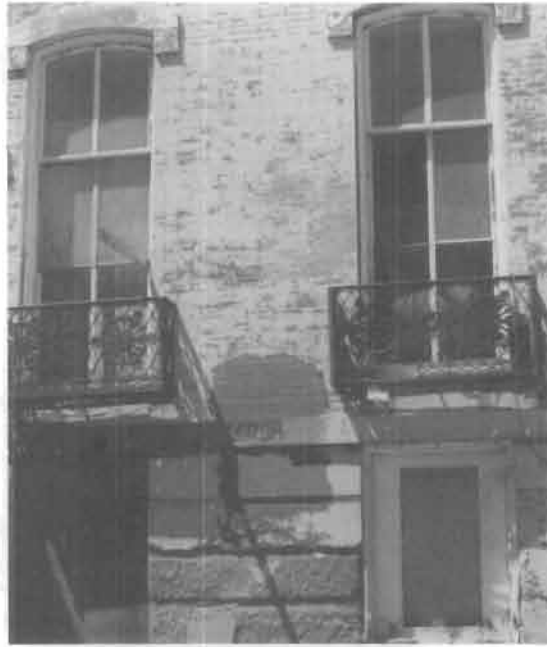
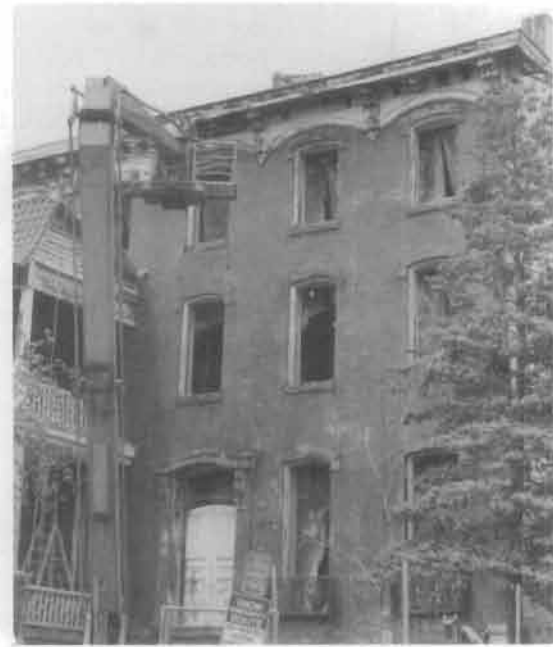
*Figures 10a-10b. This test cleaning patch on brick and sandstone was allowed to weather over a full year, while other aspects of the rehabilitation were carried out. Finally the entire building was cleaned with a proprietary paint remover sprayed-on under low-pressure and then rinsed by workmen from a truck-mounted hydraulic platform lift.*

A test patch should be allowed to weather as long as possible before the cleaning project is begun to give ample opportunity for an accurate evaluation of the results. One year is the preferred amount of time; this allows the patch to be exposed to a complete weathering cycle (figures 10a-10b). If this is not feasible, it is a good idea to

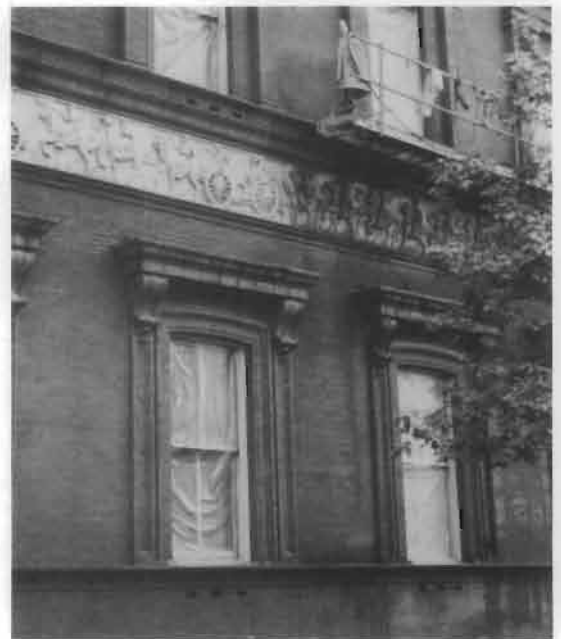
*Figure 11. Removal of 100 years of grime from the brick and terra cotta facade of the Pension Building (now the National Building Museum), Washington, D.C., was accomplished by workmen on a swing stage using a chemical cleaning product. Note the polyethylene covering the windows to prevent damage. Also note the protective clothing for the workmen which hangs on the platform while not in use. Photograph: Christina Henry*

Many other historic building materials can be damaged by chemical cleaning agents. Glass, glazed brick, and architectural terra cotta will be etched by strong solutions of hydrofluoric acid if not covered adequately. Metal, wood and paint can all be damaged by chemical cleaners, and must be shielded. Such materials can be temporarily protected by plastic sheeting or peelable coatings specifically made for this purpose (figure 11).

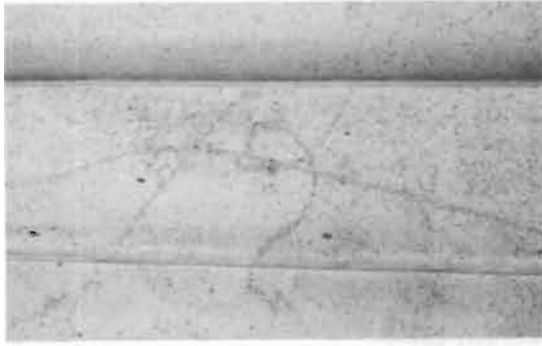
*Figure 12. Water at too high a pressure from a pin-point nozzle has etched this white Vermont granite. Photograph: David A. Look, AIA*

***Cautions and Precautions.*** Despite the fact that water washing methods may be the gentlest of all cleaning methods they are not without hazards. Even these methods can be abrasive. Water pressure should always be kept at the lowest level that will clean the masonry without damage. Too highly pressurized water can etch or otherwise scar masonry, and may penetrate through the masonry walls (figure 12).

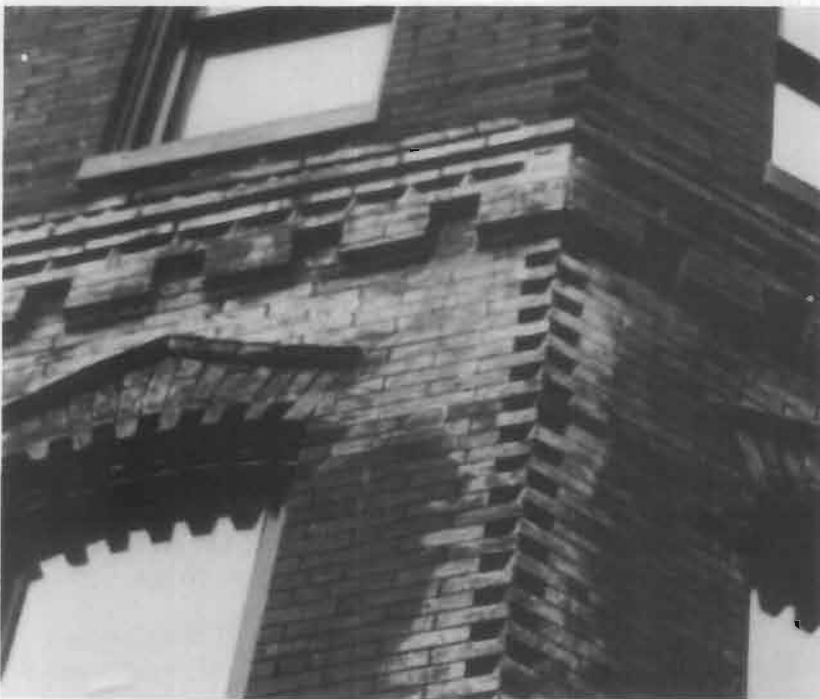
Figure 13. While hydrofluoric acid-based cleaners are often appropriate for cleaning unglazed brick, they may form hard-to-remove whitish silica deposits if left too long on the surface.

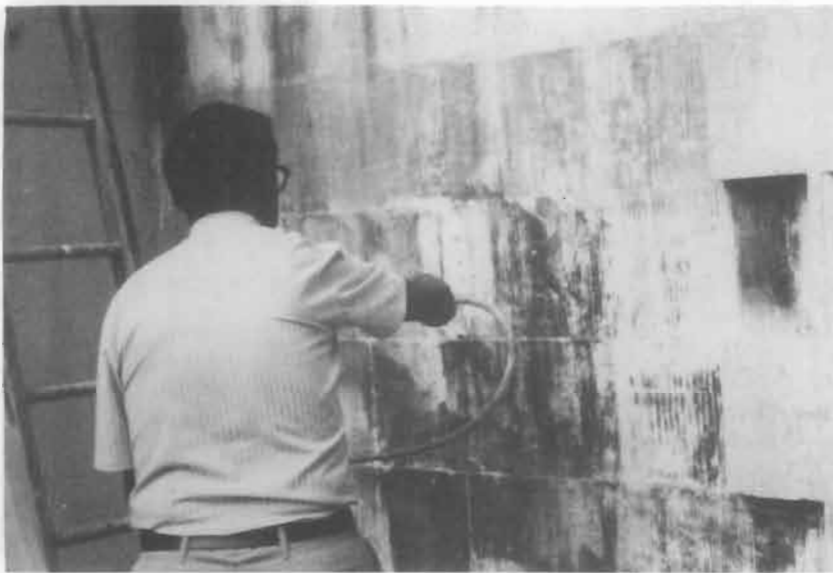
Figures 15a-15b. If a highly articulated facade is being cleaned it may be necessary to scaffold the building, one elevation at a time. When the monumental task of chemically removing all the paint from the White House was begun, each side was scaffolded in preparation for repainting. Removal of the many layers of paint that had obscured the stone tooling marks for almost a century, without damaging the historic sandstone, required much painstaking hand work.

generally formulated to remove most types of paint (except cementitious or lime-based paints such as whitewash) from all types of masonry. But it is always preferable to use an alkaline paint remover on acid-sensitive masonry (figures 15a-15b).

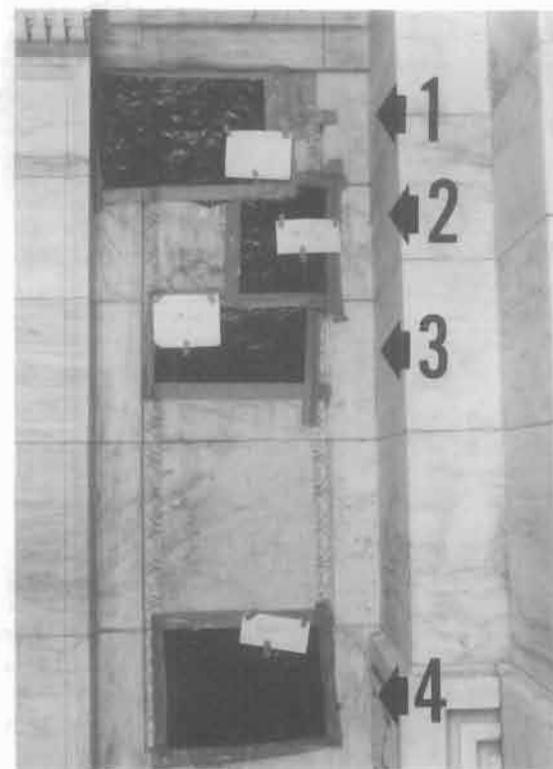
Figure 16. Four different poultice mixtures were tested to remove metal stains from this marble wall. From top to bottom, they included a commercial poultice, as well as formulations of peroxide and hydrated lime, ammonia and hydrated lime, and sodium citrate and glycerine with hydrated lime. Photograph: The Ehrenkrantz Group

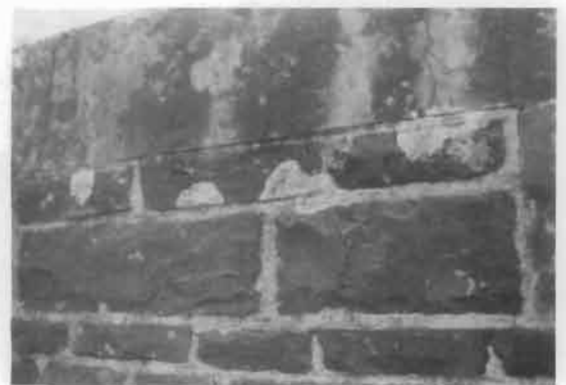
Figure 20. Plant growth such as lichens growing on a protected side of this limestone and granite parapet wall, can be damaging even to a relatively hard stone like granite because lichens secrete oxalic acid. Lichens can usually be removed, after soaking with water by scrubbing with a stiff natural bristle brush.

Lichens and algae can usually be removed with water and a stiff natural bristle brush, after soaking, if necessary (figure 20). Stains caused by plant growth such as mildew (which is a fungus) can sometimes be removed with organic solvents, but are generally best treated with diluted ammonia or bleaches. Hydrogen peroxide can also be effective. Calcium hypochlorite solutions and pastes (the basic of swimming pool chlorine) and Chloramine-T may also be useful in many cases. Chemical removal of the growth itself may sometimes be accomplished with zinc or magnesium fluorosilicate, copper naphthenate, or with a variety of quaternary ammonium salts. Low-to-medium-pressure (100-400 psi) water rinsing can be used to eliminate much of the plant material prior to treatment and stain removal. However, these compounds should be used with caution, as some copper compounds may stain light-colored

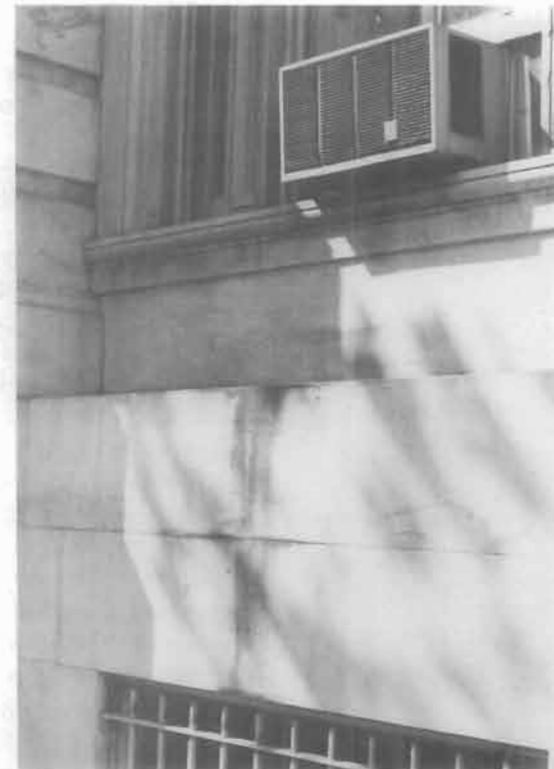
*Figure 22. The discoloration on this white marble is a green-colored algae growth on a shady side of the building and caused by water dripping from the air-conditioner above it.*

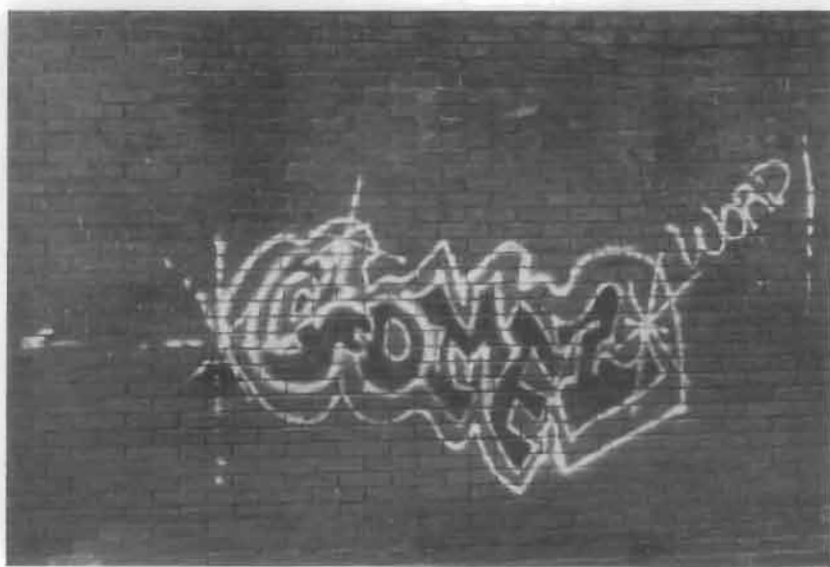
Figure 24. Spray-painted graffiti on this brick wall can be removed with paint remover, and in this case, probably will not require poulticing.

Painted graffiti applied from a spray can or by a felt-tipped marker or lipstick may generally be removed from masonry by a commercial paint remover—either a solvent type of remover such as lacquer thinner or acetone, or a methylene chloride-based remover (figure 24). In some instances, poulticing may not be necessary. If the graffiti has not permeated deeply into the masonry, it may be removed by the paint remover or a solution of trisodium phosphate brushed on with a non-metallic brush. After the paint has softened, as much as possible should be scraped off with a wooden scraper. Then the area should be washed again using a detergent and soapy water, and rinsed thoroughly with water.

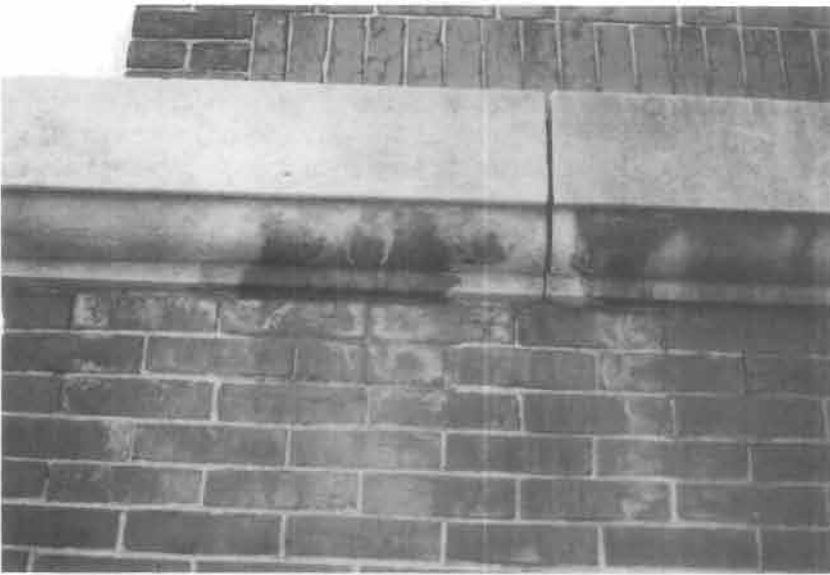
Figure 25. Excess moisture leaching out through the walls has resulted in the formation of white efflorescent salts on the brick and blackish sulfate salts on the limestone water table.

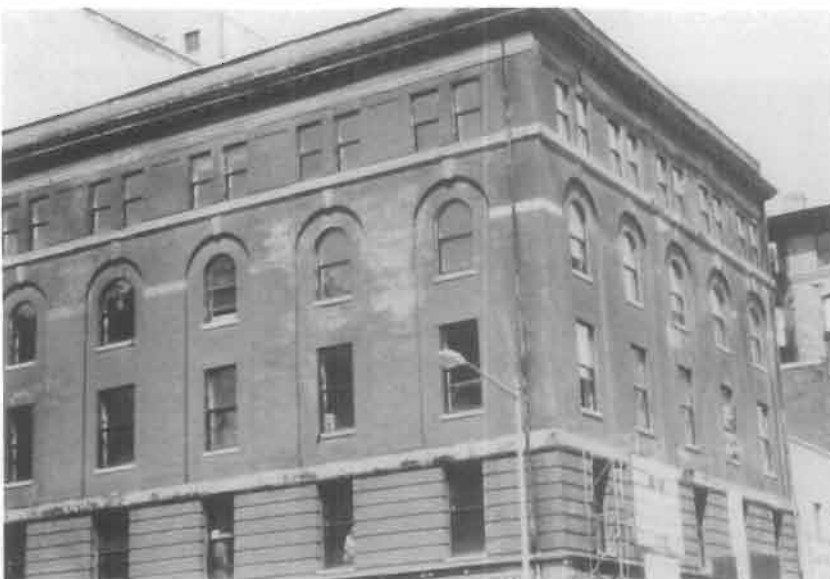
Figure 26. Efflorescent salts appearing on many of the brick piers of this turn-of-the-century building may indicate the existence of clogged interior gutters that, because they no longer function have been supplemented by an exterior rain removal system. Photograph: National Park Service

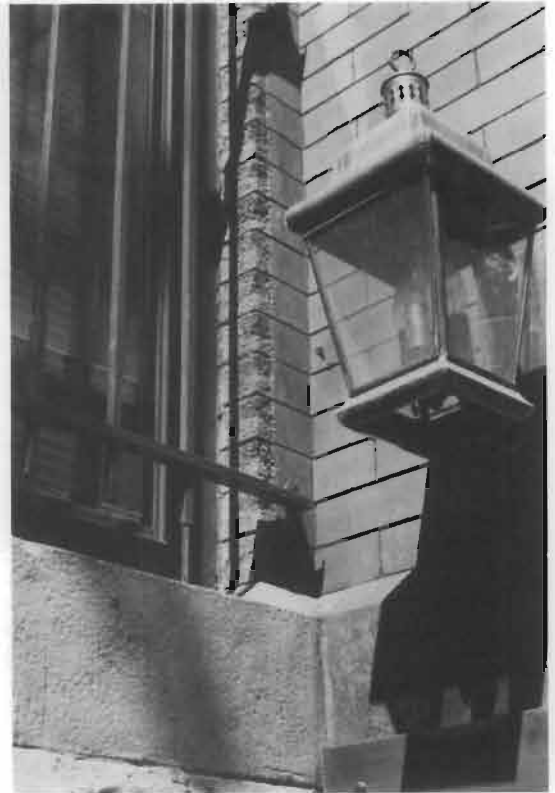
*Figure 27. Heavily pitted by sandblasting, this window recess provides a vivid contrast to adjacent undamaged brick protected from abrasion by a metal signboard.*

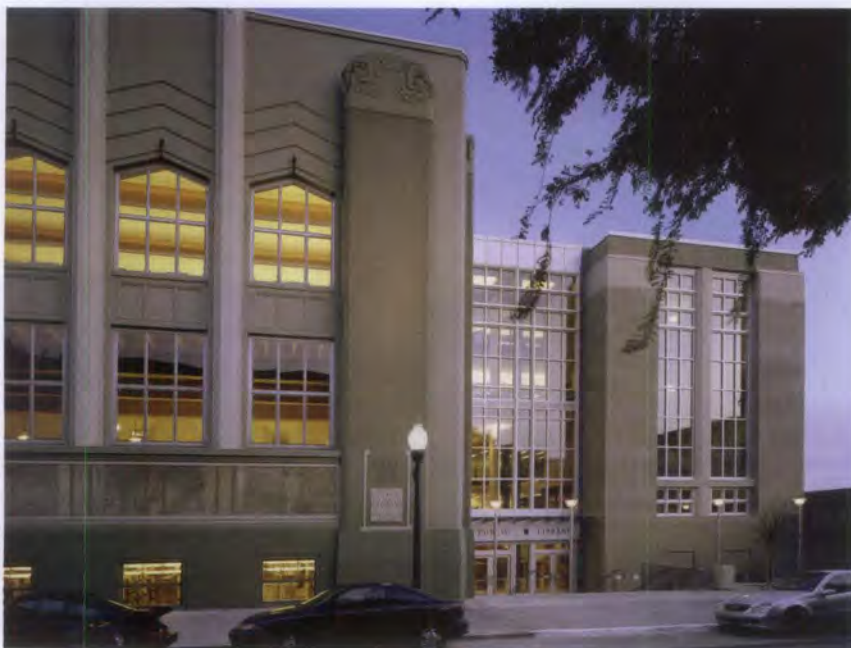
*Figure 1. The addition to the right with its connecting hyphen is compatible with the Collegiate Gothic-style library. The addition is set back from the front of the library and uses the same materials and a simplified design that references, but does not copy, the historic building. Photo: David Wakely Photography.*

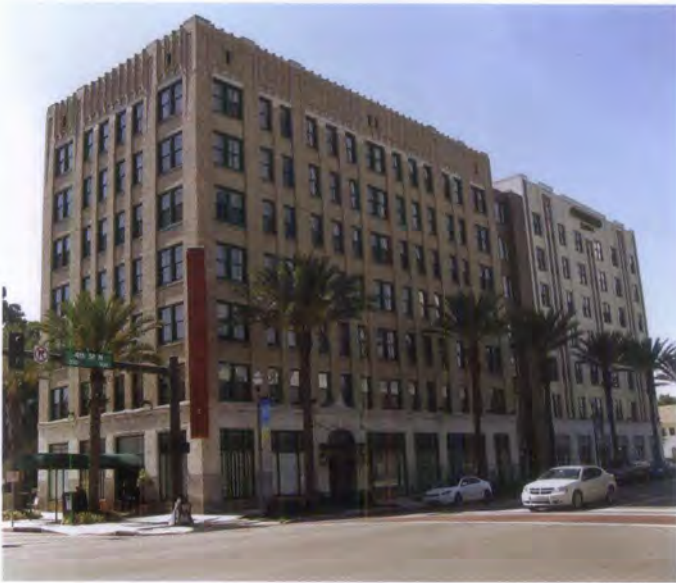
Figure 2. The new section on the right is appropriately scaled and reflects the design of the historic Art Deco-style hotel. The apparent separation created by the recessed connector also enables the addition to be viewed as an individual building.

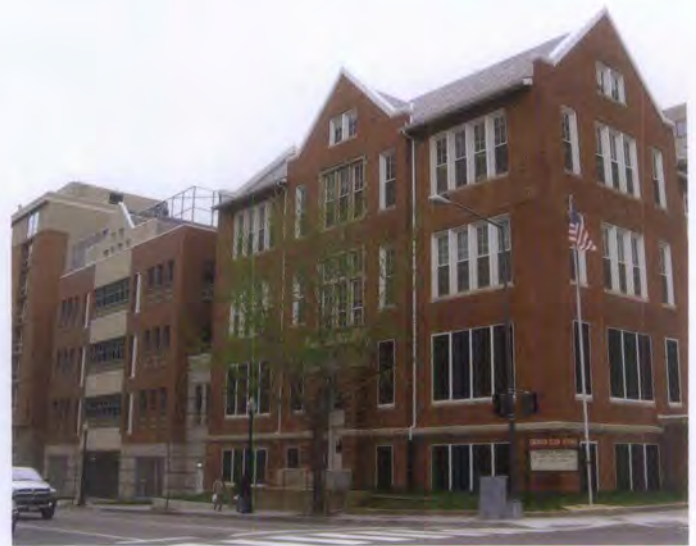
Figure 3. The red and buff-colored parking addition with a rooftop playground is compatible with the early-20th century school as well as with the neighborhood in which it also serves as infill in the urban setting.

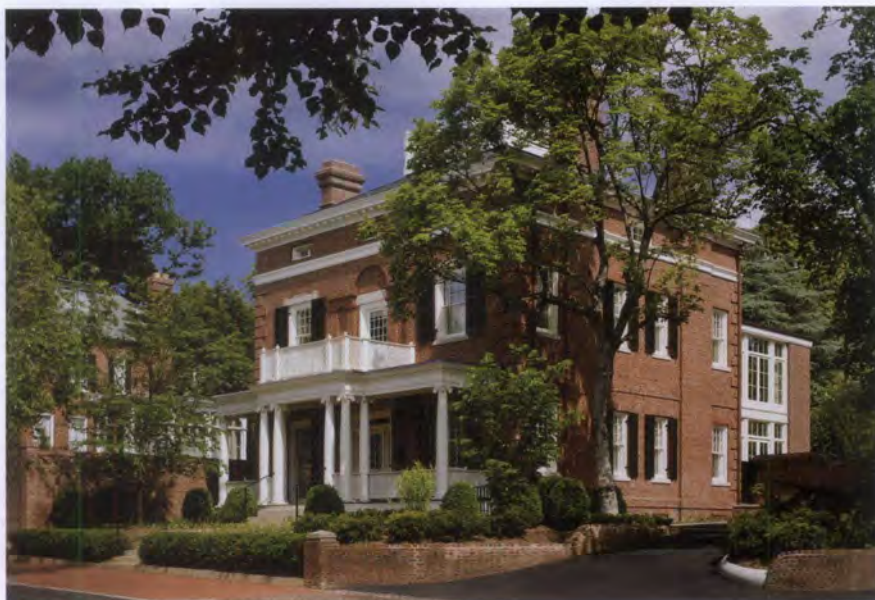
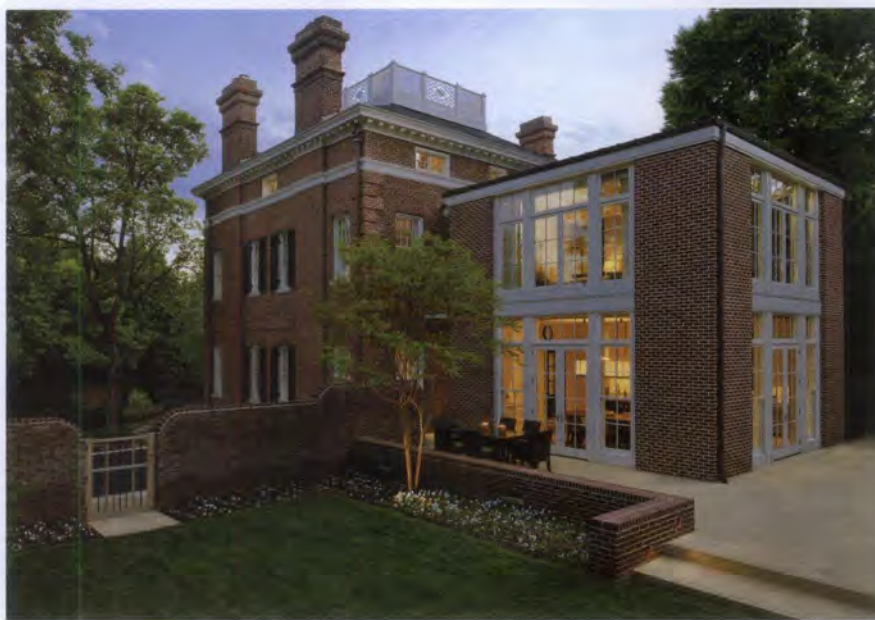
*Figure 4. This glass and brick structure is a harmonious addition set back and connected to the rear of the Colonial Revival-style brick house. Cunningham/Quill Architects. Photos: © Maxwell MacKenzie.*

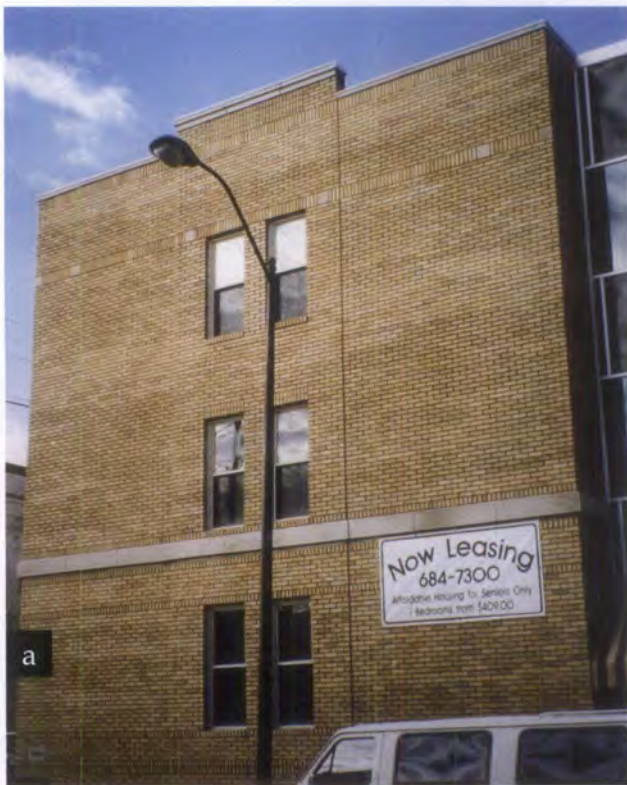
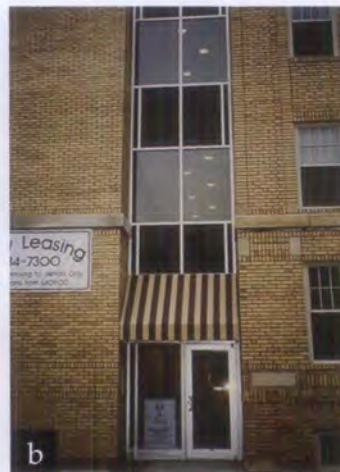
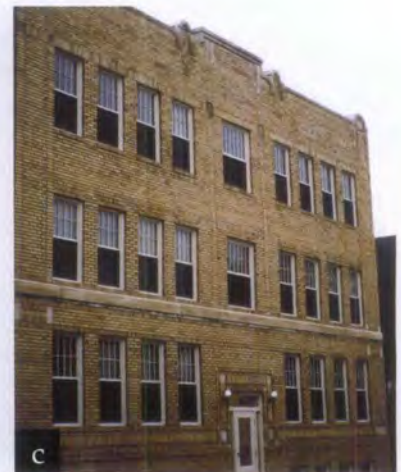
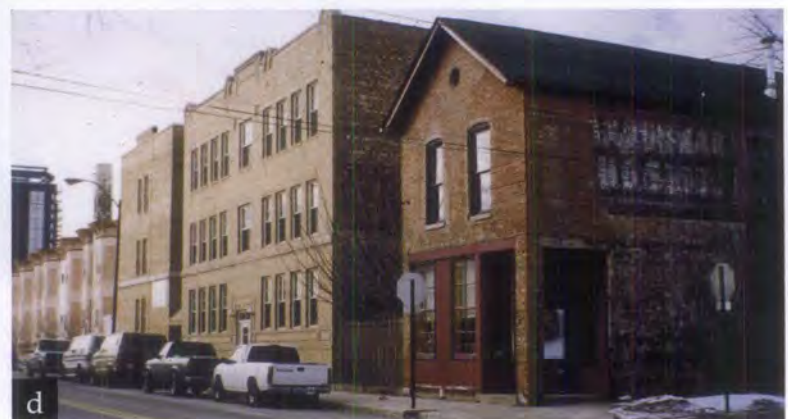
Figure 5. This addition (a) is constructed of matching brick and attached by a recessed connector (b) to the 1914 apartment building (c). The design is compatible and the addition is smaller and subordinate to the historic building (d).

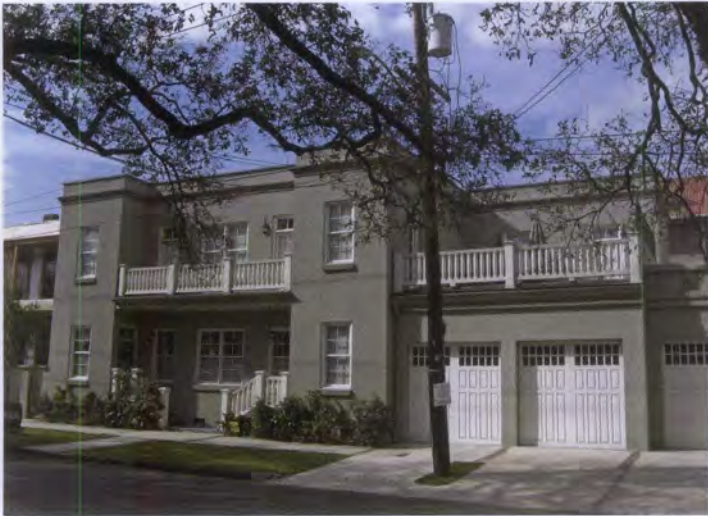
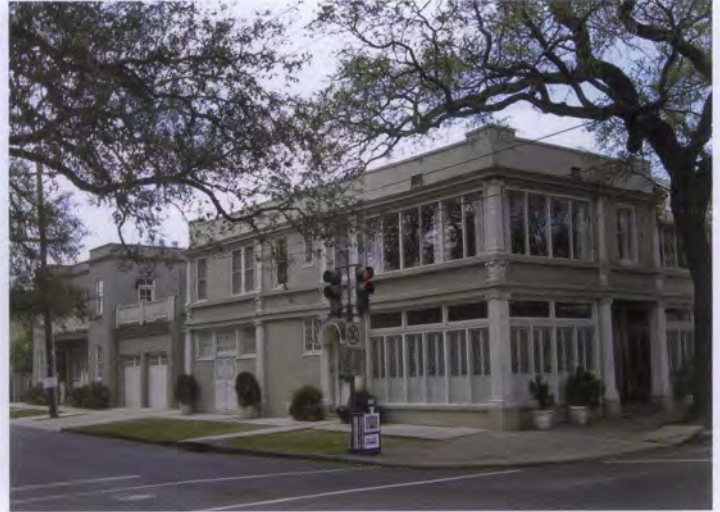
Figure 6. A new addition (left) is connected to the garage which separates it from the main block of the c. 1910 former florist shop (right). The addition is traditional in style, yet sufficiently restrained in design to distinguish it from the historic building.

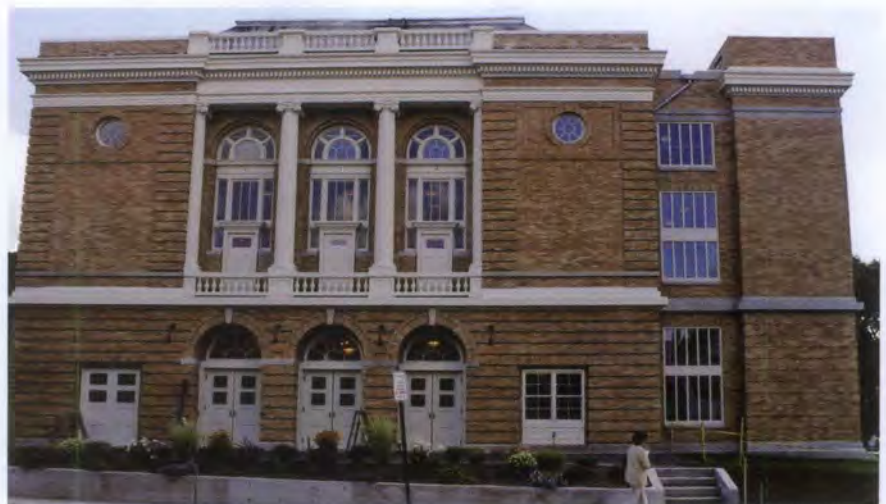
Figure 7. A vacant side lot was the only place a new stair tower could be built when this 1903 theater was rehabilitated as a performing arts center. Constructed with matching materials, the stair tower is set back with a recessed connector and, despite its prominent location, it is clearly subordinate and differentiated from the historic theater.

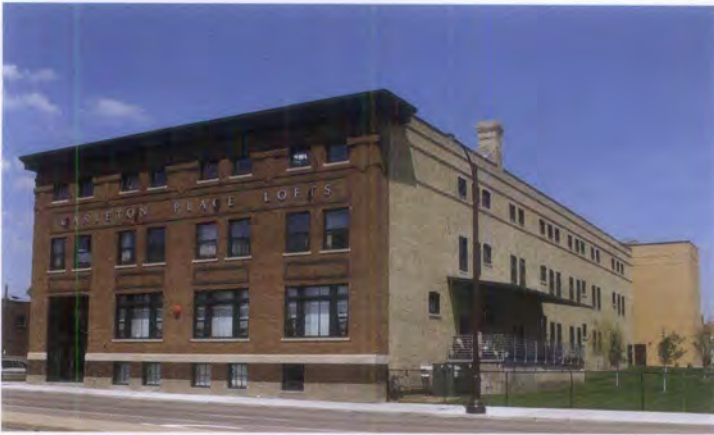
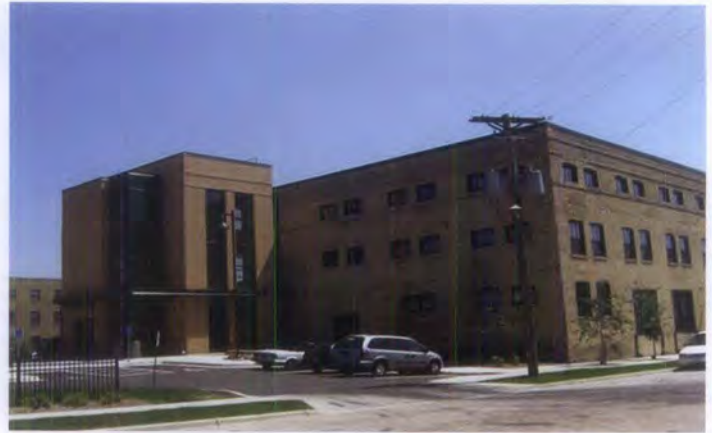
Figure 8. The rehabilitation of this large, early-20th century warehouse (left) into affordable artists' lofts included the addition of a compatible glass and brick elevator/stair tower at the back (right).

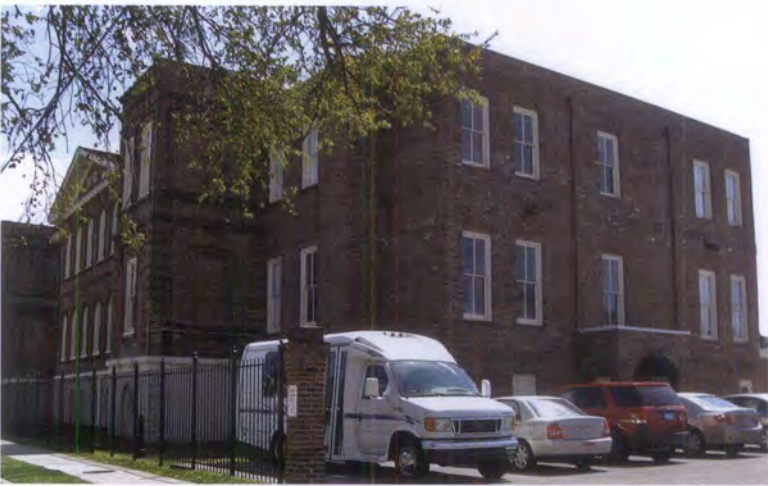
Figure 9. A simple, brick stair tower replaced two non-historic additions at the rear of this 1879 school building when it was rehabilitated as a women's and children's shelter. The addition is set back and it is not visible from the front of the school.

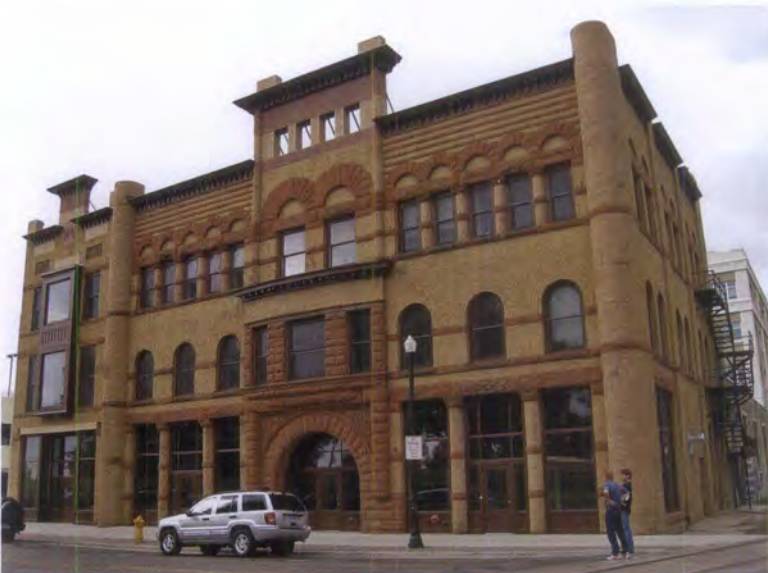
Figure 10. The small size and the use of matching materials ensures that the new addition on the left is compatible with the historic Romanesque Revival-style building.

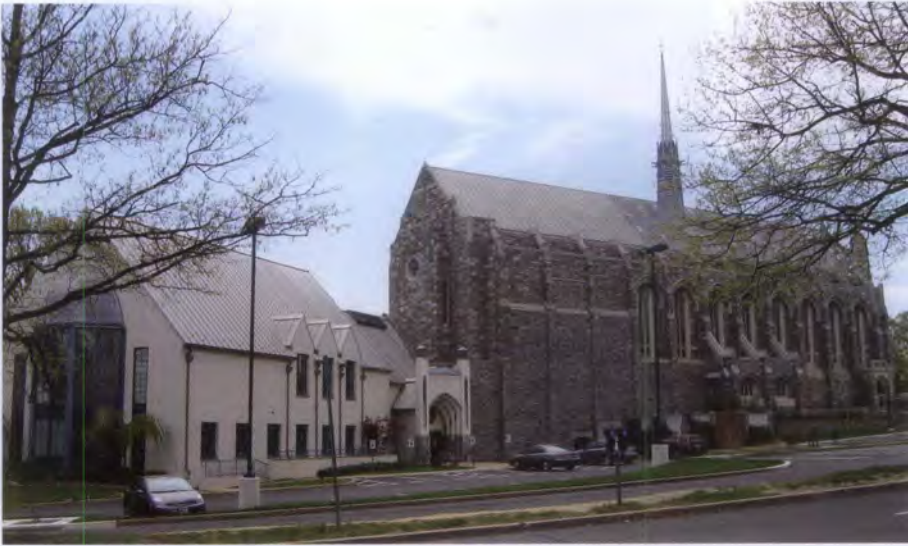
Figure 11. The addition to this early-20th century Gothic Revival-style church provides space for offices, a great hall for gatherings and an accessible entrance (left). The stucco finish, metal roof, narrow gables and the Gothic-arched entrance complement the architecture of the historic church. Placing the addition in back where the ground slopes away ensures that it is subordinate and minimizes its impact on the church (below).

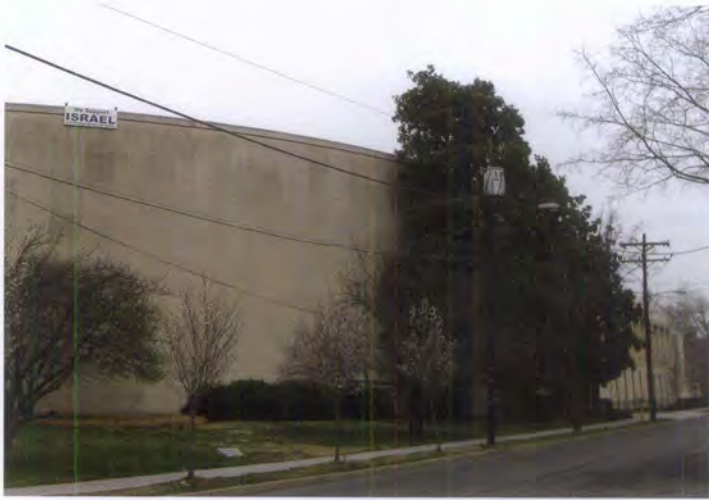
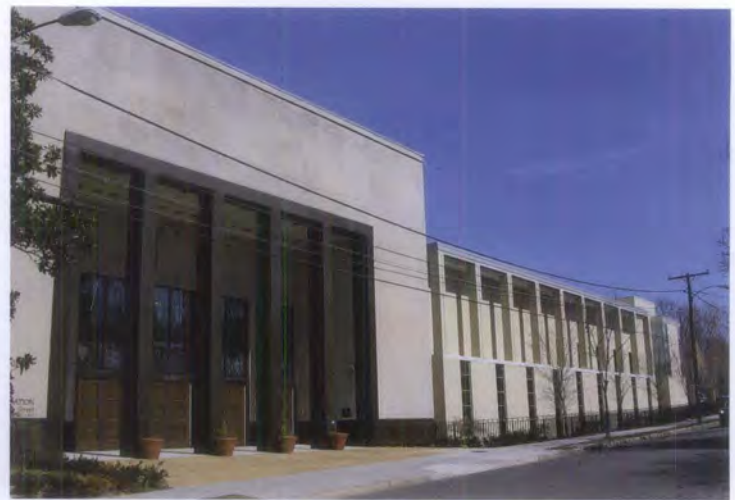
Figure 12. This 1954 synagogue (left) is accessed through a monumental entrance to the right. The new education wing (far right) added to it features the same vertical elements and color and, even though it is quite large, its smaller scale and height ensure that it is secondary to the historic resource.

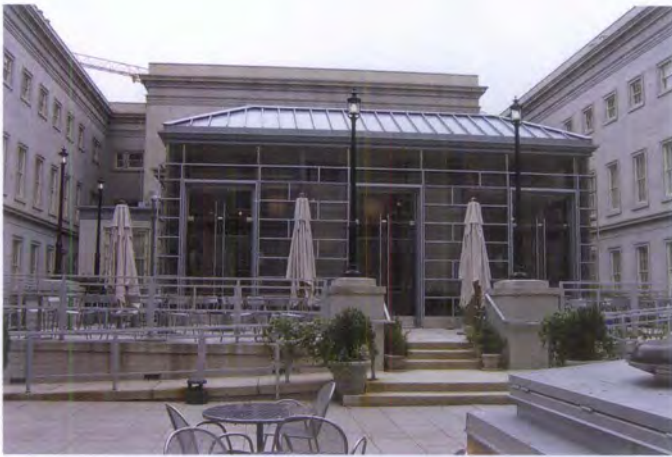
Figure 13. A glass and metal structure was constructed in the courtyard as a restaurant when this 1839 building was converted to a hotel. Although such an addition might not be appropriate in a more public location, it is compatible here in the courtyard of this historic building.

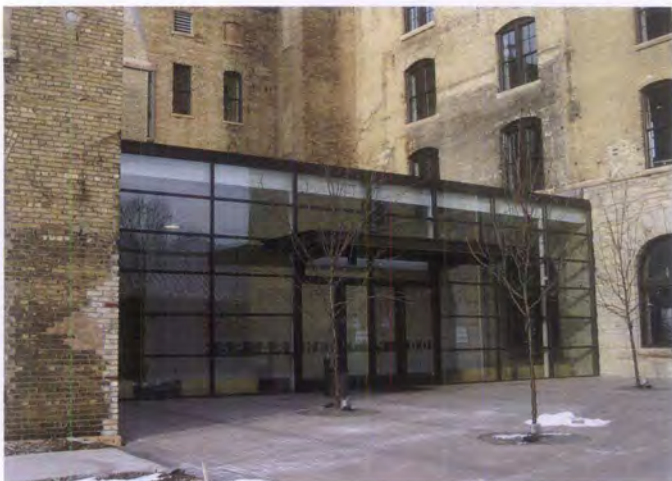
Figure 14. This glass addition was erected at the back of an 1895 former brewery during rehabilitation to provide another entrance. The addition is compatible with the plain character of this secondary elevation.

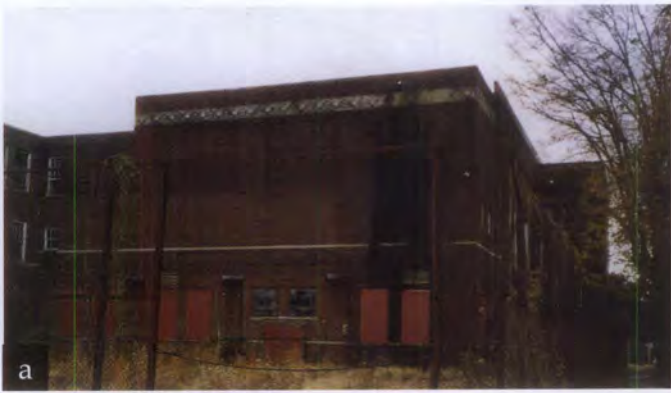
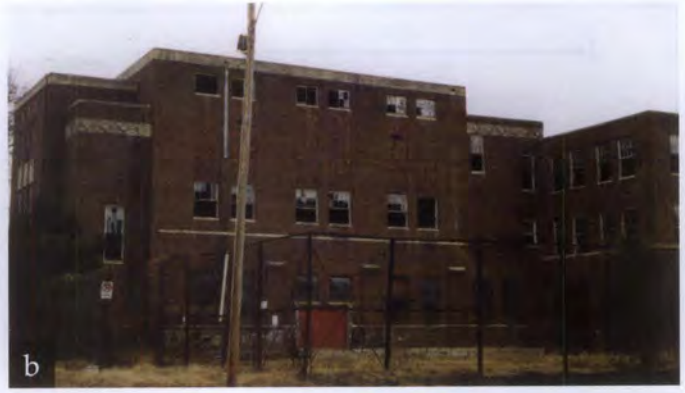
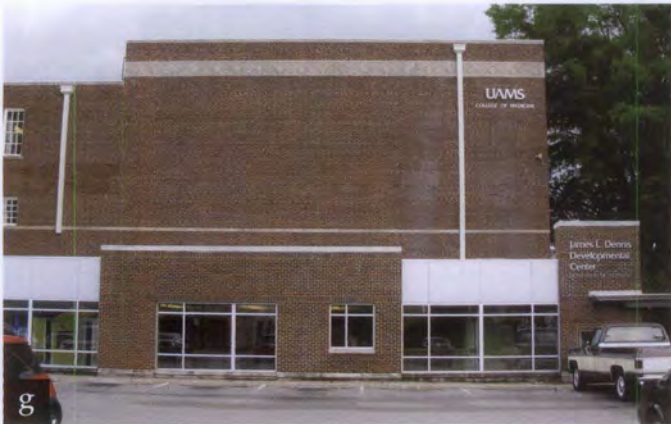
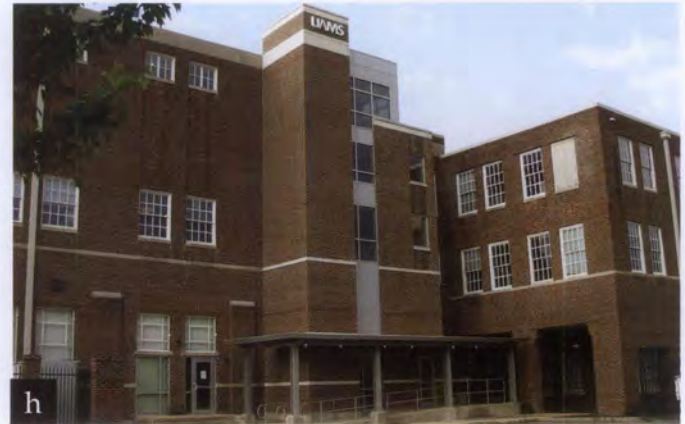
Figure 15. The rehabilitation of a c. 1930 high school auditorium for a clinic and offices proposed two additions: a one-story entrance and reception area on this elevation (a); and a four-story elevator and stair tower on another side (b). The gabled entrance (c) first proposed was not compatible with the flat-roofed auditorium and the design of the proposed stair tower (d) was also incompatible and overwhelmed the historic building. The designs were revised (e-f) resulting in new additions that meet the Standards (g-h).

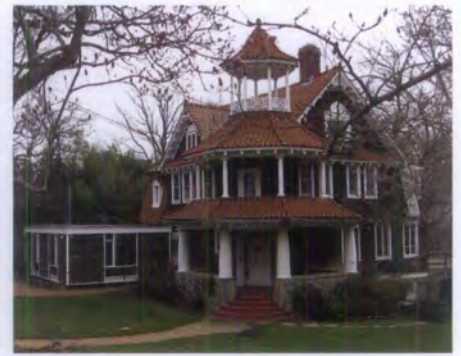
Figure 17. The small addition on the left is starkly different and it is not compatible with the eclectic, late-19th century house.

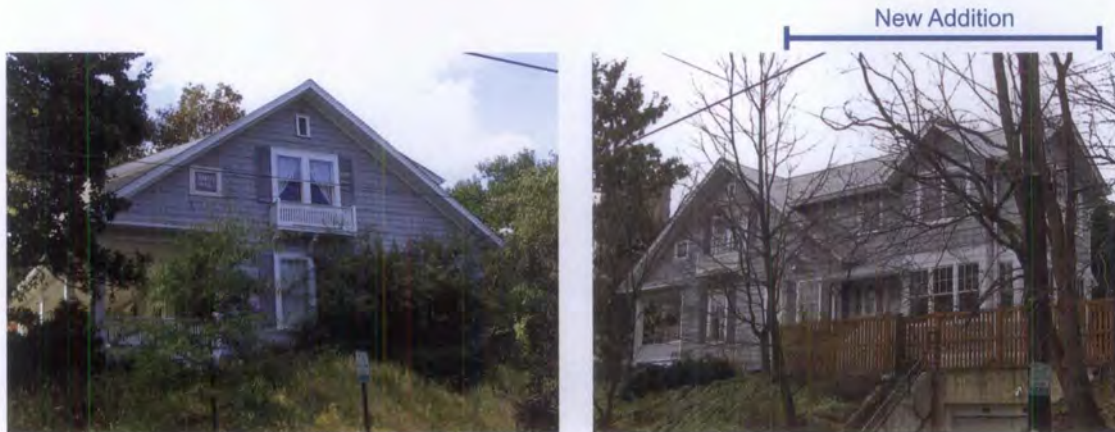
Figure 18. The expansion of a one- and one-half story historic bungalow (left) with a large two-story rear addition (right) has greatly altered and obscured its distinctive shape and form.

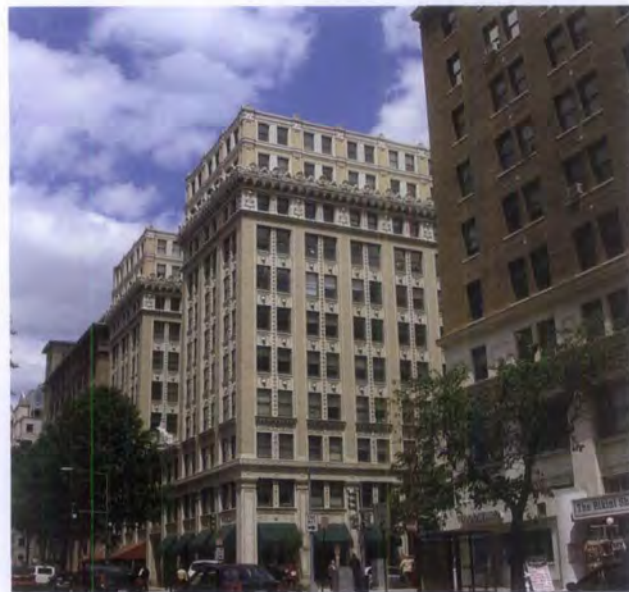
Figure 19. The upper two floors of this early-20th century office building were part of the original design, but were not built. During rehabilitation, the two stories were finally constructed. This treatment does not meet the Standards because the addition has given the building an appearance it never had historically.

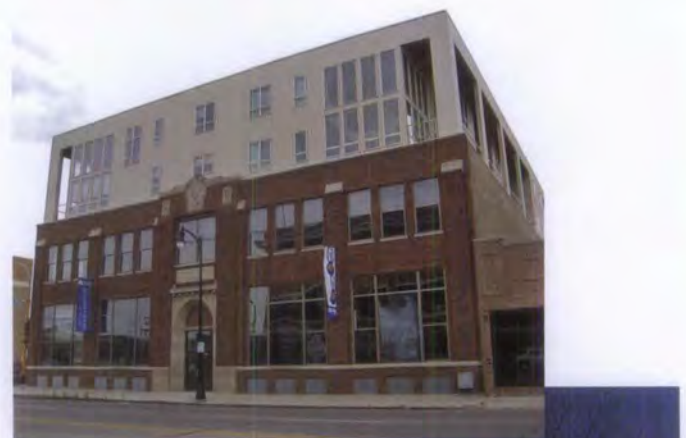
Figure 20. The height, as well as the design, of these two-story rooftop additions overwhelms the two-story and the one-story, low-rise historic buildings.

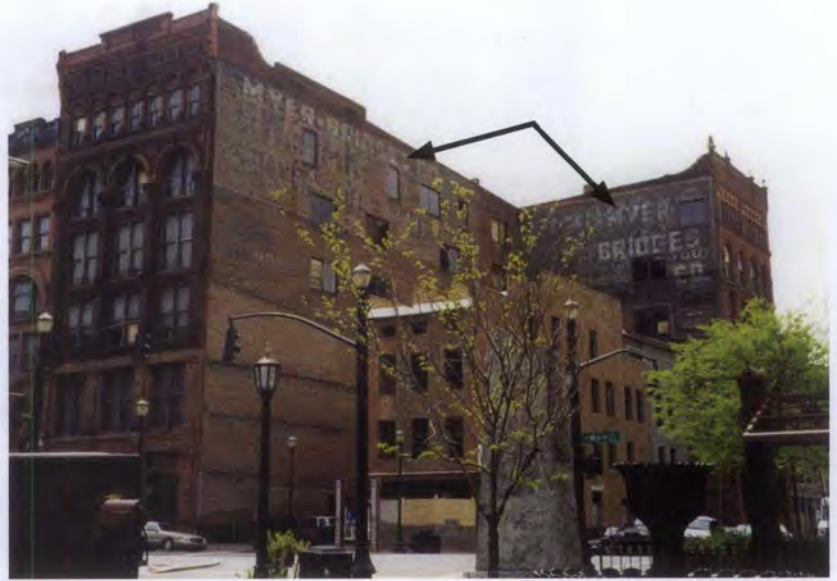
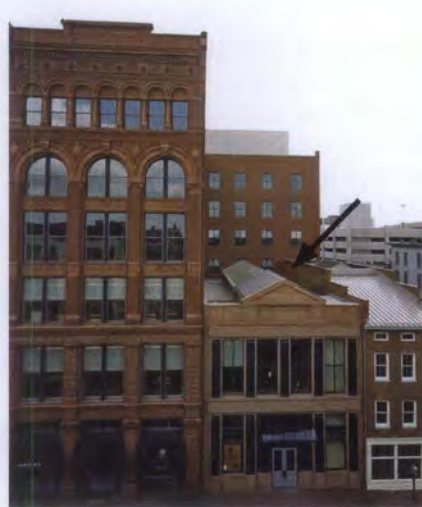
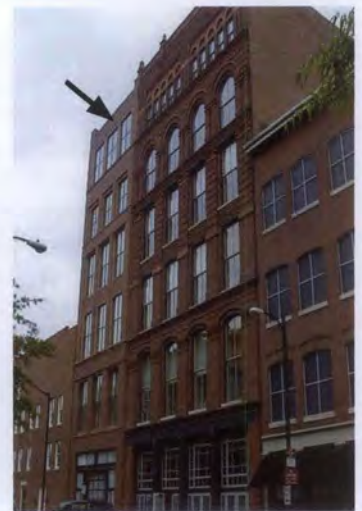
Figure 21. Both wings of this historic L-shaped building (top), which fronts on two city streets, adjoined vacant lots. A two-story addition was constructed on one lot (above, left) and a six-story addition was built on the other (above, right). Like the historic building, which has two different facades, the compatible new additions are also different and appear to be separate structures rather than part of the historic building.

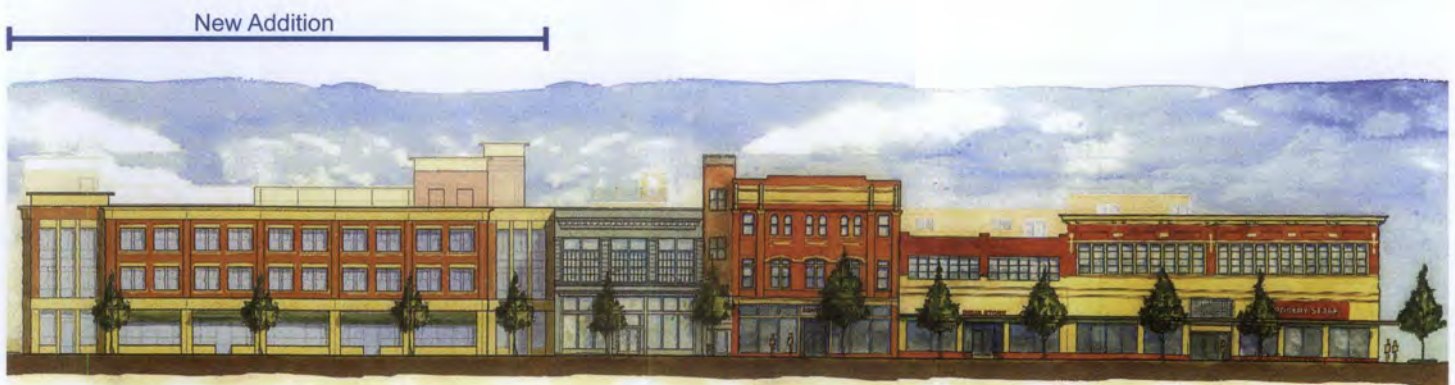
Figure 22. The proposed new addition is compatible with the historic buildings that remain on the block. Its design with multiple storefronts helps break up the mass.

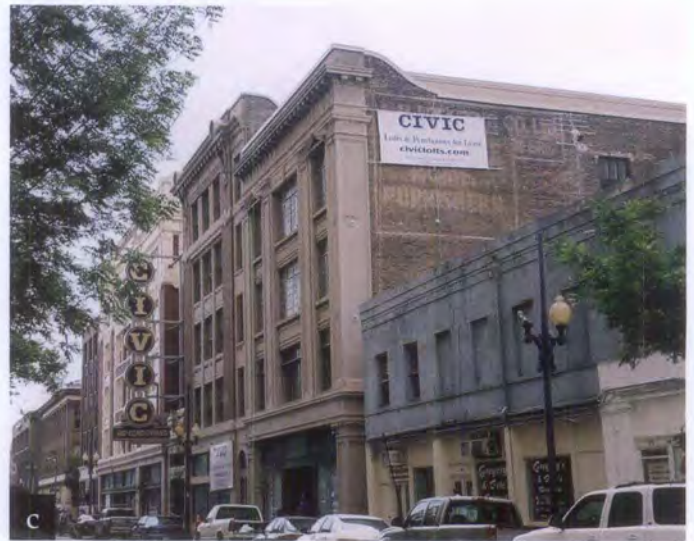
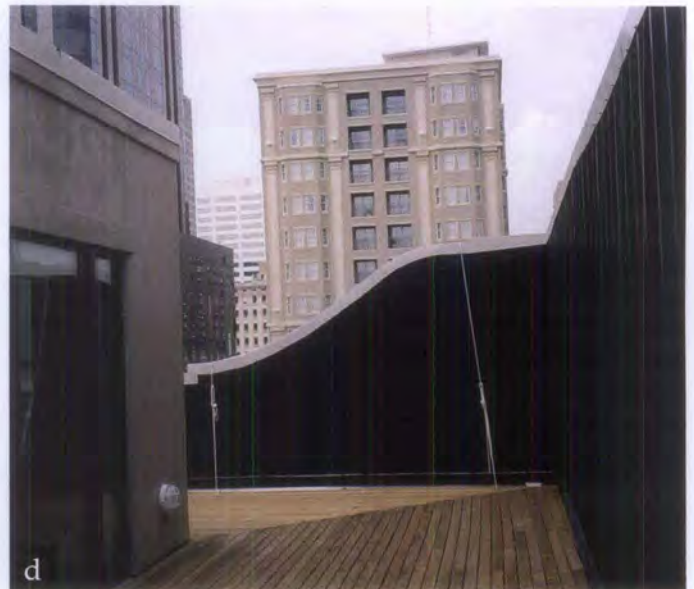
Figure 23. Colored flags marking the location of a proposed penthouse addition (a) were placed on the roof to help evaluate the impact and visibility of an addition planned for this historic furniture store (b). Based on this evaluation, the addition was constructed as proposed. It is minimally visible and compatible with the 1912 structure (c). The tall parapet wall conceals the addition from the street below (d).

A number of methods may be used to help evaluate the effect of a proposed rooftop addition on a historic building and district, including pedestrian sight lines, three-dimensional schematics and computer-generated design. However, drawings generally do not provide a true "picture" of the appearance and visibility of a proposed rooftop addition. For this reason, it is often necessary to construct a rough, temporary, full-size or skeletal mock up of a portion of the proposed addition, which can then be photographed and evaluated from critical vantage points on surrounding streets.

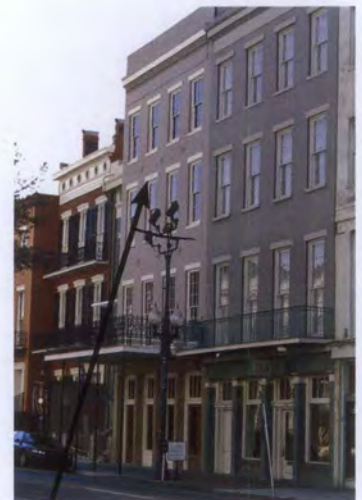
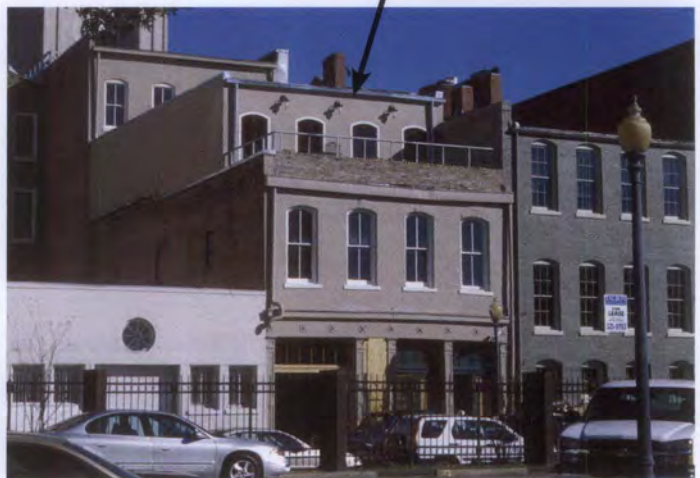
**Figure 26.** A rooftop addition would have negatively impacted the character of the primary facade (right) of this mid-19th century, four-story structure and the low-rise historic district. However, a third floor was successfully added on the two-story rear portion (below) of the same building with little impact to the building or the district because it blends in with the height of the adjacent building.
