**STAFF REPORT 2-10-2021 REGULAR MEETING**

**ADDRESSES:** 3664, 3690, 3700, 3708 TRUMBULL

**HISTORIC DISTRICT:** WOODBRIDGE FARM

**SCOPE:** ERECT NEW BUILDINGS, REHABILITATE EXISTING POWER HOUSE

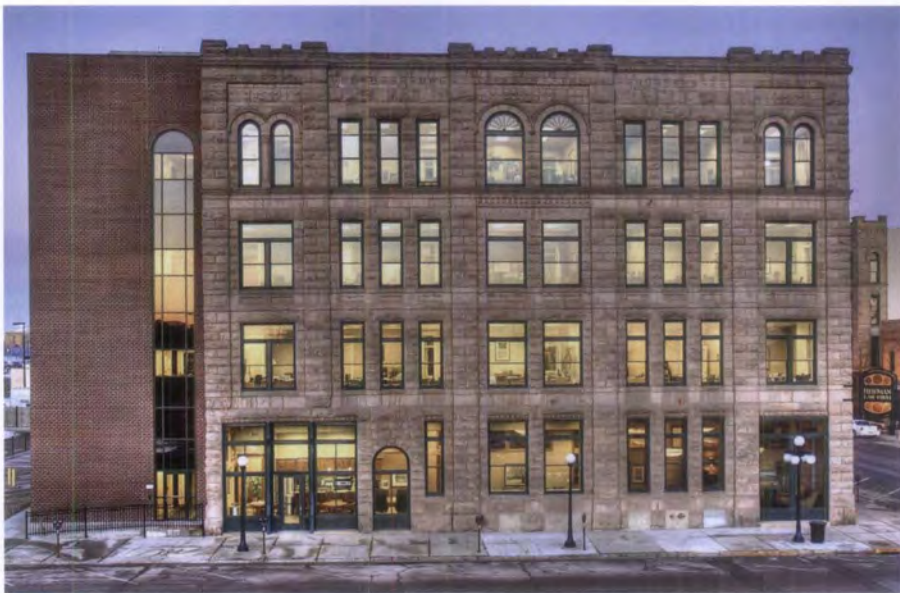
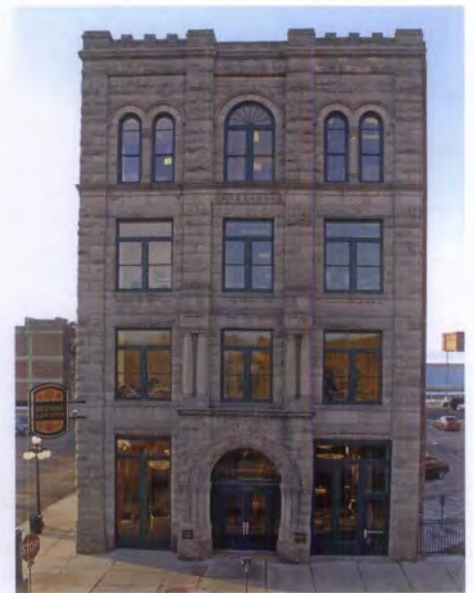
Figure 27. Although the new brick stair/elevator tower (left) is not visible from the front (right), it is on a prominent side elevation of this 1890 stone bank. The compatible addition is set back and does not compete with the historic building. Photos: Chadd Gossmann, Aurora Photography, LLC.

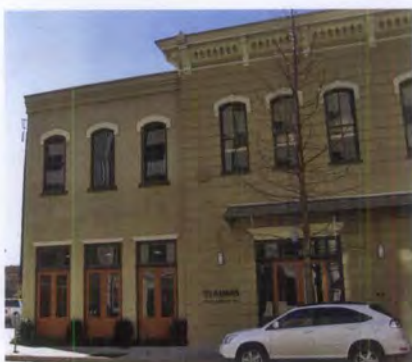
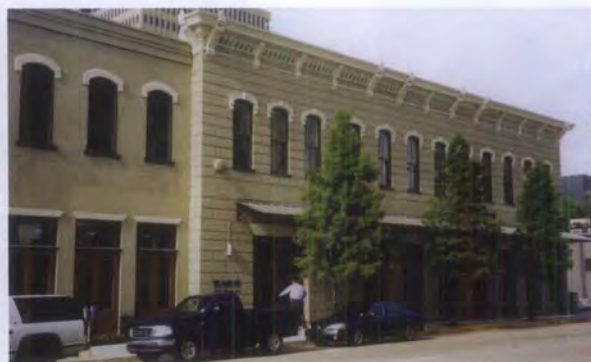
Figure 28. A small addition (left) was constructed when this 1880s train station was converted for office use. The paired doors with transoms and arched windows on the compatible addition reflect, but do not replicate, the historic building (right).

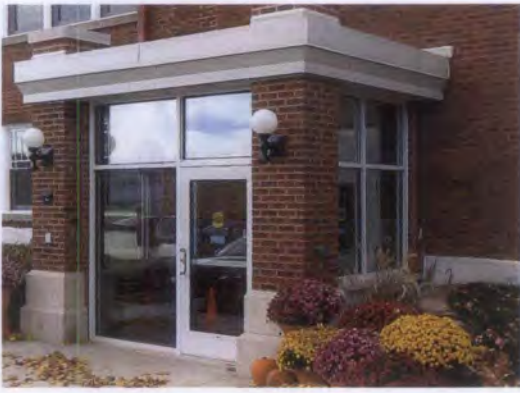
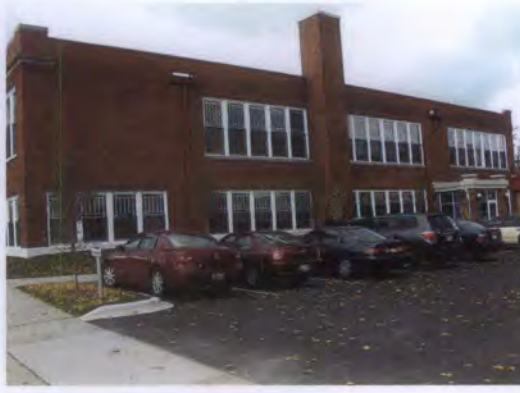
Figure 29. This simple glass and brick entrance (left) added to a secondary elevation of a 1920s school building (right) is compatible with the original structure.

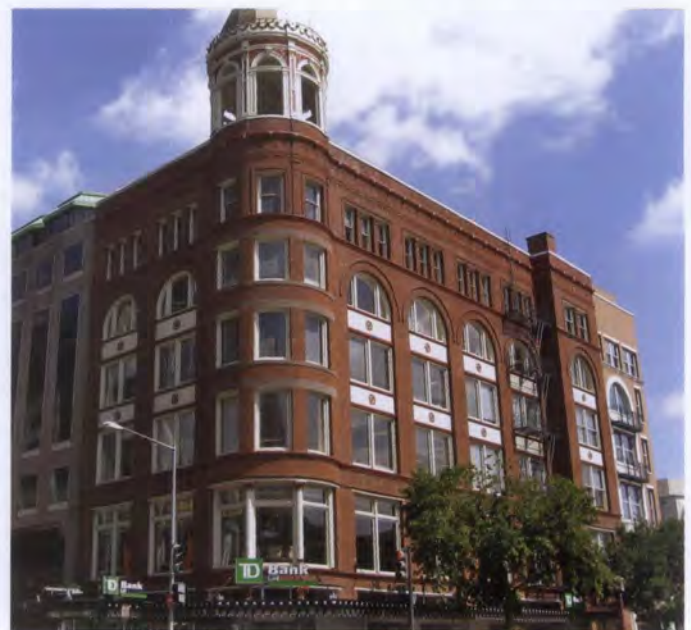
Figure 30. The small addition on the right of this late-19th century commercial structure is clearly secondary and compatible in size, materials and design with the historic building.

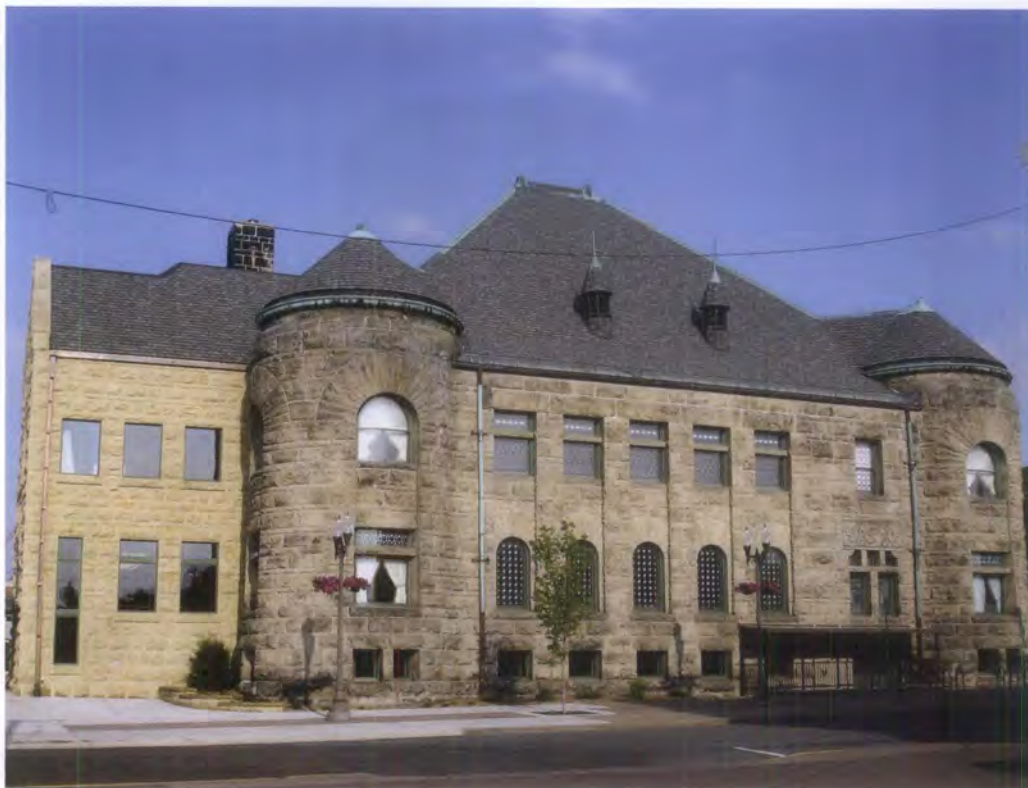
Figure 31. An elevator/stair tower was added at the back of this Richardsonian Romanesque-style theater when it was rehabilitated. Rough-cut stone and simple cut-out openings ensure that the addition is compatible and subordinate to the historic building. Photo: Chuck Liddy, AIA.
