STAFF REPORT 5-12-2021 REGULAR MEETING

APPLICATION NUMBER: 21-7223 (ASSOCIATED VIO. #21-488)

ADDRESS: 1791 BURNS AVENUE

SCOPE: REMOVE BUILDING-INTEGRATED DECORATIVE CAST-STONE FLOWER BOXES; SANDBLAST PAINT OFF EXISTING STUCCO – WORK COMPLETED WITHOUT APPROVAL; PAINT STUCCO EXTERIOR

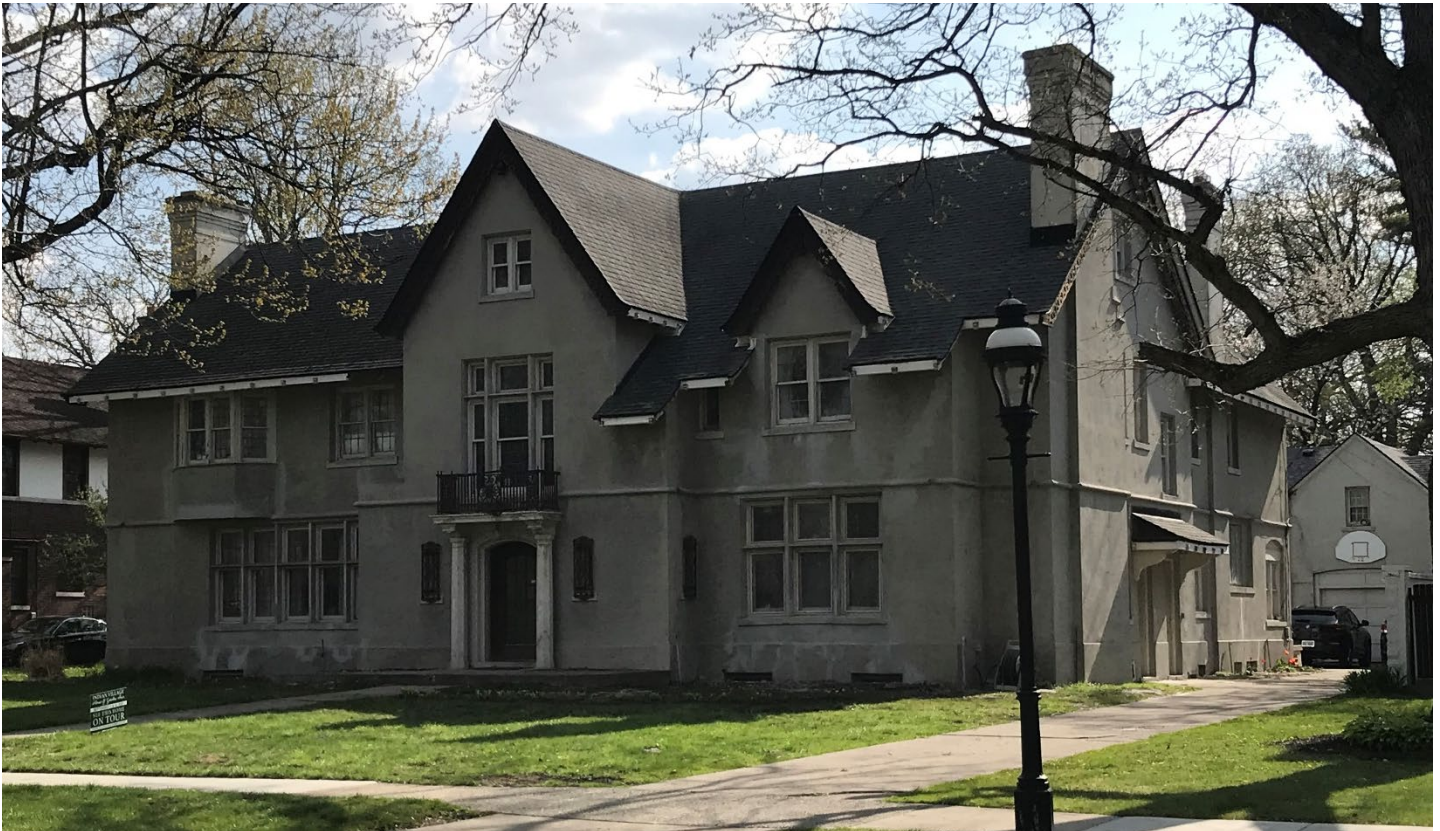
1791 Burns. View from Burns Avenue looking southwest. Photo taken by HDC staff, April 23, 2021.

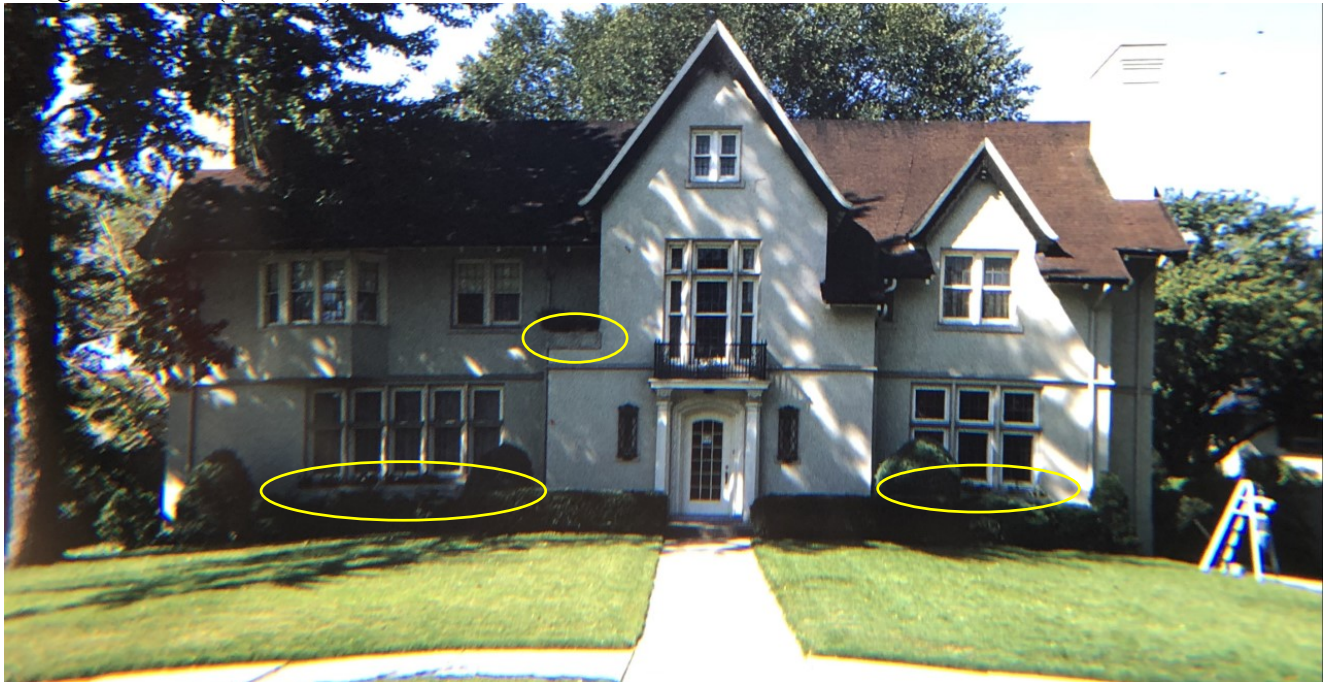
- Indian Village Historic District was designated in 1970.
- Designation slide (ca. 1971)

Flower boxes circled in yellow.

- **Flower boxes:** The building-integrated cast-stone flower boxes are distinctive and important character-defining features of the property. Their removal does not meet the Secretary of the Interior's Standards for Rehabilitation nor the Elements of Design for this district. Specifically, the following excerpted Indian Village Elements of Design:

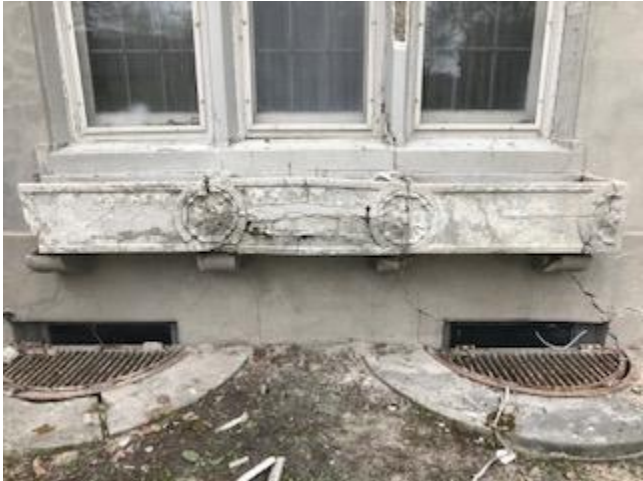
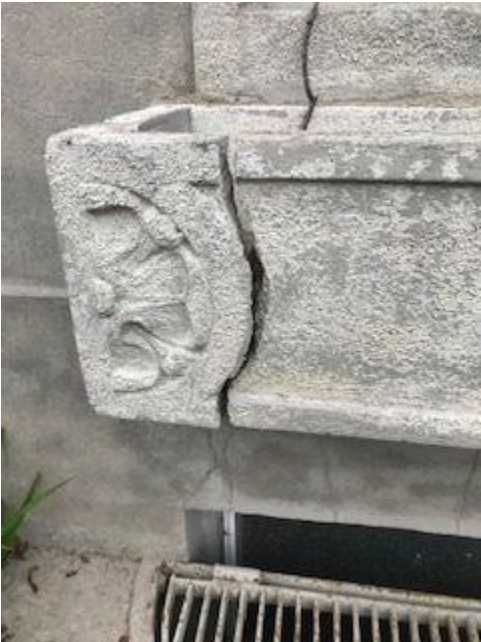
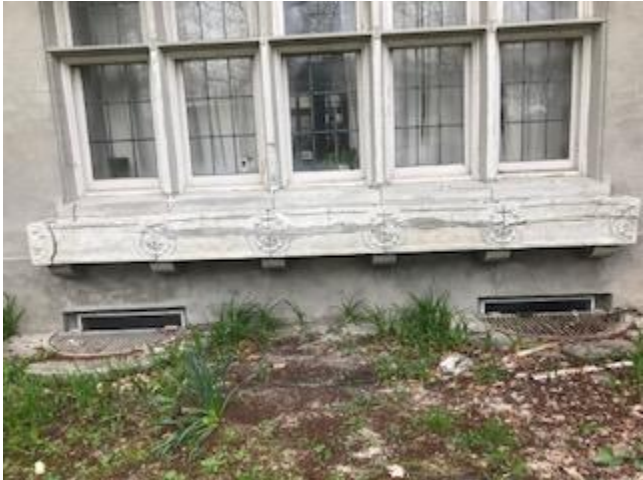
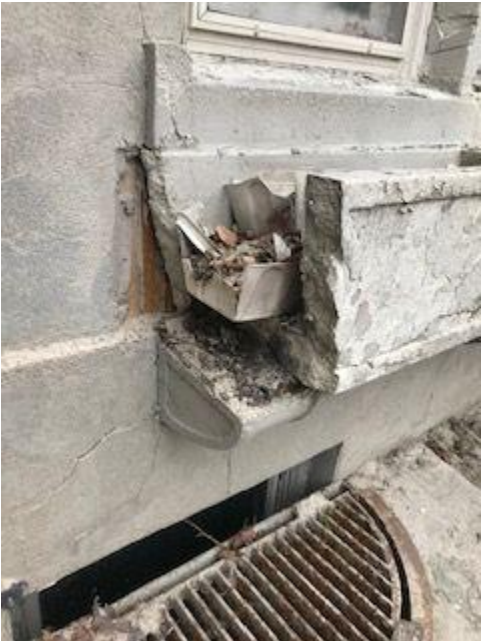
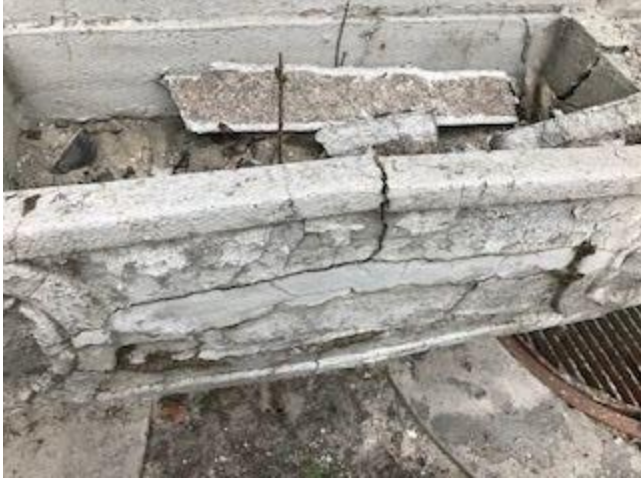
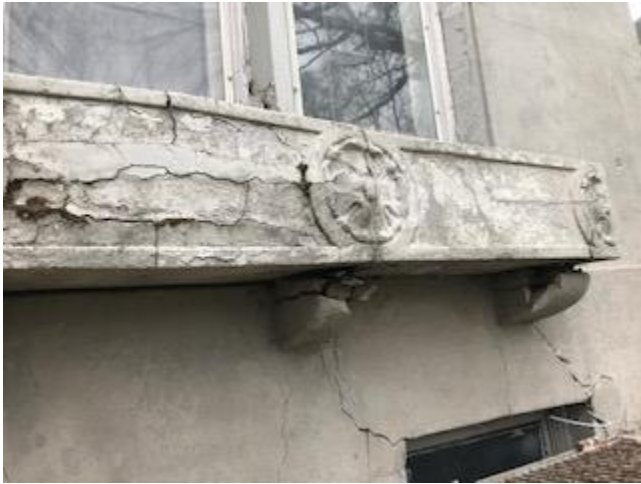
Flower Boxes

The flower boxes are in disrepair. Due to the current condition and mold of the flower boxes, they cannot be recreated. To make matters worse, the steel support beams meant to structurally support the flower boxes are rusted and could not support new flower boxes. Lastly, the flower boxes created significant water damage to the structure of the home as the boxes held water over the years, allowing it to seep into the house. That said, the 300lbs flower boxes are compromising the integrity of the house and there is no forward path properly replacing the boxes.

We plan to remove the flower boxes and repair the structural damage compromising our home. We will then repair the area where the flower boxes were, to be flush with the rest of the exterior. Once the Stucco is repaired, we are also planning on painting the house.
