STAFF REPORT 06-09-2021 MEETING

APPLICATION NUMBER: 21-7308

ADDRESS: 240 MACK

SCOPE: NEW THIRD FLOOR ADDITION AT REAR OF BUILDING, REPLACE VINYL WINDOWS WITH WOOD WINDOWS

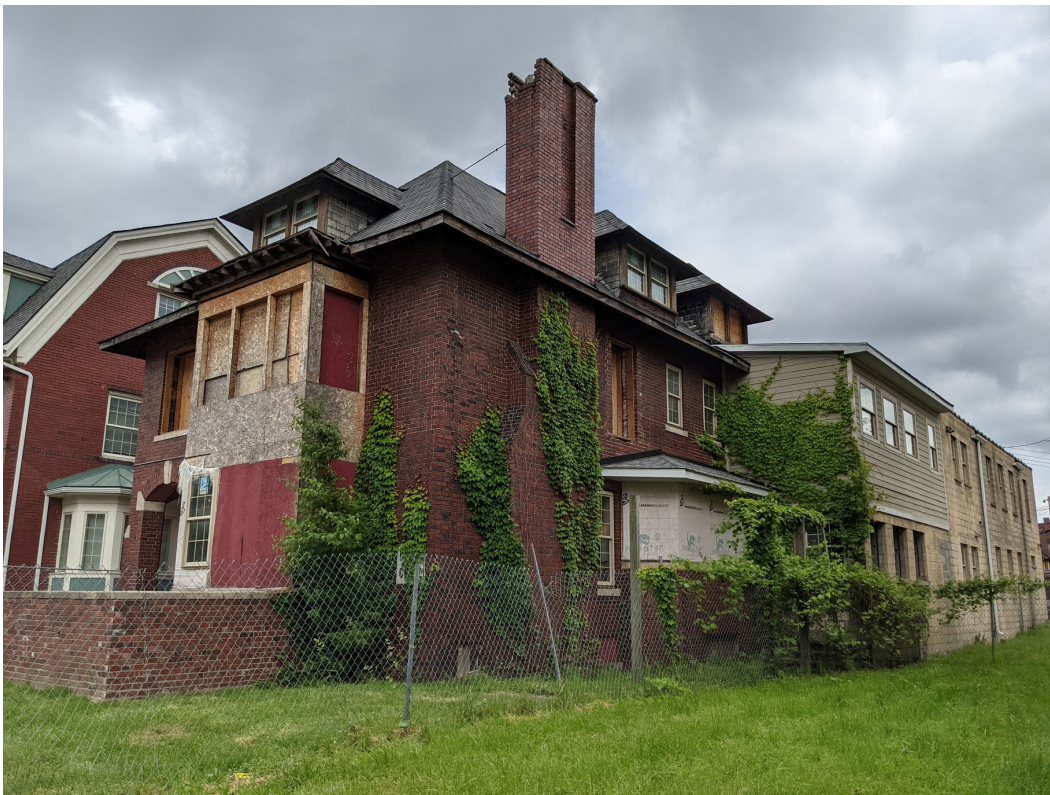
View of 240 Mack to the southeast, as seen from Mack, showing the large, non-historic rear addition towards rear. Staff photo, May 26, 2021.

The subject property is located just two parcels east of the Albert Kahn House along Mack at the northern limits of the Brush Park Historic District, between John R and Brush Streets. The building is a combination of two distinct sections built in different eras: a historic brown brick/stone home with a hipped roof featuring bracketed eaves, a prominent chimney, generous porch, recessed entry, and double height window bay; and a post-war, flat-roofed concrete block addition towards the rear, exhibiting almost no architectural character. In the second half of the twentieth century, the property served as a rooming house. The combined building extends nearly to the alley. The incompatible rear addition, erected prior to the creation of the historic district, has damaged the historic character of the property. In comparison, the street-facing expression is largely intact and readable.

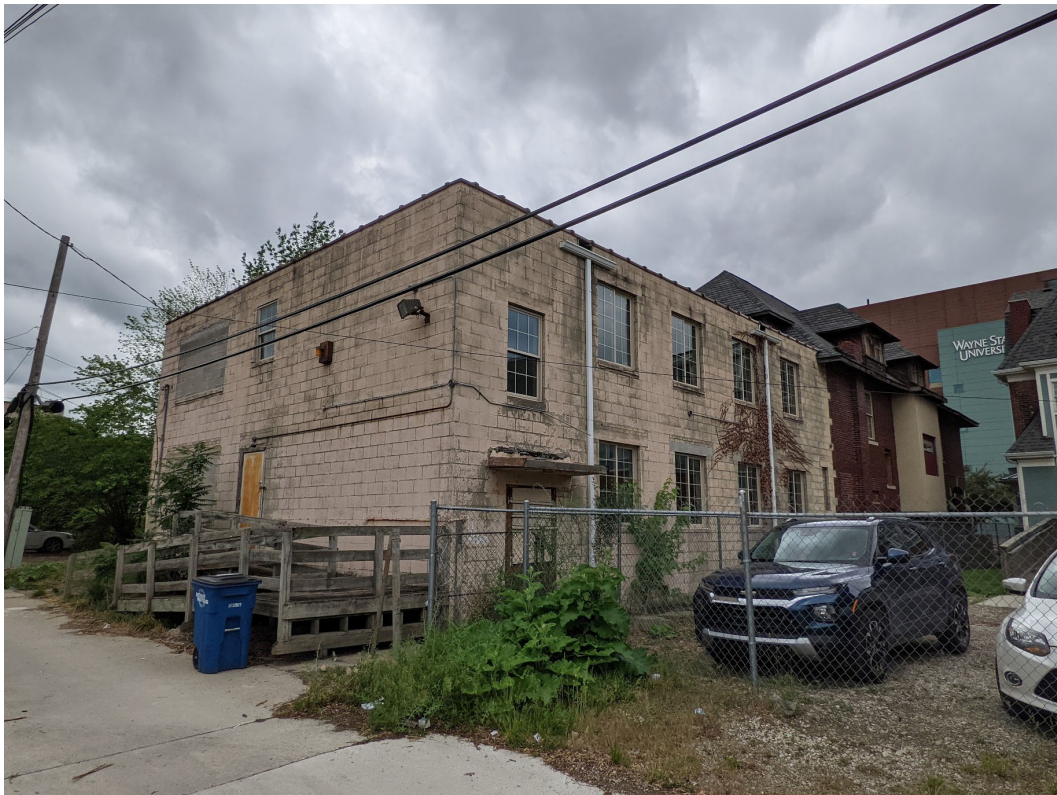
Rear (alley) view of 240 Mack, looking northwest. Staff photo, May 26, 2021.

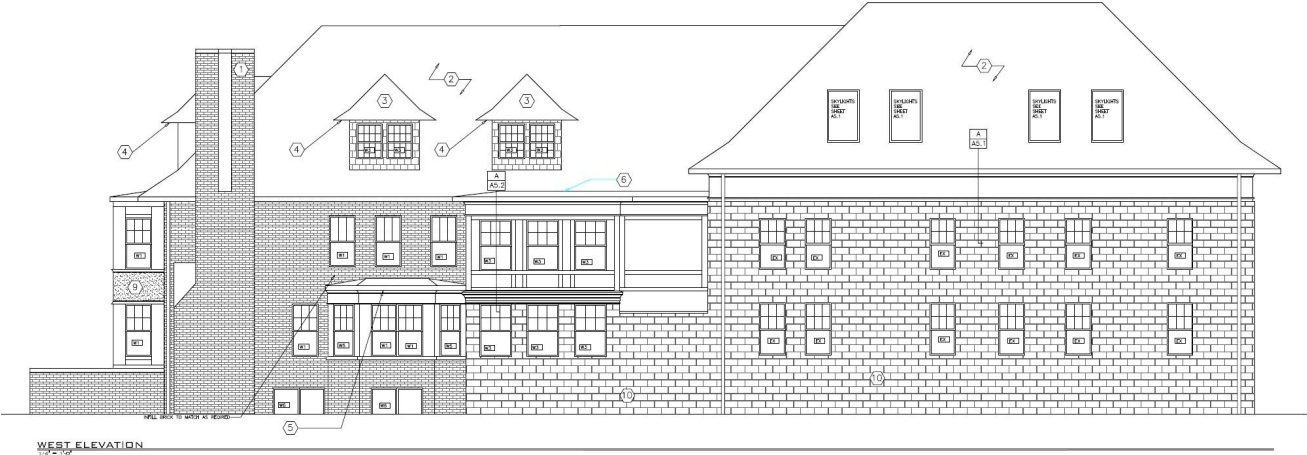
Per the submitted drawings, the applicant is proposing to rehabilitate the building and add a third story to the rear non-historic section, to return the building to service as apartments.

- The Brush Park Historic District was established in 1980.
- The main element of the current proposal is to crown the rear non-historic addition with a third level enclosed in a hipped-type roof that seeks to complement the historic building. The proposed ridgeline of the new roof rises discernibly higher than the historic roofline towards Mack, overwhelming the main house. Any addition to a historic building should remain subordinate to the historic property.

- Though the project requires the demolition of a rear-facing dormer on the historic house in order to build an integrated roof between the house and the addition, the dormer and its historic context is already obscured and degraded by the currently existing incompatible block addition, and staff advises that the subject dormer does not currently “characterize” the property under the Standards. Looked at as a whole, and given the commercial context of the street and the current negative expression of the rear block, staff feels it is reasonable and appropriate for a roof addition to be built, subject to a revision in scale/height per the point above.
