STAFF REPORT 07-13-2021 REGULAR MEETING

ADDRESSES: 1567 CHURCH

HISTORIC DISTRICT: CORKTOWN

SCOPE: REHABILITATE BUILDING FOR MULTI-FAMILY USE

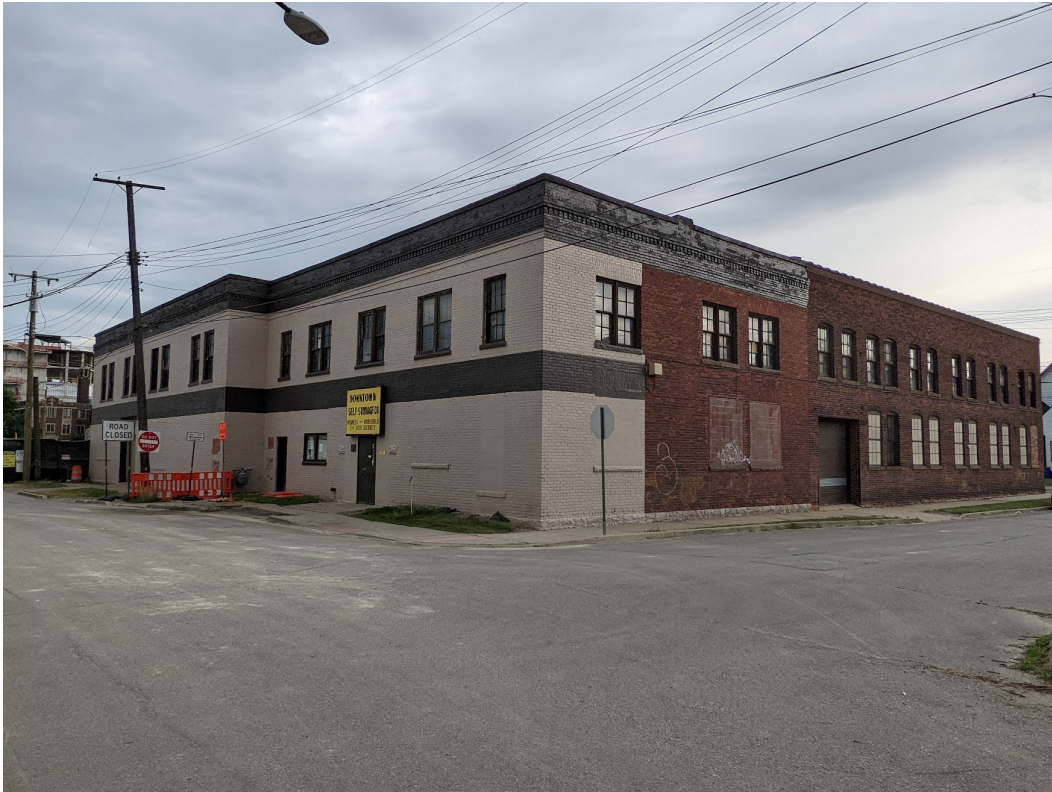
View of 1567 Church, looking southeast from intersection of Church and 10th. Staff photo, July 1, 2022.

1567 Church, at the west end of the block at 10th, is a roughly 130' square parcel fully occupied by a two-story brick warehouse/storage building. The building (addressed as 1551 Church) was erected circa 1894 and is today referred to as the Downtown Self-Storage Building. For many years, this was the John Whittaker Planing Mill, a sawmill associated with the many nearby lumberyards in Corktown. Later, after expansion in 1916, it was the Red Arrow soda factory.

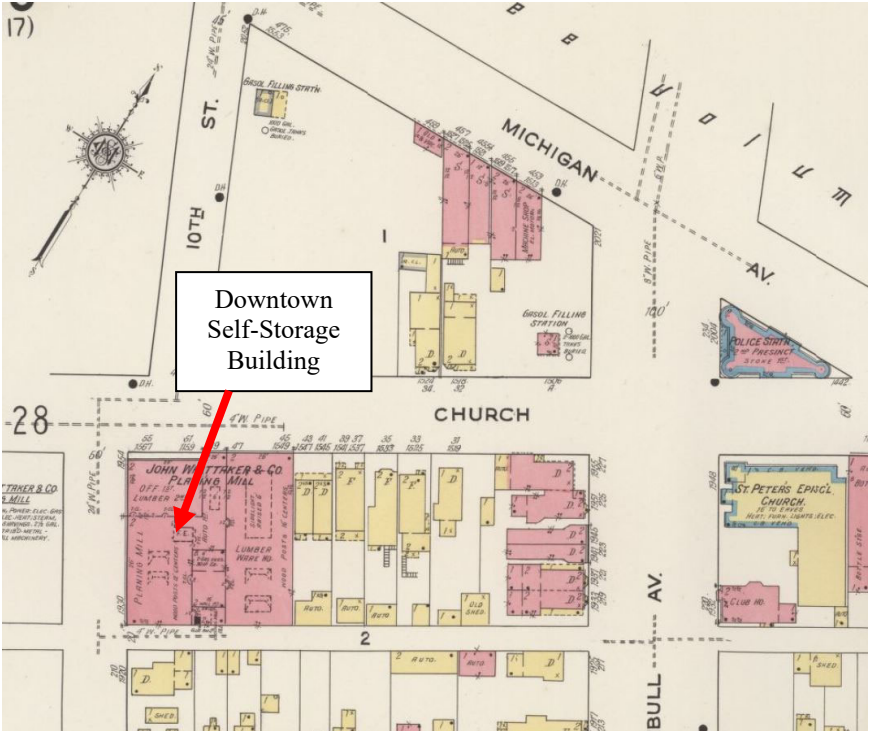
The building grew from a smaller core that was originally constructed at the corner of Church and 10th Streets, as shown below on an 1897 Sanborn map. This historic core still exists and is readable from the exterior. The building, in its current form, exhibits a high degree of historic integrity, including character-defining brickwork and opening patterns. The windows appear to be of historic age, but are in varying states of deterioration. It is considered a contributing structure to the historic district.

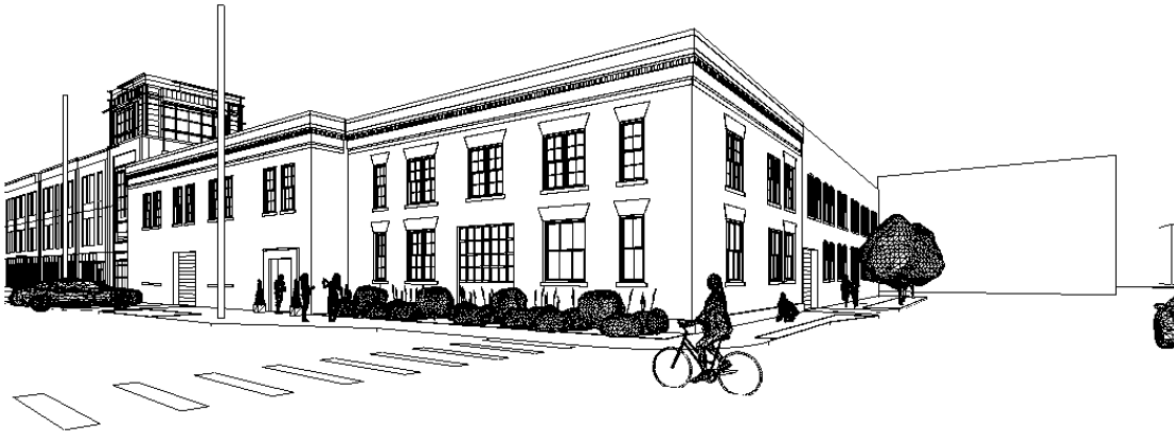
Perspective view from applicant's sightline study document.

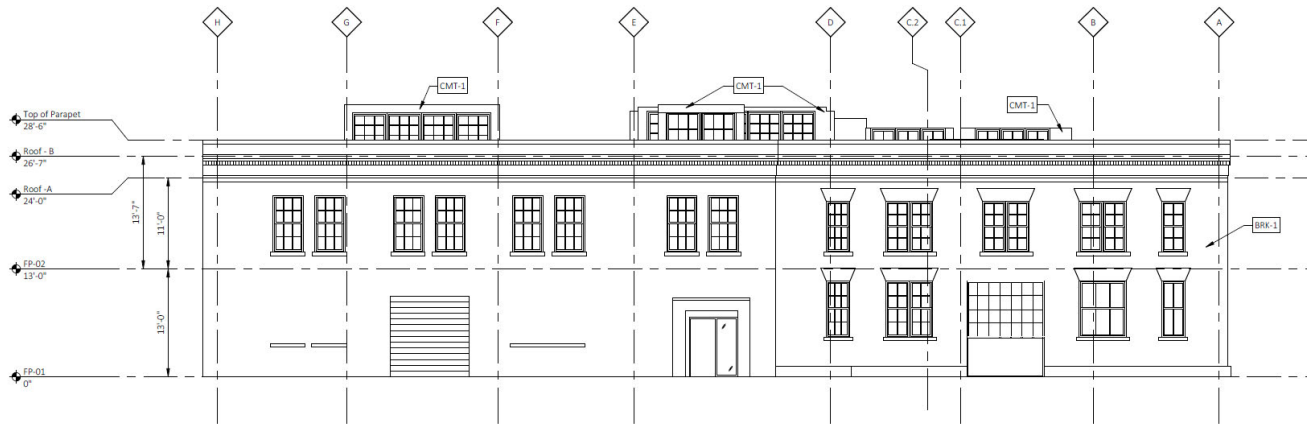
NORTH ELEVATION

North (Church Street) elevation, from applicant's architectural drawing set.

- The area of greatest change will be the window openings. Several new openings will appear either in historic locations, or in locations consistent with the historic expression (for instance, at the east alley which has fewer windows than necessary for a residential reuse). All window locations will see rusticated stone sills either restored or introduced, and be fitted with new "historic replica" window units.
