STAFF REPORT: 9/14/2022 MEETING PREPARED BY: D. RIEDEN

APPLICATION NUMBER: #22-8010 **VIOLATION NUMBERS:** #624

ADDRESS: 4700 THIRD AVENUE

SCOPE: REPLACE PILASTERS AND ENTRANCE (WORK COMPLETED WITHOUT APPROVAL)

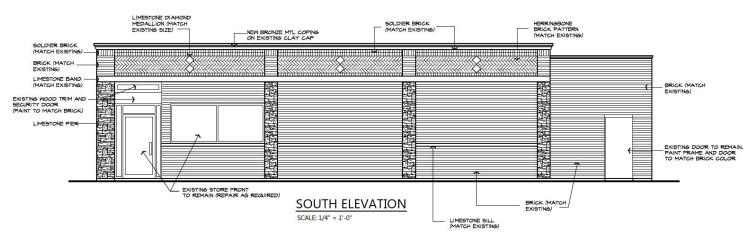
- Staff observed that the window on the south wall along Forest Ave is not placed in the position as proposed in the drawings in the following manner: both the window and the limestone sill are shown in the proposed drawing to match the running band of the walls. Currently the window and the limestone sill sit approximately 1' higher. It is staff's opinion that the proposed drawing would be appropriate over what was built without approval. (see Elevation 1, below and Site photo 1, above.)

Elevation 1, by applicant, south elevation on Forest Ave., showing the limestone sill for the window location.

- Staff identifies that the proposed window location in the drawings is an appropriate location, but the built location, without approval, appears to have been misplaced and interrupts the design and rhythm of limestone and brick interplay. Staff offers the opinion that the window on the south wall should be located as shown in the proposed drawing.

- The installed window and it's corresponding to limestone sill be reconstructed and placed according to the proposed drawings.
- The paint applied on the south wall be removed, or the applicant provide a paint scheme to HDC staff that addresses inconsistent application of paint on this wall.
- HDC staff shall review the final details of both the relocation of the window and limestone sill and the paint application for approval before the applicant executes these actions.

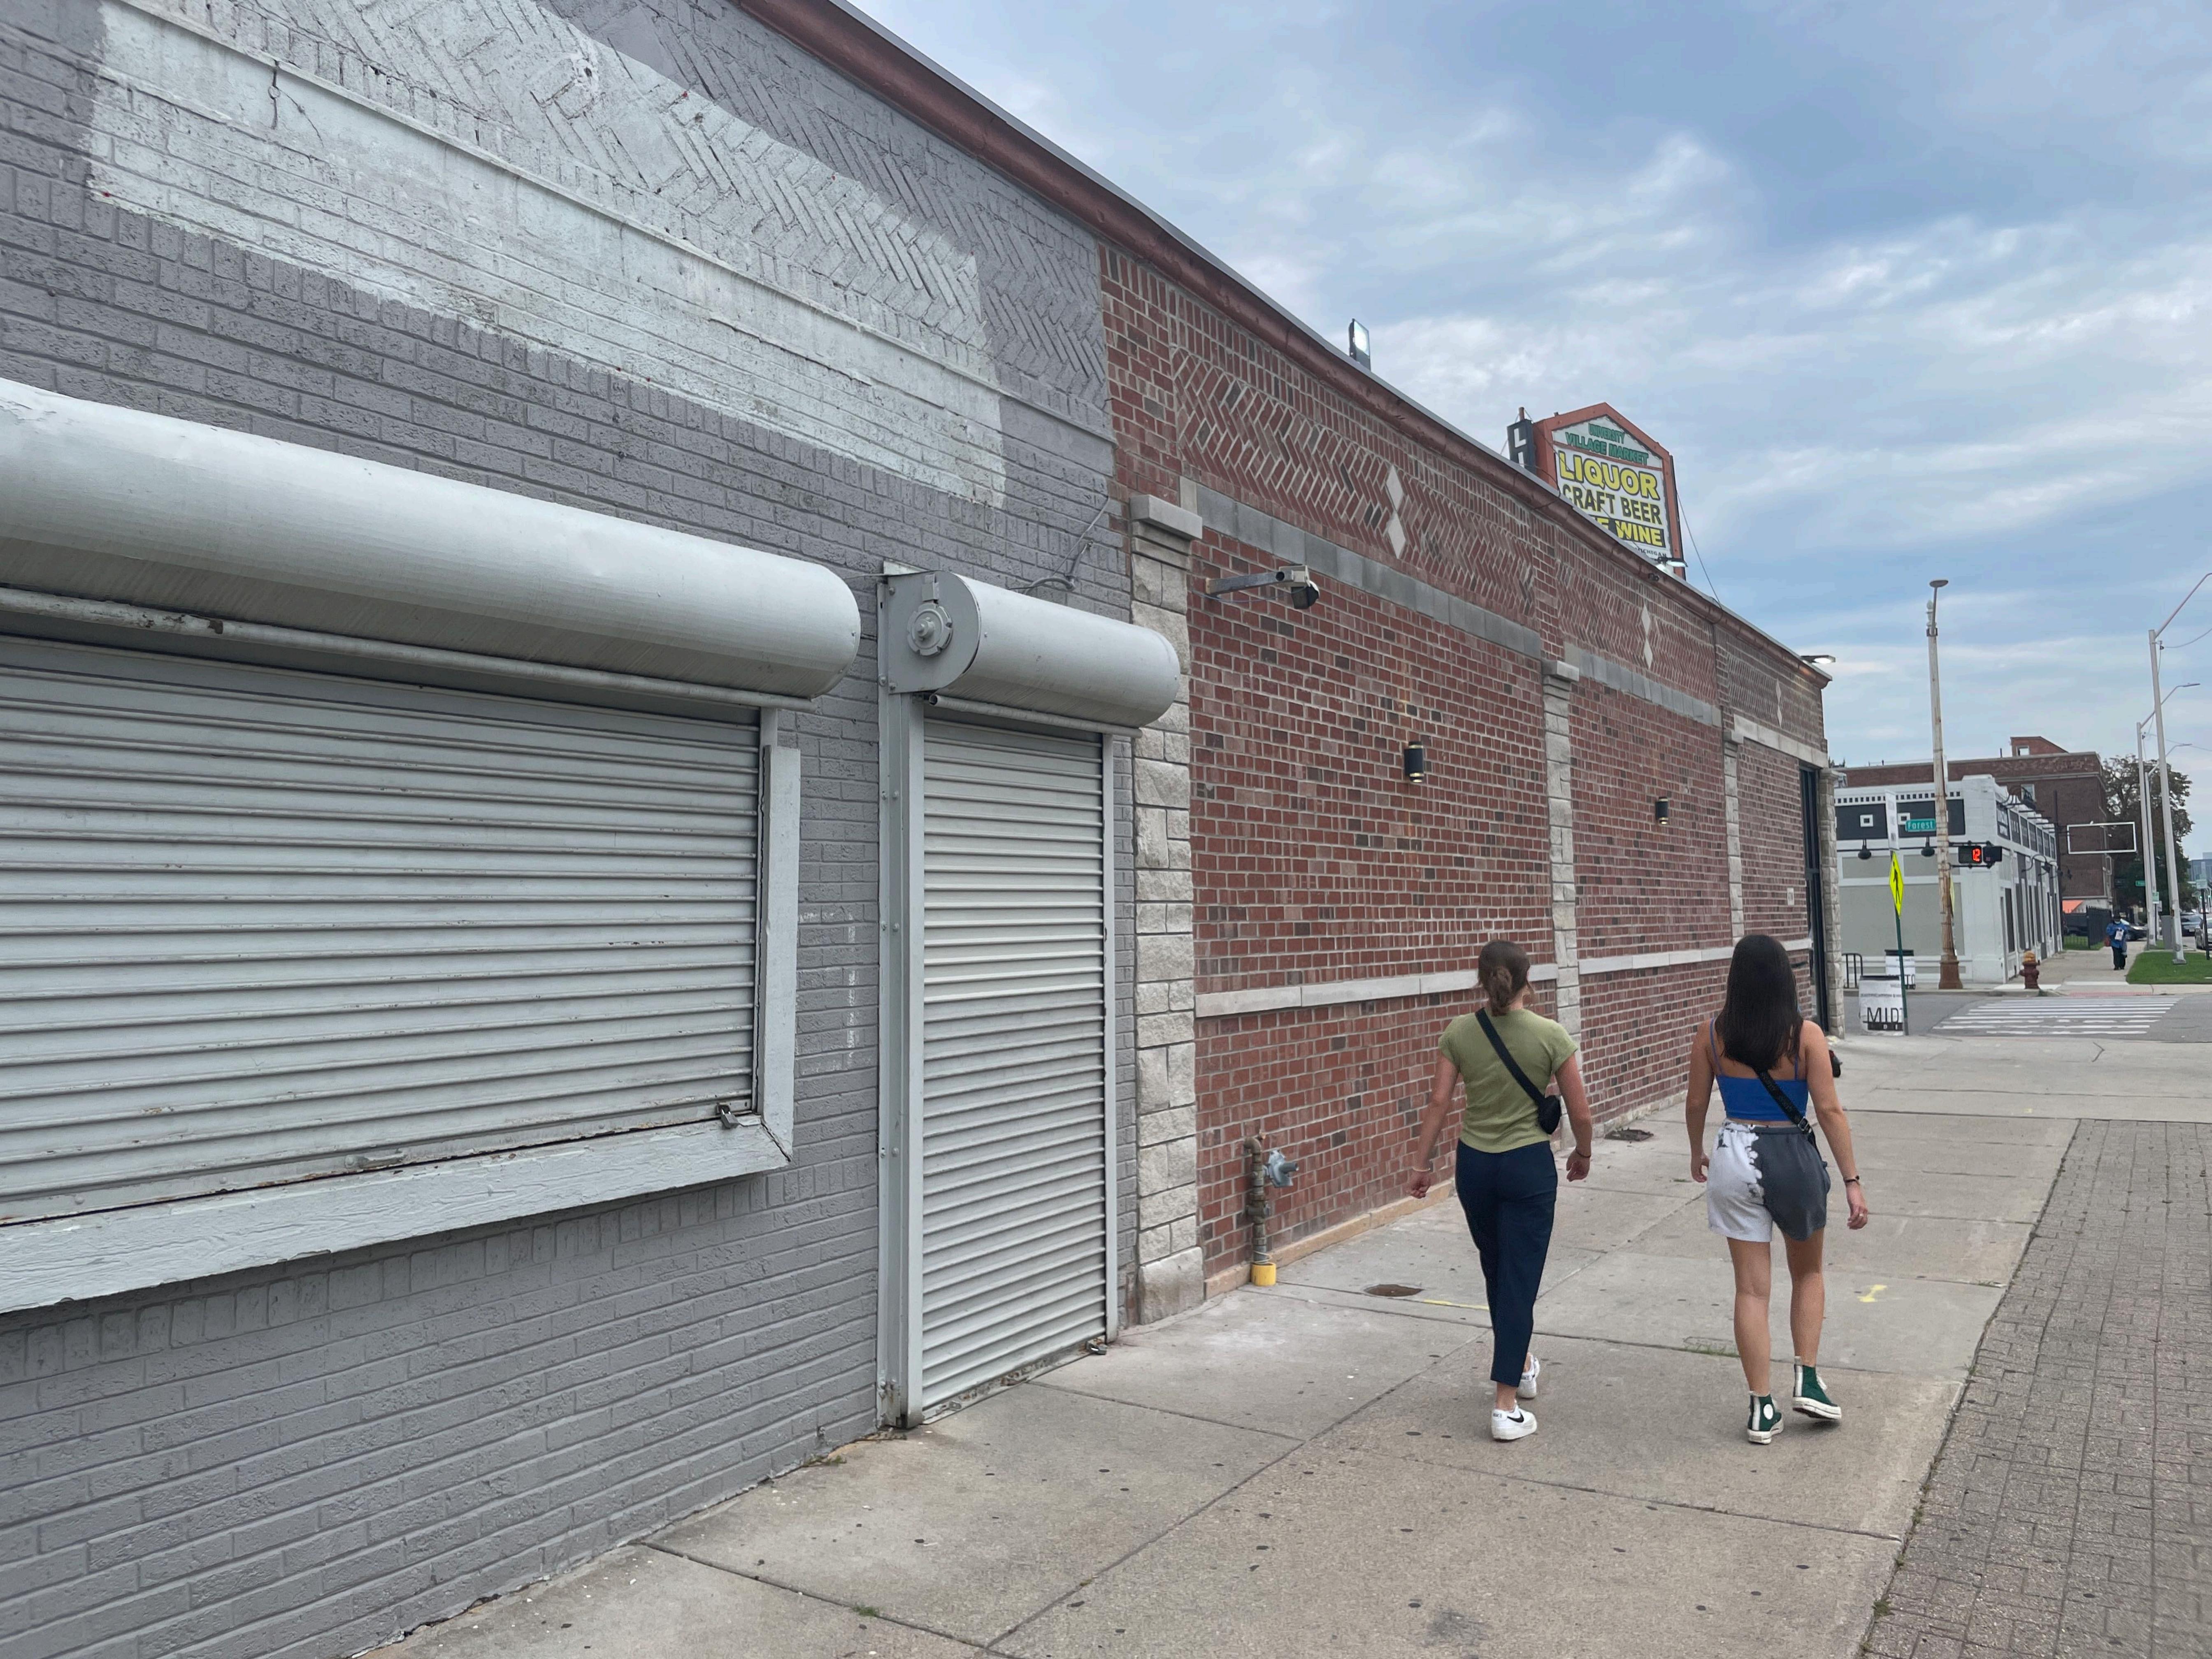
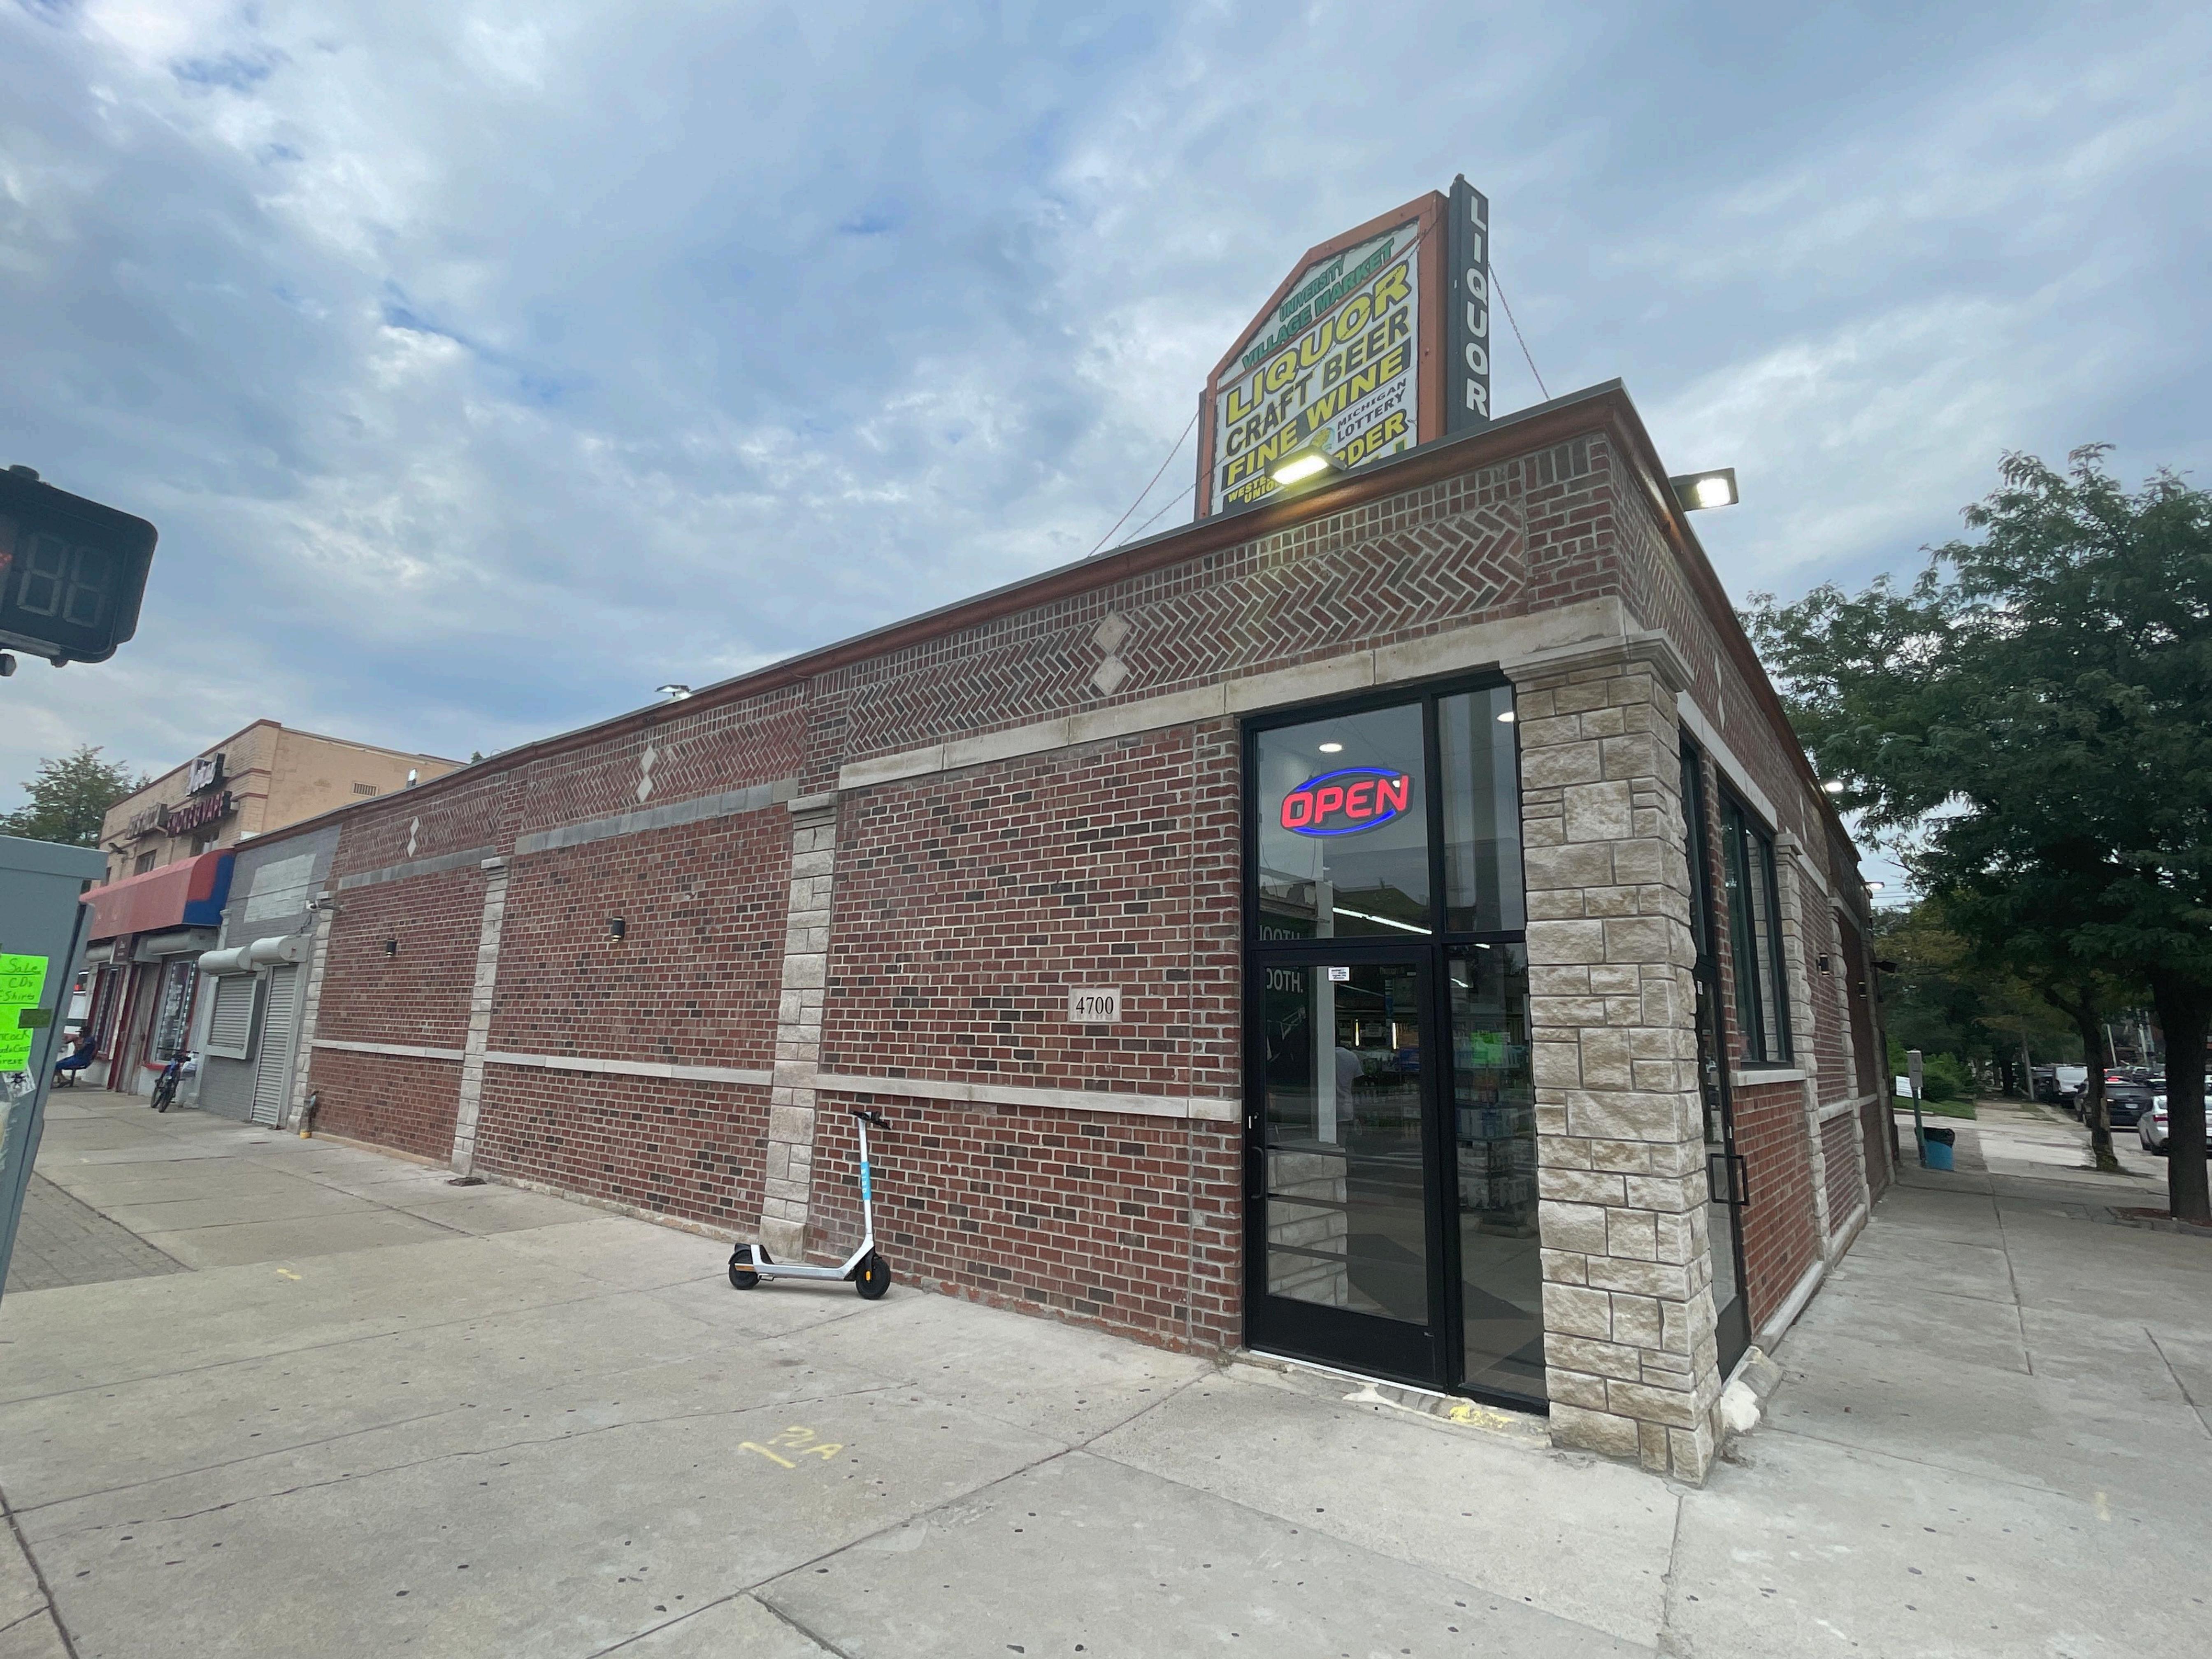
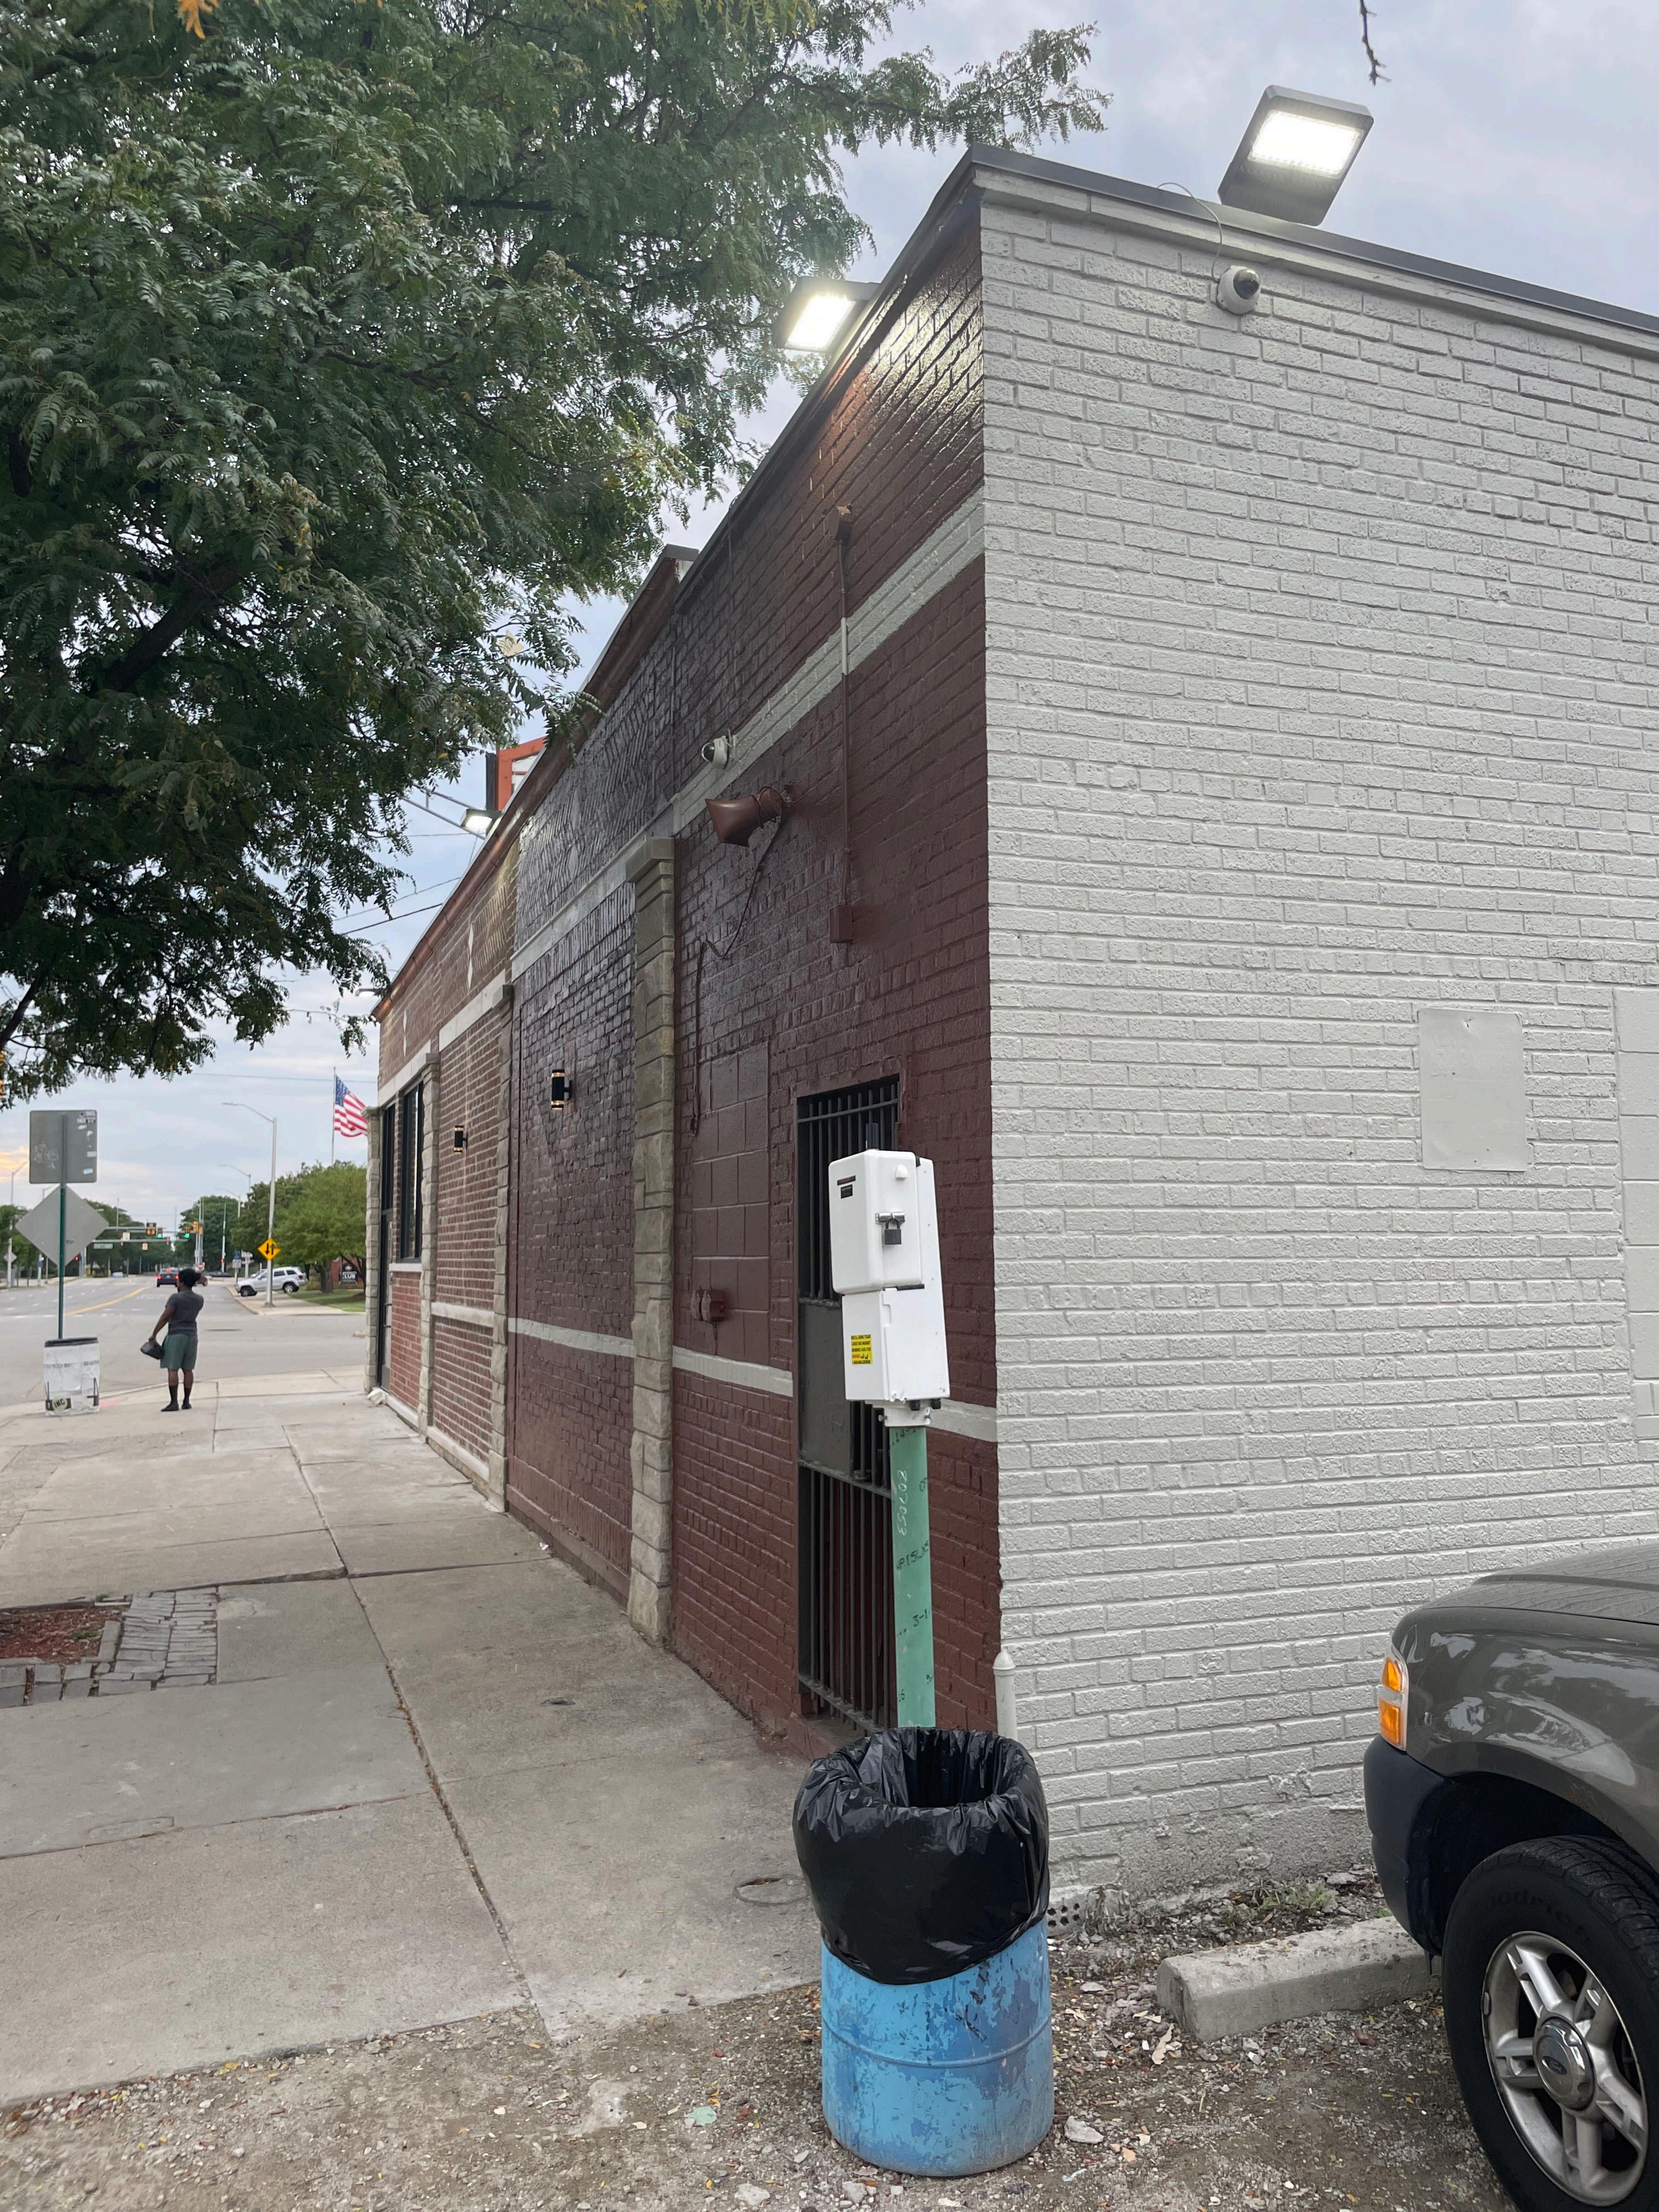
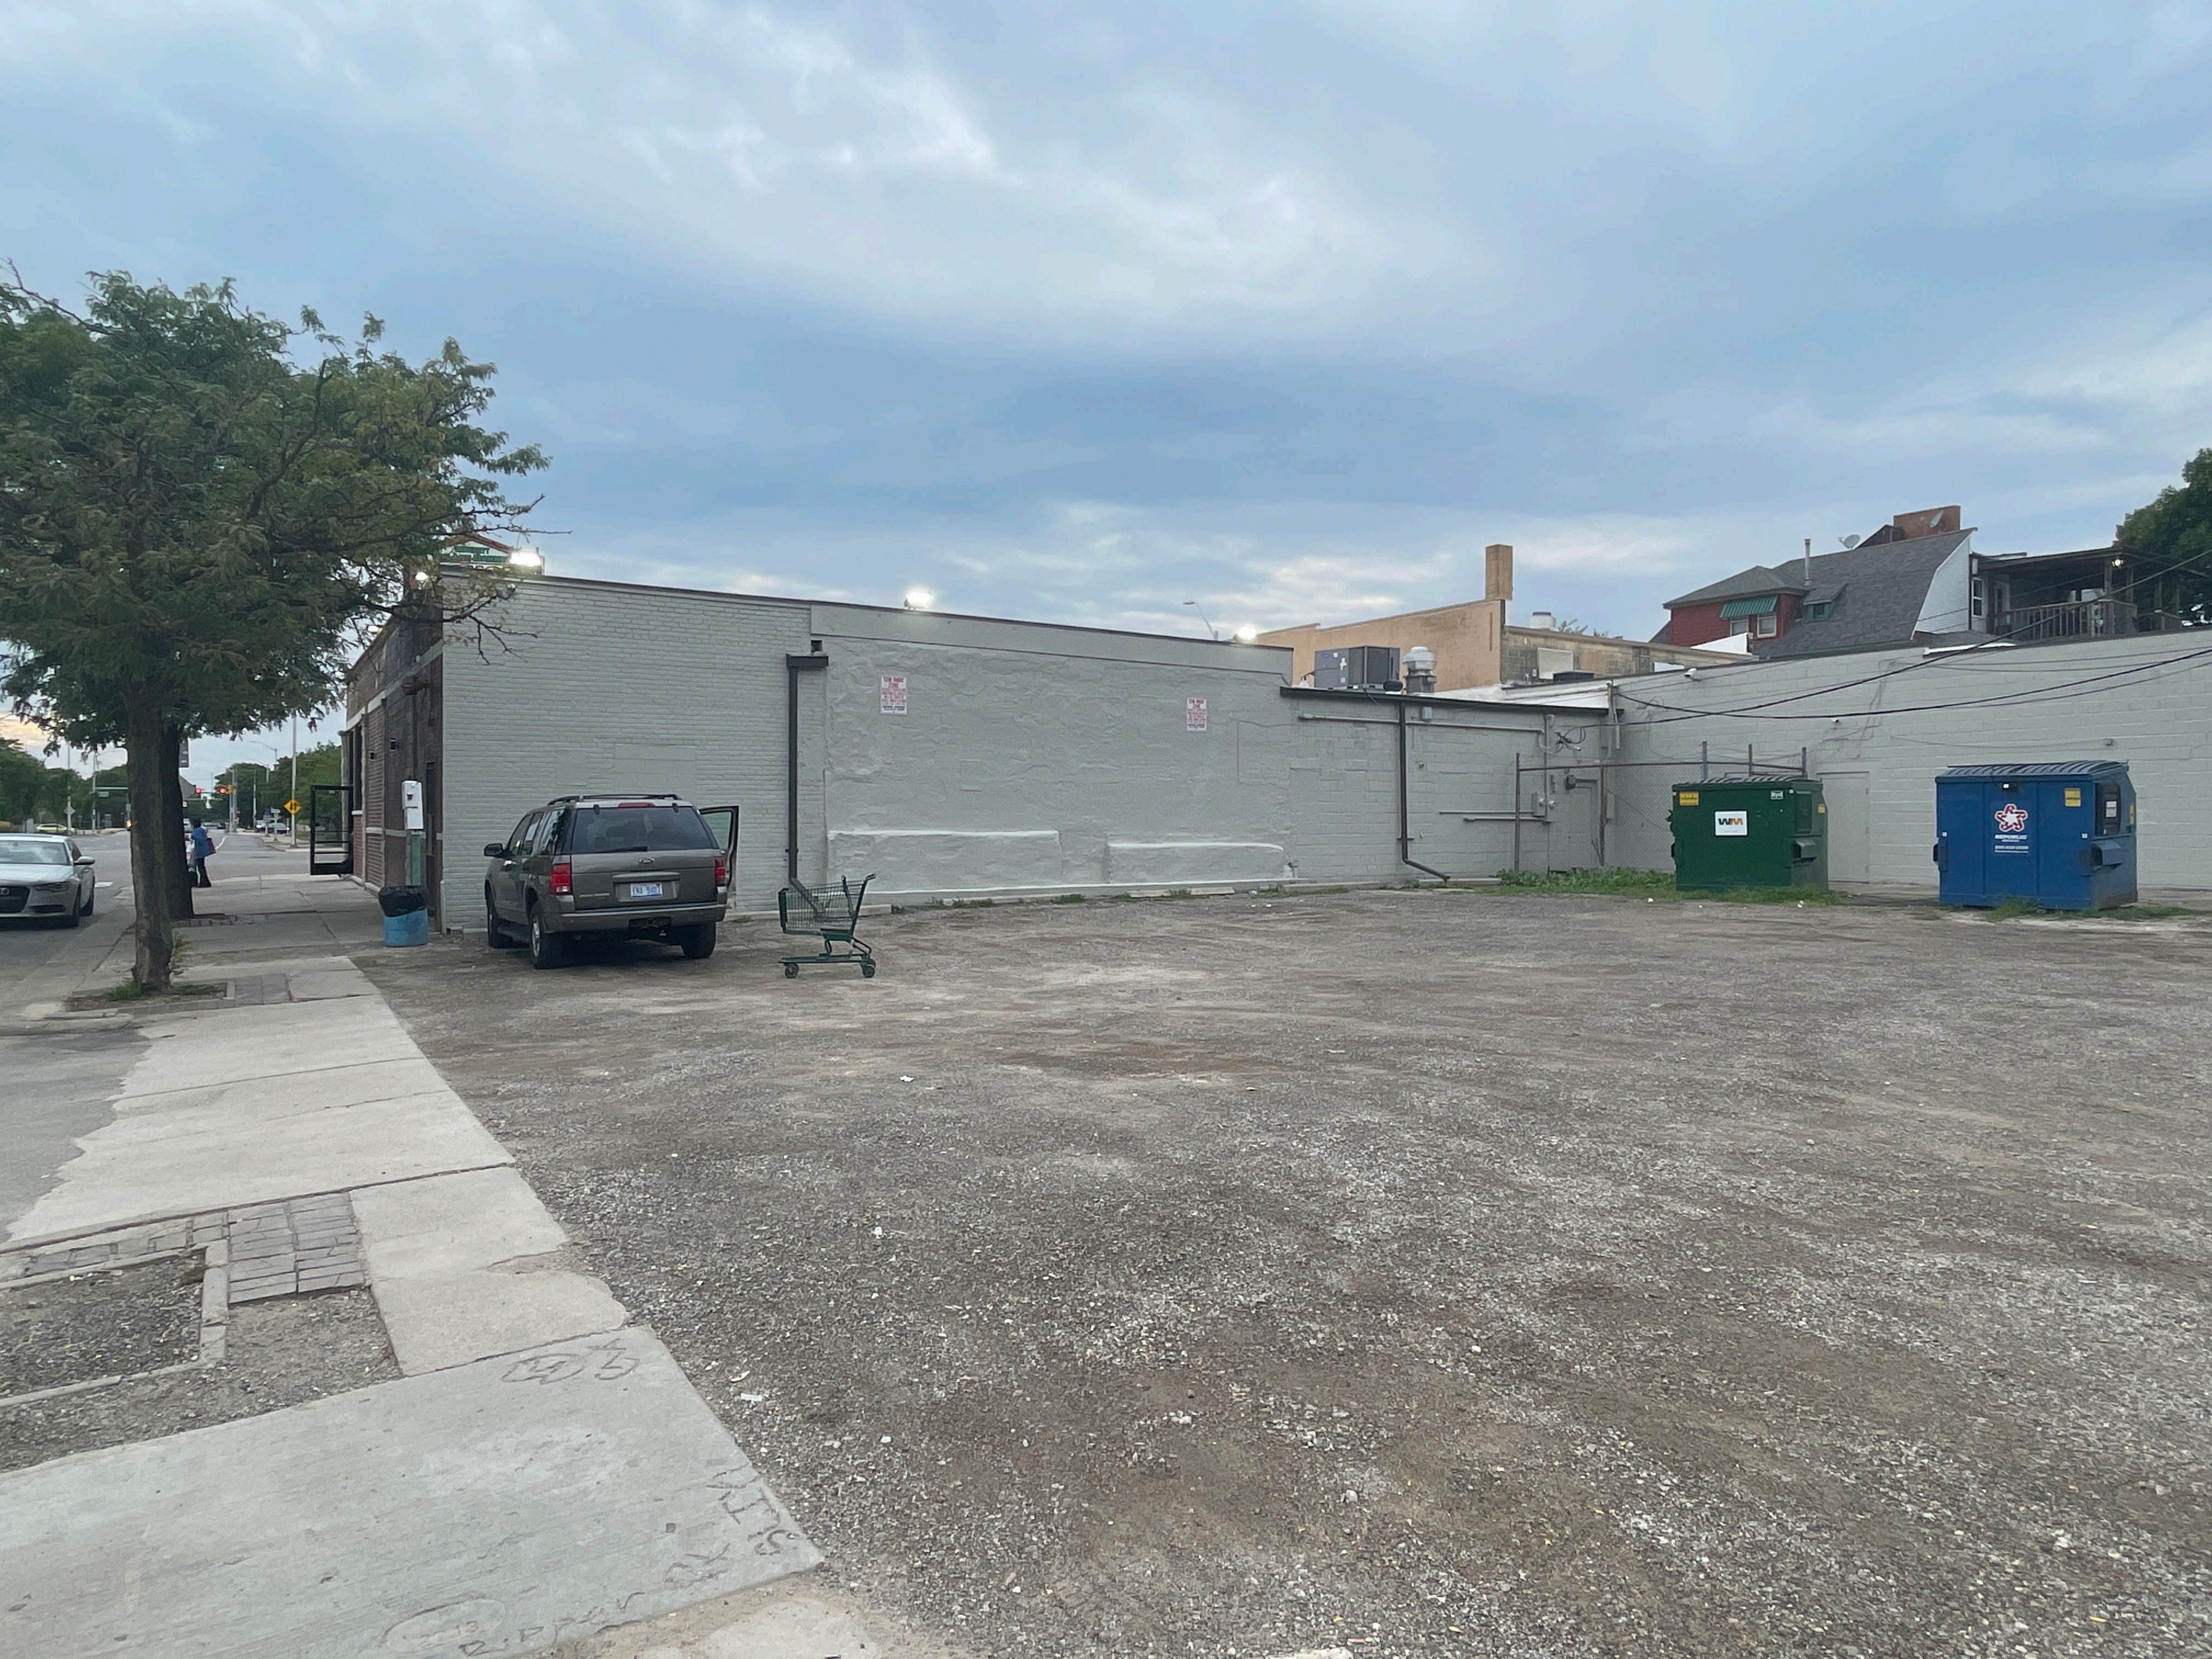
In the beginning of June 2022, we had significant storm damage, and it lifted our overhang and pulled away from the building. Pieces of the building had fallen, and we needed to remove it. There was panel brick attached to plywood that was not secure. For safety measures, we secured the sidewalk area. The pilasters on Forest side were buckled as was the brick above. Two of the walls on Forest side were face/panel brick that were crumbling, cracked, buckled, and leaning. I had rotten fascia & rotten wood siding. These photos show pilasters popping out of the wall, the TOPS of the pilasters were removed & never put back by previous mason and I have no idea what he did with them. There was an opening at the top as shown in some pics attached. The pilasters coming out of the walls were happening on third street wall as well as forest Ave. wall.

The pilasters posed a dangerous and hazardous environment as you can see from the pictures.

As the mason I hired for this job in July 2022 removed them from Third Street wall, one broke, one fell and broke, one was cracked already, and we were not able to restore them. We were not able to re-store because the materials were not available due to the Pandemic and Supply Chain Management shortage. The composition of them was limestone. In addition, the pilasters on Forest Ave, you can see was buckling, and was damaged. There were two more on the Forest side that we matched with the same material. We would have repaired to previous conditions but the material was not available nor was distribution taking place in this material industry area.

- Remove two non-historic entry doors at storefront & replace with two non-historic entry doors
- Remove three failing security shutters & replace with three security rolling shutters above door entry & window
- Remove failing Limestone pilasters along 3
 Street wall & Forest Ave wall with Limestone Indiana Split Limestone
- Remove peeling paint along Forest Ave wall & repaint reddish brown to match
- Rebuild 2 collapsed walls on Forest Ave with Brick/Limestone and Herring Bone Pattern Brick to match existing.

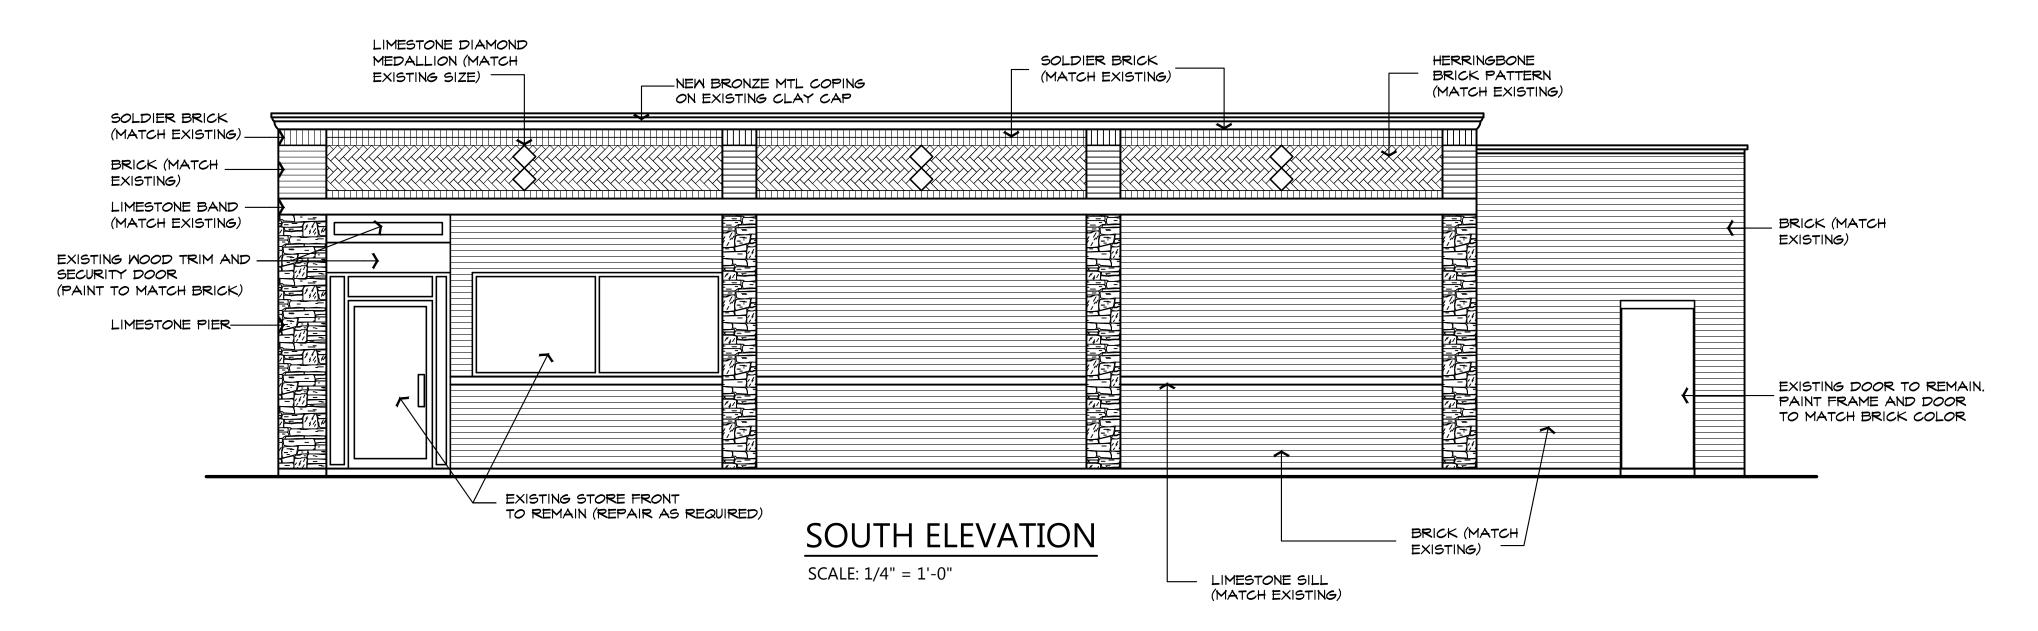
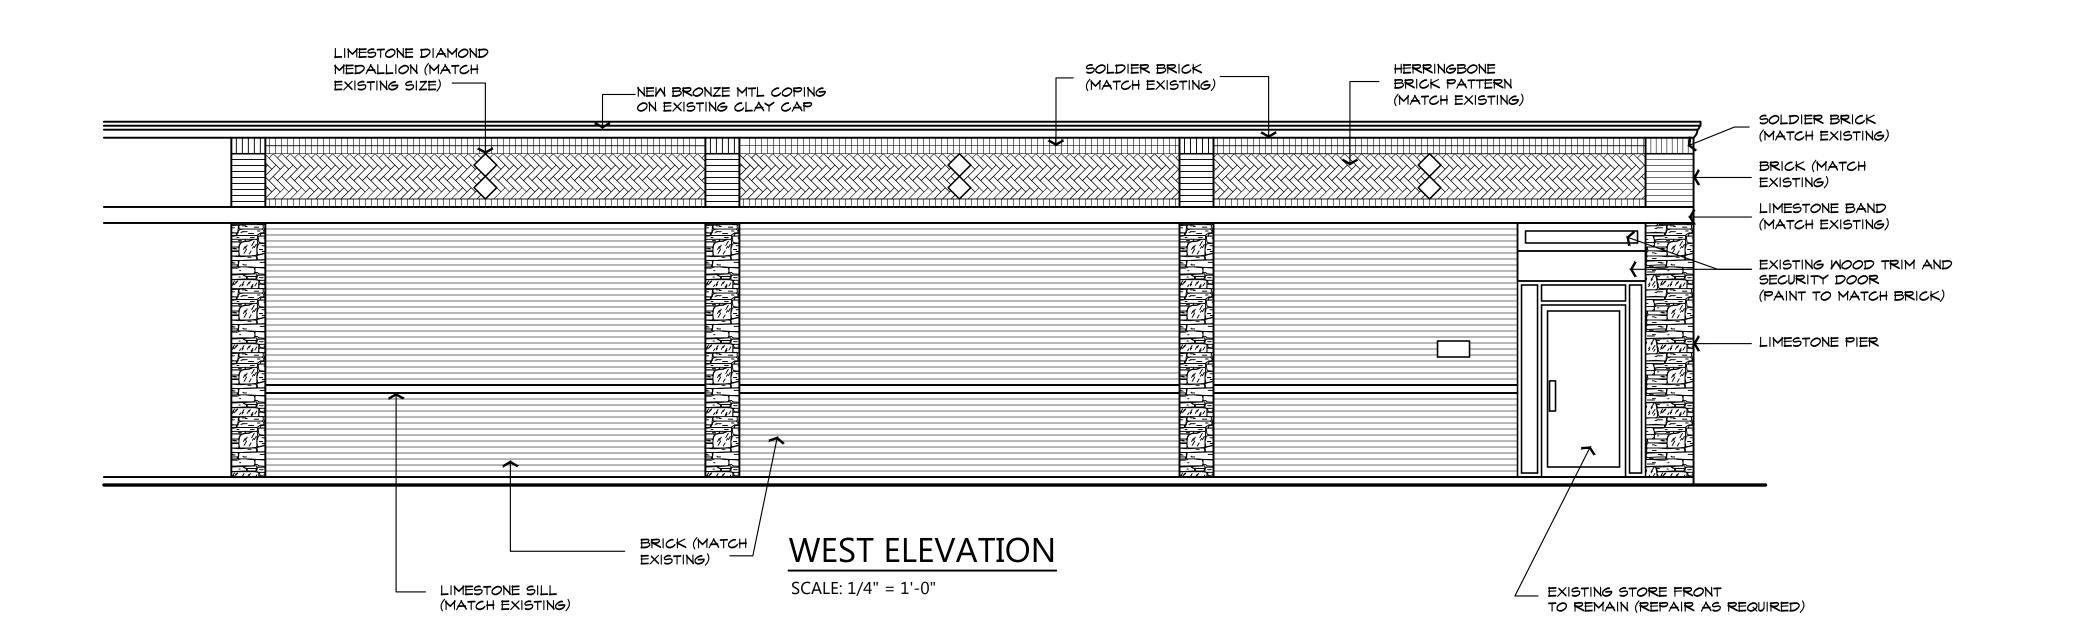
A-100

Sheet Title and Number ELEVATIONS

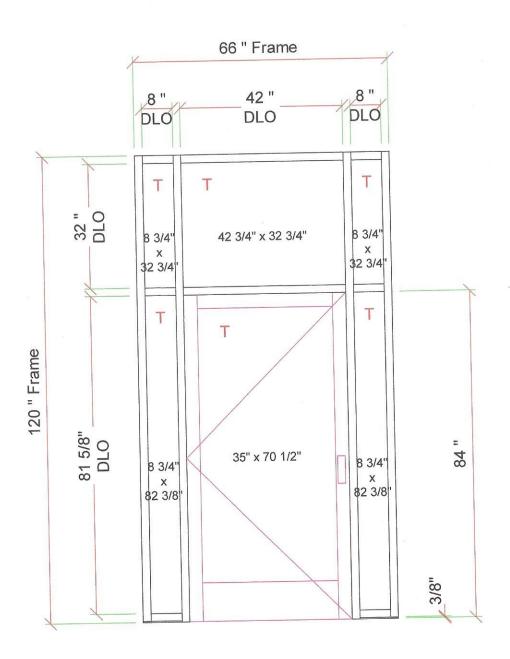
UNIVERSITY VILLAGE MARKET - SAL - 1 - 001 - EXTERIOR ENTRANCE (2 Thus)

Frame: (C2-Clear) E14000 : Storefront : 2 x 4-1/2 : Flush

Glaze: E45159 subsill

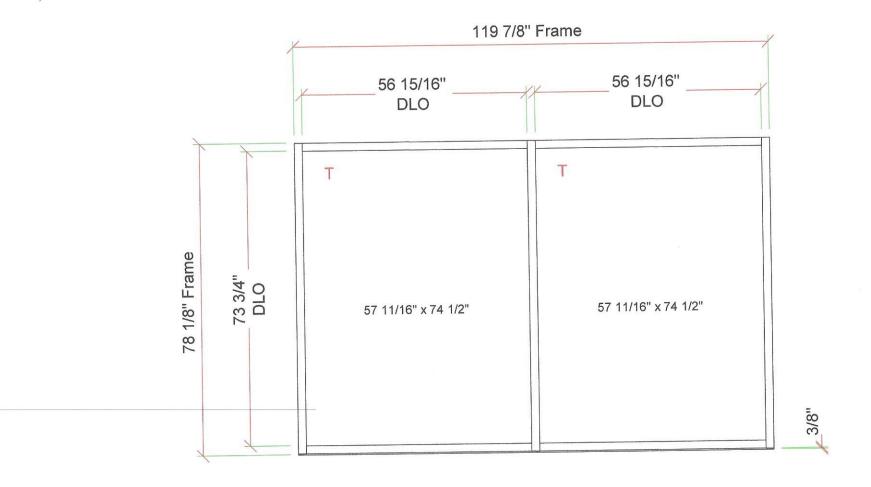
UNIVERSITY VILLAGE MARKET - SAL - 2 - 002 - EXTERIOR UPPER WINDOW (1 Thus)

Frame: (C2-Clear) E14000 : Storefront : 2 x 4-1/2 : Flush Glaze : E45159 subsill

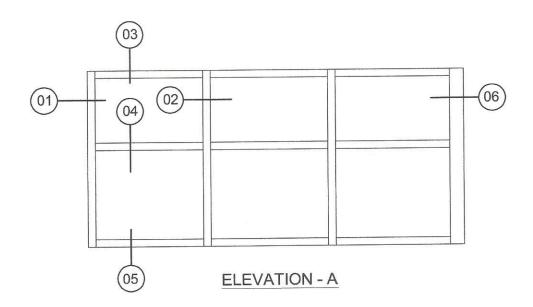
ELEVATION - B

1850 SERIES
STOREFRONT TYPICAL ELEVATIONS
(1" GLAZING)

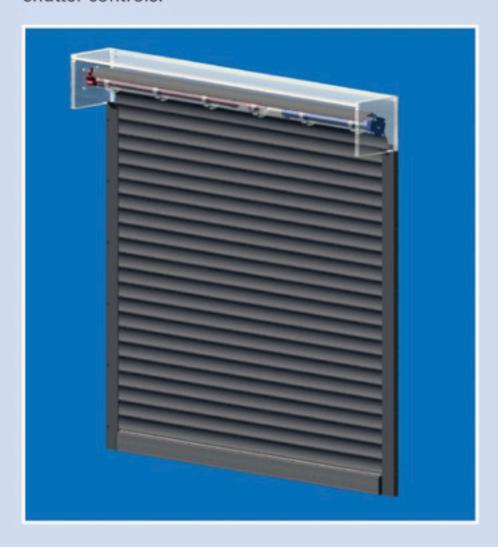
Manual Strap

A manual pull strap can be used on larger shutter sizes since the weight of the shutter is neutralized. The spring provides a counterbalance resulting in the shutter locking in the down position.

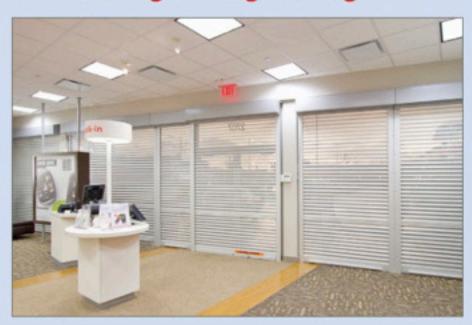
Punched slats allow protected nighttime store views, but disappear into the shutter's box housing during the day.
