**STAFF REPORT: DECEMBER 14, 2022 REGULAR MEETING**

**APPLICATION NUMBER: 22-8158**

**ADDRESS: 4205 FULLERTON**

**SCOPE: REPLACE REAR DOORS**

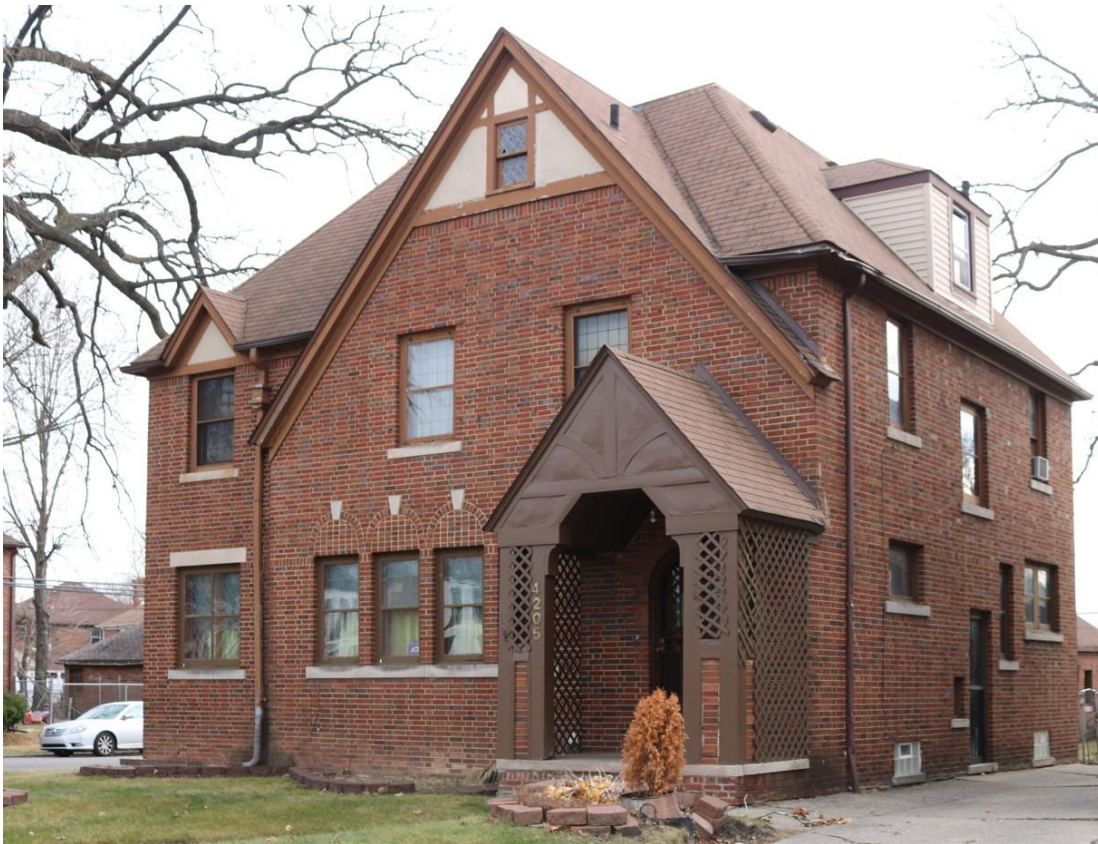
4205 Fullerton is a two-and-a-half story, brick house. It likely dates from the 1930s, though a construction date is not provided in public records. Tudor Revival or Neo-Tudor details include prominent gables, decorative timbering on the front (north) gables and projecting gable-roof front porch, brickwork in common bond with alternating Flemish courses, and leaded glass windows with horizontal and diagonal came patterns. The building is on the southwest corner of Fullerton Avenue and Petoskey Avenue with the rear (south) elevation clearly visible from Petoskey Avenue. Alterations include vinyl siding, and new windows on dormers, the apparent elimination of a door opening on the rear (south) elevation second floor, and rear (south) porch alterations as described below.

*December 2022 photo by staff.*

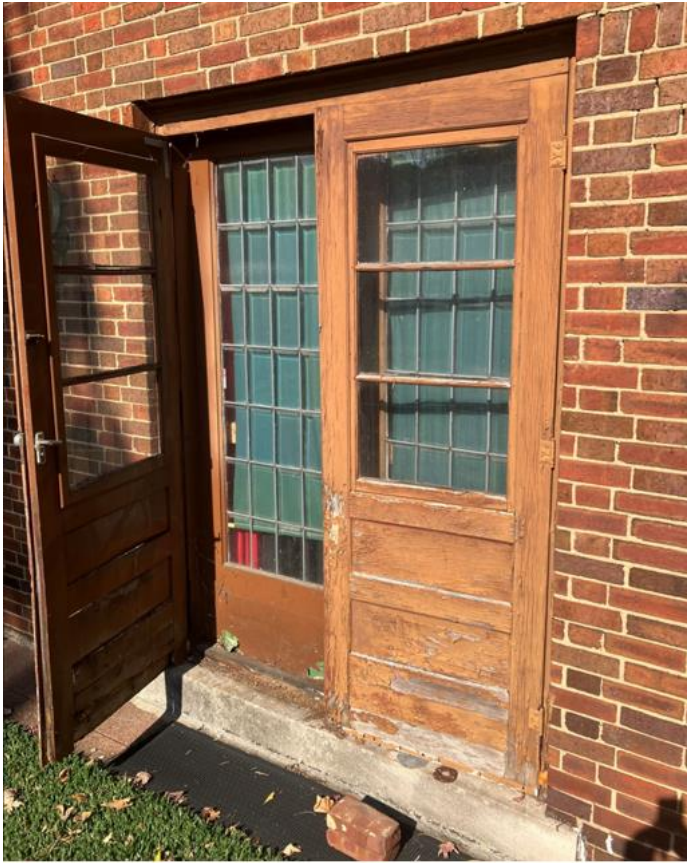
*Left: Existing conditions. Photo from application. Right: Interior view of proposed replacement. Image from application.*

The existing doors consist of an interior, wood double door, with zinc came, beveled glass (hardware is not described in the application) and an exterior, wood panel double screen door.

- From photos provided by the applicant and from a site visit, staff observes warped and rotted wood on the exterior screen doors, to the extent that they might not be feasibly repairable. There is less information regarding deterioration of the inner doors. Protected from the elements and likely built of higher quality materials, they may be feasibly repairable.

Staff recommends that the Commission issue a *Denial* of the proposed work, as the proposed work does not meet the Secretary of the Interior’s Standards for Rehabilitation, in particular:

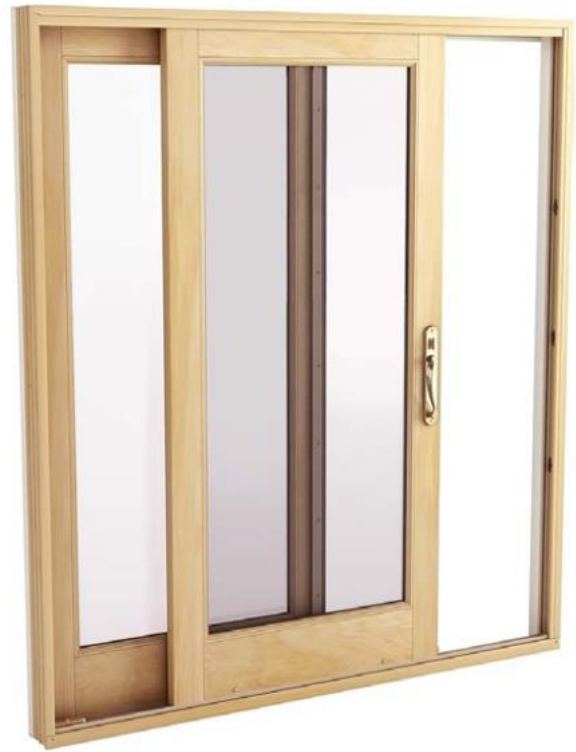
Ultimate Sliding  
French Door

The proposed new door is a Marvin Ultimate Sliding French Door, an aluminum-clad wood product. Detailed dimensions and specifications of the door are provided in the submitted application materials. The proposed door will also require aluminum coil trim on the exterior. Both door and trim are proposed to be Bahama Brown.
