STAFF REPORT: NOVEMBER 14, 2022 REGULAR MEETING

APPLICATION NUMBER: 22-8167

ADDRESS: 12142 BROADSTREET

SCOPE: INSTALL ALUMINUM-CLAD WOOD WINDOWS AND VINYL WINDOWS

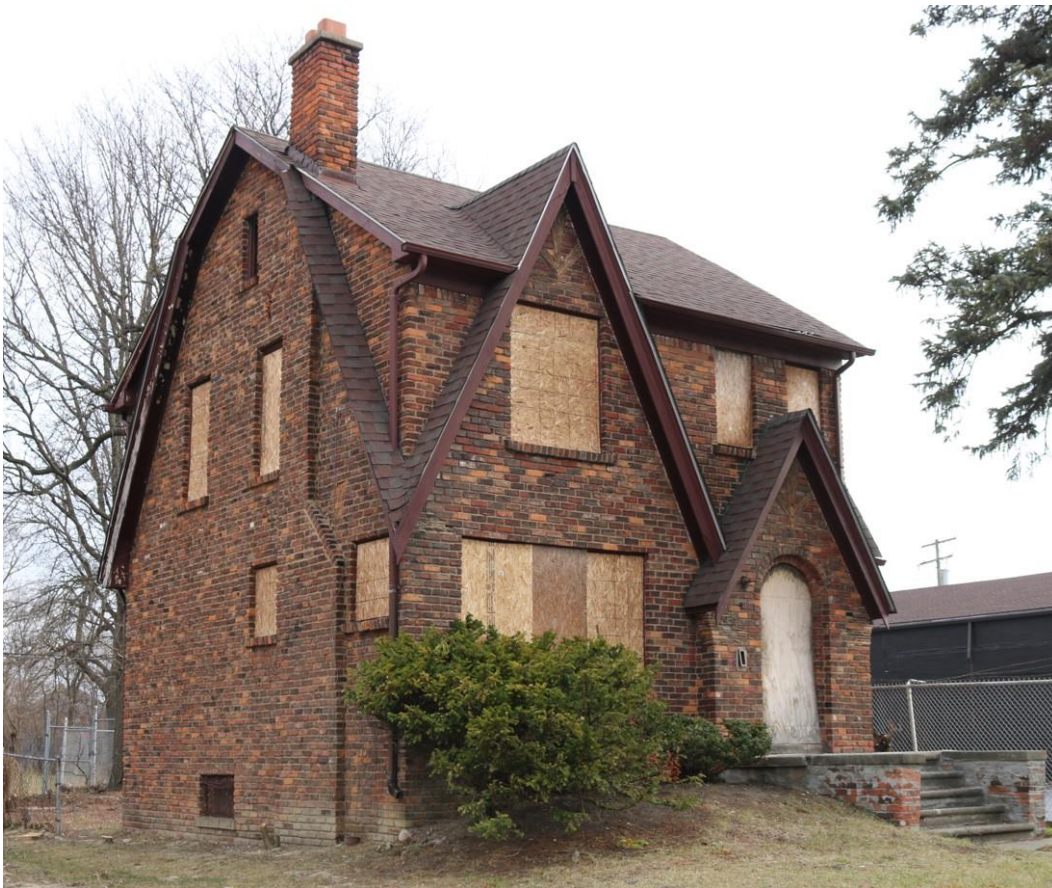
12142 Broadstreet is a two-and-a-half story, brick, Tudor Revival house built in 1927. It faces west onto Broadstreet Avenue. Defining features include prominent, sharp gables on the front façade and projecting entrance bay, a gambrel roof, decorative brickwork on the entrance bay, and a raised, landscaped berm on the front (west) side of the house. The windows, previously important features, are now missing; it is unclear if the doors remain.

December 2022 photo by staff.

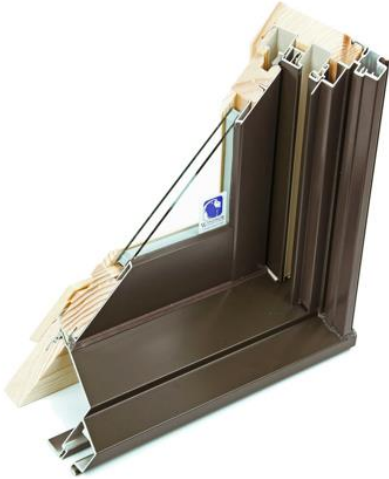
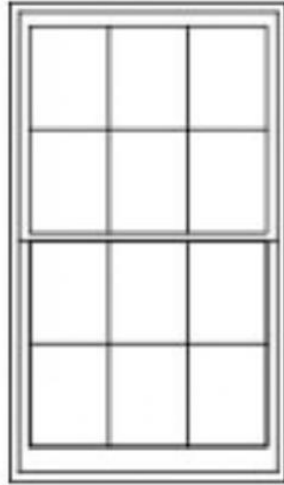
The applicant proposes to install seven (7) windows on the front (west) of the building. The proposal specifies Pinnacle double hung, aluminum-clad wood windows by Windsor Windows & Doors. They are to be six-over-one windows with a “colonial grid pattern” on the top sash. Exact dimensions are not provided; however, the application provides a link to the product website, with detailed photos. The product also has several different options for simulated muntins; the application does not specify which option is to be used.

Pinnacle aluminum-clad wood windows. Note that the application proposes six-over-one windows, not the six-over-six windows shown in the sketch. *Image:* <https://www.windsorpinnacle.com/clad/double-hung-glide-by>

- As the windows on the front façade are missing, dimensions or detailed photos are not available. However, from the images provided on the Pinnacle product website, staff suggests that the proposed windows are dimensionally appropriate (with an exception, as described under Issues, below). Of the simulated muntins shown on the product website, some are more appropriate than others.
- It is unclear from the application and from the site visit photos if the historic wood mullions between windows on the front façade remain. Standard #2 states that they should not be removed.

Staff recommends that the Commission issue a *Certificate of Appropriateness* for the remaining work items (i.e., the proposed installation of aluminum-clad wood sash windows on the front (west) façade other than the two windows above the front entrance bay), as the proposed work conforms to the district’s Elements of Design and meets the Secretary of the Interior’s Standards for Rehabilitation, subject to the following conditions:

- The choice of simulated muntins and sash color shall be subject to approval by staff.
- Historic wood mullions on the front (west) façade will be preserved or, if missing, replicated.

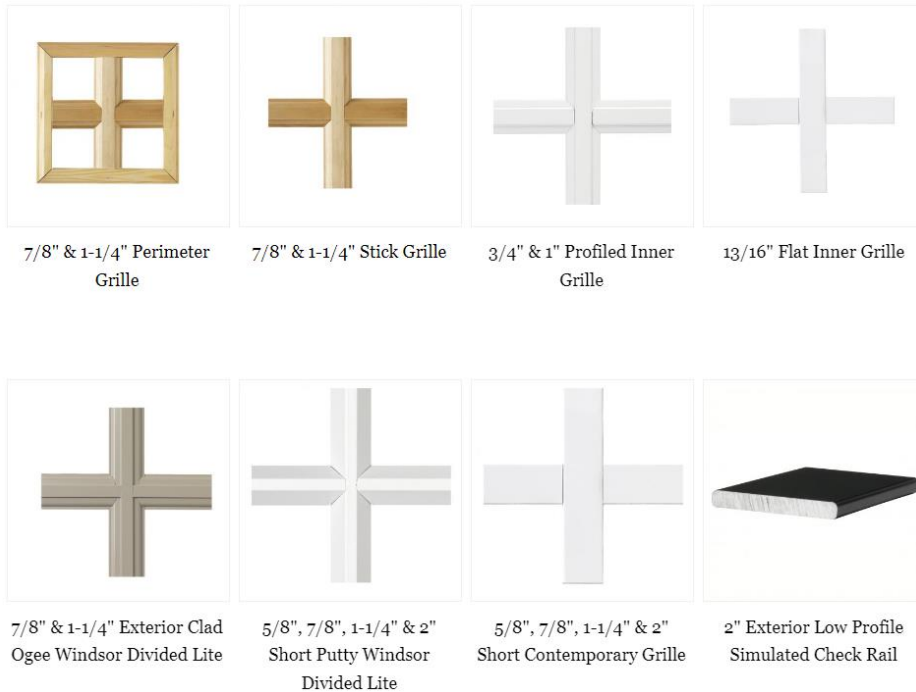
Grille and divided lite options for Pinnacle windows. *Image:* <https://www.windsorpinnacle.com/clad/double-hung-glide-by>

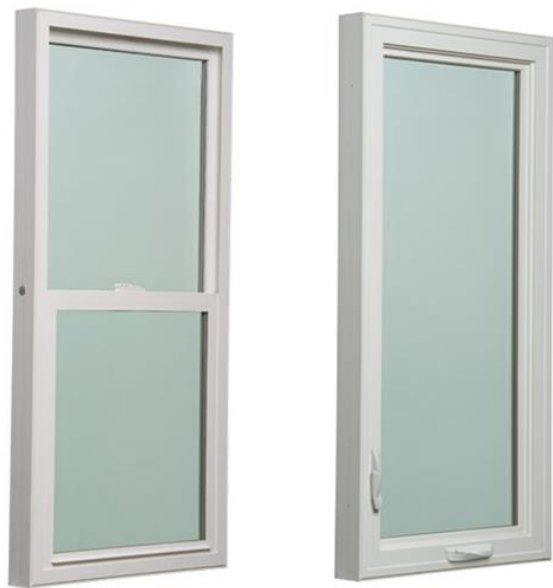
The proposed windows are Revive replacement windows by Windsor Windows & Doors. They are one-over-one sash windows; exact dimensions are not provided in the application.

Revive replacement sash and casement windows. Image: <https://www.windsorrevive.com>

- The proposed vinyl windows are not appropriate, as Standard #6 states that new features should match the “design, color, texture ... and where possible, materials” of the old. A one-over-one or six-over-one sash window of historically appropriate materials and dimensions should be used on the sides and rear.

Staff recommends that the Commission issue a *Denial* of the proposed window installation on the north, east, and south elevations, and the proposed installation of the two windows above the front entrance bay, as the proposed work does not meet the Secretary of the Interior’s Standards for Rehabilitation, in particular:

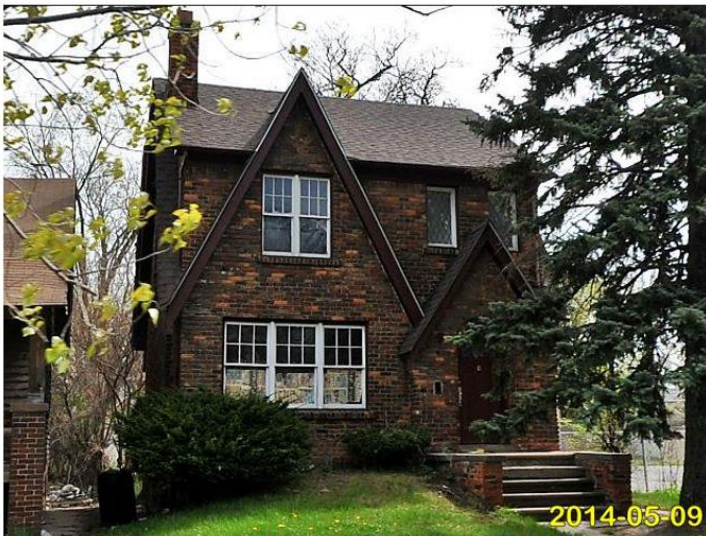
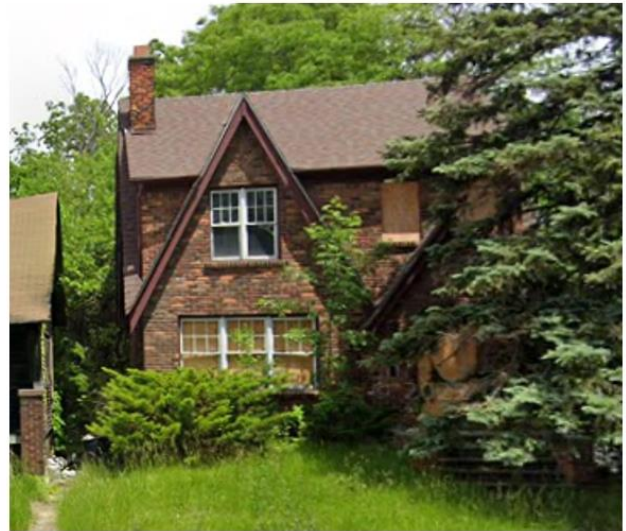
- The current owner purchased the house in 2012, according to public records. Photos from 2014 and 2019 show that the house has deteriorated noticeably during this time. Six-over-six sash windows from the north bay of the front (west) facade, and leaded glass casement windows from the south bay of the front facade, were present in 2014 but are now missing. The applicant did not state why the windows are no longer present.

Left: The subject property in 2014. Photo: city records. Right: The same property in 2019. Photo: Google Maps. All windows are currently missing.

- The leaded glass casement windows formerly on the west elevation provided “textural interest,” as described in the Elements of Design, and thus are a defining feature. Installing sash windows at this location does not provide the same “textural interest” and is therefore not appropriate.
