STAFF REPORT: 4/12/2023 MEETING

APPLICATION NUMBER: #23-8274

ADDRESS: 4152 (4156) THIRD

SCOPE: ERECT PATIO ROOF STRUCTURE

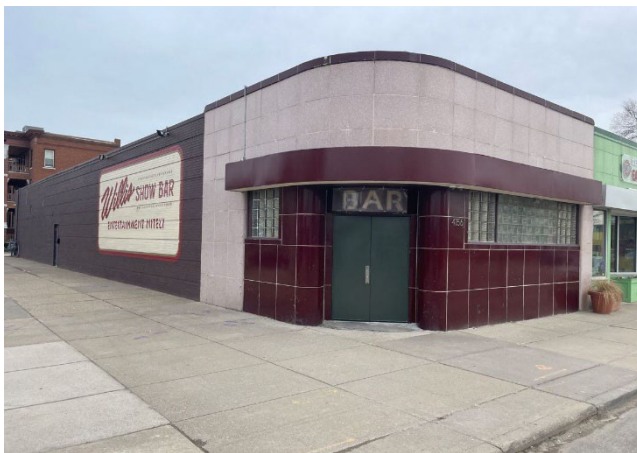
Site Photo 1, by Staff March 24, 2022: (Northwest) front elevation

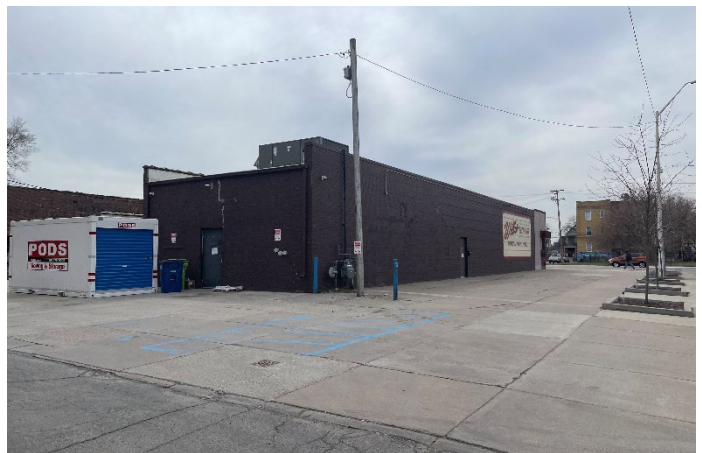
Site Photo 2, by Staff March 24, 2022: (Northeast) side elevation and adjacent lot, showing location of proposed patio roof structure.
