STAFF REPORT: 4/12/23 REGULAR MEETING

APPLICATION NUMBER: 23-8277

ADDRESS: 5021 TIREMAN (AKA THE BLUE BIRD INN)

SCOPE: DEMOLISH ADDITION, REHABILITATE ADDITION, REHABILITATE FACADE, ERECT WALL SIGN

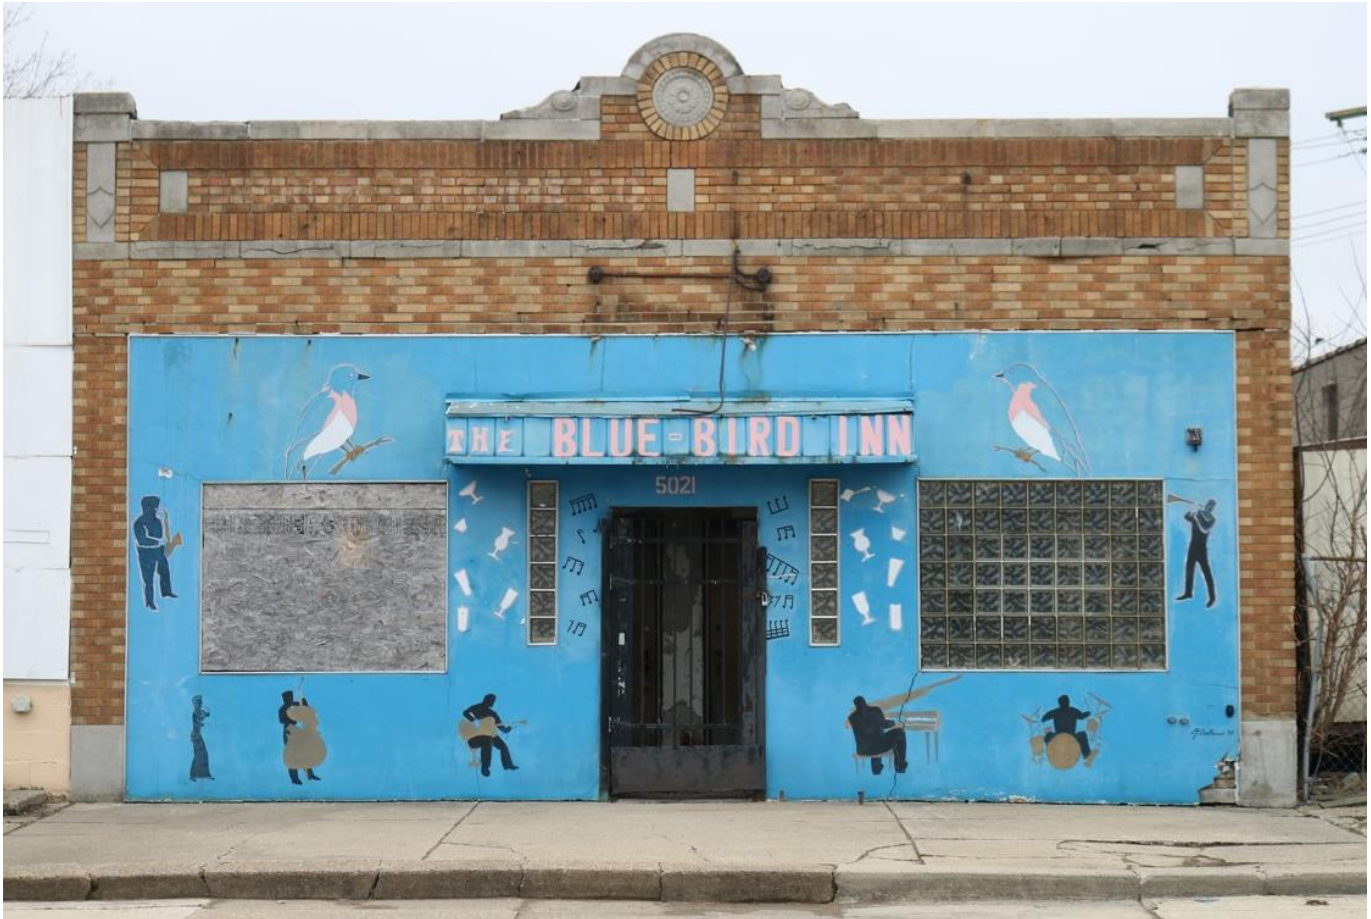
March 2023 site visit photo by staff.

The Blue Bird Inn is a small, single-story, brick commercial building facing north onto Tireman Avenue in the city's historic Old West Side area. The facade has not changed noticeably since the Historic Designation Advisory Board Final Report in 2020:

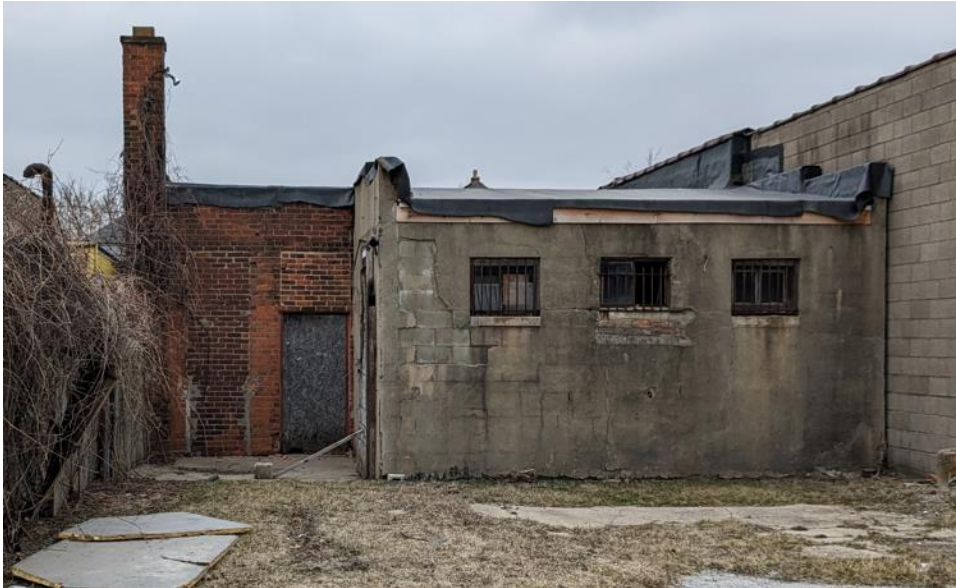
On the rear, a concrete block addition with three window openings was added in 1944.

Historic rear addition. March 2023 photo by staff.

- The current rear addition was added in 1944 and was therefore in place by the start of the Period of Significance, “reflecting the bar’s growing popularity,” according to the Final Report. Staff’s opinion is that the internal configuration of a music venue is a critically important, character-defining feature on the *interior*.¹ However, the exterior expression of the rear addition is not as significant. Based in the Historic District Commission’s review authority for exterior work only,² staff has no objection to the demolition of the historic addition and the construction of the new addition. The change in height from the core mass to the proposed addition, along with the proposed cladding of the addition in face brick, will render it “clearly differentiated” (Standard #9). Further, the Standards are to be applied “taking into consideration the economic and technical feasibility of each project.”³ The proposed addition facilitates the proposed rehabilitation of the building by making possible its adaptive use as a music archive and meeting space.

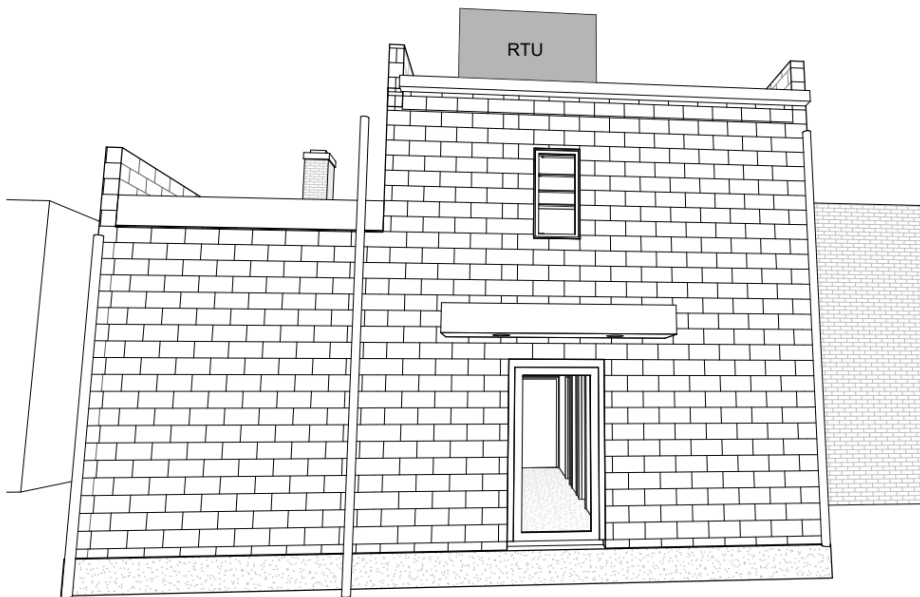
The application proposes to demolish the rear addition and construct a new, much larger addition that will accommodate the building’s new use as a meeting space and music archive. The addition would be of concrete block, clad in brick veneer, and will be, in part, approximately 7 feet taller than the historic portion of the building. It would include rooftop HVAC equipment, a loading area, and a window.

Proposed new addition. Image from application.

- The placement of the proposed HVAC equipment at the highest point of the building is a potential concern, as it may be visible from some vantage points. However, the application states that this is a deliberate choice due to interior acoustic considerations. The application also states that the equipment will not be visible from Tireman Avenue.

- The choice of brick for the rear addition is not specified. Standard #9 requires that the addition be “clearly differentiated” from the historic building.

- The removal of any bricks or masonry elements beyond those specified on sheet A20 of the application materials shall be subject to approval by staff.
- The brick veneer to be used on the addition shall be subject to approval by staff.
- Stucco veneer and mural rehabilitation shall be limited to filling existing cracks and voids and repainting with the existing color or colors. Existing material shall not be removed and the painted figures must not be disturbed.
- The final design of the proposed LED “neon” sign, including its color and the locations of its anchors, electrical penetrations, and other supporting elements, shall be subject to approval by staff.
- A full scope of work, subject to approval by staff, shall be provided before any work on the canopy is performed.

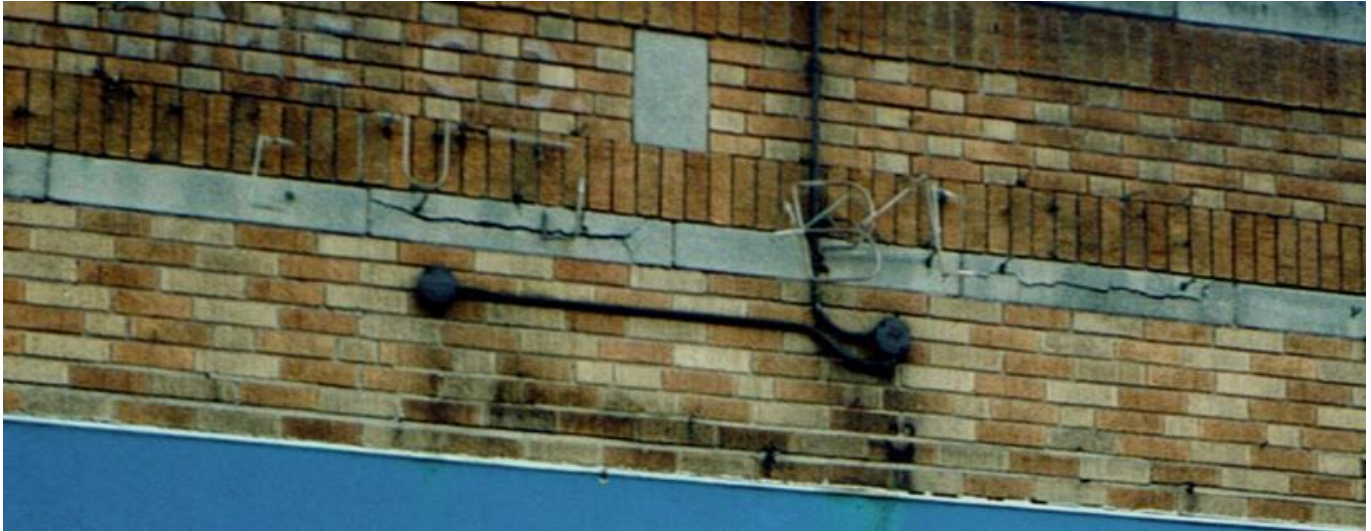
The application proposes to install “neon” LED lettering closely matching a historic sign that is now missing.

Historic neon sign circa 1995. Image provided by the applicant.

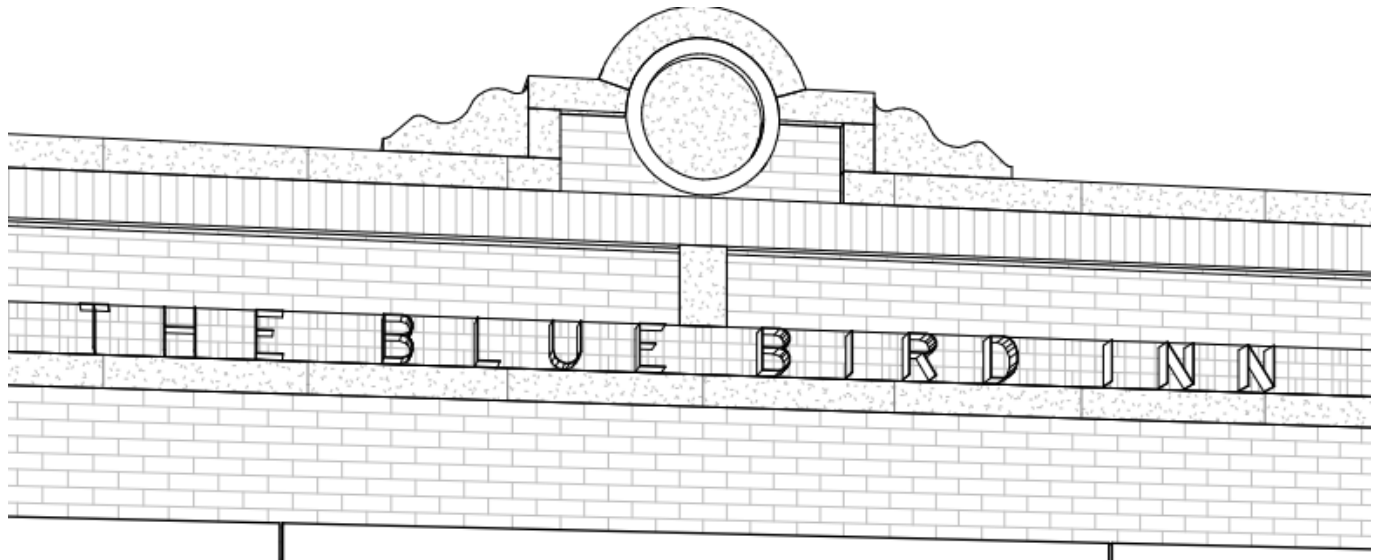
Proposed new “neon” LED sign. Image from application.

- The proposed LED sign is appropriate in that it closely replicates a lost historic feature based on photographic evidence.

- The application does not include a plan or section of the proposed LED sign.
- The application does not include a detailed scope of work for the canopy rehabilitation.

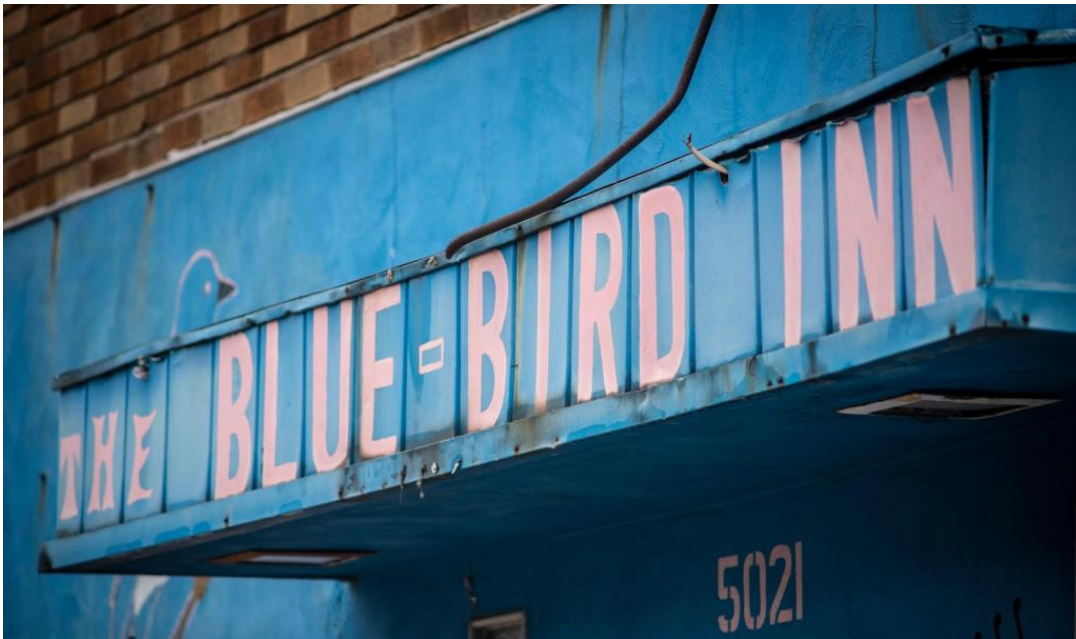
The application proposes to inspect, repair, and rehabilitate the existing entrance canopy.

Entrance canopy. Image from application.

- Particular care must be taken regarding any work performed on the entrance canopy, as it is a highly visible and character-defining component of the façade. As discussed in the Final Report, its presence expresses the history of the building and reflects its 1944 transition from a commercial building into a jazz club. Further, it is composed of materials that are likely to be difficult or impossible to replace if damaged. Any inspection of the canopy should be as noninvasive as possible and any rehabilitation work should make every effort to retain existing materials. Any change to the materials or appearance of the canopy would constitute a “removal of distinctive materials or alteration of features ... [to] be avoided” (Standard #2).

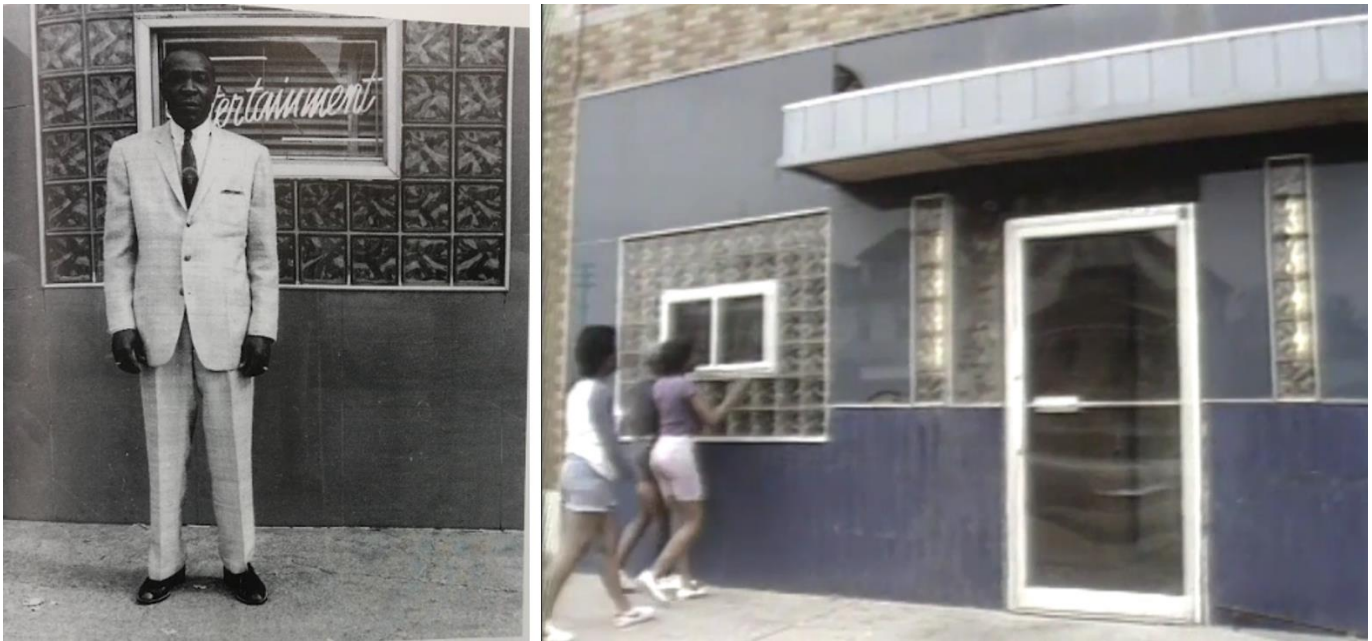
- Some elements of the front façade date from 1948. According to the Final Report (citing Bjorn and Gallert, *Before Motown: A History of Jazz in Detroit*, 2001) a “distinctive exterior—a pure blue façade accented with a New York City-style awning that ran across the sidewalk and right up to the curb” was added.

Undated photographs, provided by the applicant. The left image dates from the 1950s (during the Period of Significance) and the right image appears to be from after the Period of Significance but shows the historic finish from prior to the stucco and mural installation.

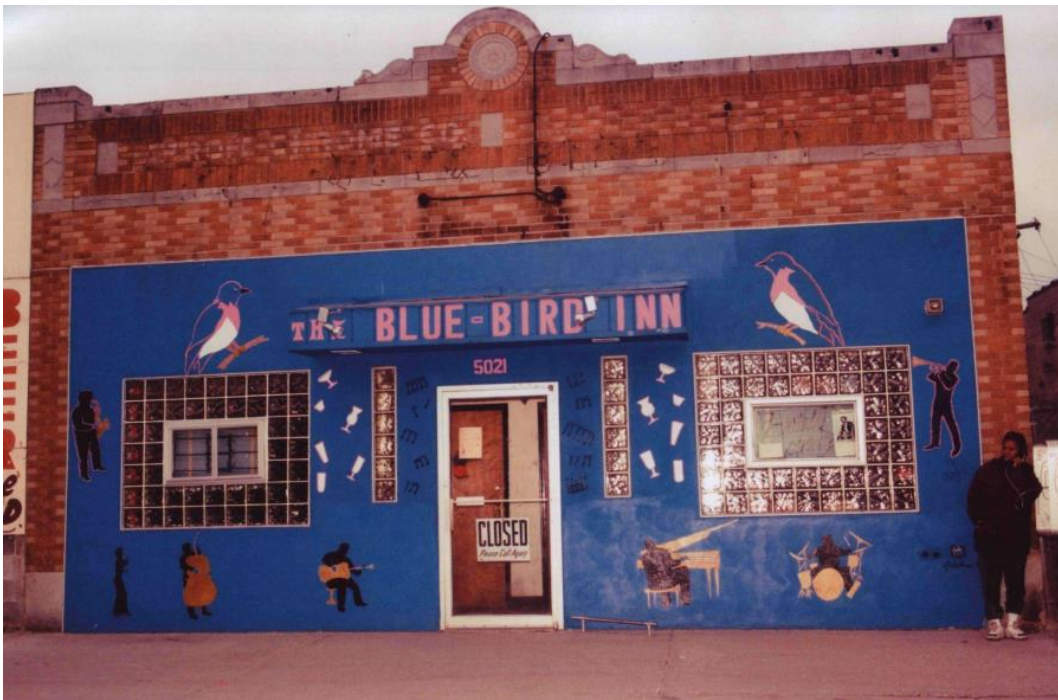
- Photographs provided by the applicant show that the current, blue-painted stucco veneer was added more recently. This is consistent with staff observation that the stucco veneer appears to be relatively new, appears to have only a single coat of blue paint, and stands approximately one inch proud of the historic surface. The mural itself is signed by the artist and dated 1994. It is possible that elements of the older façade exist beneath the newer façade.

Circa 1995 photograph provided by the applicant showing newer stucco façade.
