**STAFF REPORT: 2/8/2023 MEETING**

**APPLICATION NUMBER: 2023-8286**

**ADDRESS: 450 AMSTERDAM**

**SCOPE OF WORK: ESTABLISH LANDSCAPING/HARDSCAPING, CHANGE TO PREVIOUSLY APPROVED WINDOWS**

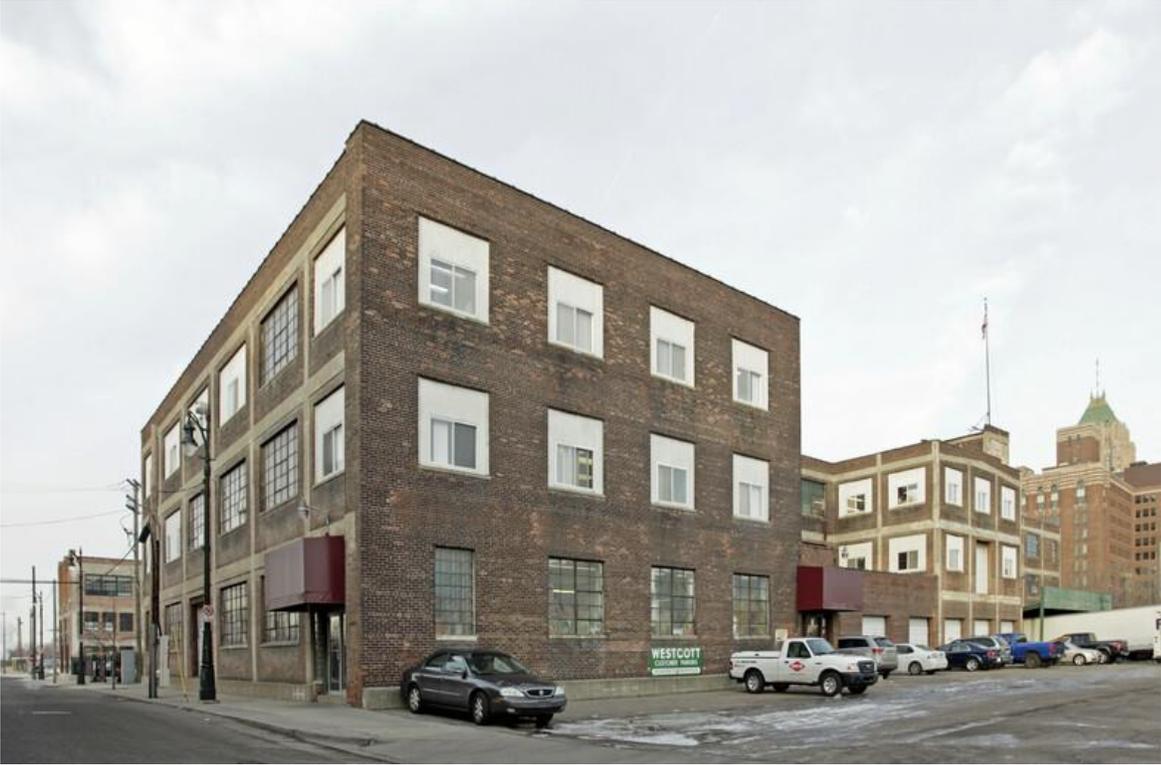
450 Amsterdam, current condition

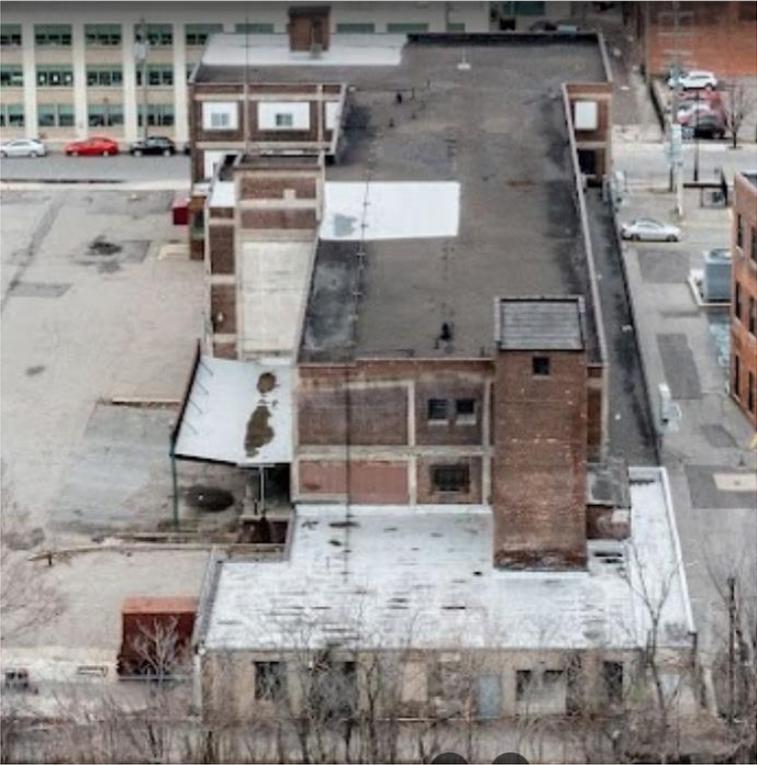
**Google aerial facing south showing rear one-story addition, 2022**

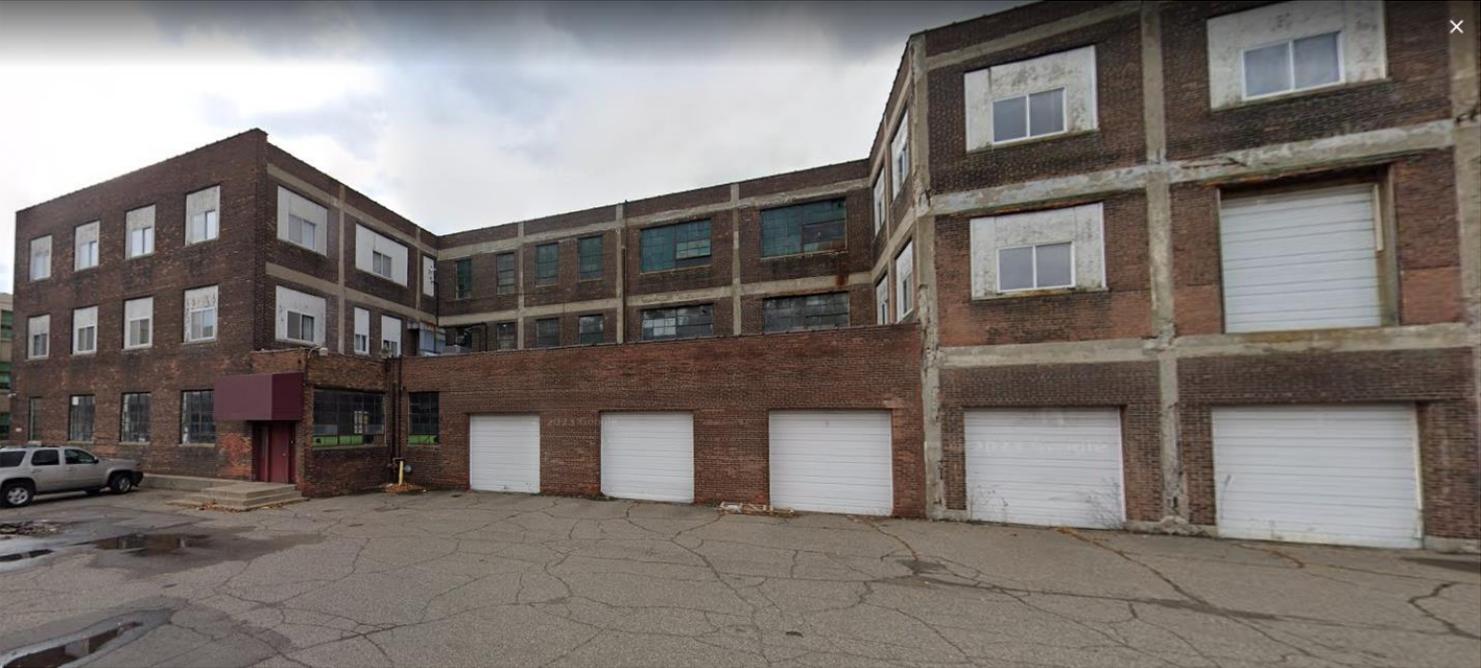
**Google Streetview, facing southwest showing east elevation, one-story addition. The Commission approved its removal at the February 2023 meeting. A new fenced patio will be installed at this location.**

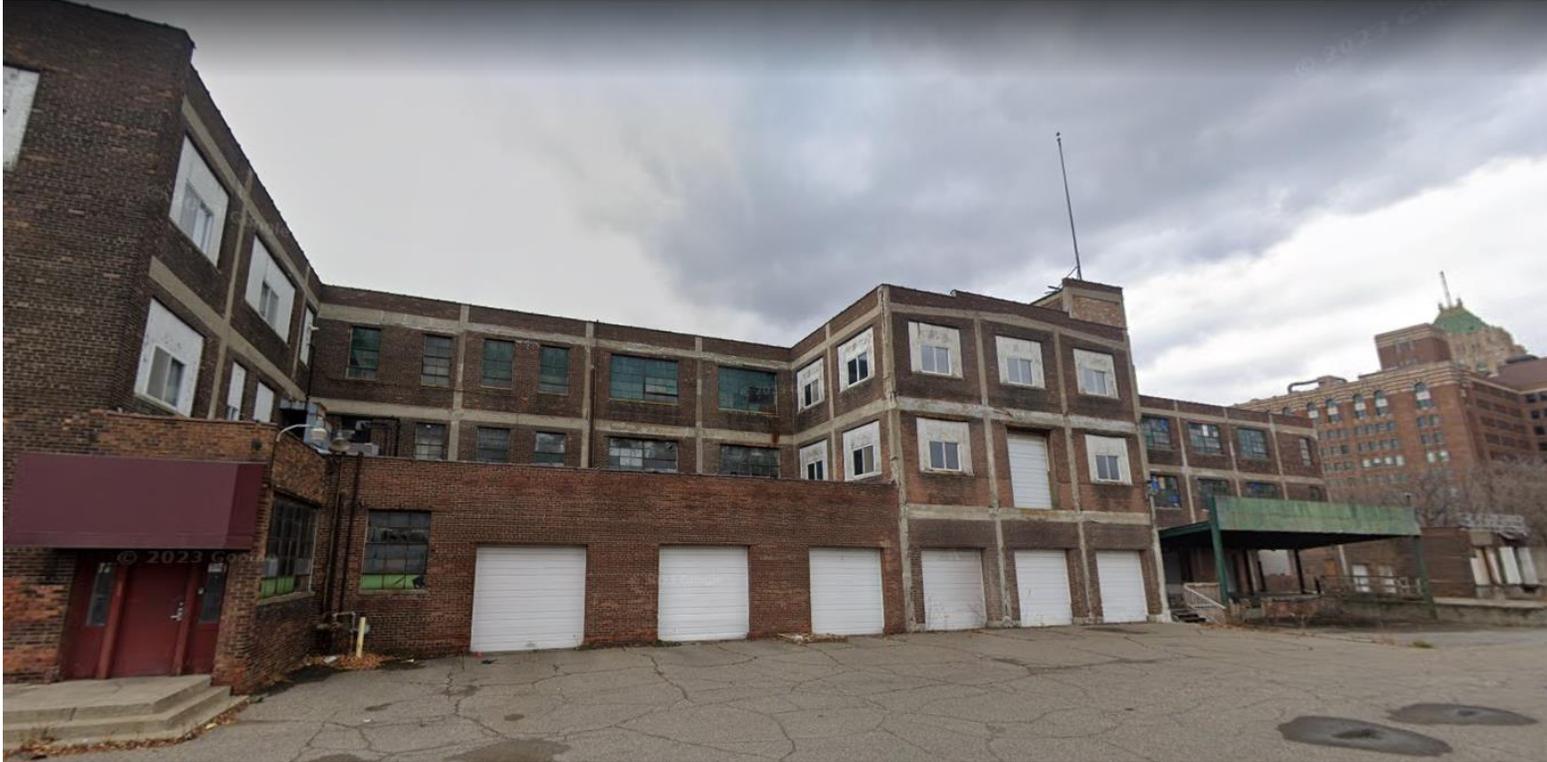
**Google Streetview, facing northwest showing east elevation, one-story addition and loading dock canopy. The Commission approved the removal of the addition and canopy at the February 2023 meeting.**

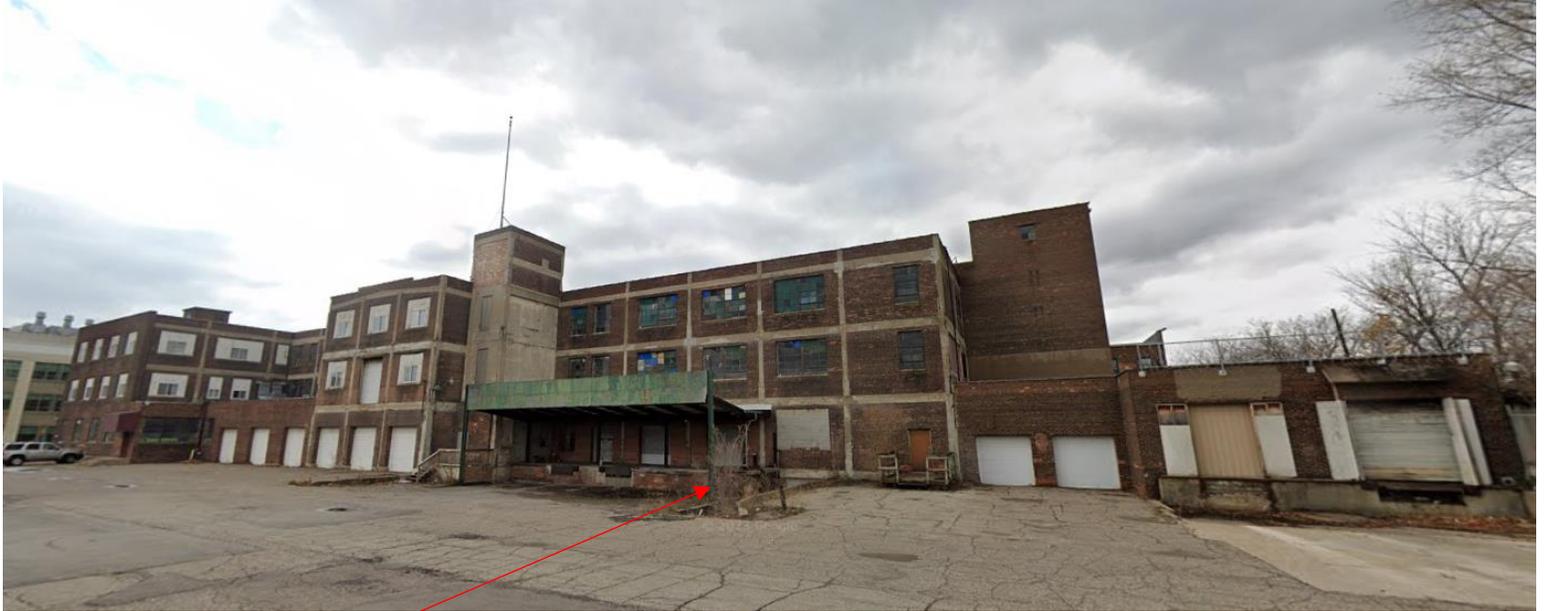
Google Streetview, facing southwest showing east elevation, showing the dock canopy. The Commission approved the canopy's removal at the February 2023 meeting. Per the applicant, the existing will be restored and a concrete ADA ramp will be added in this location.
