STAFF REPORT: MAY 10, 2023 REGULAR MEETING
APPLICATION NUMBER: 23-8332
ADDRESS: 4132 BAGLEY
HISTORIC DISTRICT: HUBBARD FARMS
APPLICANT: MICHAEL REYES
PROPERTY OWNER: MICHAEL REYES
DATE OF PROVISIONALLY COMPLETE APPLICATION: MARCH 27, 2023
DATE OF STAFF SITE VISIT: APRIL 24, 2023

SCOPE: ERECT FENCE, INSTALL DECK AND OUTDOOR SEATING

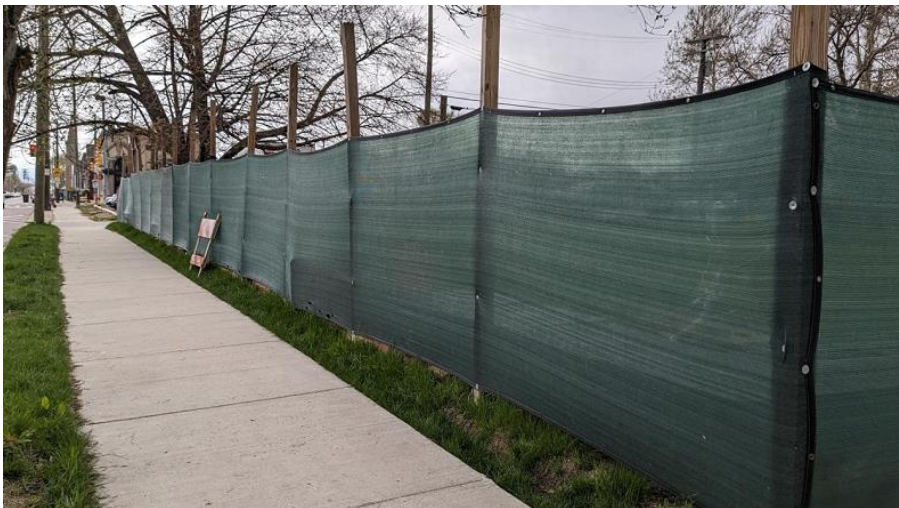
4132 Bagley is a vacant corner lot currently enclosed by a green fabric windscreen on 4” treated wood posts. Formerly known as 1702–1716 Scotten, the lot once contained a four-unit, two-story townhouse building, a two-story house, and a garage.

Temporary fabric fence, April 2023 photo by staff.

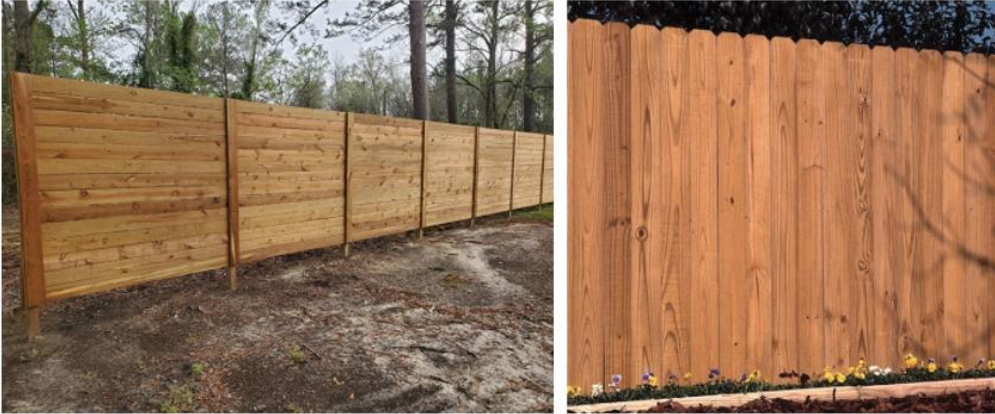
Two optional configurations are proposed for the fence. Option One is a horizontal board fence. Option Two is vertical dog ear board fence. The proposed stain color is red mahogany,

Left: Option One. Right: Option Two. Images from application.

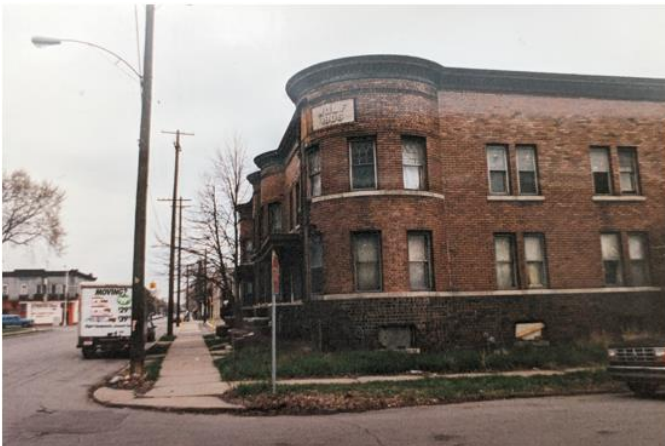
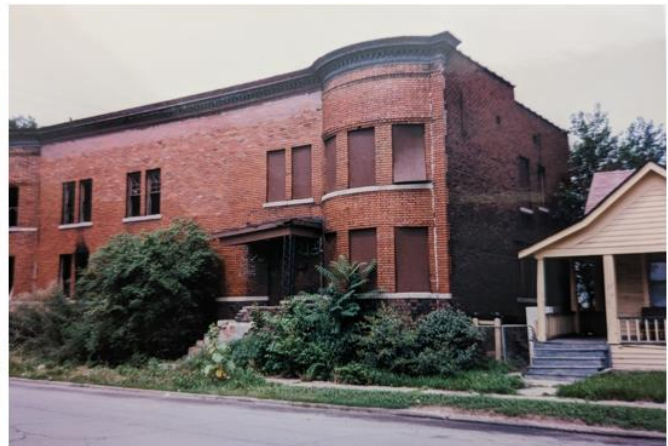
- Historic District Commission records contain no information regarding the former house and garage oriented towards Bagley other than several undated photographs showing the Wolf and house.

Undated Historic District Commission photographs.

- The Wolf was demolished after a fire in 1995 and the house was demolished some time thereafter (it is not known when the garage was demolished).
- In 2001 the Historic District Commission issued a Certificate of Appropriateness for a house to be built on the property, oriented towards Bagley, but the house was never built and the property later came under City of Detroit ownership. In 2004 the City Planning Commission recommended the sale of the property for use as a parking lot, arguing that it was “the best use of the land,” though another proposal for infill housing was also submitted. The Historic District Commission, exercising its Sec. 21-2-7 role, noted that the proposed parking lot would have an “adverse effect” on the district due to the design of the parking lot. The Commission argued that a parking lot with screening walls and landscaping would be more appropriate than the unscreened parking lot that had been proposed. The Commission also noted that they have “heard from several parties in the neighborhood that the site would be better designed for infill housing.”

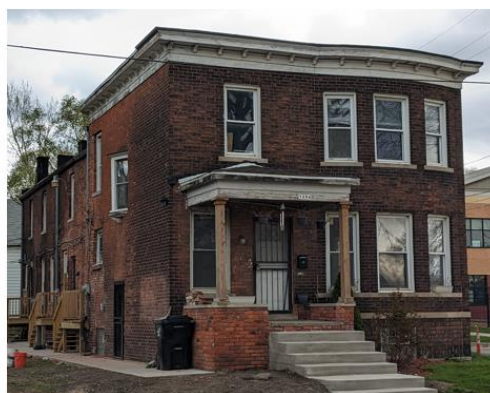
- Staff observes that all buildings surrounding Clark Park are oriented towards Clark Park and generally have shallow setbacks, creating the effect of a wall of continuity. The only notable exceptions, during the Period of Significance and at the time the historic district was enacted in 1993, were the large-scale institutional buildings of Western High School and Amelia Earhart Intermediate School. The wall of continuity, together with the large school buildings, surrounded and enclosed Clark Park and continues to be an important feature that defines the public space of the park. The former Wolf apartment building contributed to this sense of continuity.

Example buildings on Scotten with shallow setbacks facing Clark Park. Left image: Google Street View. Right image: Staff.
