STAFF REPORT: SEPTEMBER 13, 2023 REGULAR MEETING

APPLICATION NUMBER: 23-8525

ADDRESS: 12632 (12638) DEXTER

SCOPE: INSTALL STONE AND STUCCO VENEER

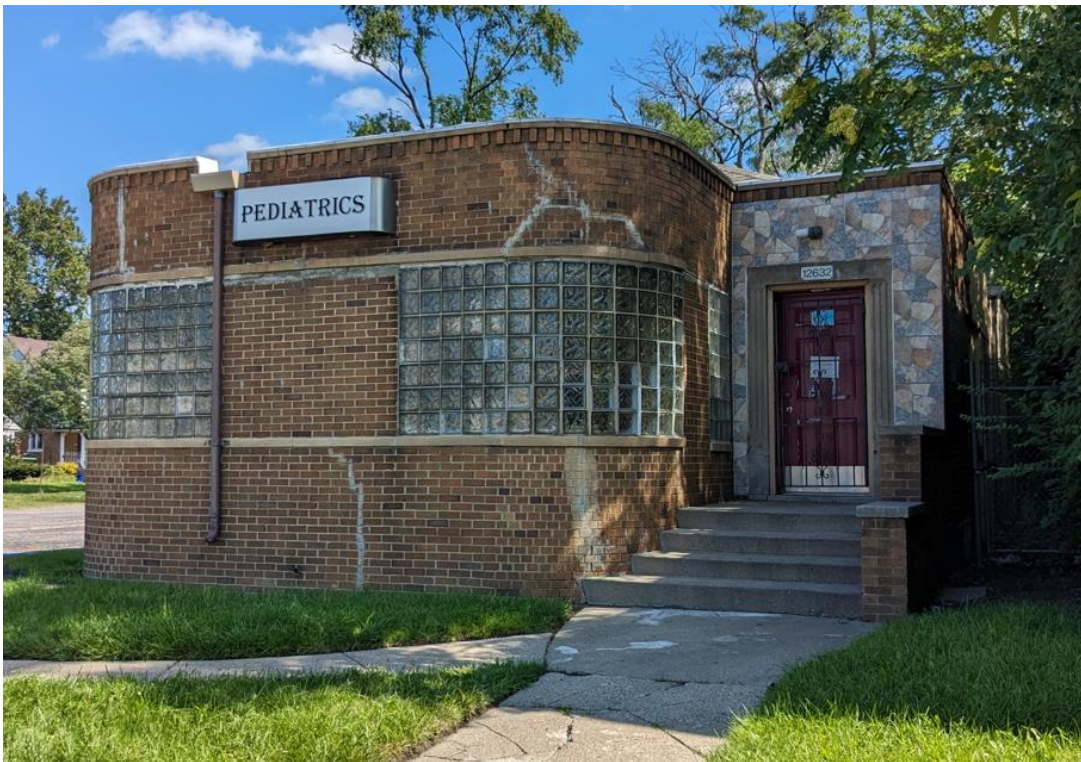
This property is a single-story, Art Moderne or Streamline Moderne professional office building, built in 1946, facing west onto Dexter Avenue. The curved, brick façade, glass block windows, stone sills and lintels, stone coping, fluted stone door surround, and dentil cornice are important, character-defining features of this minimalist architectural style. Portions of the side (north and south) elevations and the entire rear (east) elevation are constructed of concrete block, also a historic feature. Non-historic components include square tiles surrounding the front (west) entrance, red-painted steel doors on the front (west) façade and side (north-facing, towards the present-day parking lot) elevation, and a stainless-steel identification sign on the front (west) of the building. The latter is likely a newer sign in its historic location.

August 2023 photo by staff.

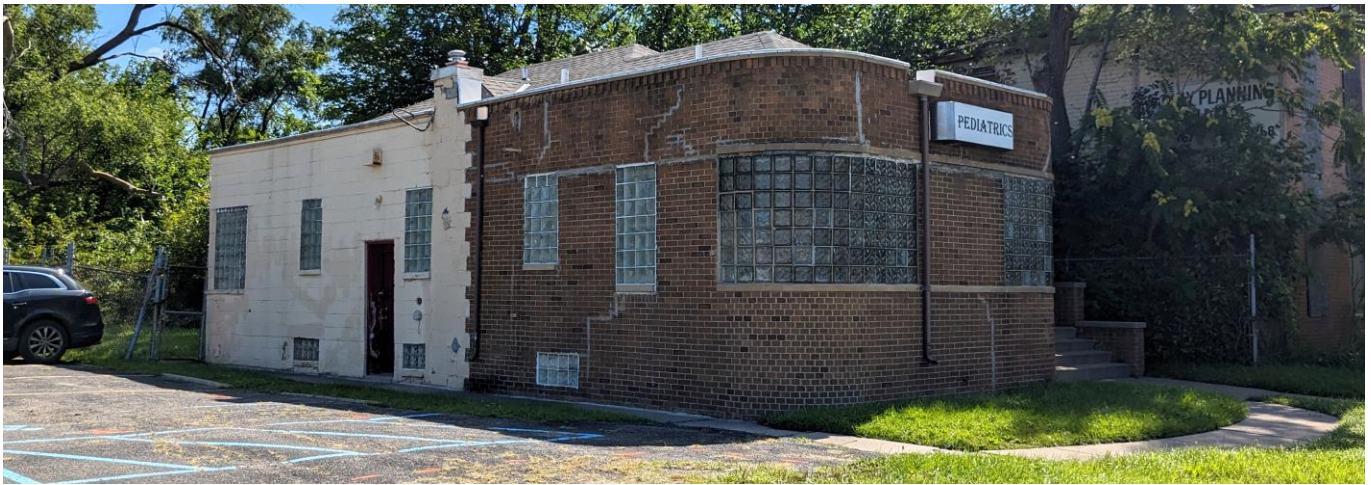
August 2023 photo by staff.

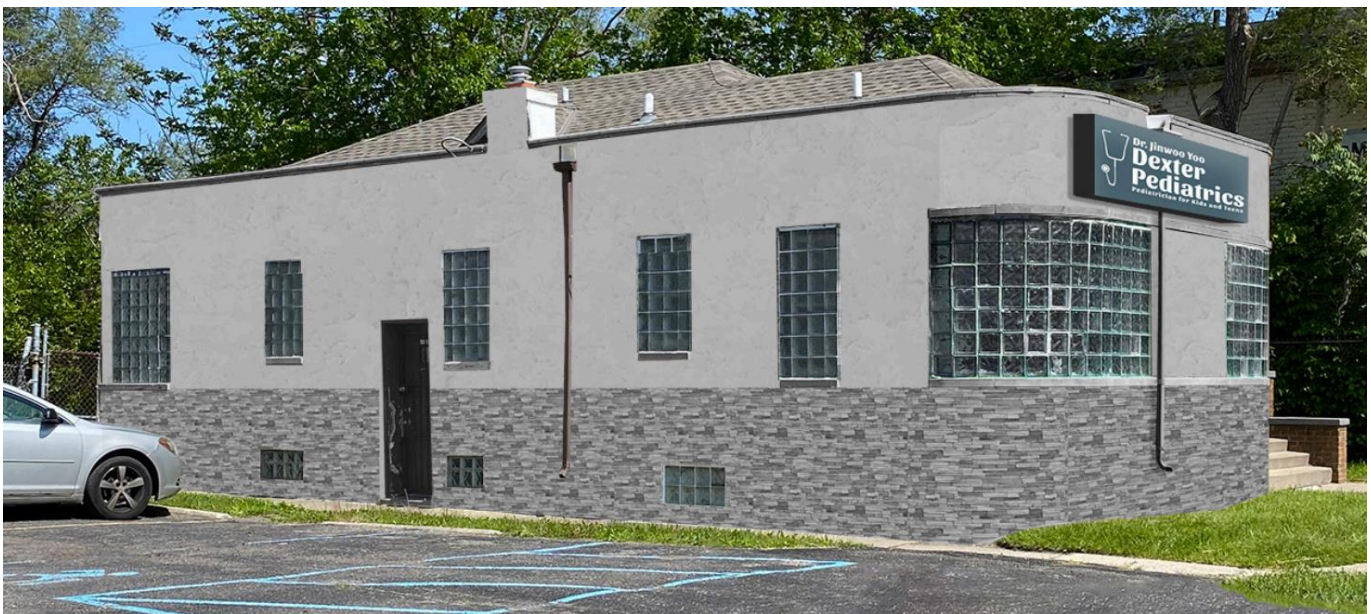
The applicant proposes to install new cladding materials on the front (west) façade and on the north elevation of the building. The materials would be stone veneer on the lower third and plaster on the upper two thirds. Also shown in the application drawings are a new sign on the front façade and a fenced area in the rear (east) of the building.

Rendering of proposed cladding materials and sign, provided by applicant.

- The proposed work would alter the character of the building by obscuring character-defining features including textured and patterned brick, mortar joints, and concrete block.
- The proposed stone cladding, specifically, introduces a novel texture and finish that is not compatible with the Art Moderne style of the building, not compatible with the period of significance of the Russell Woods-Sullivan Historic District, and not compatible with other historic buildings found within the district. The proposed plaster finish is also incompatible with the district.

Therefore, staff recommends that the Commission issue a Denial for the proposed plaster and stone veneer installation as the proposed work fails to meet the Secretary of the Interior's Standards for Rehabilitation, in particular:

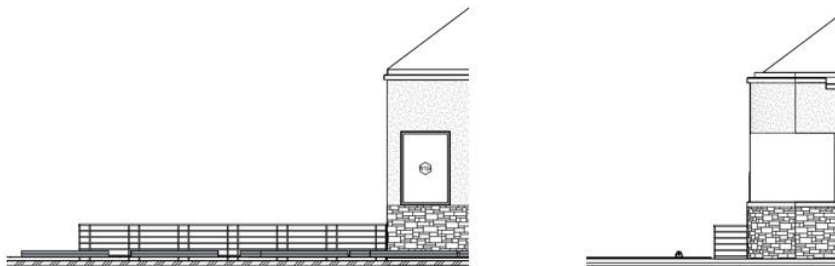
Proposed fence, from application drawings, cropped by staff. Left: north elevation. Right: west elevation.

- The fence shown in the drawings is likely appropriate, as it meets the *Fence and Hedge Guidelines*, is in the rear of the building, does not hide or distract from significant or character-defining architectural features, and does not interrupt significant or character-defining open spaces.
- The proposed sign appears to be larger than the current sign. However, it potentially meets the *Sign and Awning Guidelines* and is potentially appropriate in that it occupies a blank space on the façade, is compatible in proportion to the rest of the building, and does not obscure or destroy any character-defining features.

- The proposed fence material and finish shall be subject to approval by staff.
- The proposed sign will be subject to approval by staff.

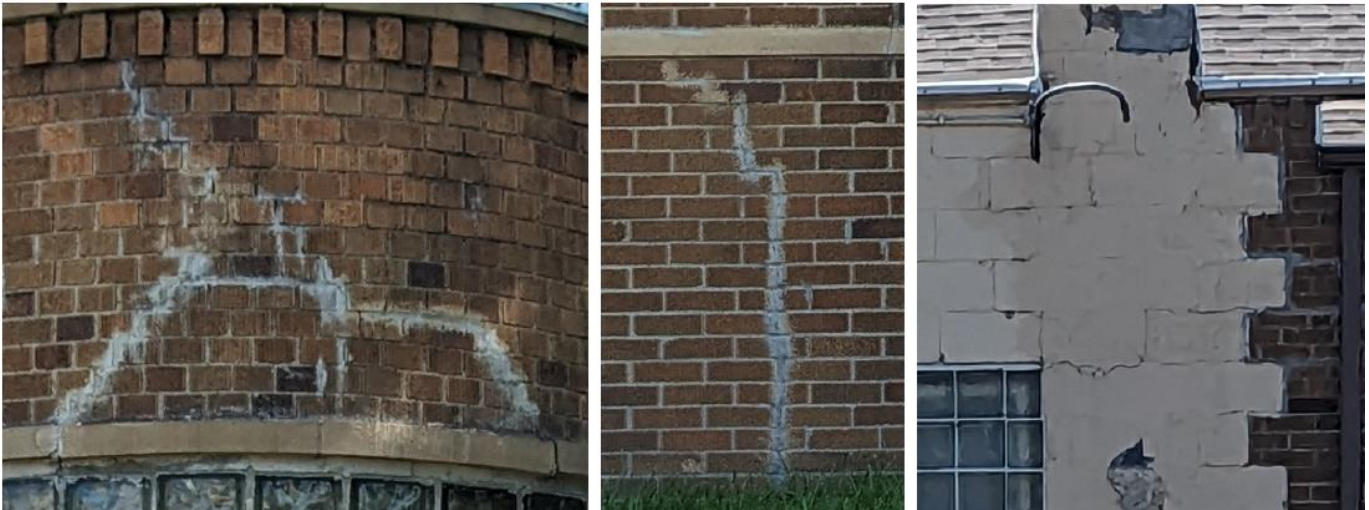
- The Secretary of the Interior’s Standards allow for in-kind replacement of historic materials if they are shown to be deteriorated beyond repair (Standard #6). Although staff observes cracking of brick and evidence of past mortar repair, there is no evidence that the brick veneer and concrete block are beyond repair. Even if individual bricks or blocks or expanses of brick or block are damaged, the appropriate rehabilitation approach would be replacement with matching masonry and compatible mortar. This approach is financially and technically feasible using readily available materials and trades. Ideally, the underlying cause of the deterioration (such as moisture infiltration or corrosive expansion) would be addressed at this time as well.

Representative areas of damage and prior repair. August 2023 photos by staff.

- 2. The historic character of a property shall be retained and preserved. The removal of historic materials or alteration of features and spaces that characterize a property shall be avoided.*
- 6. Deteriorated historic features shall be repaired rather than replaced. Where the severity of deterioration requires replacement of a distinctive feature, the new feature shall match the old in design, color, texture, other visual qualities, and where possible, materials. Replacement of missing features shall be documented by documentary, physical, or pictorial evidence.*
