**STAFF REPORT: SEPTEMBER 13, 2023 REGULAR MEETING**

**APPLICATION NUMBER: 23-8536**

**ADDRESS: 13201 DEXTER**

**SCOPE: INSTALL STONE AND STUCCO VENEER**

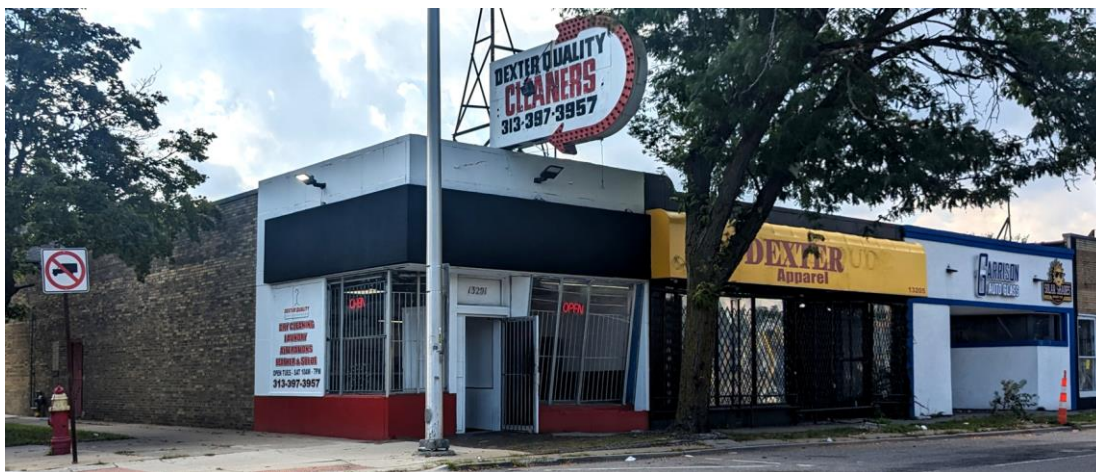
*13201–13217 Dexter, with 13201 Dexter visible at left. August 2023 photo by staff.*

Located at the northwest corner of Dexter Avenue and Tyler Street, 13201 Dexter is a small-scale (about 25 feet wide) storefront facing east onto Dexter Avenue. The building was built in 1947, according to building permits; the façade treatment appears largely original to the building. 13201 Dexter includes several unique and distinctive features including a tall, poured concrete foundation with integrated planter, outward-angled, nonfinish aluminum windows on the primary (east) façade, and a prominent, formerly illuminated, business sign projecting from a tripod bracket above the roofline. A vertical expanse of black-painted EIFS (exterior insulation finishing system, a low-cost substitute for stucco) encloses an area that, as recently as 2015, contained a vinyl awning. 13201 Dexter is clad in square and rectangular, smooth-finished, hardboard (e.g., Masonite or a similar product) panels resembling in appearance the structural glass panels, commonly known by trade names of Vitrolite and Carrara Glass, often found on Streamline Moderne buildings of the 1930s and 1940s. A subtle, yet distinctive feature is the slight S-curve by which the higher parapet of 13201 Dexter drops to meet the adjacent storefront. This element, along with the use of smooth façade panels and the slanted storefront window, evoking themes of motion and transportation, place the building within the Streamline Moderne style.

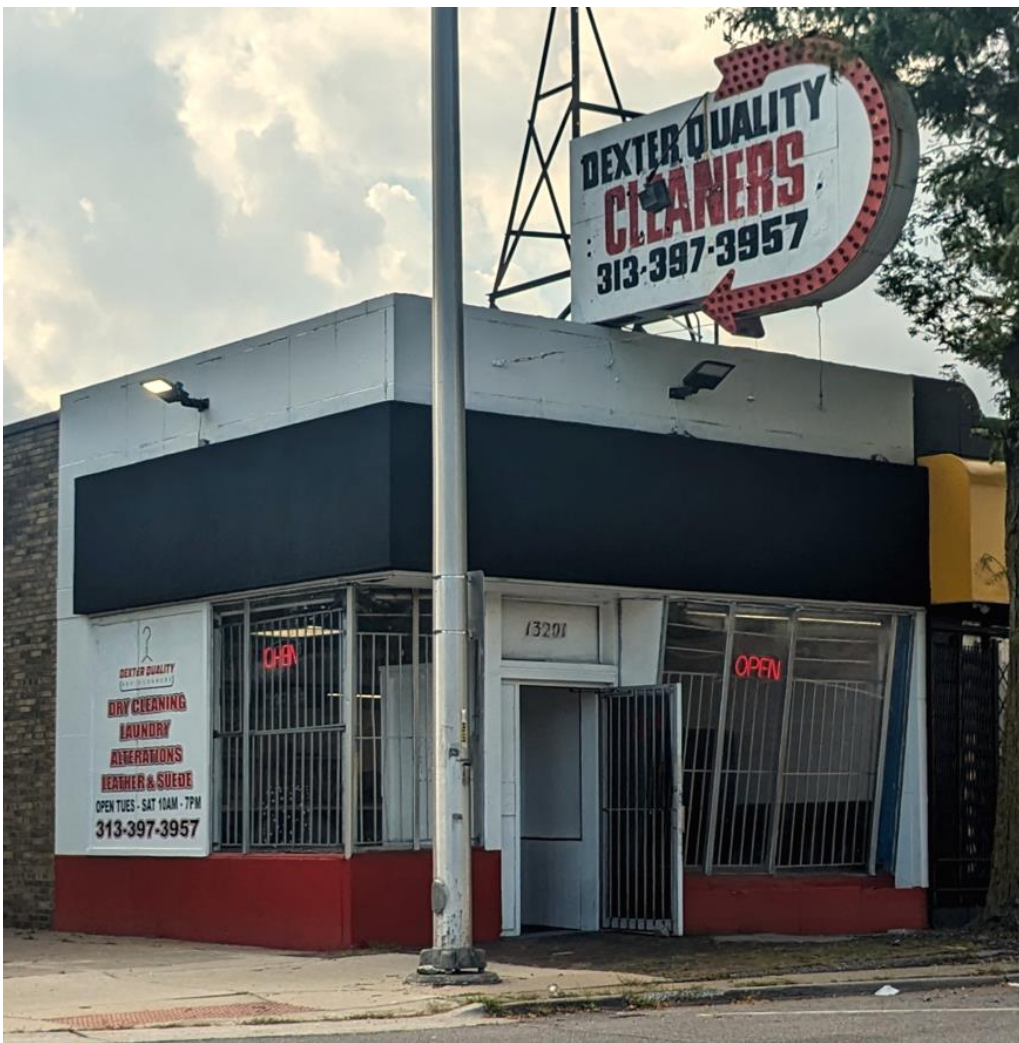
*13201 Dexter. August 2023 photo by staff.*

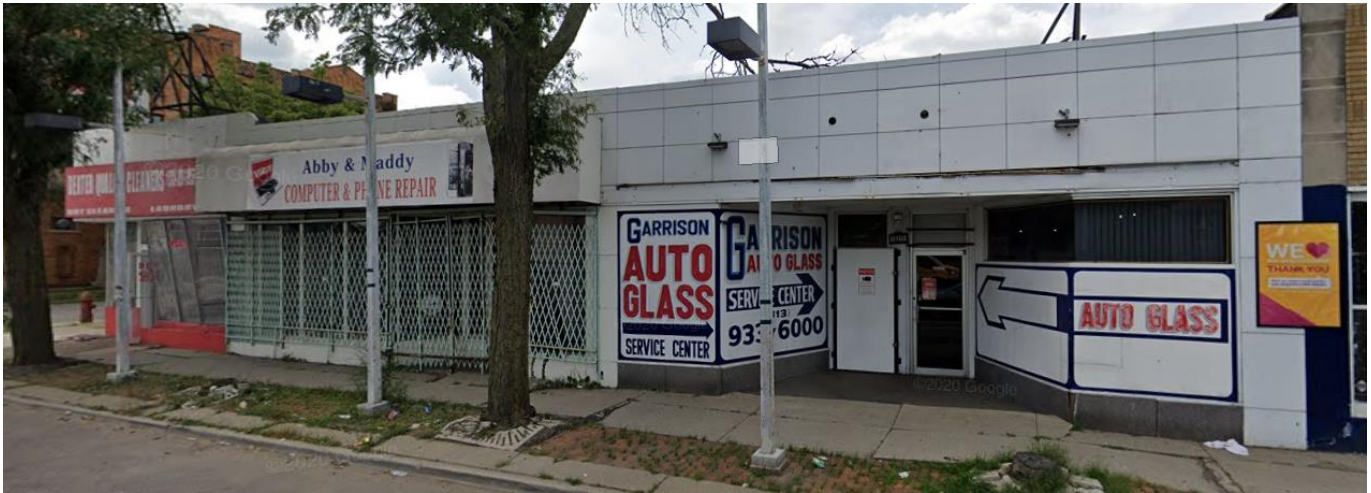
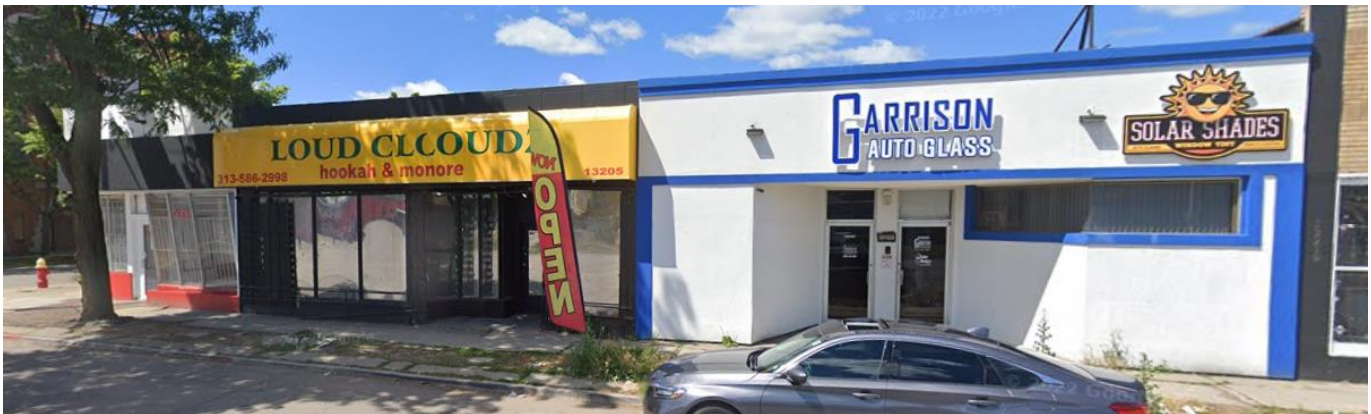
Until recently, the hardboard panels created a unified appearance that connected all three storefronts of 13201–13217 Dexter. Sometime between 2019 and 2021, the northernmost storefront, 13217 Dexter, was reclad in EIFS and an internally illuminated, channel-letter business sign was added. This work appears to have been completed without approval, as staff has no record of a Certificate of Appropriateness or Notice to Proceed for the work. It is

13201–13217 Dexter in 2019. Image: Google Maps.

13201–13217 Dexter in 2022. Image: Google Maps.

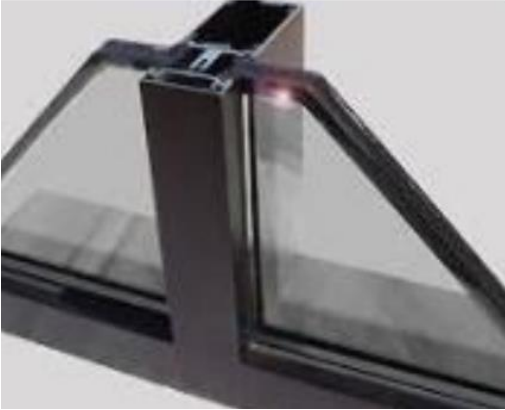
The windows are proposed for replacement with Trifab VersaGlaze fixed aluminum units with 2” wide sightlines. The door is also proposed for replacement; specifications are not provided.

*Section of proposed window system. Image from application documents.*

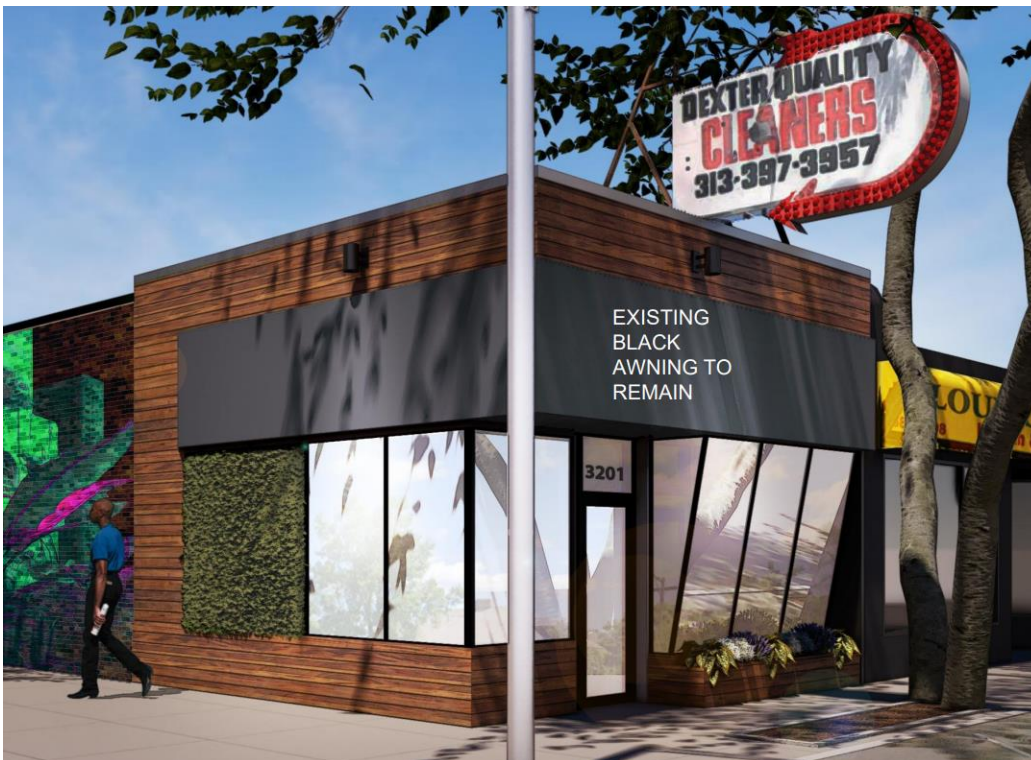
New UltraShield Natural Cortes composite 1x6” decking board, with a synthetic “Peruvian teak” woodgrain finish, is proposed to be installed horizontally as an exterior cladding material.

*Rendering depicting the proposed changes. Image from application. The mural and living green wall depicted are not part of the application.*

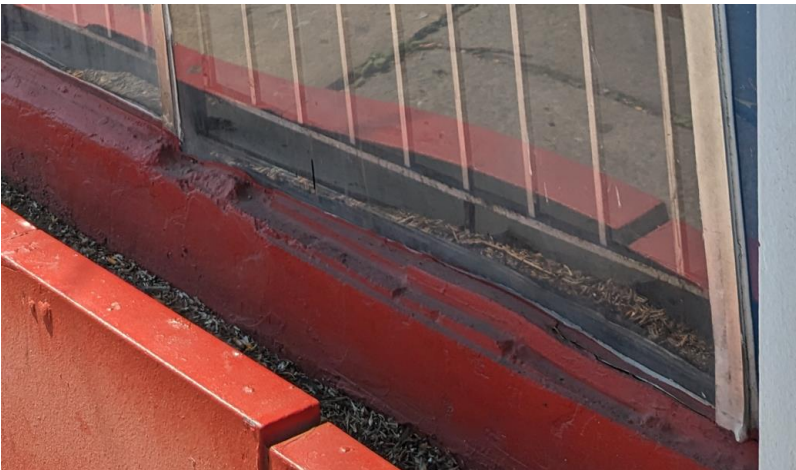
*Example of window damage. August 2023 photo by staff.*

- Although the window configuration is certainly an important character-defining feature, it is not clear if the windows, themselves, are historic or are more recent replacements. Regardless, the existing windows appear, to staff, to be deteriorated beyond repair. On both elevations, the aluminum windows are bent due to apparent impact damage; the loss of plane means that they can no longer accommodate glass. They are

presently glazed with acrylic sheets. Straightening the bent aluminum is not feasible.<sup>1</sup>

- The proposed replacement window, in 2” wide aluminum, is a close match to the existing window, meeting Standard #6: “Where the severity of deterioration requires replacement of a distinctive feature, the new feature shall match the old in design, color, texture, and other visual qualities and, where possible, materials.” The black anodized finish is an appropriate color and texture for the style of the building.

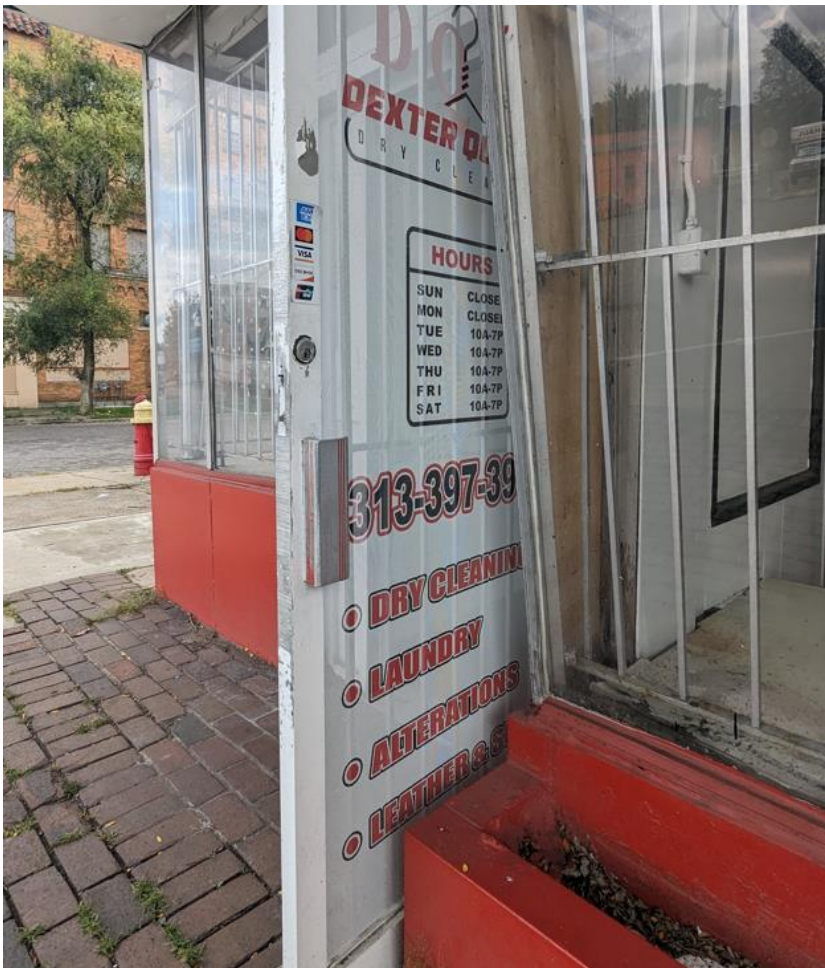
- The door is a historic element that has not been shown to be deteriorated beyond repair. Further, the application does not provide specifications for the proposed replacement door.

Front (east) door. September 2023 photo by staff.

- The proposed composite deck board cladding, providing a stark contrast with the other storefronts on the same building and the other buildings on the block, would disrupt the “repetitive flow of storefronts” described in the Elements of Design.
- The proposed door replacement would remove a historic element that is not deteriorated beyond repair.

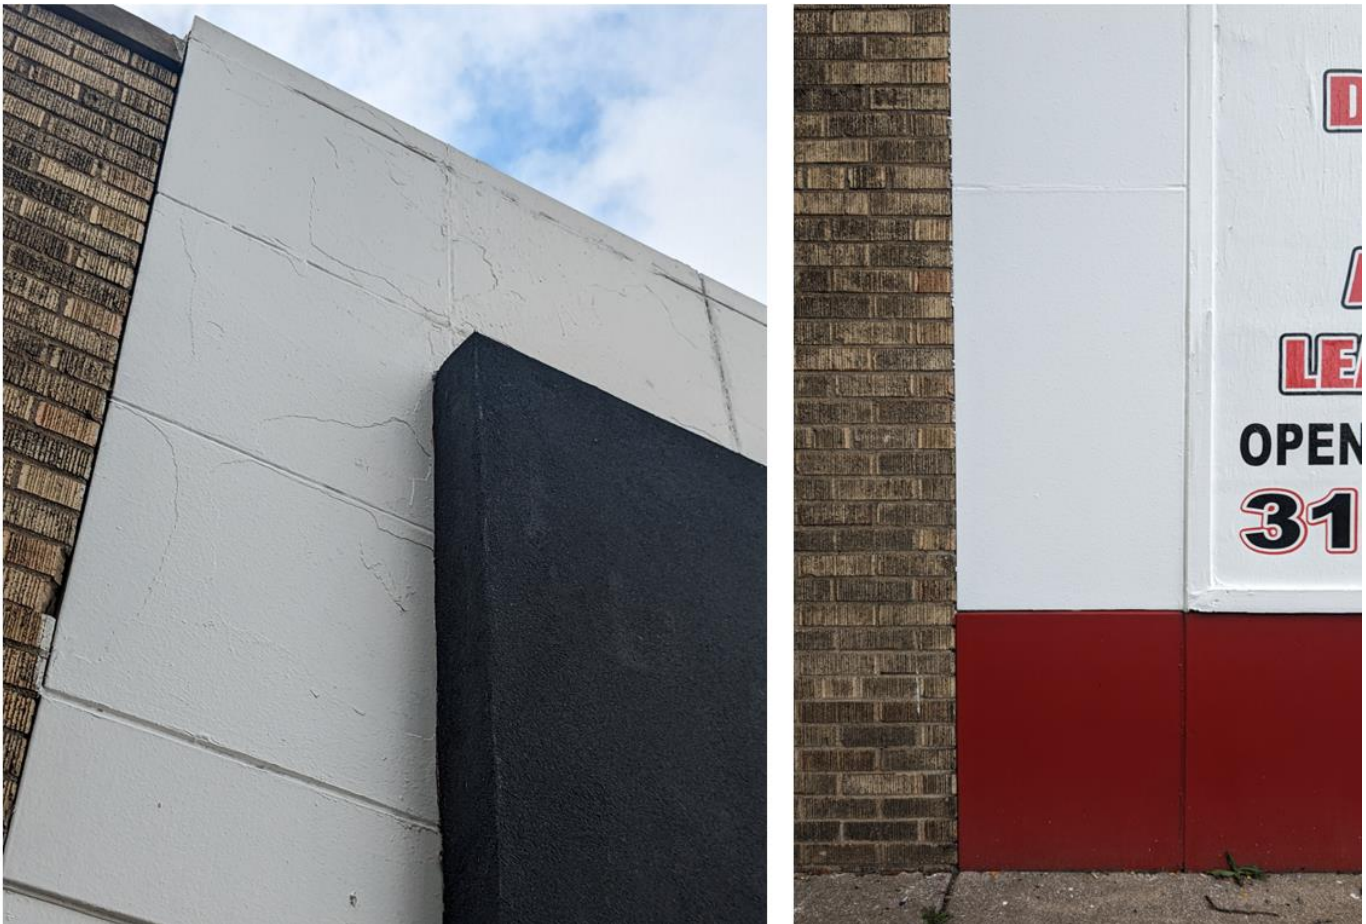
- Staff opinion is that the hardboard cladding panels are a character-defining feature of the building. According to Standard #2, they should be retained: “alteration of features and spaces that characterize a property shall be avoided.” The proposed synthetic cladding would alter the character of the building, contrary to Standard #2.
- Also, in staff opinion, the hardboard panels represent a “distinctive ... construction technique [and] example of craftsmanship” as described in Standard #5. That standard, likewise, directs that such features be preserved.
- The Secretary of the Interior’s Standards allow for in-kind replacement of historic materials if they are shown to be “deteriorated beyond repair” (Standard #6). In this case, however, the existing historic cladding appears to be in very good condition, with no signs of deterioration or delamination.

*Detail of cladding. September 2023 photos by staff.*

- Further, the proposed cladding material is not appropriate as neither unpainted wood, nor synthetic wood, nor butt-joint siding of any kind, are compatible with the district as a whole, or with its commercial buildings in particular.
- In conclusion, as this is a city-sponsored façade improvement project, staff points out a few options for façade rehabilitation work items that would likely meet the Secretary of Interior’s Standards at a minimal cost:

- The proposed work would alter the character of the building by covering character-defining smooth rectangular hardboard siding with new material.
- The existing rectangular hardboard siding constitutes a distinctive construction technique and example of craftsmanship that would be obscured and damaged by the proposed work.
- The proposed composite deck board cladding is not compatible with the building or the Russell Woods-Sullivan Historic District in that it introduces characteristics which are not historically found therein, including an unpainted woodgrain appearance and a butt-joint installation.

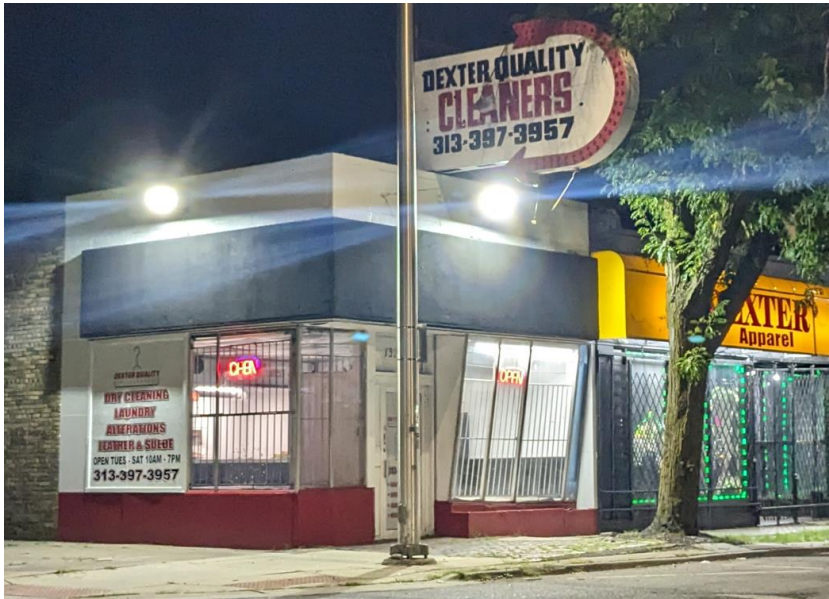
*The building at night. August 2023 photo by staff.*

- Expanses of non-historic plywood and EIFS on the façade could be replaced with historically appropriate materials such as metal, glass, or brick, or a historically appropriate awning could be added, subject to Historic District Commission review.
