STAFF REPORT: 10/11/2023 REGULAR MEETING

APPLICATION NUMBER: HDC2023-00057

ADDRESS: 12512 DEXTER

SCOPE: PAINT ENTIRE BUILDING (WORK COMPLETED WITHOUT APPROVAL), PAINT MURAL ON SIDE

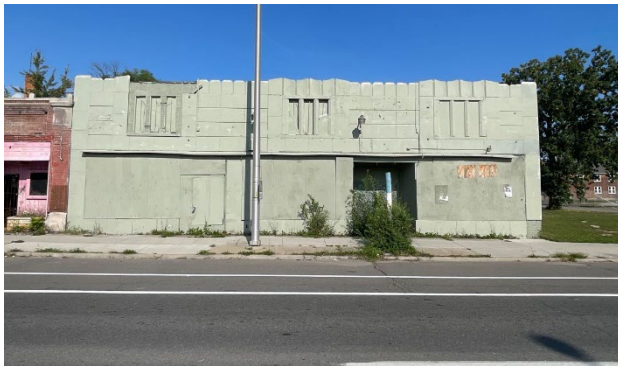
Site Photo 1, by Staff September 21, 2023: (West) front

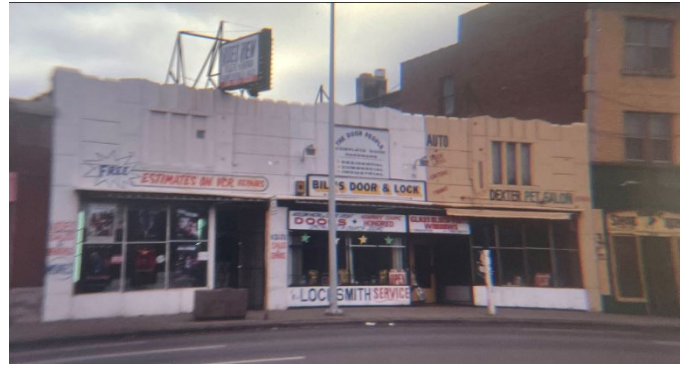
Designation photo 1999: (west) front elevation, showing storefront.

- The designation photo and preceding photos of the front elevation of the building shows that the structure was previously painted. At the time of designation, different colors denote various businesses occupying the same structure (see designation photo and site photo 3). A consistent characteristic over time, however, is that the windows, doors, and storefront were distinct and discernable features

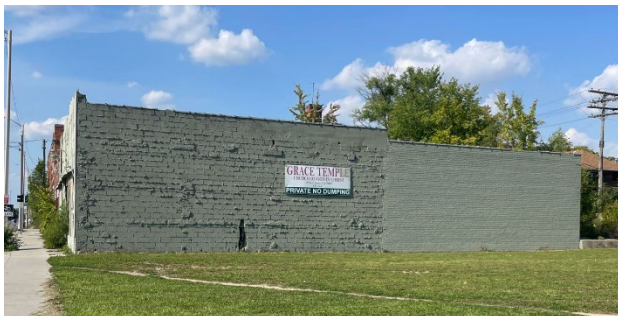
Site Photo 2, by Staff September 21, 2023: (South) side elevation, showing mural location.

- The proposed mural will cover a non-primary side of the building that does not exhibit historic character or any distinctive character defining features. Graphic signage and murals along commercial corridors' non-primary elevation walls have historic precedence.

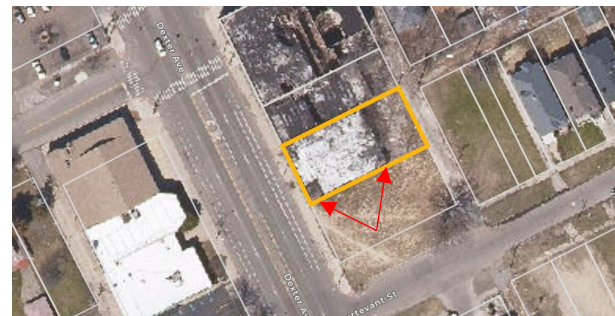
Aerial#1 of Parcel # 12010532-4, showing extent of mural location (arrows) along the south facing wall.

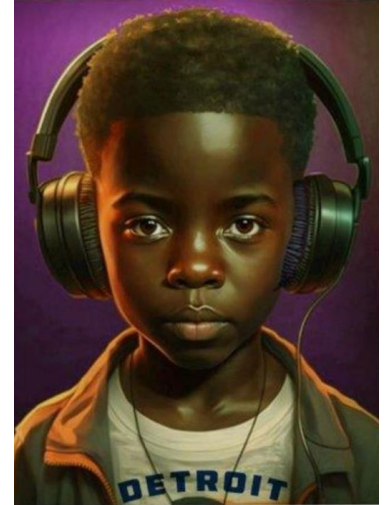
- At south (side) elevation, power wash concrete block and brick walls with water/steam, no abrasives or chemicals added. Rough surfaces will be left in place.
- Apply mural as shown in City Walls project. Please note that the initial image provided by the artist, Sintex, is an initial sketch which will be modified to reach the entire extent of the wall’s length and height, including both the brick and concrete block surfaces. (See Diagram 1)
- Paint product information has been requested and not yet supplied.

Diagram 1, by applicant: proposed concept image provided by the muralist, Sintex.

Staff finds that the proposal for the remaining work items will not alter the features and spaces that characterize the property and district and therefore recommends the Commission issue a Certificate of Appropriateness for the work as proposed as it meets the Secretary of the Interior's Standards and the Elements of Design for the district.

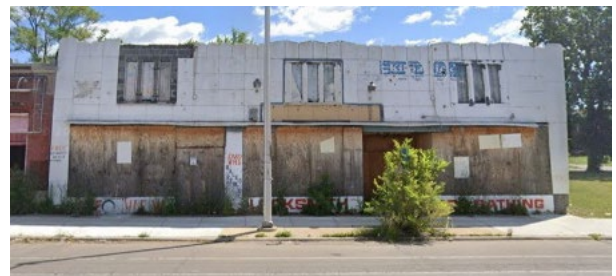
Site Photo 3, by Google Streetview June 2022: (West) front elevation, showing conditions prior to GSD painting the facade.

of the building, even when boarded-up. It is staff's opinion that these distinctive character-defining features of the façade were reduced by the uniform, monochromatic coloration of the painting work, which was completed without approval.

- The façade's fenestration is a historic, character-defining feature that is lost under the wash of a single, monochromatic color. Legibility, detailing, dimensionality, and color variation, especially while temporarily boarded, is lost under a single color.
- Monochromatic painting of the building reduces the features that distinguishes the historic prominence of the front façade from the secondary elevation of the side wall.

Staff therefore recommends that the Commission issue a Denial for the work as proposed, as it does not meet the Secretary of the Interior's Standards for Rehabilitation, specifically Standards 2 and 5:

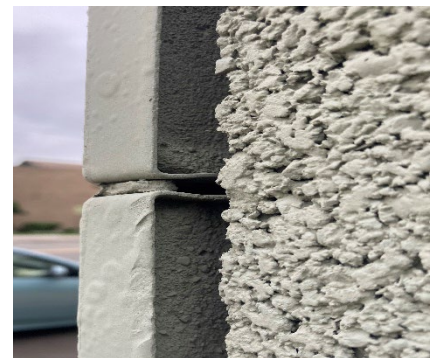
Site Photo 4, by Staff September 29, 2023 (front elevation): showing metal paneling detail.

- It is staff's opinion that the rectangular metal paneling of the building's façade is a distinctive character-defining feature.
- The Sanborn map shows that the property adjacent to 12512 Dexter was occupied by a 3rd story structure that obscured the now exposed south elevation. 12512 Dexter had an adjacent wall along a portion of the south-facing elevation, which did not have brick facing. The remaining portion of the wall, which was not publicly visible, was with brick. (See Sanborn image, red dashed area.) This south facing wall, while integral to the building's materiality is not, in staff's opinion, a historic distinctive character-defining feature.

- Should the removal of paint be attempted, staff is concerned with potential damage to the historic metal paneling and face brick.
- As the proposed mural does not alter, cover or destroy any distinctive character-defining features, staff finds it to be not demonstrably inappropriate.
