STAFF REPORT: OCTOBER 11, 2023 REGULAR MEETING

APPLICATION NUMBER: HDC2023-00051

ADDRESS: 4300 W. VERNOR

SCOPE: INSTALL WINDOWS AT SIDE WALL

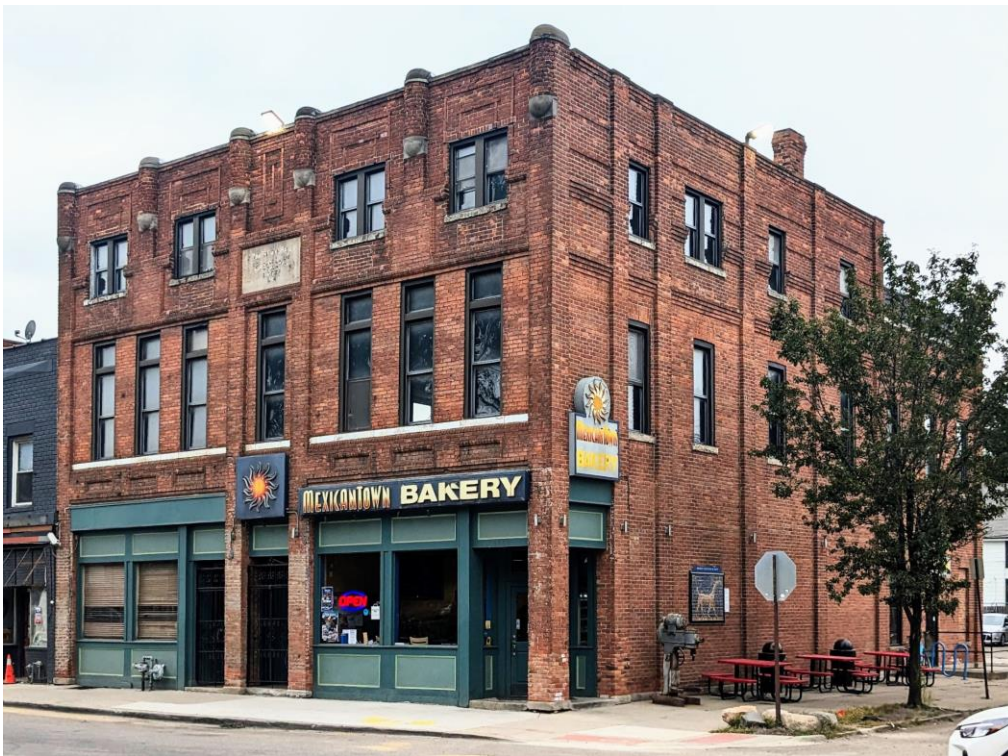
Subject property viewed from intersection of Vernor Highway and Clarkdale Street (view facing northwest). September 2023 photo by staff.

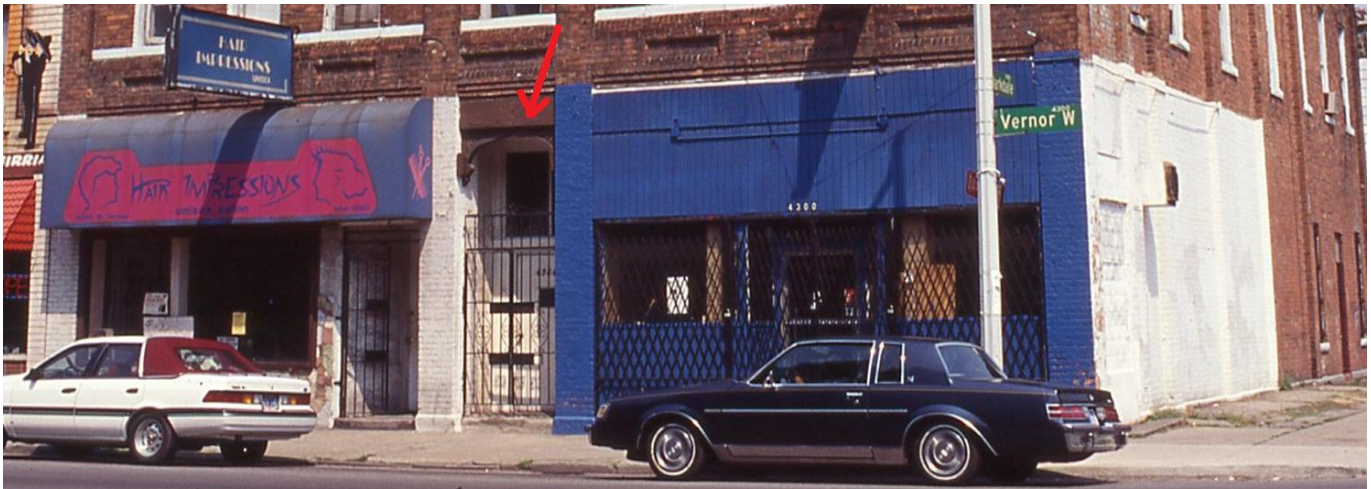
The ground-level storefronts have been altered since the 1993 description. Most prominently, a recessed, diagonal entrance bay has been created at the southwest corner, allowing access from Clarkdale Street in addition to West Vernor Highway. A vinyl awning and an expanse of T-111 siding have been removed. In their place, the present wood-panel and glass storefront has been added. Two business signs have been removed. Finally, a decorative arch, set within the central, south-facing doorway (noted in the HDAB description above) has been removed. Staff has no record of this work being approved by the Historic District Commission. The work meets the Secretary of the Interior's Standards for Rehabilitation, in the opinion of staff, except for the removal of the arch, which is not appropriate.

1993 Historic Designation Advisory Board photo, arrow added to indicate missing arch.

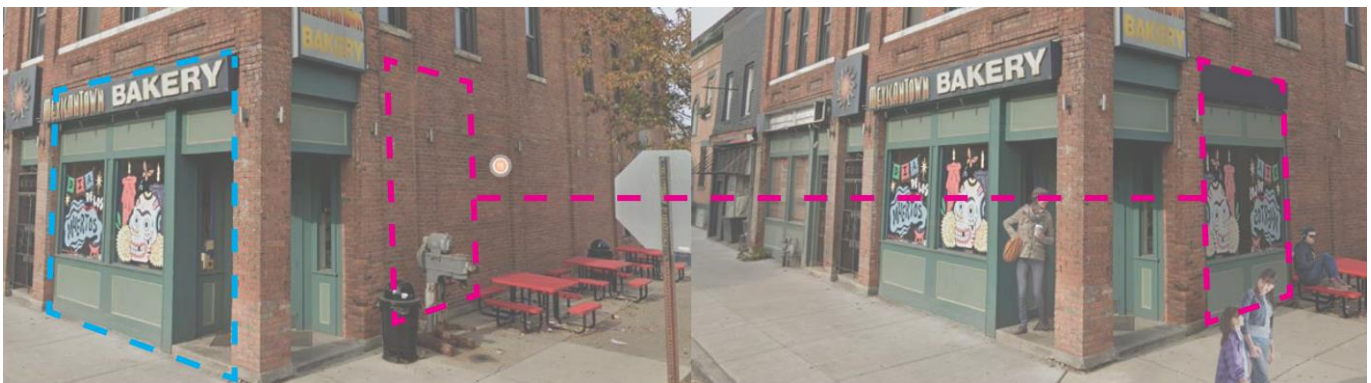
The applicant proposes to expand the storefront by creating additional window openings on the east elevation. The new window area would have a similar appearance, including profile and color, to the existing storefront on the front (south) façade. The unfenestrated areas of the storefront are proposed to be clad in a proprietary exterior insulation and finish (EIFS) system. Above the window area, a sign is proposed.

Left: Existing conditions. Right: Rendering of proposed work. Illustration from application documents.

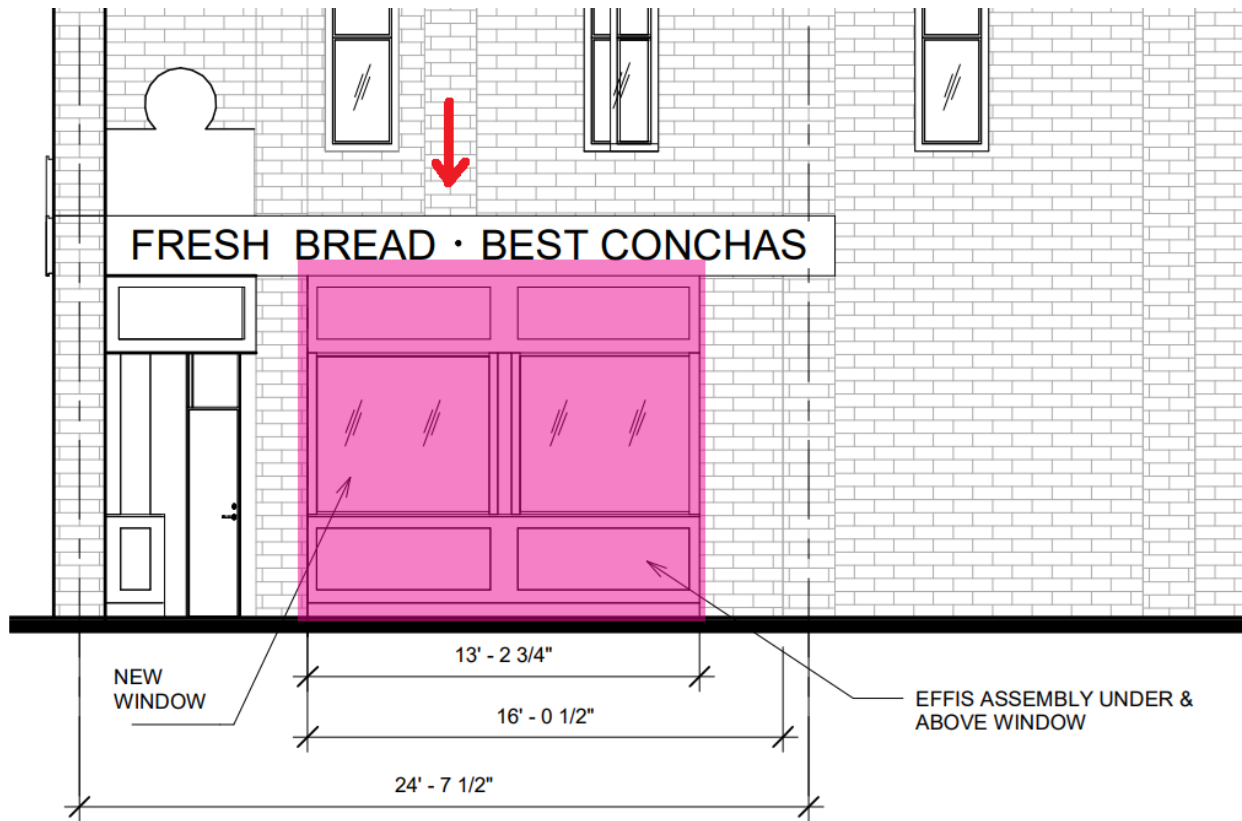
East elevation with proposed work highlighted in colored box. Image from application documents. Arrow added by staff to indicate pilaster location, discussed below.

- The proposed location of storefront window openings, severing one of the pilasters at the first story, is not compatible with the vertical emphasis of the building, as described above, contrary to Standard #9.
- The proposed use of EIFS would introduce a new material that is not historically found in the Hubbard Farms Historic District, contrary to Standard #9.
- Specifications for the proposed sign are not provided.

- The proposed openings will be adjusted to avoid severing the brick pilasters on the east elevation.
- Wood, rather than EIFS, will be used for the unglazed portions of the storefront.
- The sign will conform to the *Sign and Awning Guidelines* or be approved by staff subject to the Secretary of the Interior's Standards for Rehabilitation.

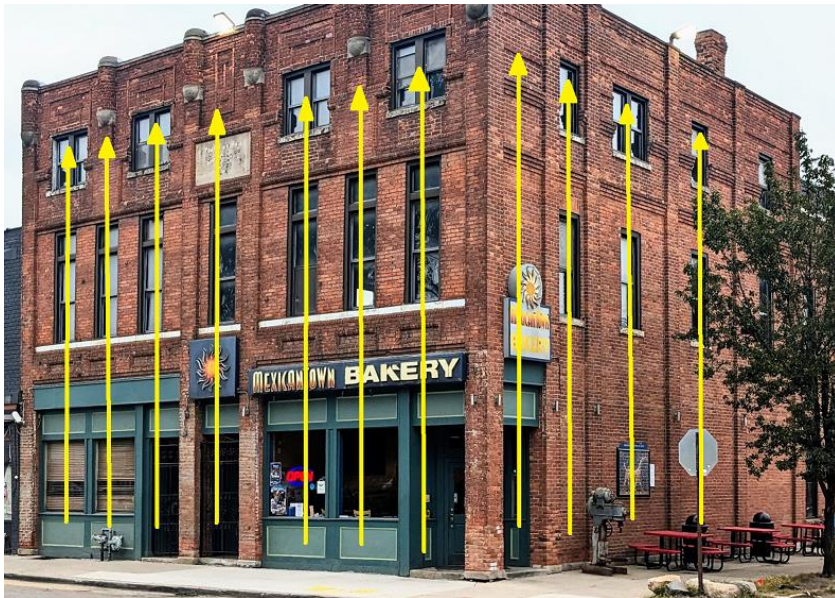
- As noted in the Final Report, although the first-floor storefront has been altered, the historic arrangement of openings remains as a character-defining feature; the arrangement remains unchanged despite post-1993 alterations.
- The placement of storefront windows and doors between pilasters and directly beneath second- and third-story window openings creates a vertical emphasis and rhythm to the façade. The proposed storefront windows break this established rhythm, with one of the pilasters being truncated by the work. Additional window openings would most appropriately continue this emphasis in order to be compatible with the massing and architectural features of the building (Standard #9).

Vertical emphasis of the façade. Illustration by staff.

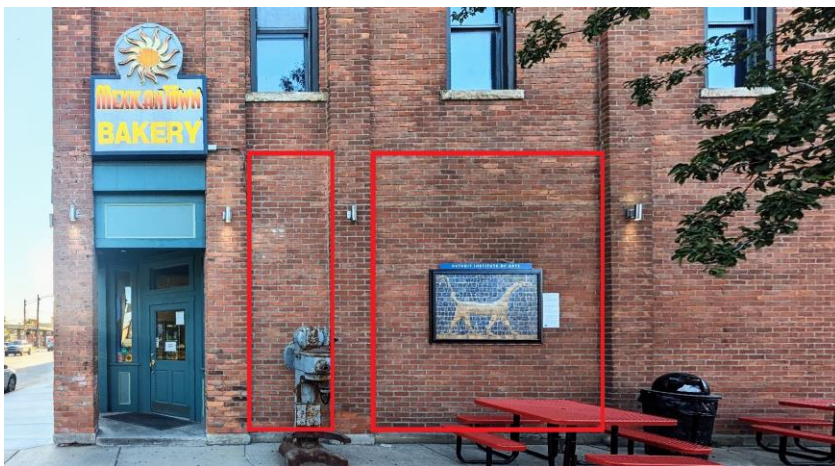
Examples of appropriate locations for new openings. Illustration by staff.
