STAFF REPORT: DECEMBER 13, 2023, REGULAR MEETING

APPLICATION NUMBER: HDC2023-00137

ADDRESS: 4305-4309 BUENA VISTA

SCOPE: INSTALL CHAIN-LINK FENCE

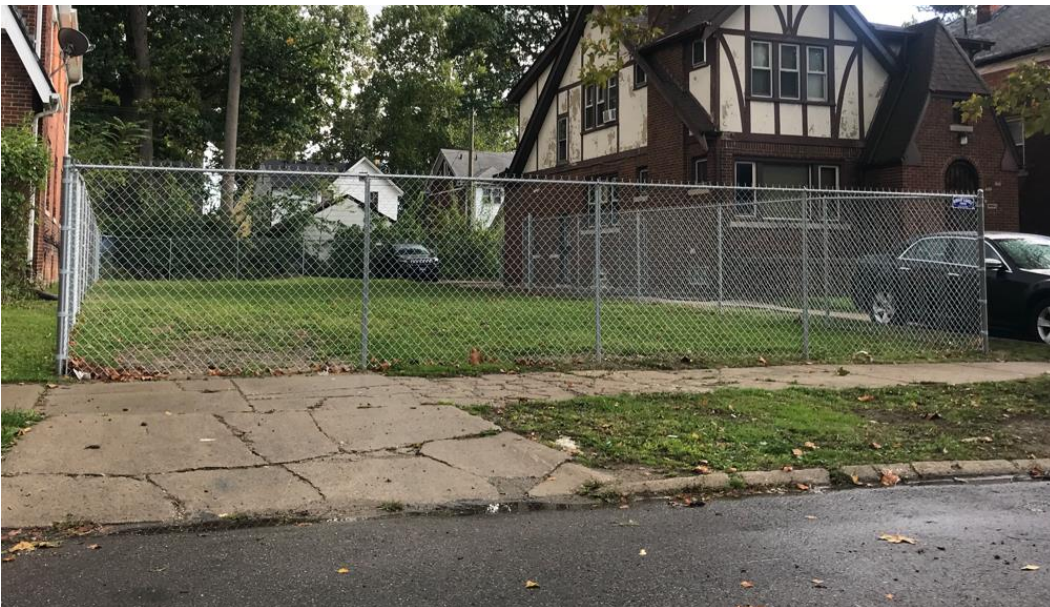
The subject property consists of two adjacent parcels under common ownership, shown in the photo and site plan below. 4309 Buena Vista is occupied by a two-story, Tudor Revival house built in 1927. 4305 Buena Vista is a vacant lot that formerly contained a house and is now covered in a maintained, grassy lawn. Both lots have concrete driveways at their eastern edges. A six foot, chain-link fence encloses the back yard of 4309 Buena Vista and nearly the entire area of 4305 Buena Vista.

October 2020 photo by staff.

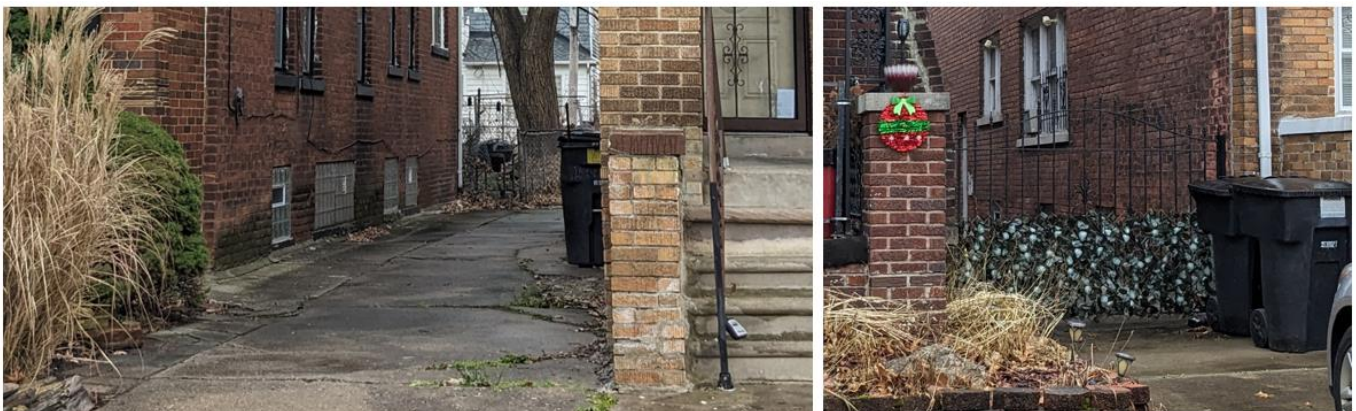
- The 4200–4300 block of Buena Vista is consistent with the character described in the Elements of Design quoted above. There are 23 lots on each face of the block (46 total). Back yards are always fenced. As the west side of each house abuts the lot line, and the remaining space on the east side of each house is taken up by a driveway, there are no side yards and, consequently, no side-yard fencing. In almost all cases, a back-yard enclosure is completed by a four-foot- or six-foot-high gate across the driveway near the rear of the house. In only five cases on the block, the gate is located near the front plane of the house.

Left: Driveway spanned by a gate near the rear of the house and not readily visible. This configuration is common. Right: Driveway gate at the front plane of the house. This is much less common but is also appropriate. November 2023 staff photos.

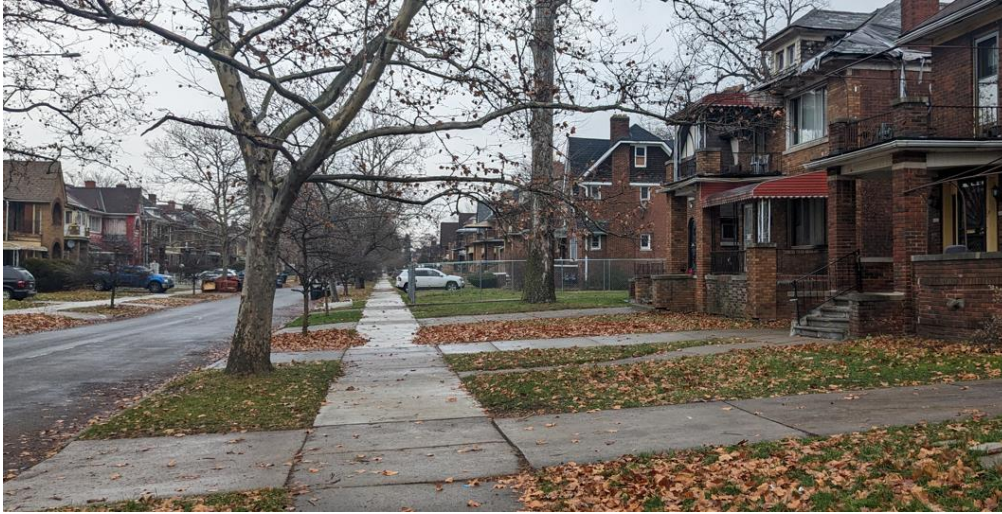
- The uniform setbacks and consistent, open front yards are an important, character-defining feature of the Russell Woods-Sullivan Historic District, as noted in the Elements of Design.

Open front yards and uniform setbacks, as noted in the Elements of Design. The proposed (already installed) fence is visible in the background. November 2022 photo by staff.

- A front-yard fence disrupts the character-defining pattern of open front yards and uniform setbacks that defines the Russell Woods-Sullivan Historic District, contrary to the Secretary of the Interior’s Standards for Rehabilitation, which direct that “spaces that characterize a property” should not be altered (Standard #2).¹

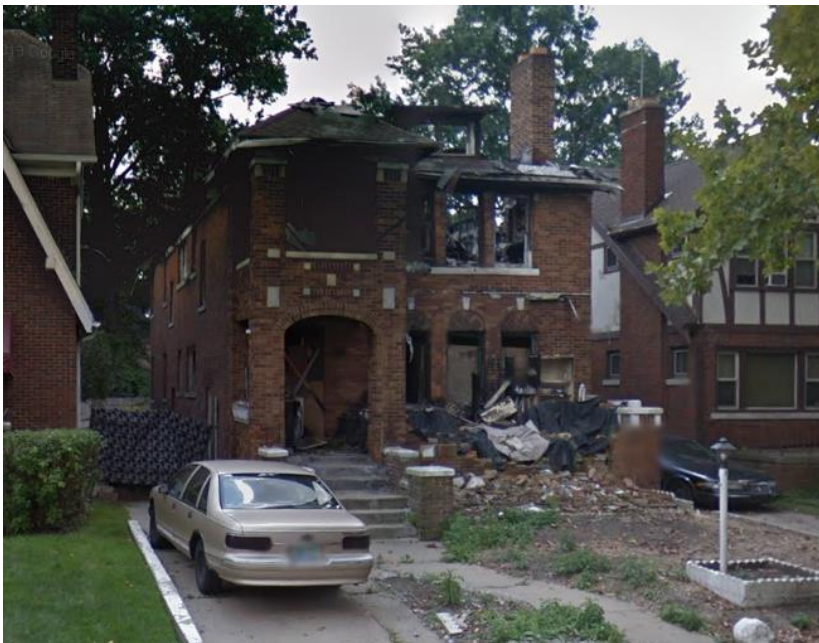
Damaged house at 4305 Buena Vista. 2013 Google Maps photo.

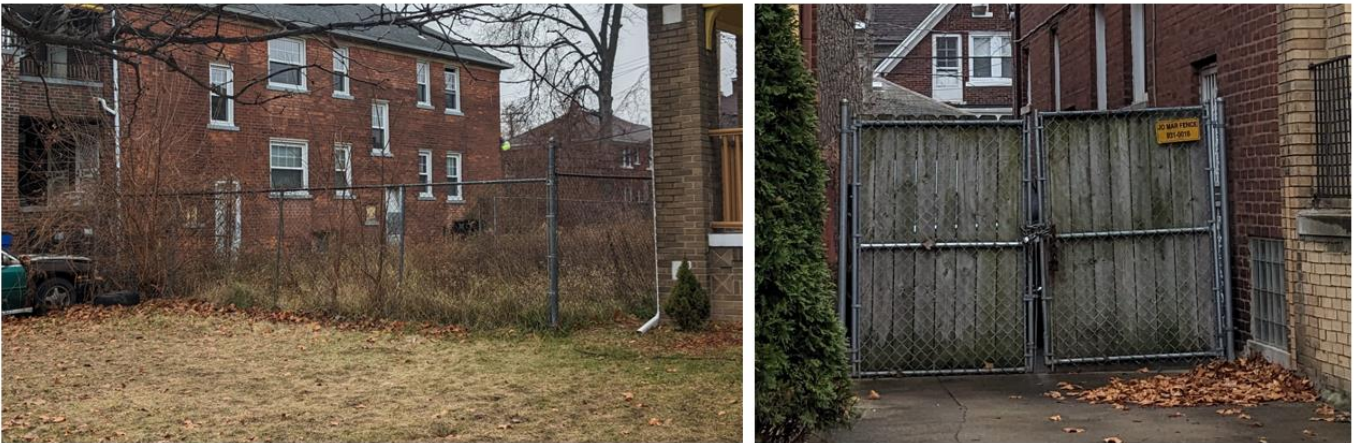
- In a relatively small number of instances, six-foot, chain-link fences are employed at the front façade of a house in Russell Woods-Sullivan. However, these are not historically appropriate and appear to be old enough that they likely predate the designation of the historic district. Therefore, they should not be used as models for new fences.

Six-foot chain-link fences in the vicinity of the subject property. November 2023 photos by staff.
