**STAFF REPORT:** NOVEMBER 13, 2024 REGULAR MEETING

**APPLICATION NUMBER:** HDC2024-00567

**ADDRESS:** 14936 GLASTONBURY

**SCOPE:** REPLACE WINDOWS WITH ALUMINUM-CLAD WOOD WINDOWS, REPLACE DOOR

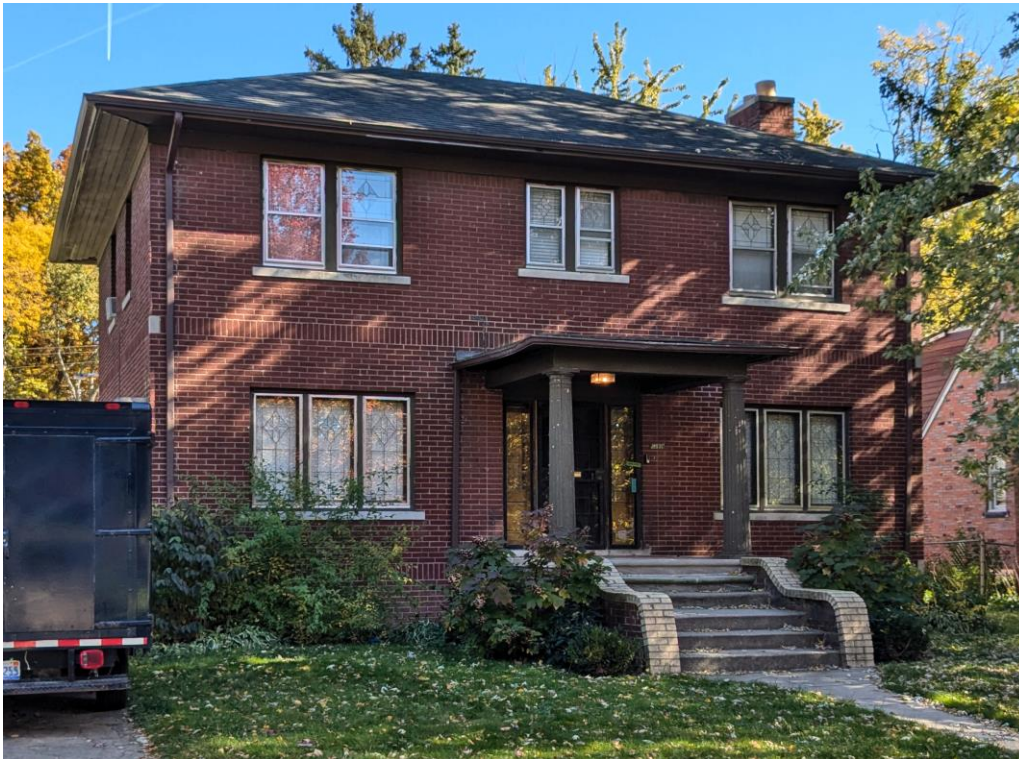
14936 Glastonbury is a two-story, brick house demonstrating a mix of Colonial Revival and Prairie elements. Its symmetrical, three-bay facade is clad with red-brown brick and features a low-pitch, hip roof. Noteworthy features include a porch with Doric columns, soldier belt courses of brick, and leaded glass windows on the front façade only (not subject of this application), and a prominent wall chimney on the south elevation. The house was built in 1927.

*October 2024 photo by staff.*

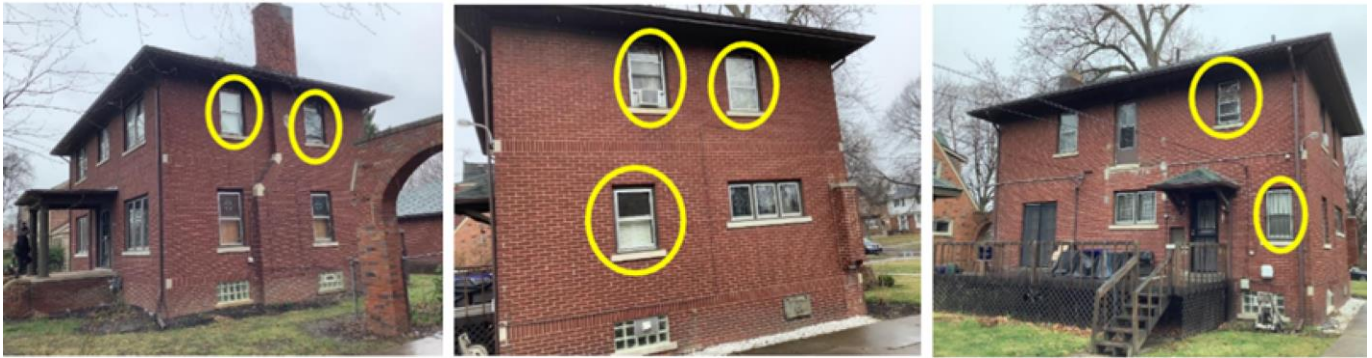
The proposal is to replace seven existing side (north and south elevation) and rear (east elevation) windows with aluminum-clad wood windows. The proposed windows are Pella Lifestyle, aluminum-clad wood, double-hung windows in “white” color.

*Windows proposed for replacement. Left to right: south elevation, north elevation, east elevation. Photos from application materials.*

- The applicant also states that there is deterioration of the windows: “Two of the windows being replaced have large cracks. The other five don’t open, don’t have handles to open and/or are broken.” However, these conditions are typical maintenance needs of old windows and are usually repairable (John H. Myers, “The Repair of Historic Wooden Windows,” Preservation Brief 9, (National Park Service Technical Preservation Services), <https://www.nps.gov/tps/how-to-preserve/briefs/9-wooden-windows.htm>). Again, staff has asked for additional photos to establish the condition of the windows.

- Although the windows proposed for replacement are not as distinctive as the leaded-glass windows on the front façade, they are nonetheless character-defining, in staff opinion: they appear to be original wood windows, as referenced in the Elements of Design, and they support the character of the building due to their materials, dimensions, operation, and overall appearance. Replacing these windows would be contrary to the Secretary of the Interior’s Standards, namely Standard #3 (quoted below).

- Although the applicant estimates that the windows are only a few decades old, no confirmation of this is provided; staff suggests that they are likely original or historic features, based on their thickness and appearance.

- Although the applicant describes damage to the windows, staff believes that they are very unlikely to be beyond repair.
- Similar to the windows, the application does not provide enough information to determine if the door is a historic, distinctive, or character-defining feature. (Replacement of non-historic doors can be approved administratively by staff per resolution 97-01.)

- The windows proposed for removal appear to be original or historic features that contribute to the character of the property (no evidence is provided that they are newer or non-historic).
- The windows proposed for removal have not been shown to be deteriorated beyond repair.

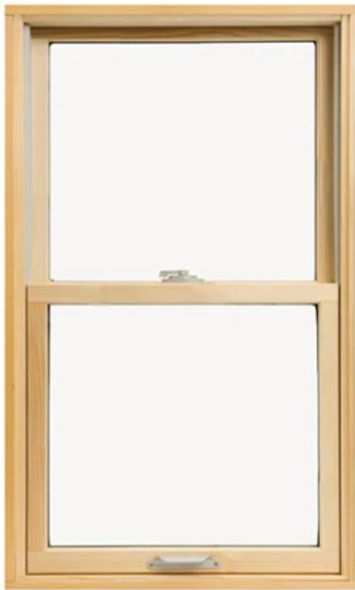
*Pella Lifestyle Series window, interior view. Image from product website.*

- The Pella Lifestyle Series windows specified are appropriate for the building, in that their materials and dimensions closely resemble that of a wood window from the building’s period of significance. The proposed white color is also appropriate for the Classical/Colonial building, as stated in the Elements of Design.

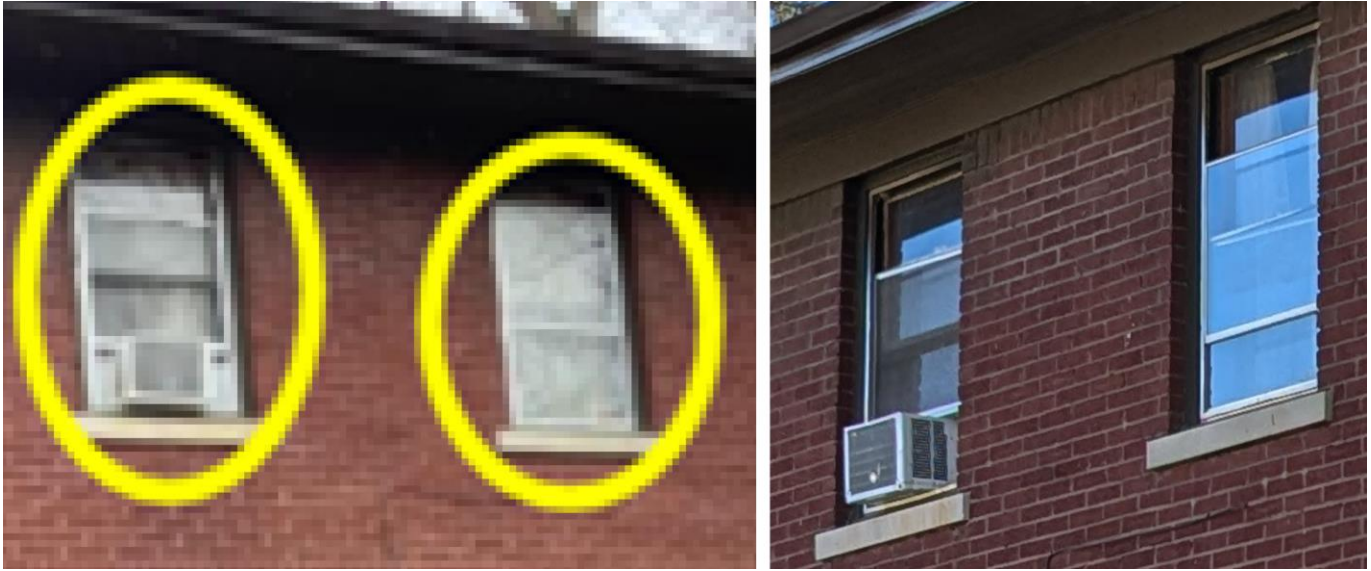
- The applicant estimates that the windows proposed for replacement are “25–30 years old.” If so, they would not be historic features and their preservation would not be required. However, staff is unable to verify the age of the windows. The photos submitted with the application are difficult to interpret due to their low resolution; further, staff was not able to easily view the windows from the sidewalk due to their distance and because they are partly obscured behind storm windows. Nonetheless, the existing sashes appear to have thicker dimensions characteristic of historic wood windows. Staff asked the applicant for

additional photos and description by email on October 28 and October 31, 2024, but has not yet received any additional information.

Left: Example windows. Image from application materials, cropped by staff. Right: Staff photo from October site visit.

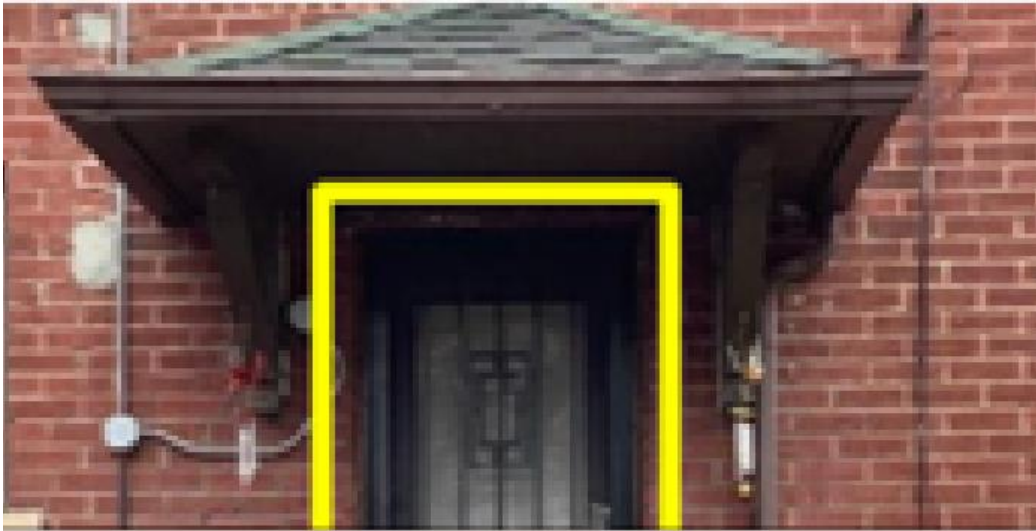
- The applicant states that the door proposed for replacement is non-historic and is missing a knob. However, as with the windows, the existing photos do not clearly show the door, and staff has asked for more information.

*Back (east) door. Image from application. Note that the submitted photo does not show the bottom half of the door.*

- Not enough information is provided to determine if the door is a historic, distinctive, or character-defining feature; such features must not be replaced.
- The proposed replacement door is not specified; any replacement must be compatible with the historic character of the property.
