STAFF REPORT: DECEMBER 11, 2024 MEETING

APPLICATION NUMBER: HDC2024-00662

ADDRESS: 1502 PARKER (AKA INDIAN VILLAGE TENNIS CLUB)

SCOPE: REMOVE TREE, REPLACE PATIO WITH NEW PATIO AND PERGOLA

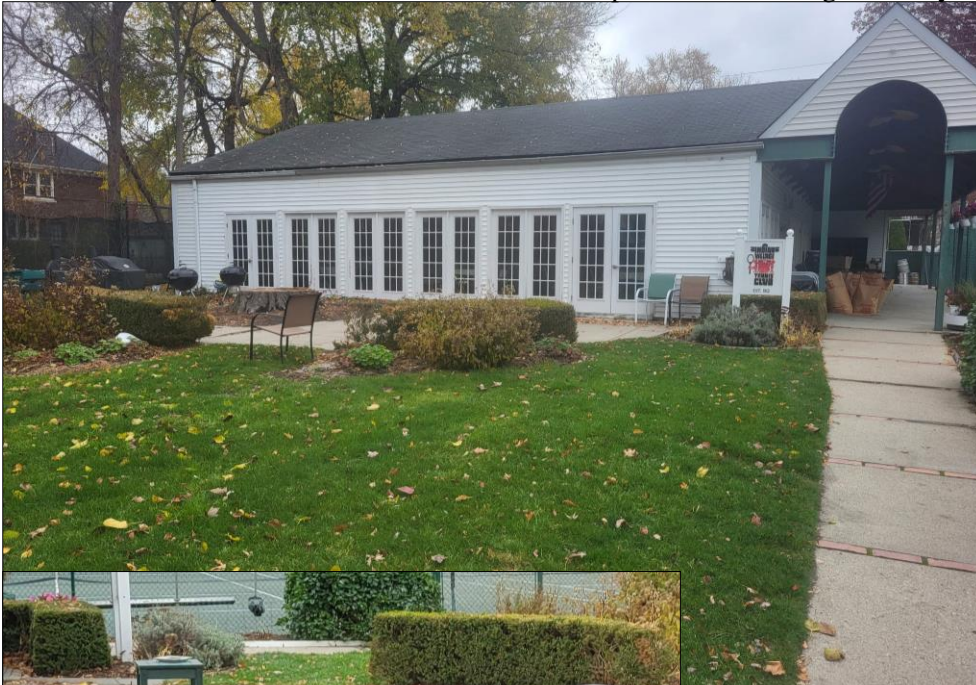
Above left: This view looks east toward the clubhouse from the walkway that enters from Parker. Applicant photo.

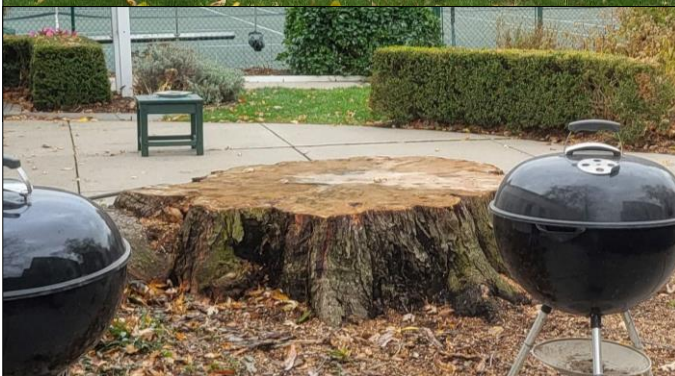
Left: View of a stump that remains from the three that was recently cut down. Based on its diameter, staff believes the tree likely predated the late 19th century house that had been near this location (which the tennis club demolished in 1949).

- Information on the health of the tree and/or documentation of problems the tree was causing the patio/building were not submitted. The rendering shows new trees are to be planted near the north side property line, which can offer a soft visual buffer for the adjacent dwelling.
- Additional details for the proposed design, including a legible dimensioned site plan and elevation, a planting plan, lighting plan and details on a perimeter fence were not included with the application.

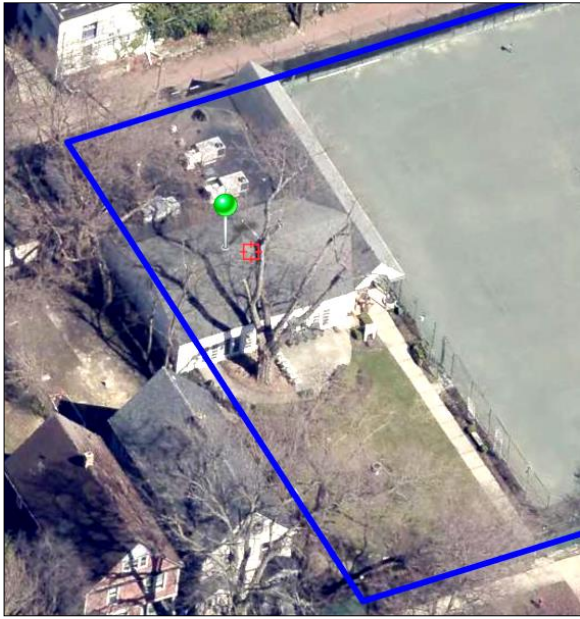
- A complete site plan wasn't submitted (which would include an indication of the sidewalk and gate into the club). Therefore it isn't clear to staff if there will be additional greenspace between the patio/seating area and Parker Street.

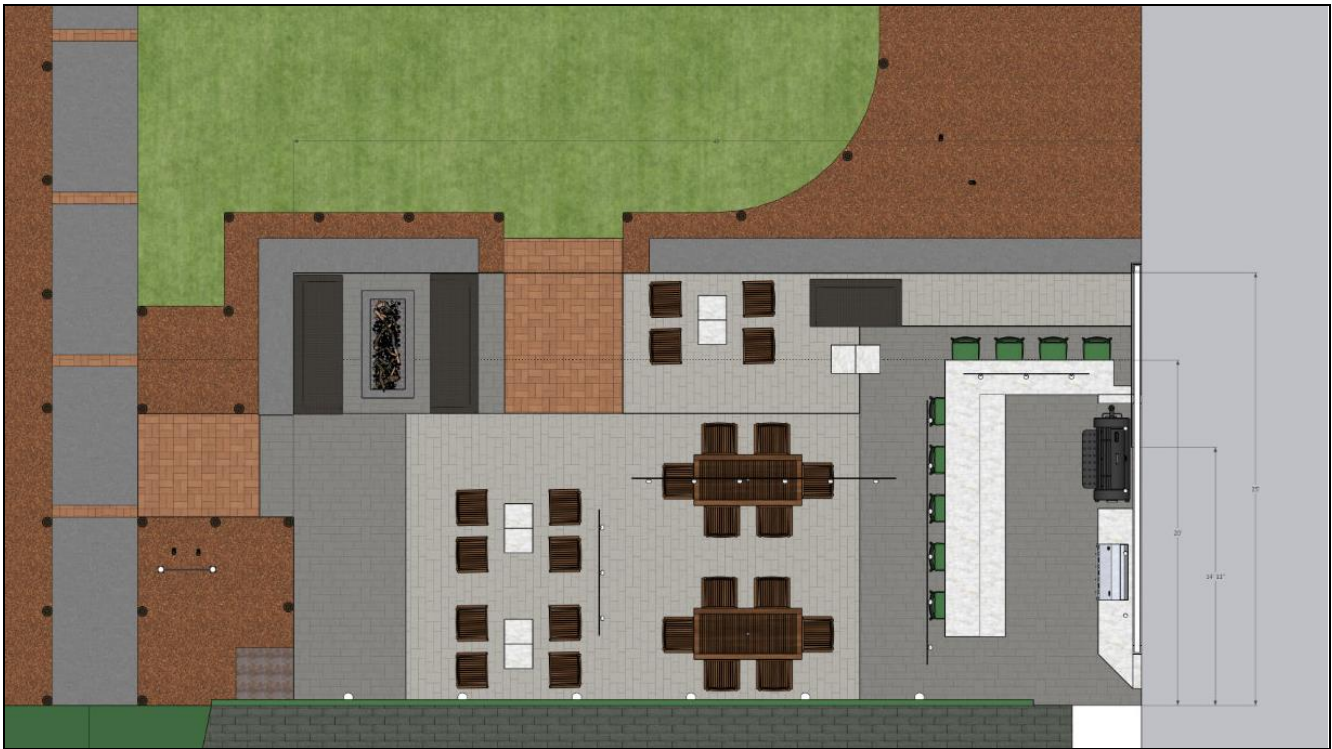
N → Applicant site plan, elevation and rendering. The gray shingles directly above denotes the edge of the clubhouse's roof

- Additional details for the proposed design, including legible dimensioned site plan and elevation, a planting plan that will include new trees near the north property line, lighting plan and details of a perimeter fence will be submitted for staff review.

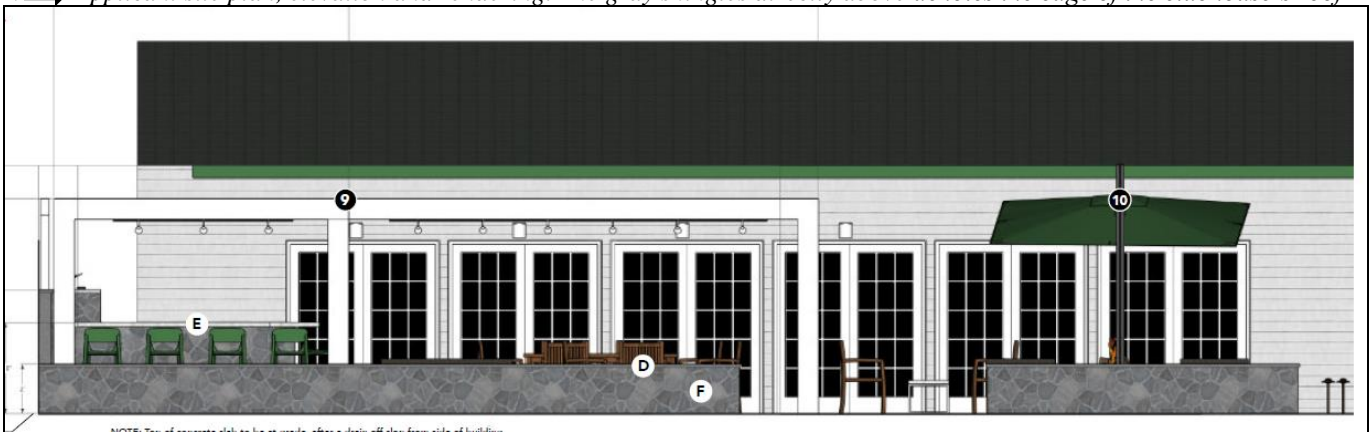
Looking east toward the clubhouse.

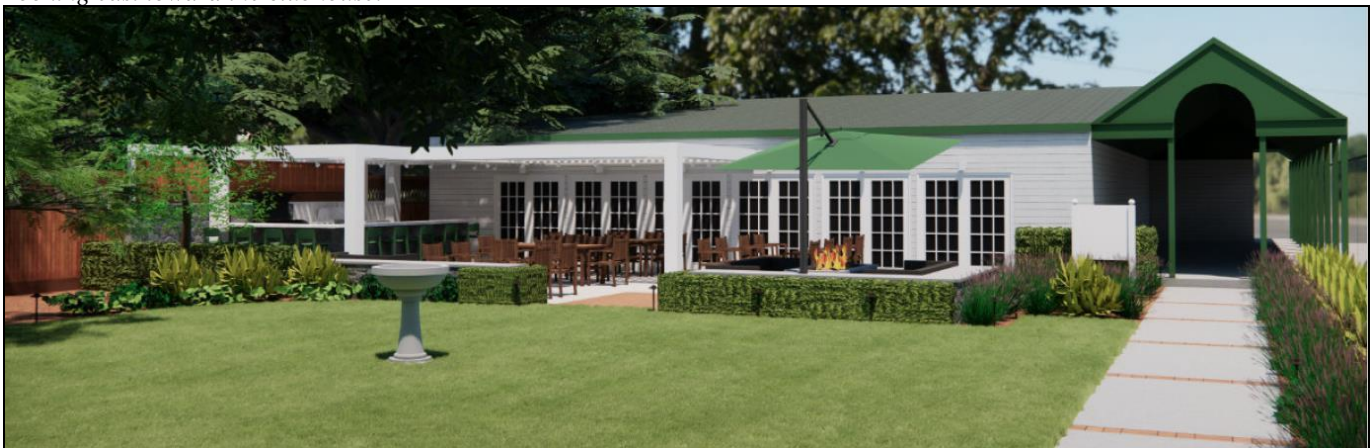
This rendering offers the best visual aid on how the area could look upon completion.

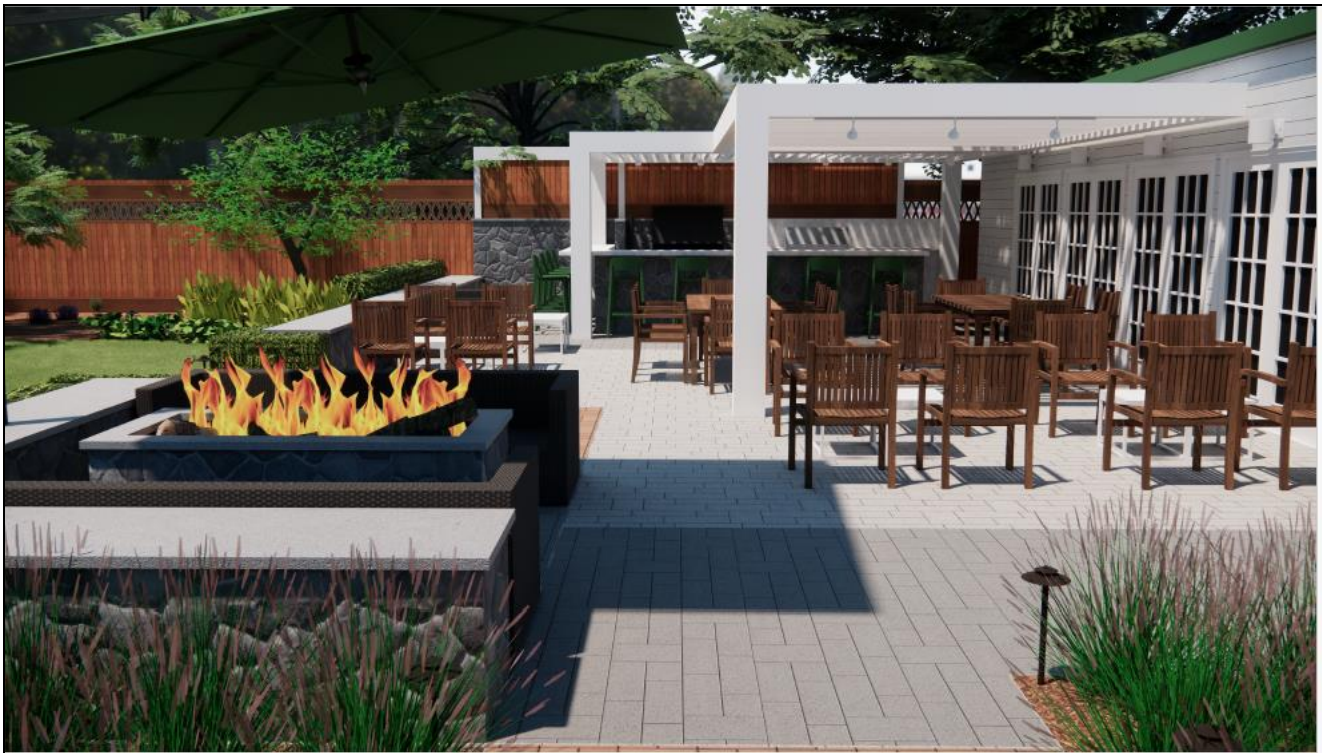
Applicant drawings.

PATTERNS		COLORS		MATERIALS	
A

<p>BRICKFORM BASKET WEAVE USED BRICK FM-5200S-PRO 18.375" X 30.75"</p>	A

<p>BRICKFORM ARTESIAN (CONCRETE) STAIN DRIED THYME AS-1700</p>	D

<p>SILVER CREEK STONENWORKS INDIANA LIMESTONE CONCRETE SEAT 24 in W x 12 D. W x 2.25 in. H</p>
B C

<p>BRICKFORM TUSCANY STONE FM-1775S-PRO 28" X 40"</p>	B

<p>BRICKFORM ARTESIAN (CONCRETE) STAIN PEWTER AS-2000</p>	F

<p>STONE FASCIA FIELD STONE - RUSTIC Mountain View Stone field stone rustic is a classic natural stone profile.</p>
		C

<p>BRICKFORM ARTESIAN (CONCRETE) STAIN SANDBANK AS-1200</p>	E

<p>SOLID SURFACE COUNTER-TOP Ultra Durable Counter-top Sample in Natura. Dekton is an ultra-compact porcelanic surface inspired by the beauty of natural stone with an optimized manufacturing process to achieve high performance.</p>

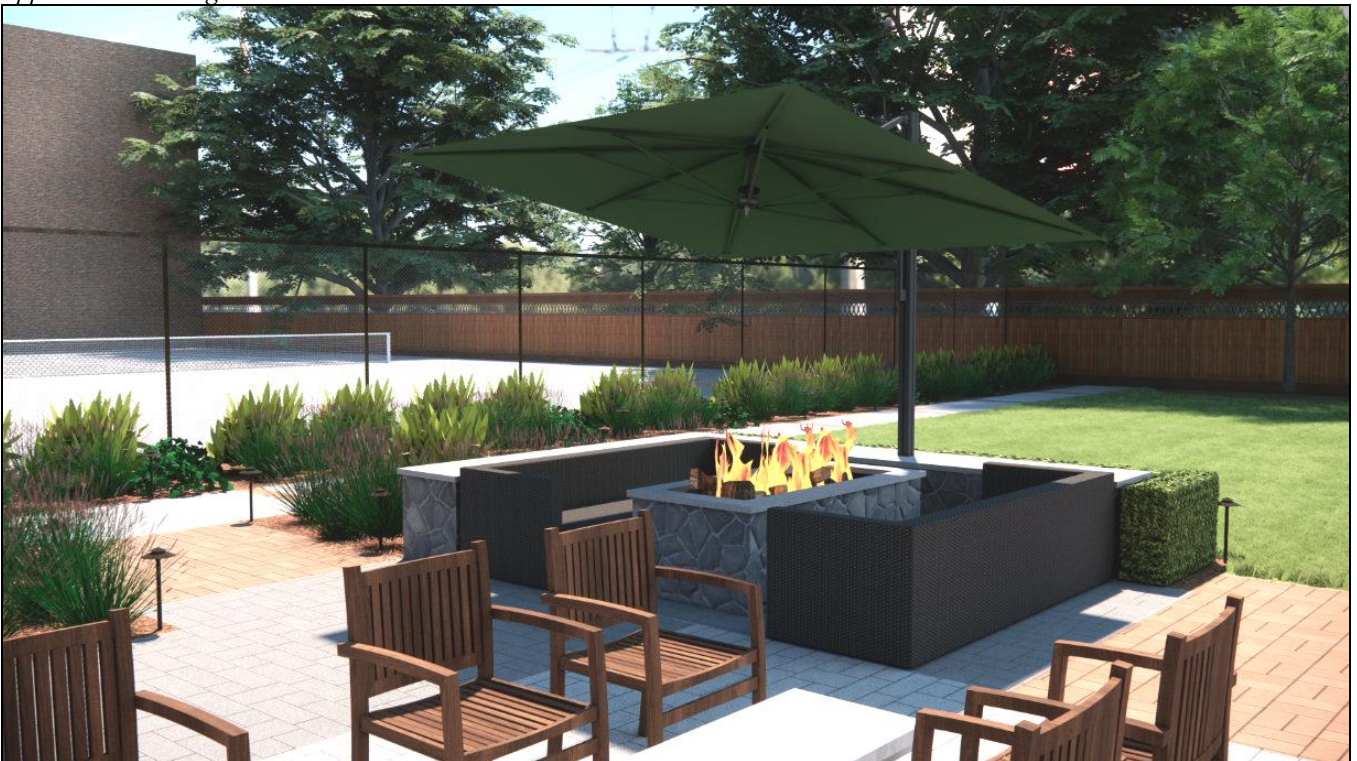
- The renderings show a new fence running the perimeter of the parcel, yet the fence is not drawn on the yard plan, it is not listed in the scope of work, nor were cut sheets submitted on the fence's design, material, finish and height.
