# 13 PRESERVATION BRIEFS

## The Repair and Thermal Upgrading of Historic Steel Windows

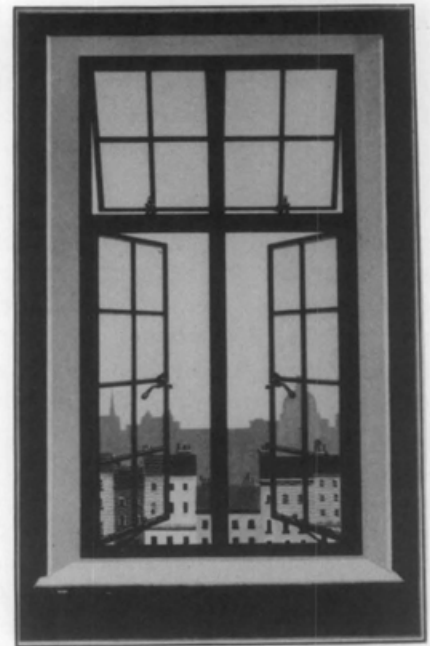
The Secretary of the Interior's "Standards for Rehabilitation" require that where historic windows are individually significant features, or where they contribute to the character of significant facades, their distinguishing visual qualities must not be destroyed. Further, the rehabilitation guidelines recommend against changing the historic appearance of windows through the use of inappropriate designs, materials, finishes, or colors which radically change the sash, depth of reveal, and muntin configuration; the reflectivity and color of the glazing; or the appearance of the frame.

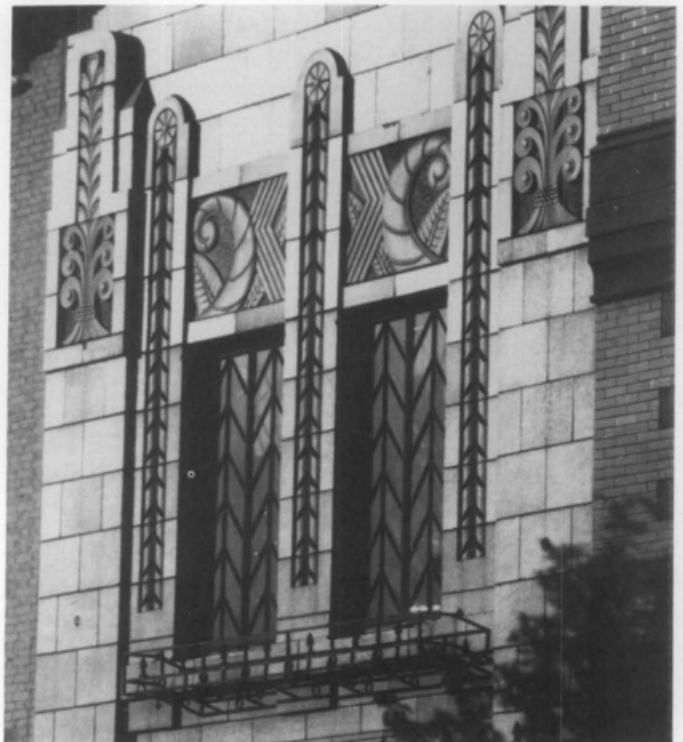
*Fig. 1 Often highly distinctive in design and craftsmanship, rolled steel windows play an important role in defining the architectural character of many later nineteenth and early twentieth century buildings. Art Deco, Art Moderne, the International Style, and Post World War II Modernism depended on the slim profiles and streamlined appearance of metal windows for much of their impact. Photo: William G. Johnson.*

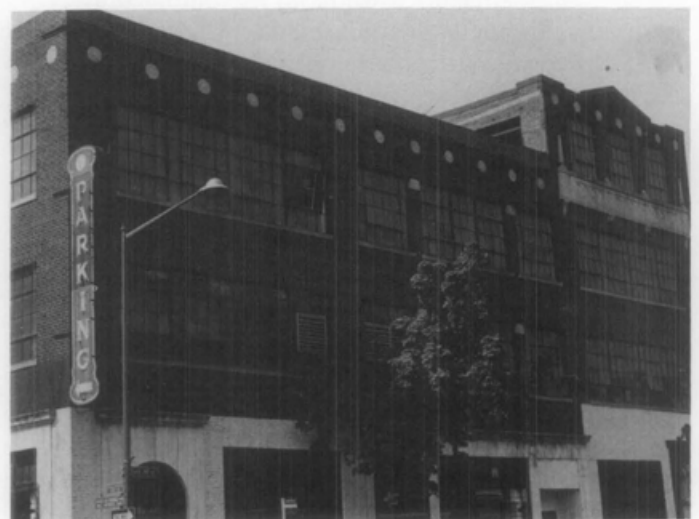
Fig. 5 Windows often provide a strong visual element to relatively simple or unadorned industrial or commercial buildings. This design element should be taken into consideration when evaluating the significance of the windows. Photo: Michael Auer.

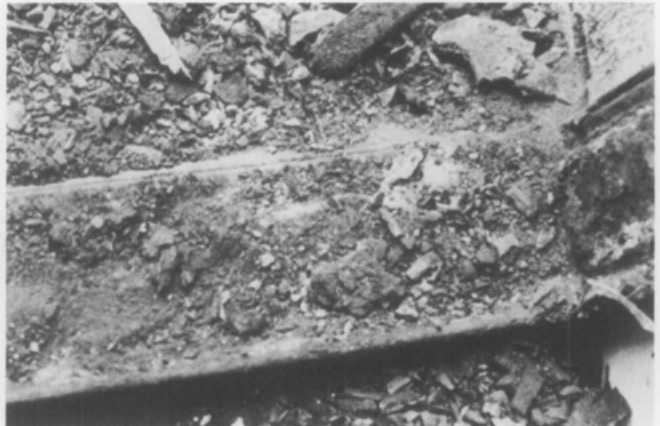
Fig. 6 d. View looking down towards the sill. The subframes appeared very rusted, but were in good condition once debris was vacuumed and surface rust was removed, in place, with chemical compounds. Where necessary, epoxy and steel filler was used to patch depressions in order to make the subframe serviceable again.

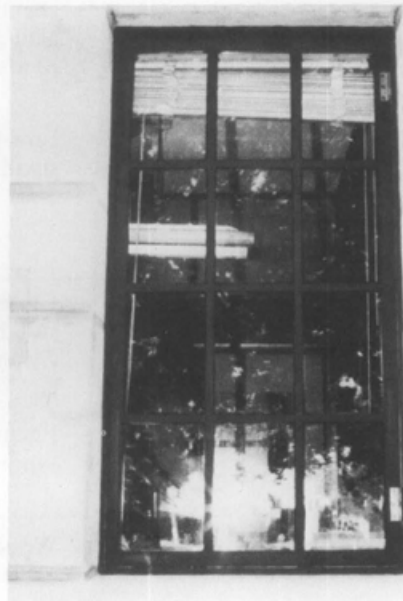
Fig. 6 f. View from the outside of the completely refurbished window. In addition to the steel repair and the installation of vinyl weatherstripping, the exterior was caulked with polyurethane and the single glass was replaced with individual lights of thermal glass. The repaired and upgraded windows have comparable energy efficiency ratings to new replacement units while retaining the historic steel sash, frames and subframes.

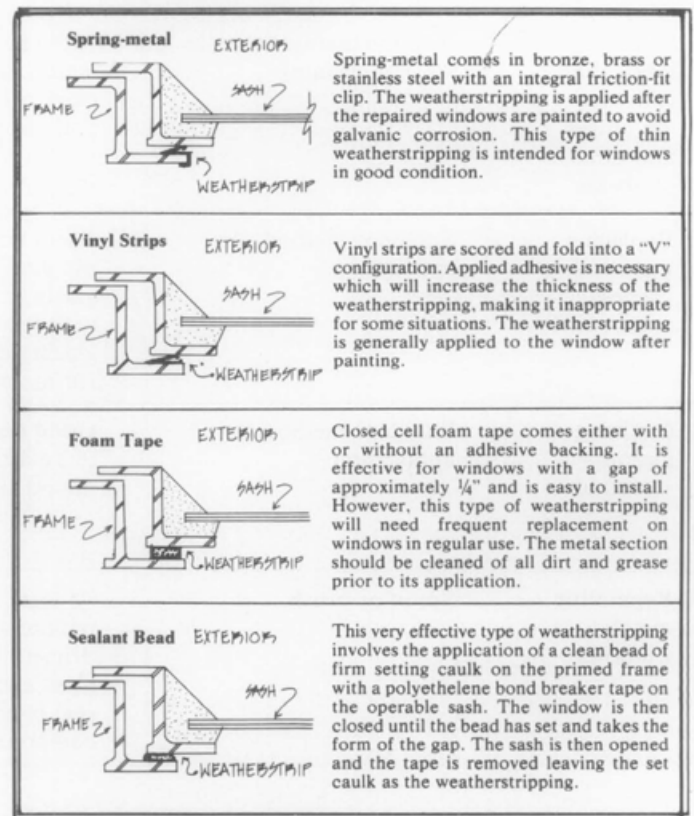
Fig. 8 APPROPRIATE TYPES OF WEATHERSTRIPPING FOR METAL WINDOWS. Weatherstripping is an important part of upgrading the thermal efficiency of historic steel windows. The chart above shows the jamb section of the window with the weatherstripping in place. Drawings: Sharon C. Park, AIA.

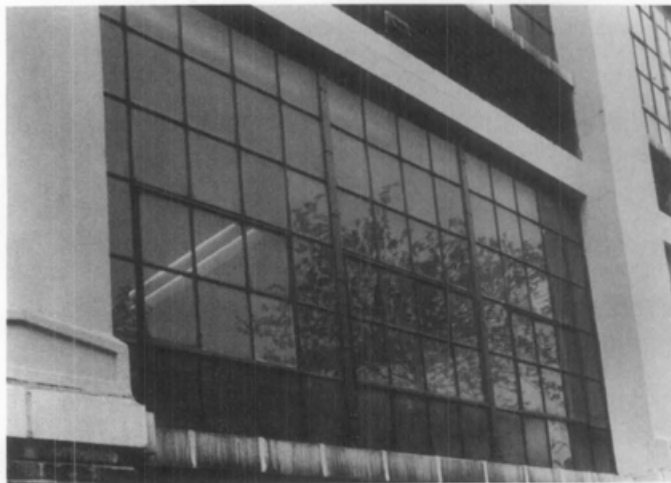
Fig. 10 b. Close-up view of the new replacement steel windows which matched the multi-lighted originals exactly. Photo: Charles Parrott.
