Project Review Request Documentation – 1681/1683 Atkinson St.

Description of Project

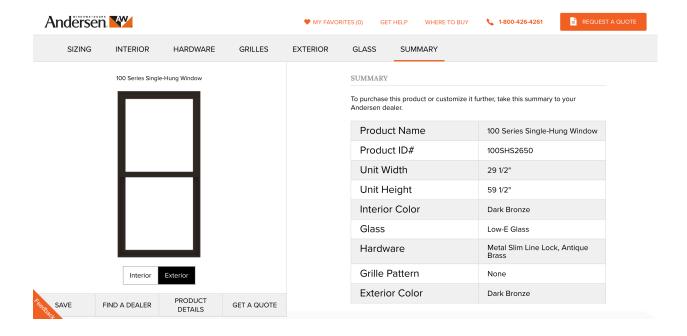
Andersen Windows: 100 Series Single-Hung Window (for all double-hung windows)

Dark Bronze color, to match original dark stained woodwork (some of which is still preserved in the interior of the home). Sizes will be the same as existing windows, since Andersen builds them custom to within a quarter of an inch. Specs for the exact width of the sashes is not available, but we had a store employee measure the floor display, and it was approximately 1.5 inches, comparable to the original windows.

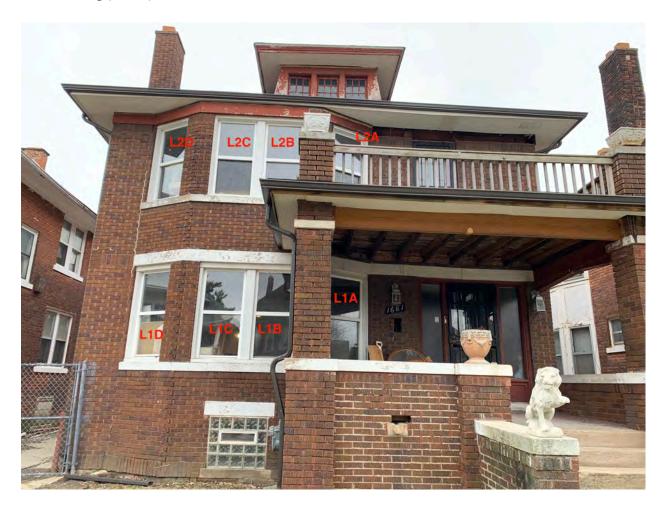
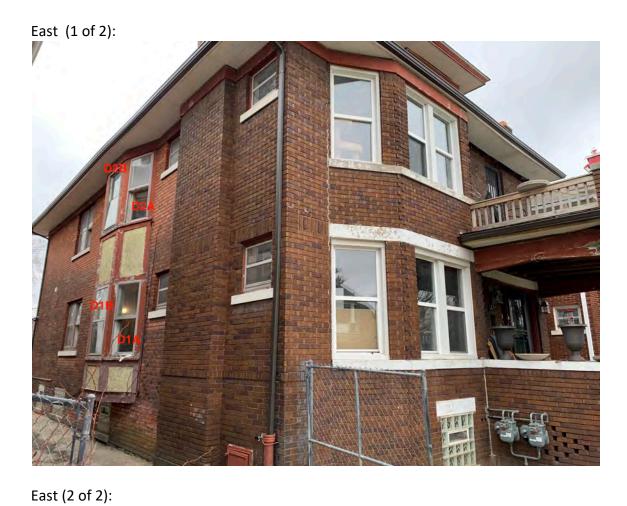
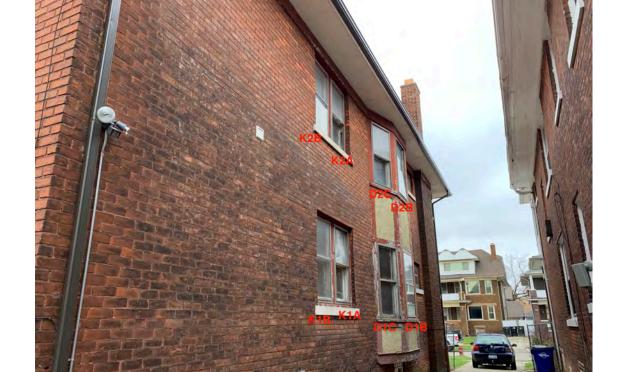
Street-facing (north):

Street-facing living room windows are cheap, broken (glass and/or latches are broken, or seals have failed), white vinyl single-hung windows. Remainder of windows included in this request are wood, single-paned windows that are broken, drafty, and/or impossible to open (or to fully close), that have been painted several too many times, and that are rotting in places. Most were probably originally double-hung, though all top sashes are now immobile. There are a handful of small wood windows that are in-swing casements. Aluminum storm windows are on all wood windows, but almost all are missing the glass, and/or the frames themselves are broken. To get through the winter we literally packed the gaps in the windows with fiberglass insulation and tried to seal them up as best we could with contractor bags and duct tape.

The one additional visual change we are requesting is to add a grille pattern to the top sashes of the street-facing (currently vinyl) single-hung windows to accentuate the Arts & Crafts style of the house. We have not been able to find any documentation of what the grille pattern was on the original windows, but based on Arts & Crafts/Prairie style architecture and the houses on our block with original street-facing windows, we would like to use the pattern circled below in the Brochure/Cut Sheets section. We are willing to consider other grille patterns if that will affect the acceptance of our proposal.
