Detroit Historic Commission 2 Woodward Ave. Suite 808 Detroit, MI. 48226

Project Review Request RE: 14500 Rosemont

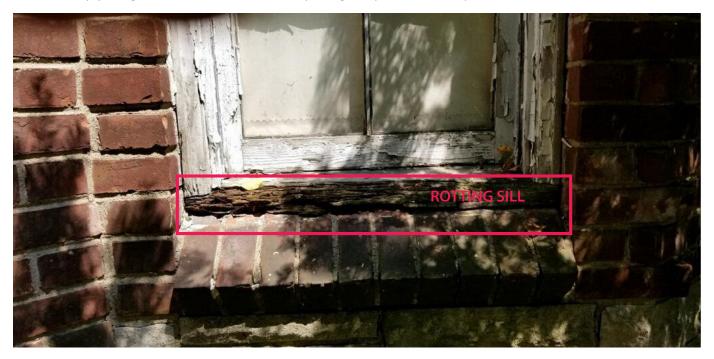
In Window 2, we can already see signs of the sill rotting away in the bottom left. The rot damage has already been so deeply integrated in to this wood that repairing this piece isn't an option.

From our experience, we can tell it's only a matter of time before each window ends up in the state of the first window. At this point, in our professional opinion, we cannot see a way to repair these windows. The damage to them is so deeply ingrained that any repairs made to them would not be dealing with the core issue, preventing further damage to the home. We are looking for a permanent fix which is why we are proposing to use vinyl windows. These vinyl windows will have the same look as the old wood windows. We are proposing to use simulated divided lite windows which have the muntin on the outside of the windows. I've previously sent a brochure of the windows, but I'll also include pictures of the style of window we propose to use.

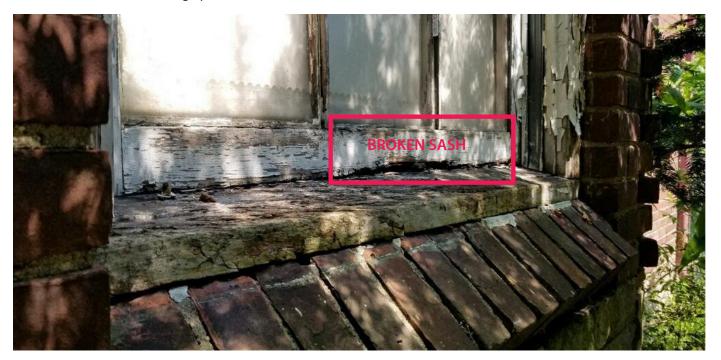
Window 3 is also suffering from the same things as the previous two windows. The sill is discolored from rot and there are cracks starting to form in it. A small section of the sash has broken off, which as we've seen in Window 1, can become a huge problem
