**RENDERING OF  
EAST ELEVATION**

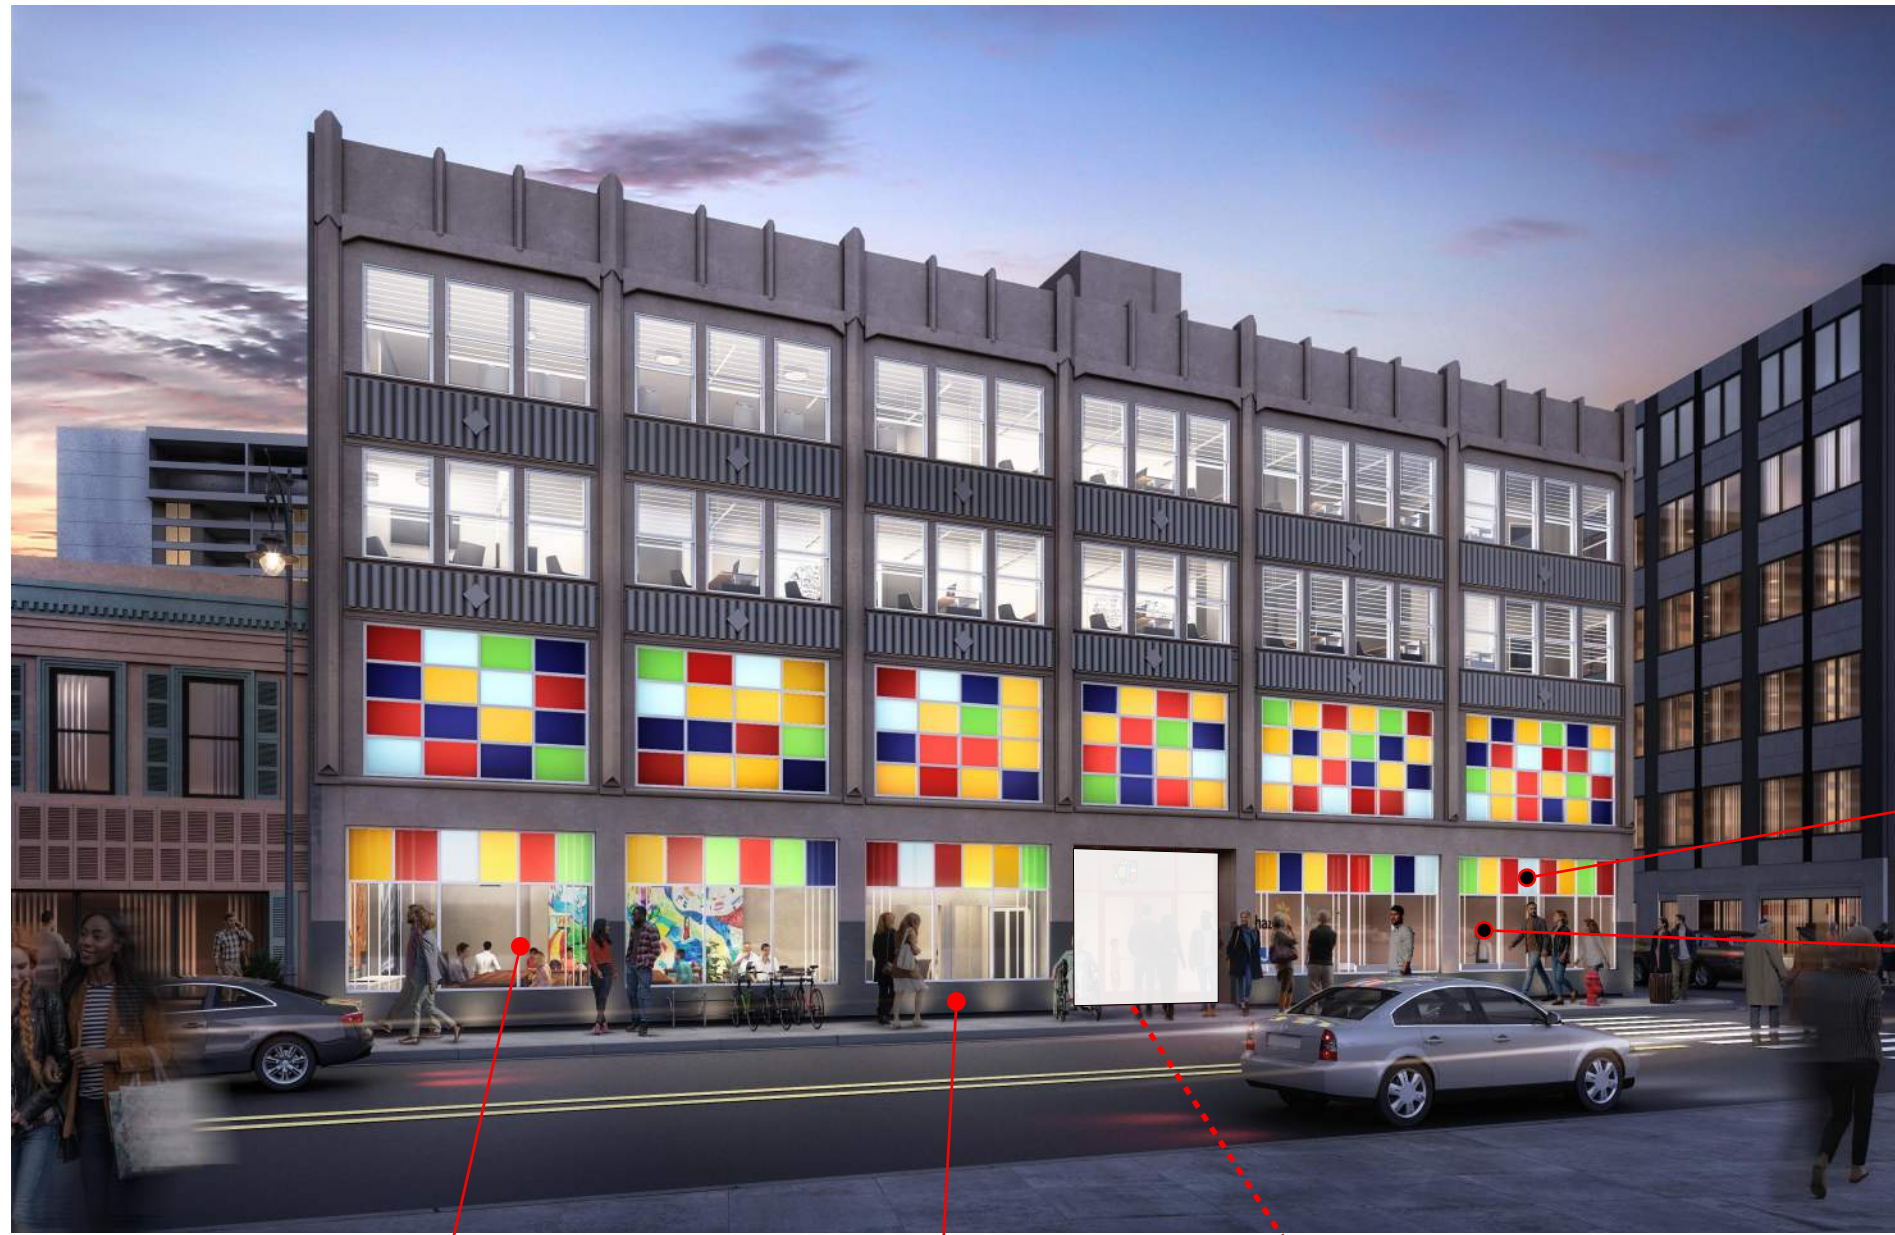
Ballistic Level 3  
insulated glass unit  
transom with colored  
film on interior side.

Ballistic Level 3  
insulated glass unit.

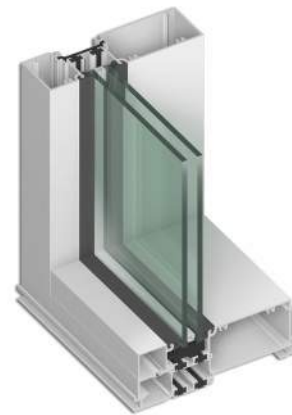
**NEW CLEAR ANODIZED  
STOREFRONT SYSTEM**

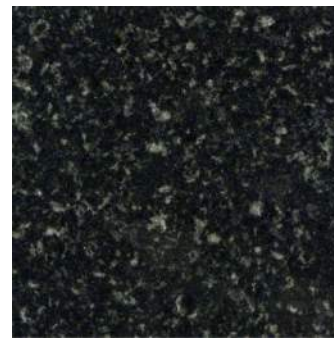
**BLACK GRANITE BASE  
BELOW NEW STOREFRONT.**

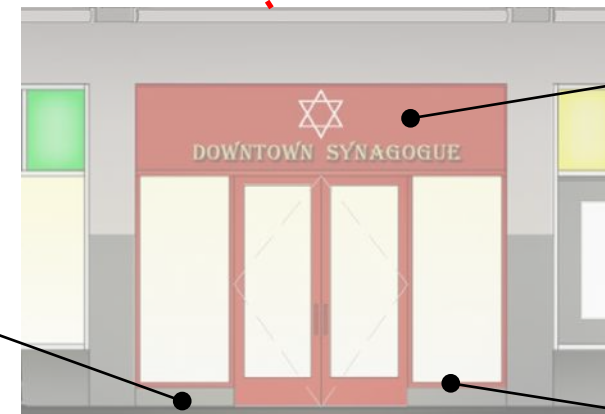
**PROPOSED NEW ENTRY.**

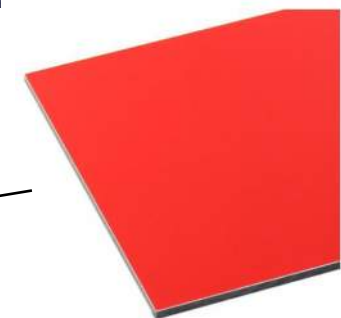
**RED ALUMINUM  
COMPOSITE  
PANEL**

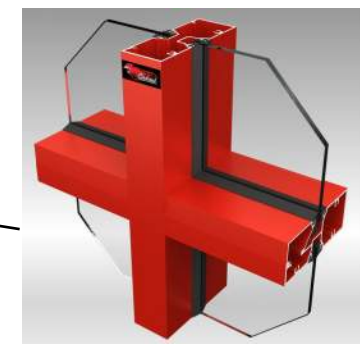
**RED  
STOREFRONT  
SYSTEM**
