7650 E. JEFFERSON AVENUE, DETROIT MI

R. Thornton Brodhead Naval Armory

Narrative Letter Prepared for Detroit Economic Growth Corporation by Kraemer Design Group

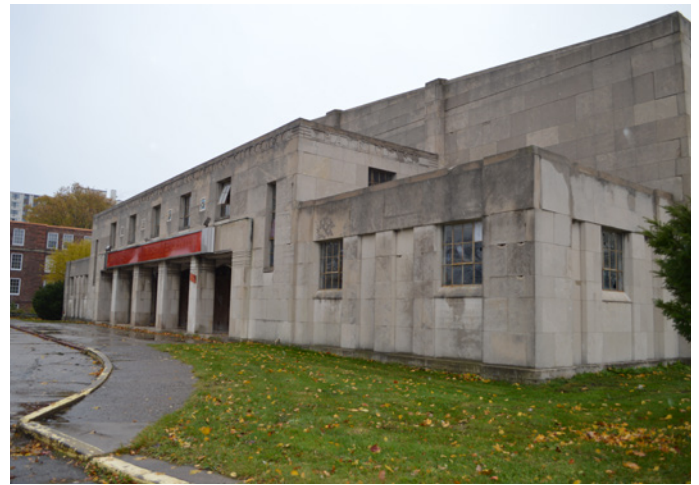
Primary facade of the Brodhead Naval Armory, 2022

Signage Condition: There is a non-historic red Plexiglas (or similar material) sign currently installed over the historic carved stone signage band above the main entrance doors. Additionally, there is a historic sign carved into a band just below the parapet of the main entrance vestibule which reads "HONOR PEACE PATRIOTISM THE BEST DEFENSE OF A DEMOCRACY IS A WELL TRAINED CITIZENRY." The historic sign under the red Plexiglas—which, according to historic photographs, reads NAVAL ARMORY—is believed to be extant, carved into the frieze above the doors.

Signage Scope of Work: The carved signage band at the parapet will be cleaned and retained. The non-historic red Plexiglas sign will be removed from the façade. If the historic NAVAL ARMORY sign remains, it will be retained and rehabilitated. Signage for The Parade Company and their significant donors is anticipated on the building but has not yet been confirmed. The signage currently shown in the renderings is conceptual. The applicant will obtain HDC approval before installing any signage on or near the building.

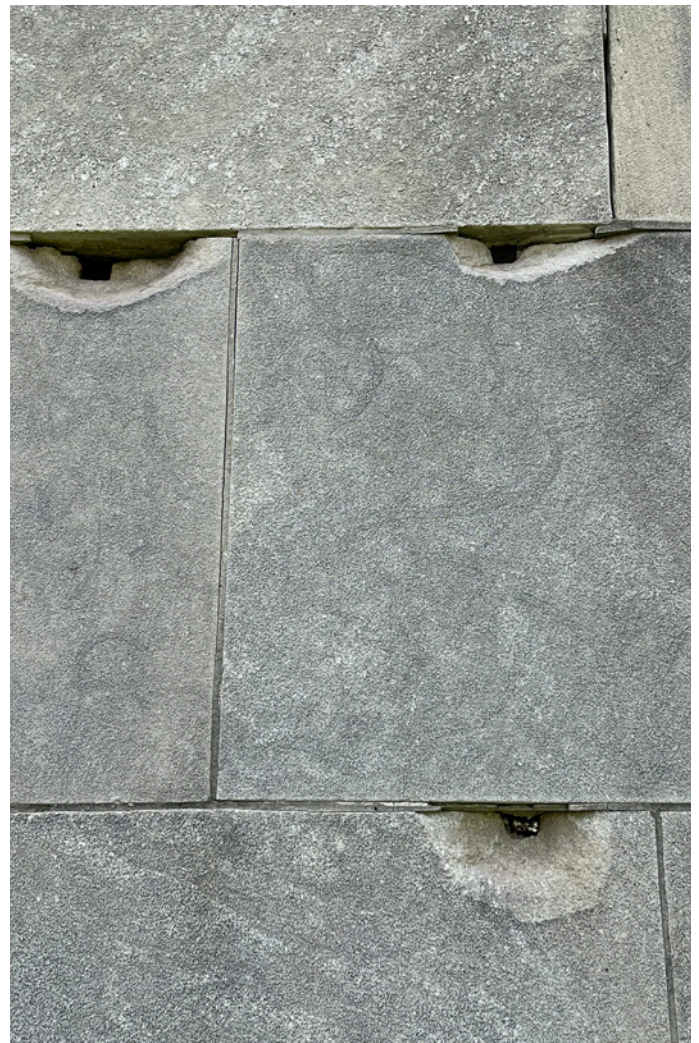
Masonry Condition: While the exterior masonry of the North Block is generally intact, over the years it has sustained environmental damage that has been neither remediated through repair nor proactively averted through periodic facility maintenance. As a result, deterioration of the exterior is visible in many locations. The limestone panels are heavily stained in places, require repointing, and will require cleaning. Please see Exhibit A, Figures 1-21. There is consistent spalling of the limestone at many of the support clips. This spalling has been attributed to incorrect mortar used in previous joint repair efforts. Additionally, several of the exterior architectural details, including the Pewabic pottery tile and memorial elements, have either been damaged or removed. On the west façade of the north block, there used to be a bas relief plaque memorializing Edwin Denby. This plaque and a portion of the stone surround was removed by vandals sometime after 2004—one section of the stone surround (comprised of an engaged fluted column) is still extant. The stone surround in this area is damaged and the structural elements of the building are now exposed—see Exhibit A, Figure 10.

Detail of Masonry, 2022

Masonry Scope of Work: After a review of the exterior masonry by RAM Construction Services it was determined that 100% of the exterior limestone mortar joints will require replacement. Please see Exhibit D which includes RAM’s masonry report along with additional photographs. In addition to repointing the entire exterior, severely damaged limestone pieces will be replaced with salvaged limestone taken from the south block of the building. Dutchmen repairs (inserting new stone where extant stone is damaged beyond repair) will be installed in areas where stone is missing or excessively damaged. The entire façade will be cleaned, and all graffiti will be removed via a water pressure wash. The Pewabic tiles will be cleaned, retained, and repaired. On the west façade, all extant elements around the removed Edwin Denby plaque will be retained and salvaged limestone from the south block will be used to infill the missing components. The salvaged limestone will be set 1” proud of the extant limestone to differentiate the replacement stone from the historic limestone cladding. The applicant plans to install a plaque explaining the history and significance of the Denby memorial and to explain why it is no longer present—the exact details of this plaque have not been fully developed but HDC will be consulted before a new plaque is installed.

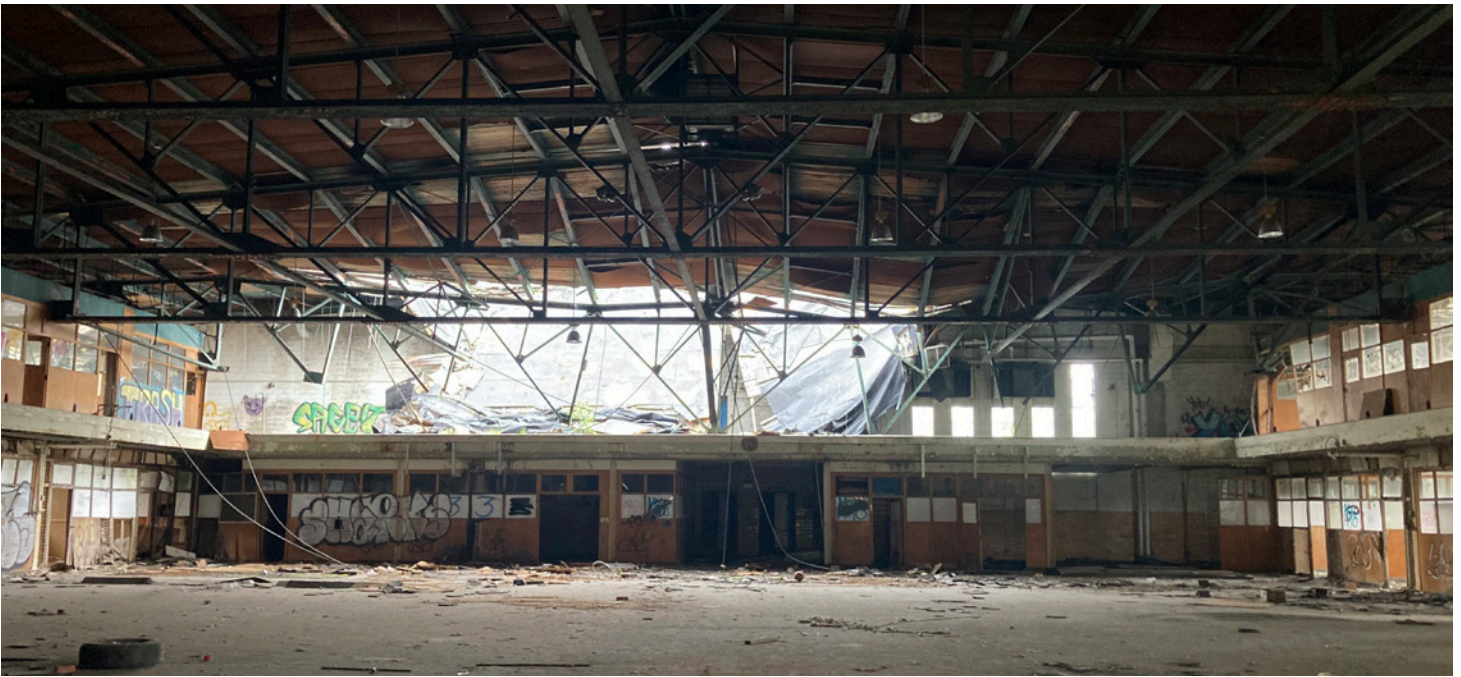
Drill Deck, 2022

Drill Deck Condition: The drill deck is a large open gymnasium-type room with a severely deteriorated wood floor, flat plaster and glazed block walls, and a partially collapsed roof. The plaster walls are in fair condition while the glazed block walls in the drill deck are in good condition although some areas have been painted over. The drill deck is ringed by a series of non-historic office partition walls which create offices and meeting rooms above and below the mezzanine. These partition walls and offices are in poor condition—see Exhibit A, Figures 30, 31, 33.

Drill Deck Scope of Work: The drill deck will receive a new flooring material as the current wood flooring is severely deteriorated. The glazed block walls around the perimeter of the drill deck will be retained. A new tiered seating arrangement will be installed on the drill deck floor at the northwest corner of the space to provide seating for educational presentations and tours. The non-historic partition walls around the edges of the drill deck will be removed to accommodate new partitions for a volunteer room, two multipurpose rooms, and a retail space. The corridor located directly south of the drill deck floor will be rehabilitated to provide access to service spaces including costume storage, costume workshop, restrooms, lockers, catering, and offices.

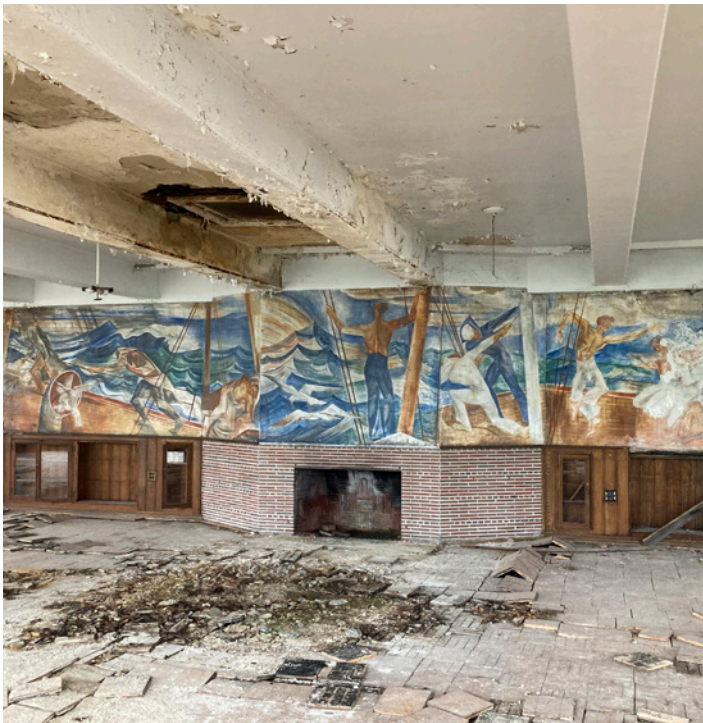
Wardroom showing David Fredenthal mural, 2022

Fresco mural by David Fredenthal (Wardroom): As examined by Anthony Kartsonas, the Fredenthal mural in the wardroom is in "overall fair [condition] except for the eastern panel which is poor. Amazingly, the actual paint finish of the fresco is mostly stable with limited areas that are loose or flaking except for the eastern panel. The biggest issue with the fresco mural is the structural stability of the plaster." See Exhibit C for a full description and analysis of the condition of this mural.

Fresco mural by David Fredenthal (Wardroom): The plan is to save and remove the entirety of this mural although there are questions as to whether the severely deteriorated area at eastern end of the mural can be successfully salvaged due to its condition. Water infiltration at the eastern end of the mural has severely damaged the panel in that area. Please see Exhibit C for a full report on the recommendation considerations as described by Mr. Kartsonas. Mr. Kartsonas discusses many of the options and variables and also provides diagrams for the condition of the mural.

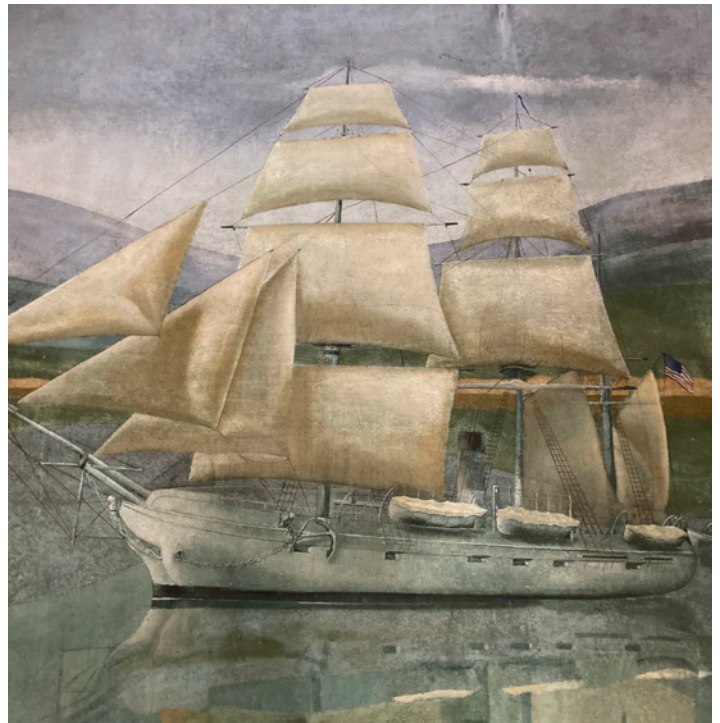
Detail from the Edgar Yaeger mural, 2022

the dining room by Yaeger covers 174 linear feet of wall surface and these murals are painted onto canvas and applied to a plaster substrate. From Anthony Kartsonas' report concerning the condition of the murals: "At first glance, the canvas murals appear to be in fair condition with minimal loss or damage." Kartsonas goes on to elaborate that because the canvas murals were applied to the wall with lead paste (as opposed to the wheat pastes) the bulk of the murals have remained relatively attached to the substrate which has prevented severe detachment and warpage. That being said, "there are some random areas of loose canvas. The largest is an area of canvas delamination on the south wall on the western end." There are also areas of significant flaking paint. See Exhibit C for a full description and analysis of the condition of this mural.

Canvas mural by Edgar Yaeger (Dining Room): The canvas murals in the dining room present unique removal challenges due to the type of glue used to adhere the canvas to the wall. Please see page 10-11 in Exhibit C for a full report on the glue type, the challenges it presents, and the recommendation considerations as described by Mr. Kartsonas. The adhesive used to hang the canvas murals on the walls is lead-based which creates a much stronger bond that water soluble pastes more typically used for these types of installations. The lead-based adhesives create an exceptionally strong bond between the canvas and the wall which will greatly slow the removal process. Additionally, because

the adhesive is lead-based the conservation team will be required to wear protective gear during removal which may be a factor in the actual mechanics of how these canvases are removed. As Mr. Karstonas details, the process to remove these canvases will be highly labor intensive. Because of the extreme labor costs that would be inherent in a full removal of all 174 linear feet of this mural, it is proposed that a large panel or portion of this mural be salvaged. The exact portion and size of the panel(s) to be moved has not yet been decided and will likely depend upon a variety of factors once removal begins (e.g., condition upon beginning, condition as the removal process continues, condition of the canvas after removal, and the pace of the progress of removal). Once the removal process has begun, if it goes well and goes more quickly than anticipated, than it may be possible to save more of this mural—if that occurs then as much of the mural will be salvaged as possible. The applicant intends to maximize the amount of mural saved in this room based upon field conditions once the work begins.

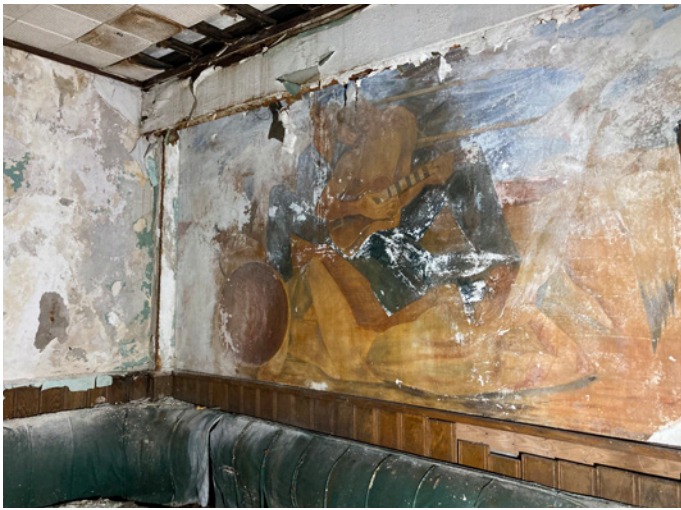
Fresco mural by David Fredenthal (Bar): The fresco mural by Fredenthal in the bar is in very poor condition: "The previous water infiltration has caused significant damage to the paint and plaster. There is severe water damage and loss, especially on the left side (north) of the mural. There is also significant plaster delamination, efflorescence, flaking paint, losses and discoloration on other areas of the mural as well." See Exhibit C for a full description and analysis of the condition of this mural.

Bar mural by David Fredenthal, 2022

Fresco mural by David Fredenthal (Bar): After the initial consultations with our experts, we believe this mural is too deteriorated to prioritize its removal and stabilization. The majority of this artwork has lost integrity due to missing material and faded paint and, as mentioned above, this is based on the standard of care within the conservation/art historian industry where artifacts with less than 40% integrity are not candidates for conservation. However, because this mural has the same construction method as the wardroom murals, the bar mural is identified by Mr. Kartsonas as a potential area to test the removal method proposed for the wardroom murals (see page 9 of the report at Exhibit C) to ensure the method is fully tested before trying to remove the murals in the wardroom. Because of this, this mural may be stabilized for removal, removed, and then, if removal is successful, may be stored along with the rest of the murals during the renovation of the north block. Note, that this plan will depend upon how the test run with this mural goes. The goal would be to test the removal process with the bar room mural to ensure the maximum chance of success with the wardroom mural and, in the process, hopefully save some of the bar mural as well.

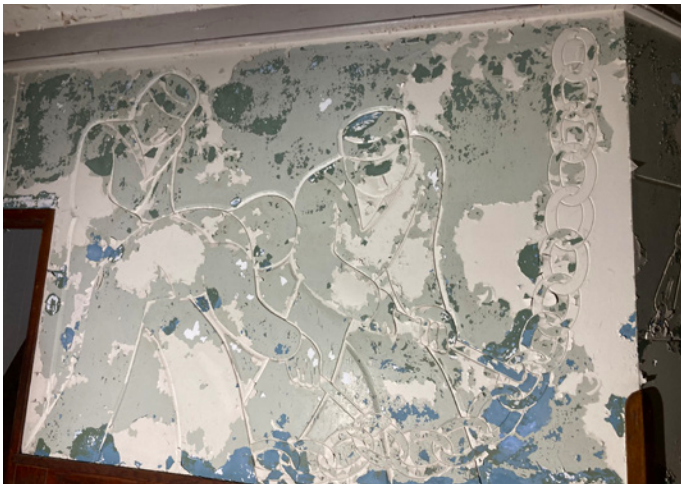
“No laboratory analysis was completed of the plaster, but it appears to be a standard gypsum plaster.” These relief panels are in fair to poor condition, depending on the location. “There is a large area of water damage on the north wall of the west corridor and a large loss at the pilaster in the east corridor where the plaster and lath are completely missing.” See Exhibit C for a full description and analysis of the condition of this mural.

Plaster Relief Mural by Gustav Hildebrand, 2022

Plaster relief mural by Gustav Hildebrand (1st Floor Corridor): Because of the deteriorated conditions of the relief murals, it is proposed that one panel of the Hildebrand mural be removed and rehabilitated. When The Parade Company initially began planning to acquire the Brodhead they originally intended to salvage and remove the tall sailor panel at the eastern end of the northern corridor, however, in just two years that panel has now deteriorated near the bottom and it is no longer the best candidate for conservation. Because of this, an alternate panel is proposed to be removed. The panel now identified for removal is located on the west wall of the corridor and it shows several sailors pulling a large

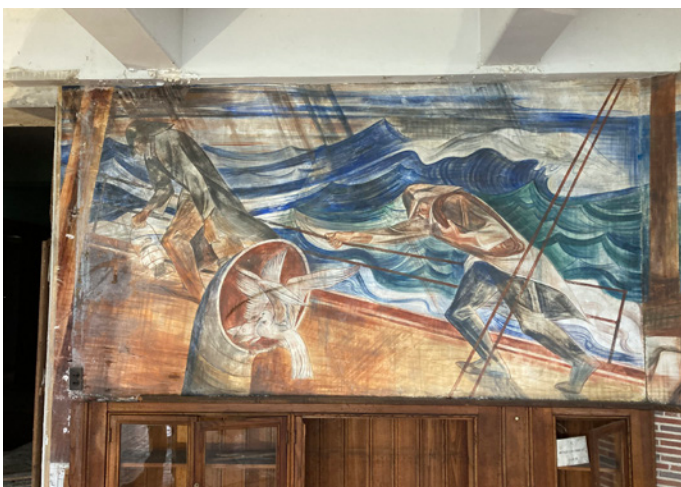
Detail of the Wardroom mural by David Fredenthal, 2022
