General notes on Window Renovations, walkway repair, and chimney painting from last submission.

Window Renovation – East Elevation (one photo):

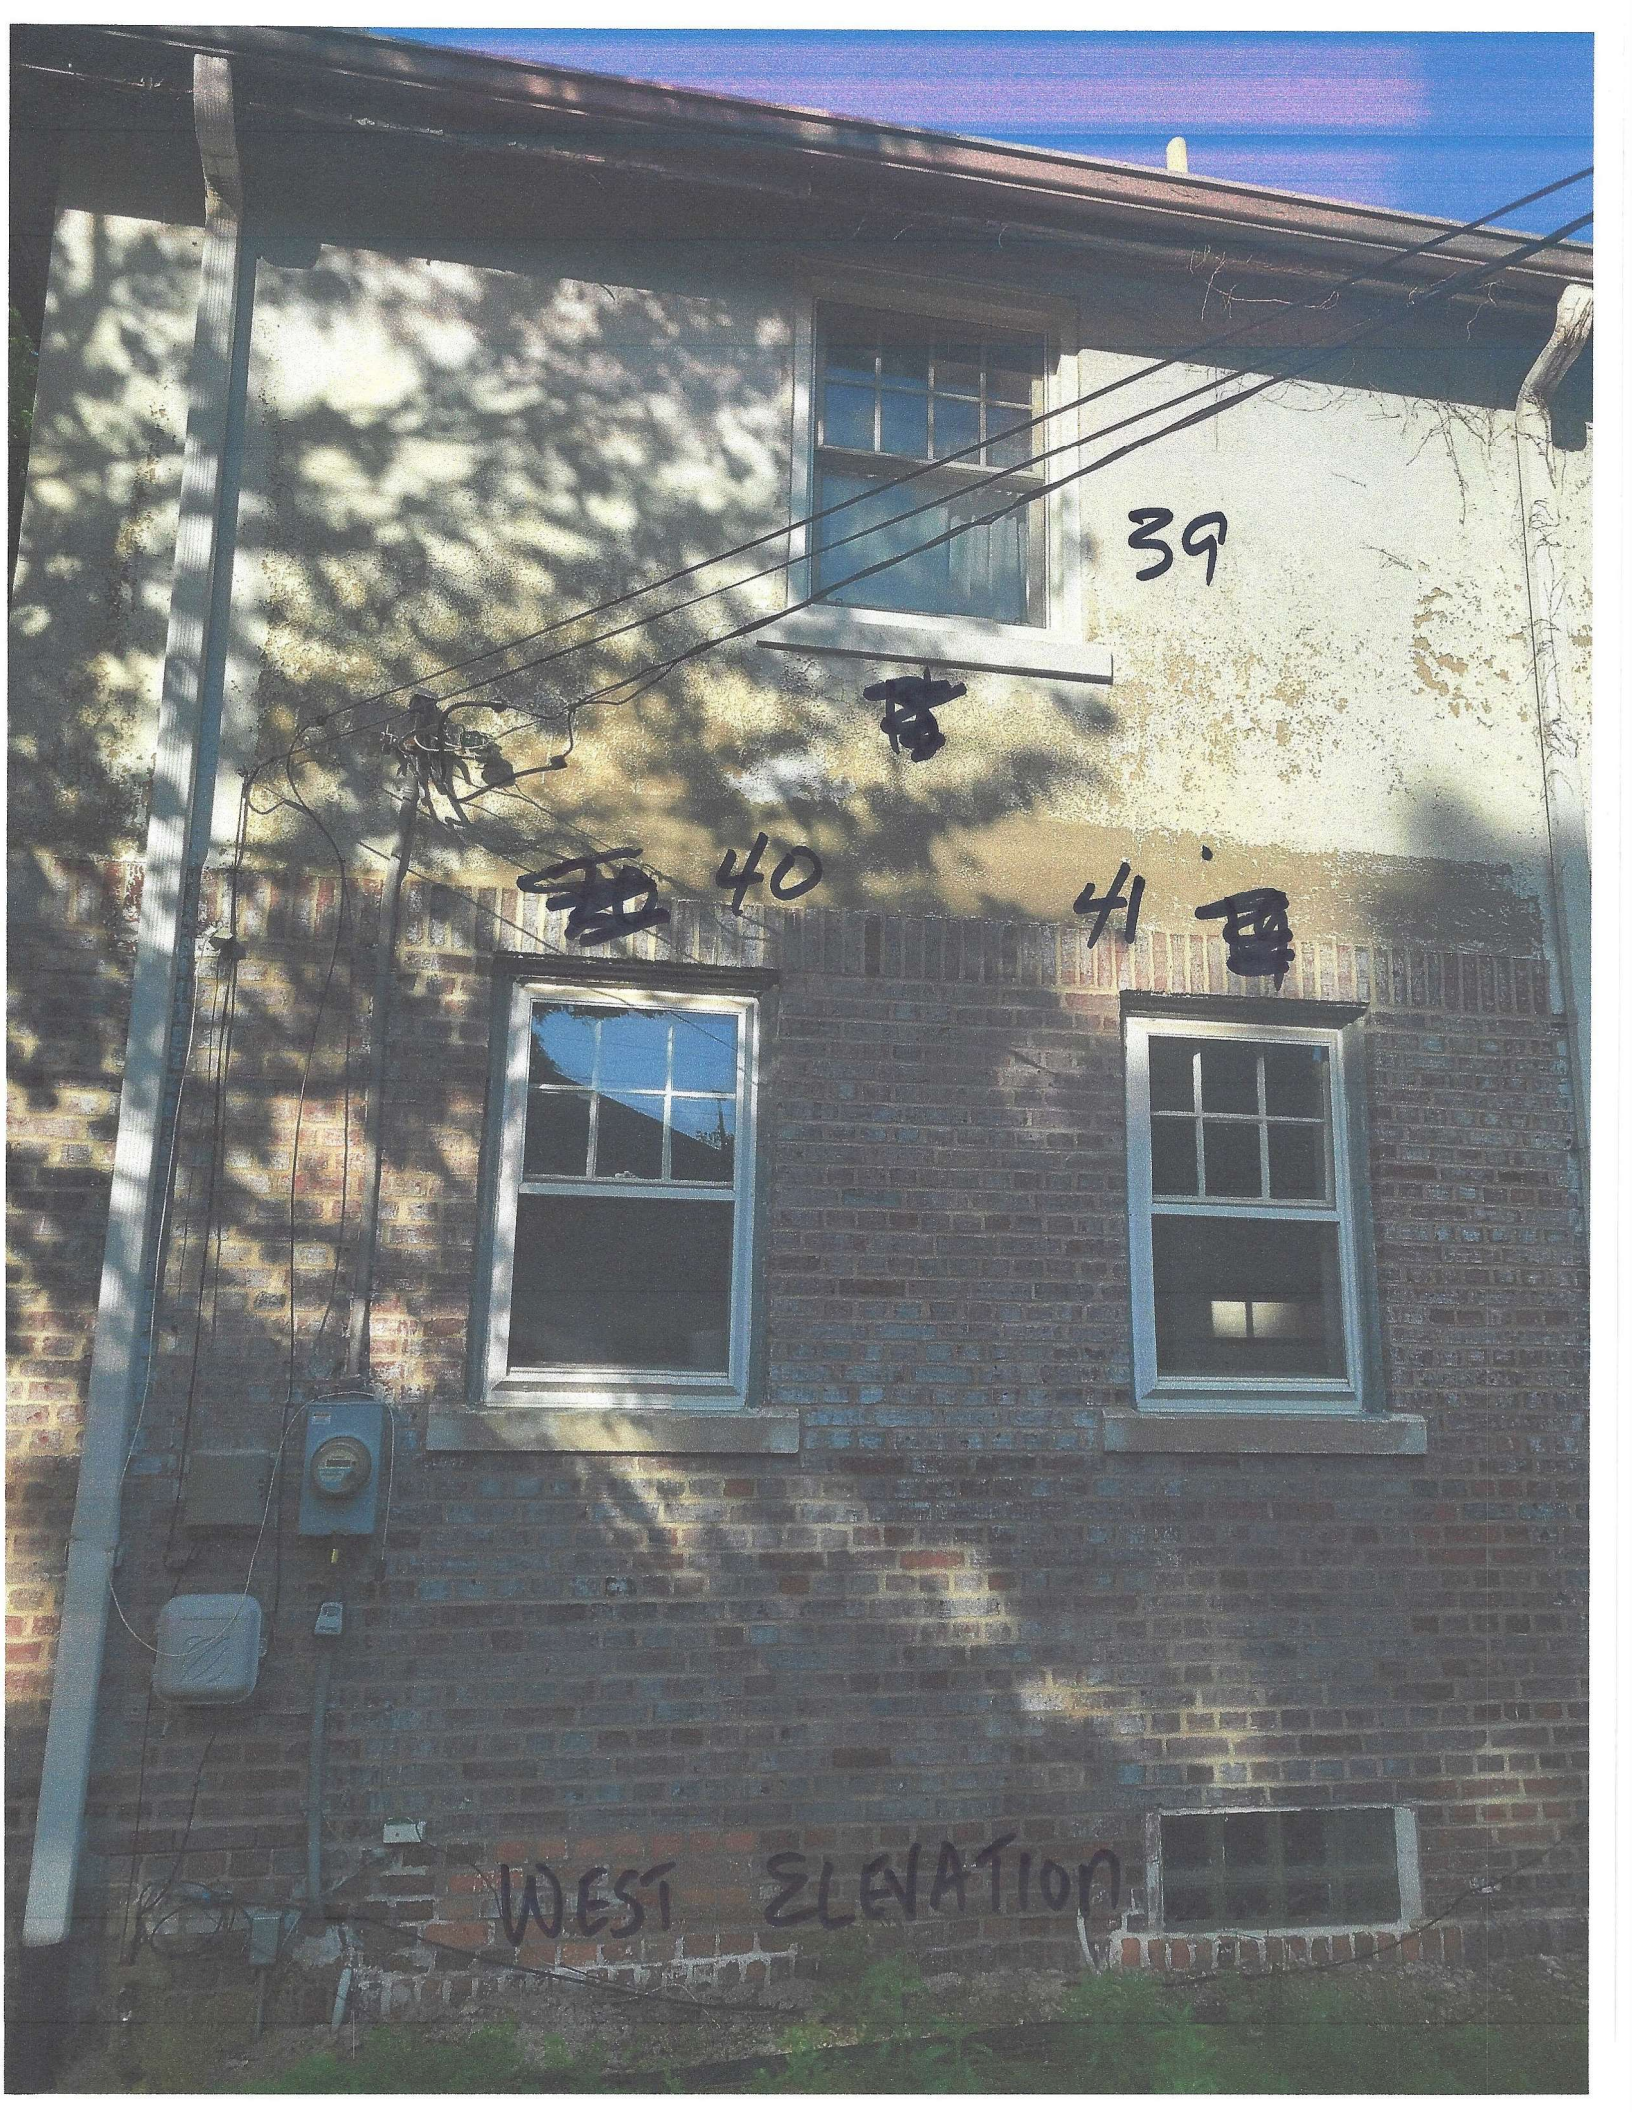
WEST ELEVATION

25, 26, 29, 38, 40, 41 – Original windows still installed, will be removed and renovated.

All remaining windows on these elevations will be left as is. All break metal trim will be removed and the trim underneath will be repaired and painted.

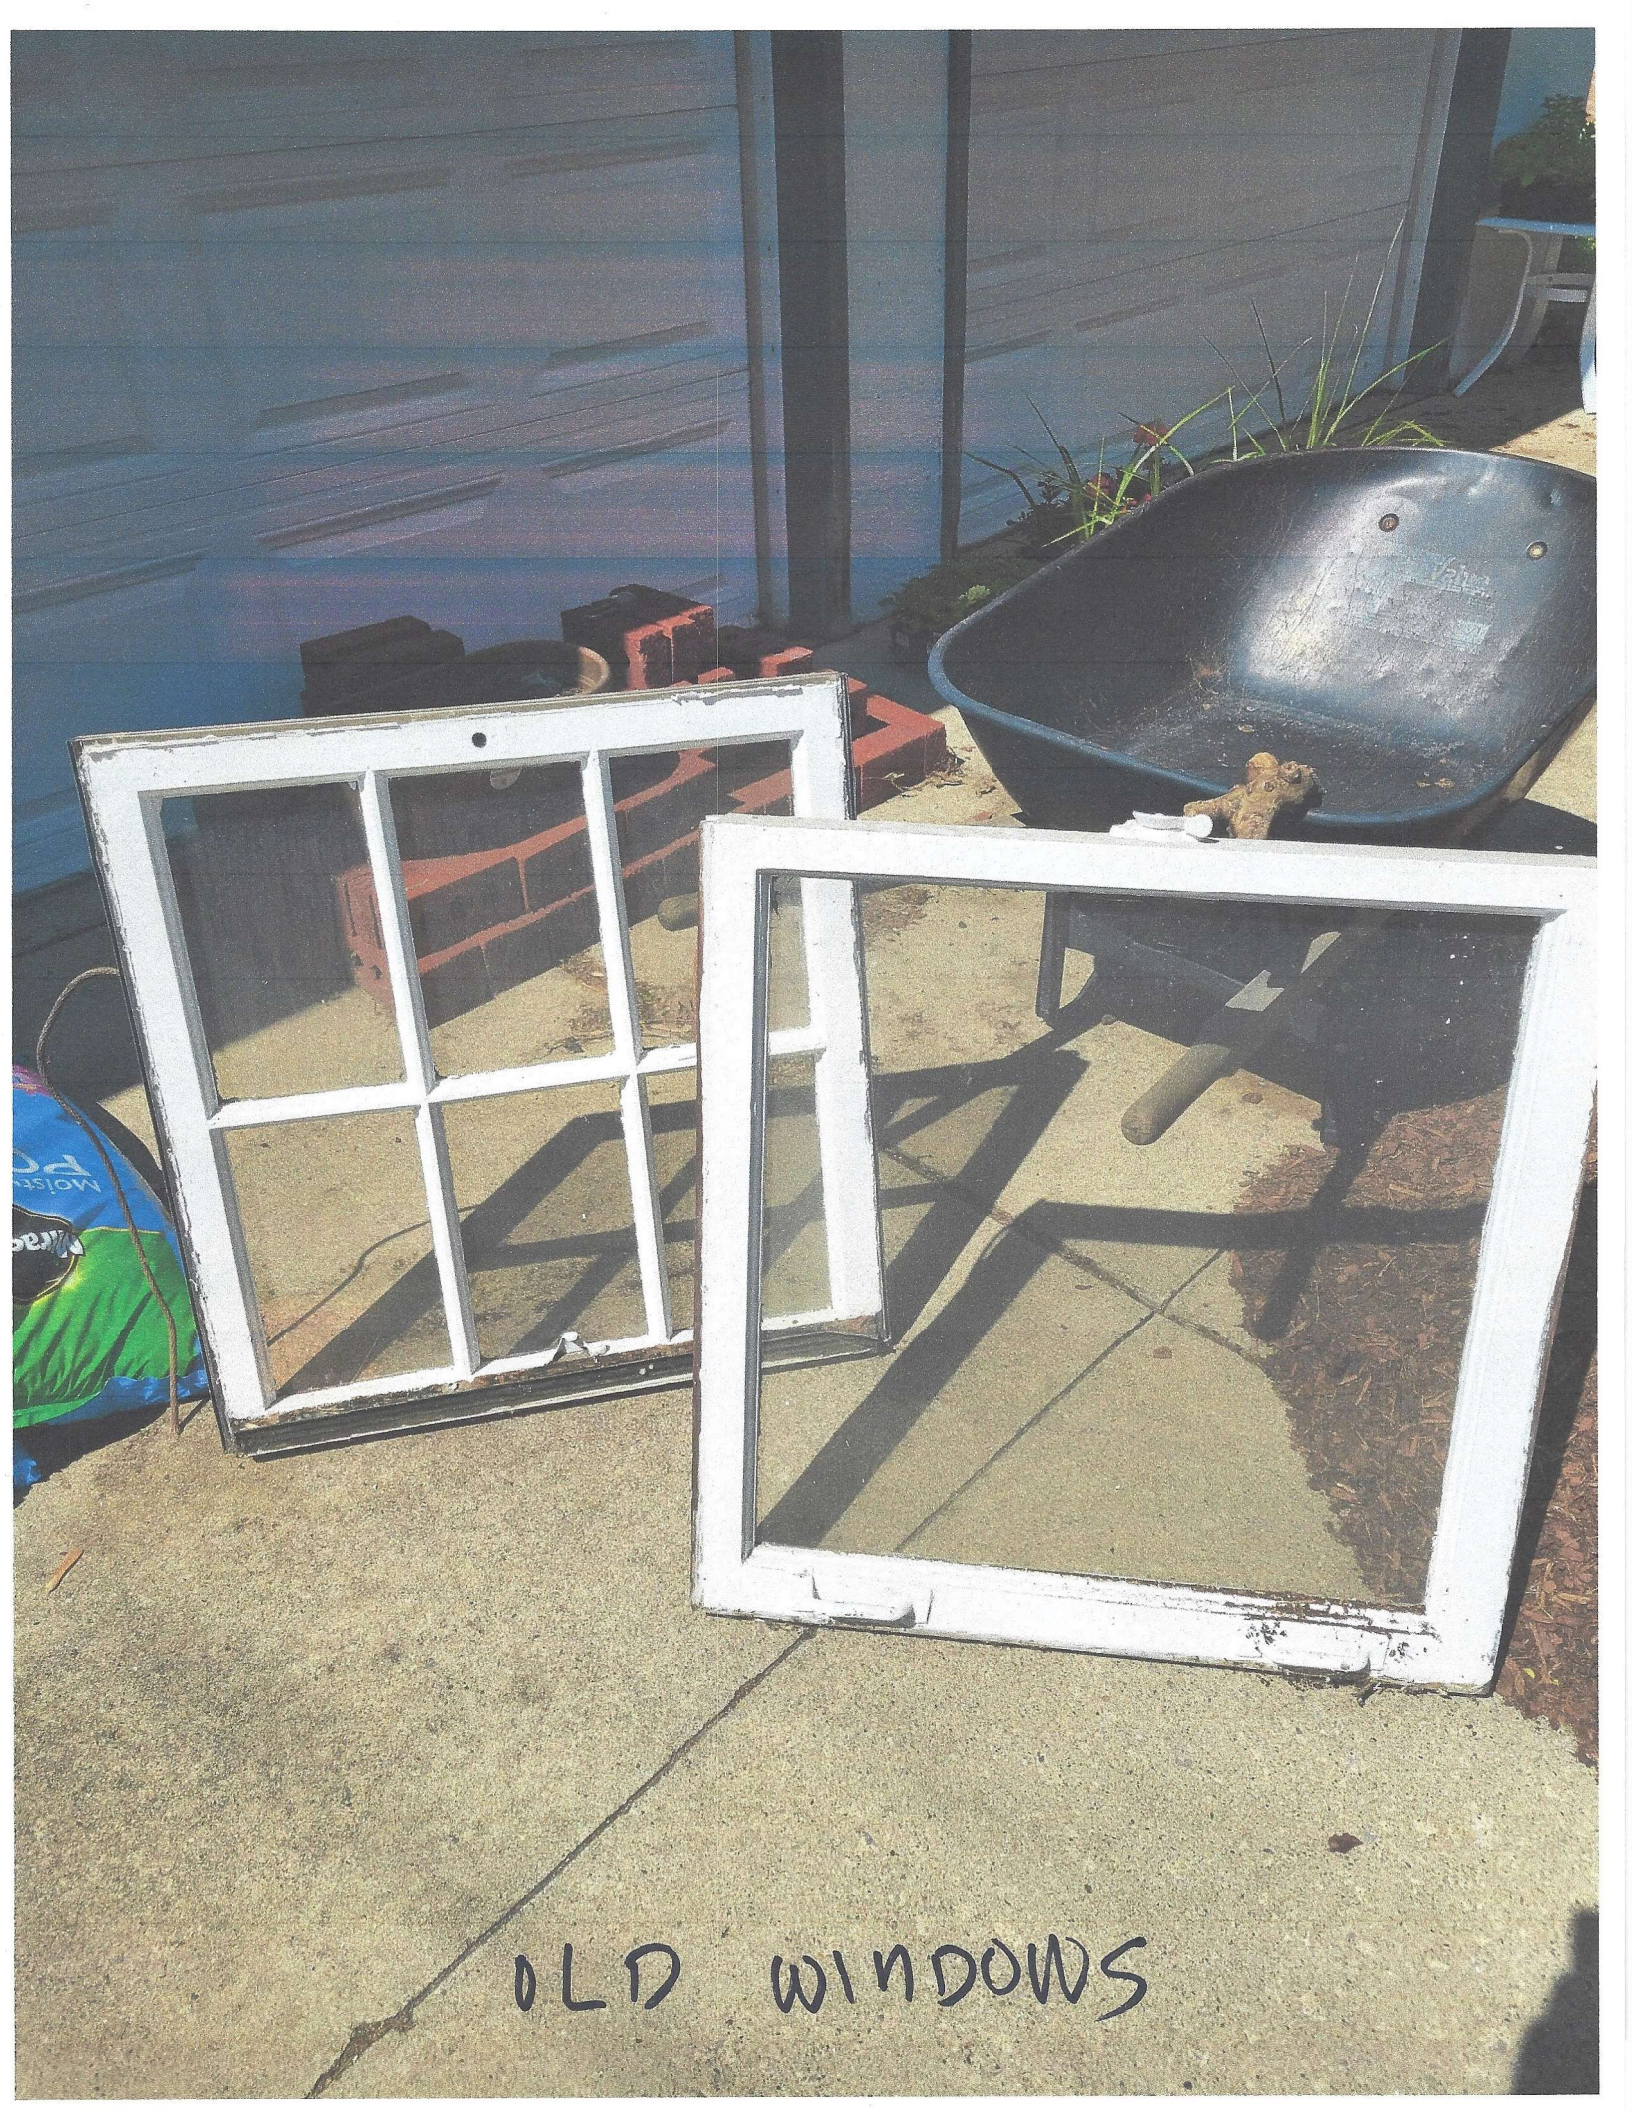
OLD WINDOWS

Also shown on the next page is a pair of old windows that is currently being restored. Glass is de-glazed and removed, paint stripped, hardware removed and cleaned. Condition of the wood is excellent. It is my intention to have the window renovations completed by the end of this year on the East, West and South elevations. The north elevation may spill into next spring.

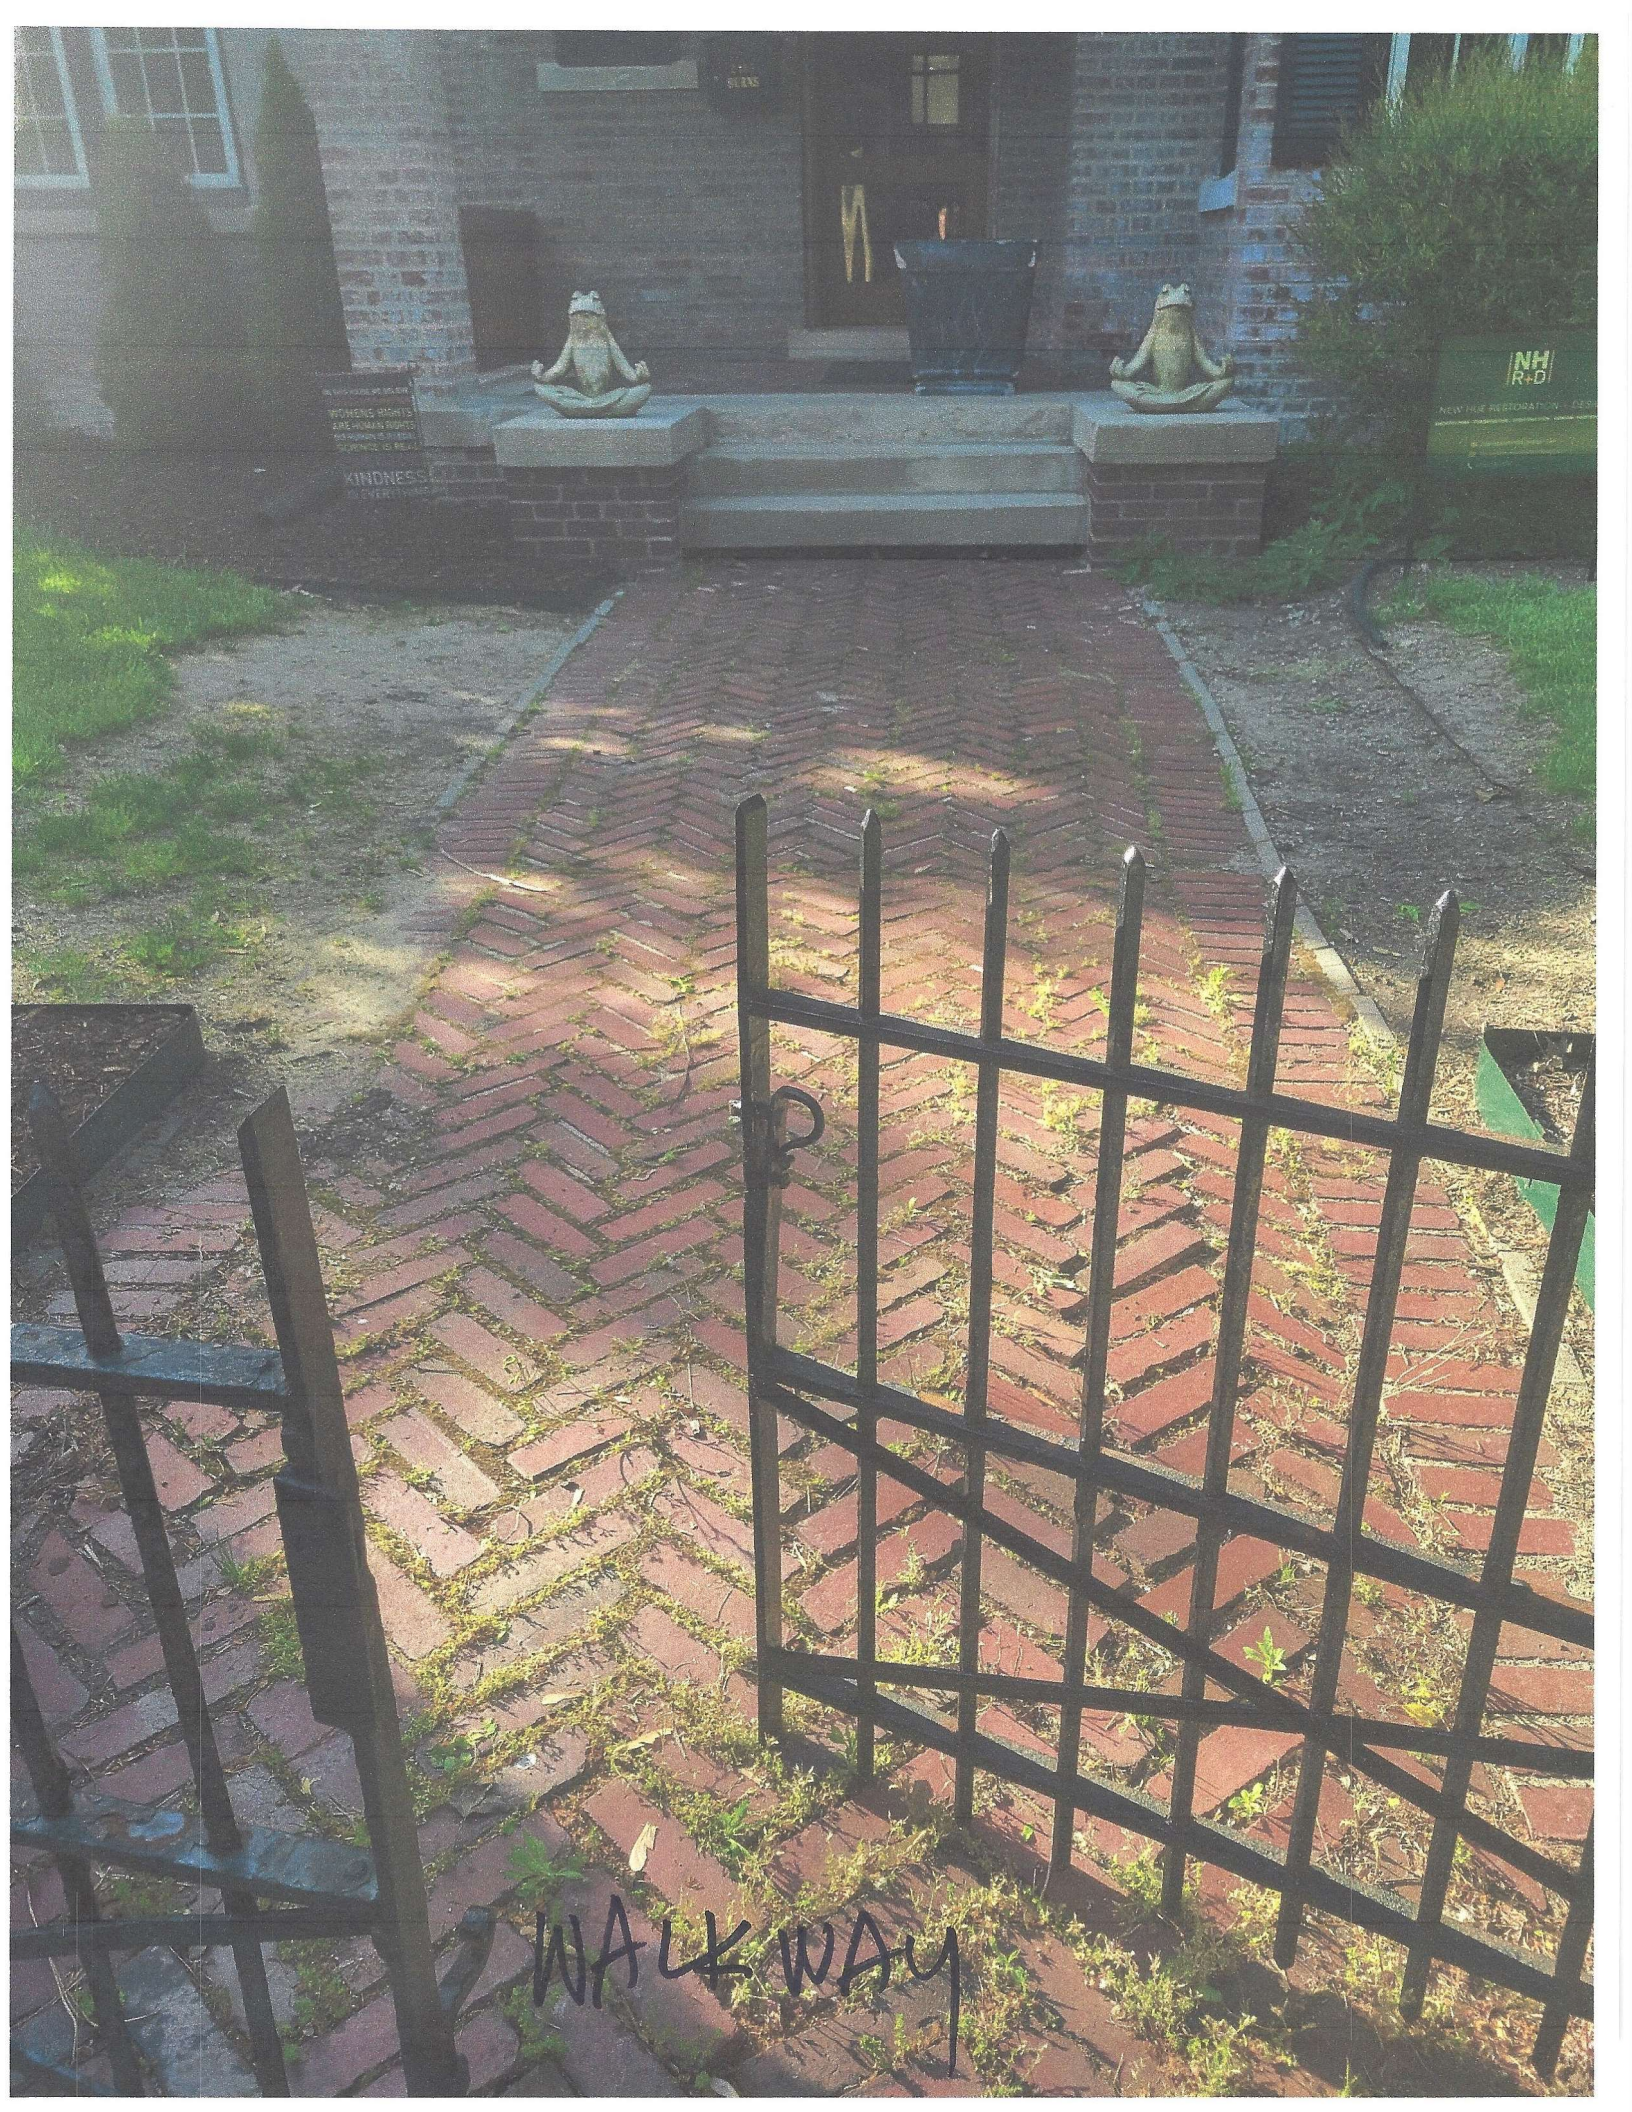
WALKWAY

Reiden, I will be eliminating one row of bricks, making the sidewalk approximately 8 inches narrower. This way I should have enough bricks to complete the rebuild.

The walkway will be removed and all of the bricks will be cleaned. The substructure will be releveled and the bricks will be re-installed. There are currently several bricks that are broken and as discussed with Mr.
