REQUEST FOR EGLE REVIEW – RESPONSE ACTIVITY PLAN TO COMPLY WITH 7A(1)(B)

PROJ:
THE ANCHOR AT MARINERS INN
PROPOSED CONDOMINIUM UNITS 1 AND 2
AND GENERAL COMMON ELEMENTS
DETROIT, MI

We have performed a Phase I Environmental Site Assessment in conformance with the scope and limitations of ASTM Practice E 1527-13 of The Anchor at Mariners Inn, proposed Mariners Inn Condominium Units Nos. 1 and 2 and General Common Elements, located in the eastern and southern portions of 445 Ledyard Street, Detroit, Wayne County, Michigan, the subject property. Any exceptions to, or deletions from, this practice are described in Sections 2.4 and 2.5 of this report. This assessment has revealed no evidence of recognized environmental conditions connected with the property except the following:

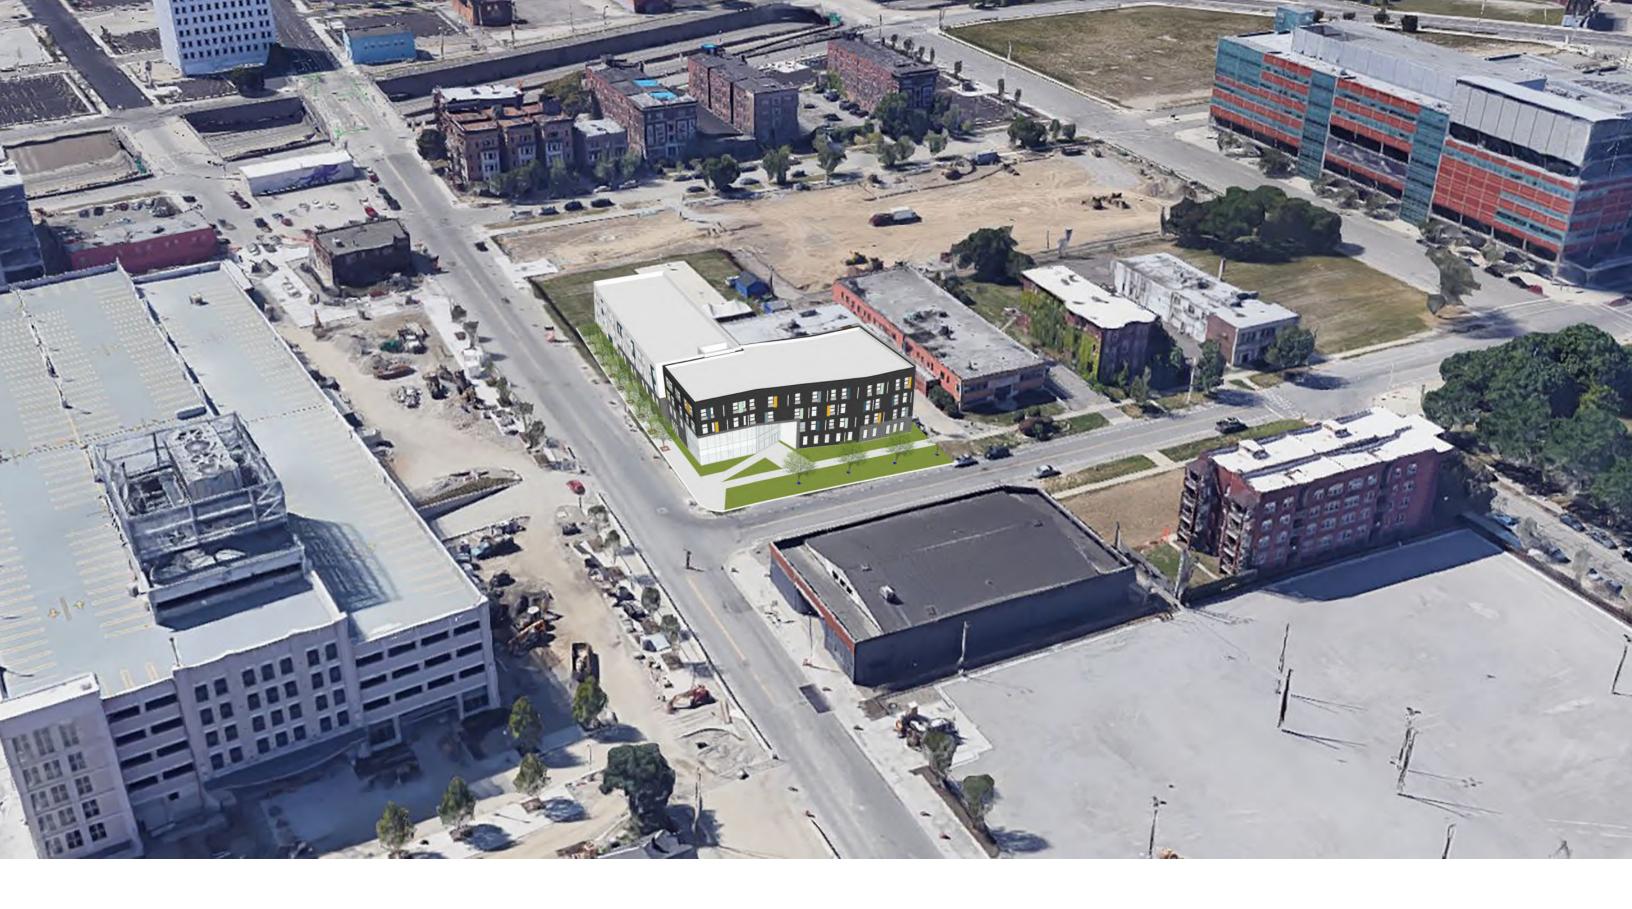
PROPOSED SITE PLAN

The four-story, slab-on-grade, mixed use apartment building will be 7,126 square feet with 44 supportive housing units and 40 recovery housing units and equipped with an elevator with an elevator pit 5 feet below grade, containing a sump. The first floor will contain both commercial retail and administrative, office, and counseling spaces. The second to fourth floors will contain housing units. Following redevelopment activities, the subject property will primarily consist of concrete/asphalt paved parking, drives, and walkways, a basketball/recreation court, portions of building foundations/slabs, concrete plank paver walkways, and landscaped areas. Site plans are included in Appendix A.
