RESPONSE ACTIVITY PLAN- REMEDIAL ACTION PLAN
PROPOSED CAMPBELL WESSON APARTMENTS
5800, 5848, 5850, 5858, AND 5862 MICHIGAN AVENUE
AND 3951 CAMPBELL STREET
DETROIT, WAYNE COUNTY, MICHIGAN

OCTOBER 21, 2022

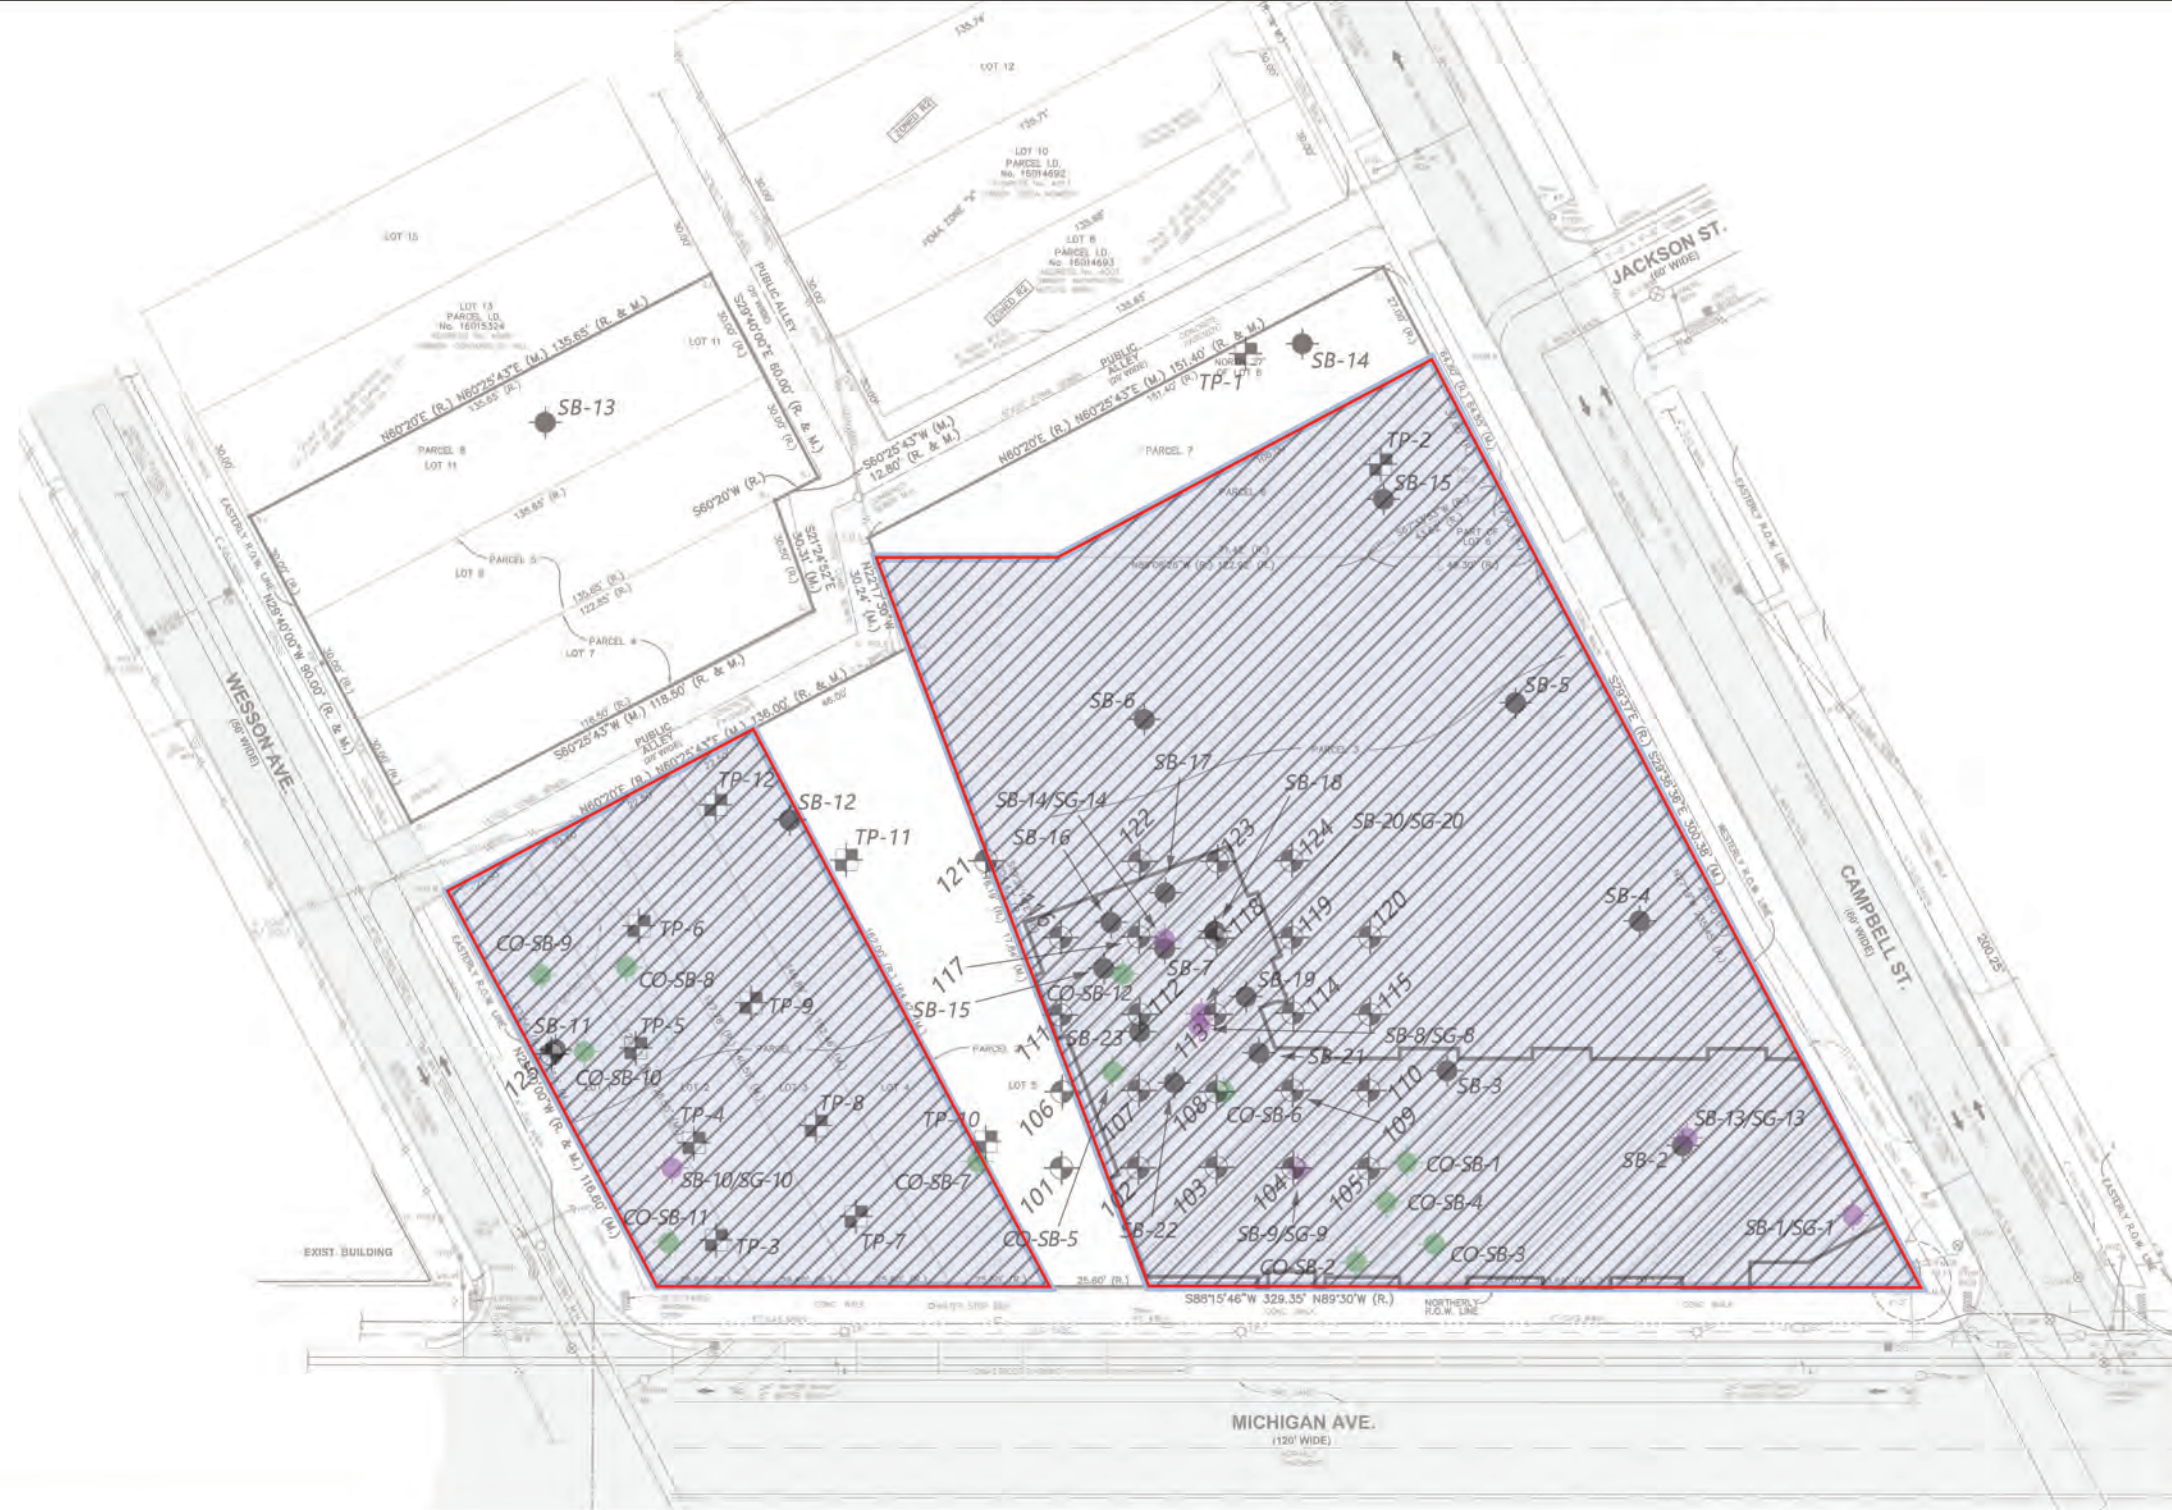
FIGURE 6 - PROPOSED SOIL REMOVAL MAP

- Contaminated soil excavation, transport, and disposal at Type II landfill. Based on subsurface conditions encountered on the subject property, it is expected that the entirety of the subject property will be excavated to at least the depth at which native clay is present.

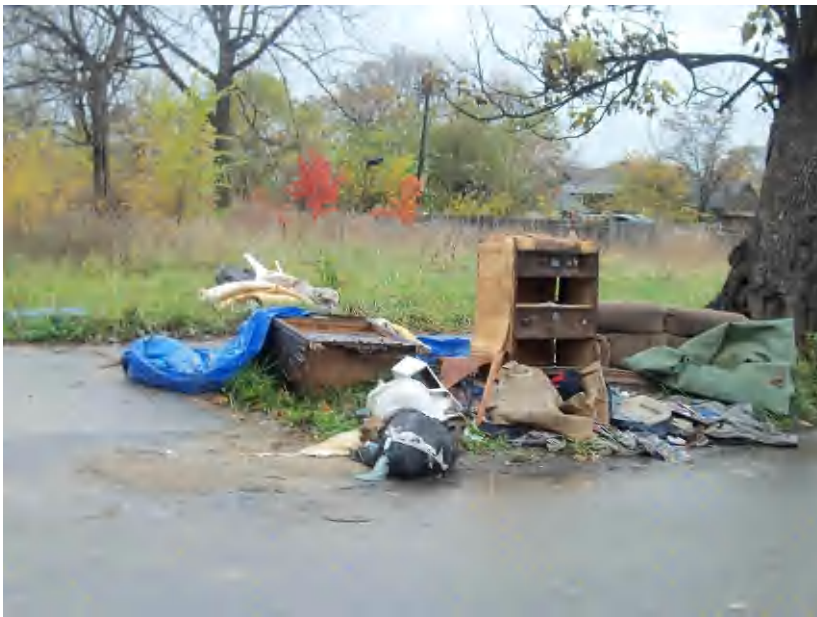
Photograph 6

View of the general refuse and debris located in the eastern portion of the subject property.
