Window Components

Exterior Photographs

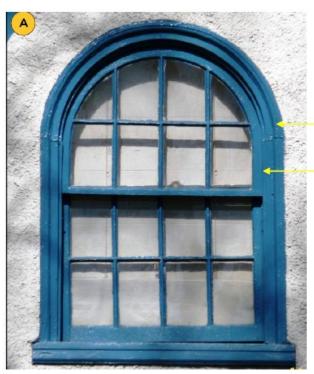
Brickmold - external trim that frames windows and doors in masonry walls.

Brick Mould – wood trim used on masonry buildings to cover the gap where the brick meets the window sash. It also provides a visual frame around the window.

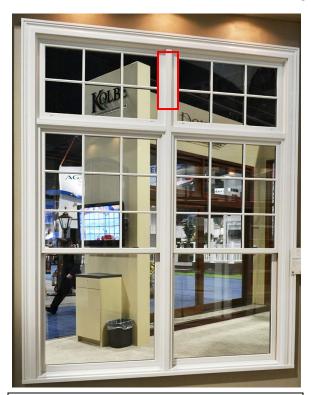
Mullions – Vertical member between window units in a series. These elements offer structural support for the windows and are character-defining features of a building and must be retained.

ABOVE LEFT: This is a factory mulled window. The mullion is very thin as the side-by-side windows were fabricated as one large window unit.

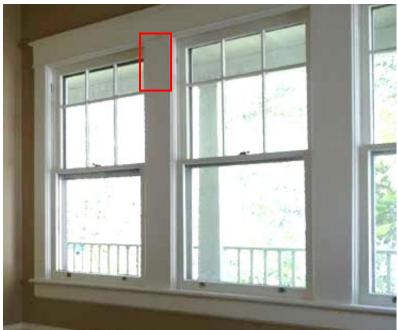
ABOVE RIGHT: This example shows mullions as separate and dominant structural elements within the larger window opening. This is how window openings were originally constructed; these elements must be retained.
