STAFF REPORT 8/14/2019 MEETING
APPLICATION NUMBER 19-6367
ADDRESS: 601-607 SHELBY
HISTORIC DISTRICT: DETROIT FINANCIAL
APPLICANT: TYSON GERSH

607 Shelby Bridge Artwork
Historic District Commission
Project Review Request

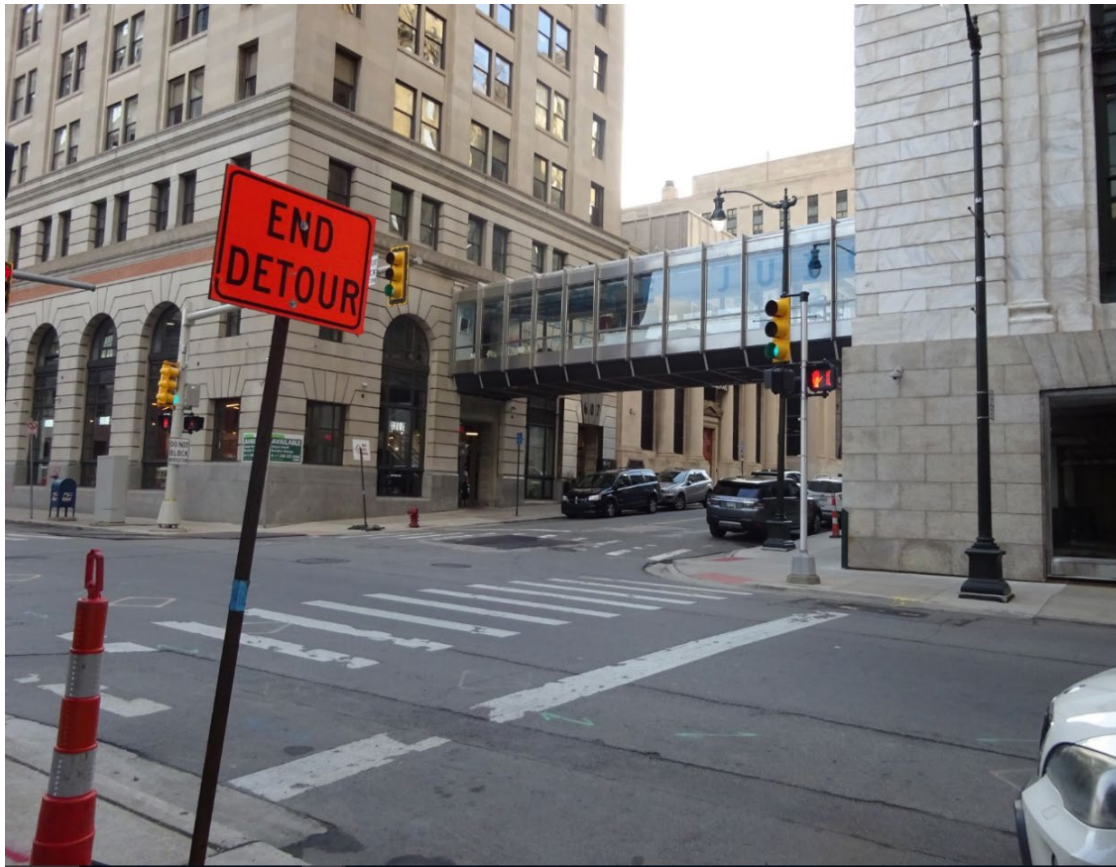
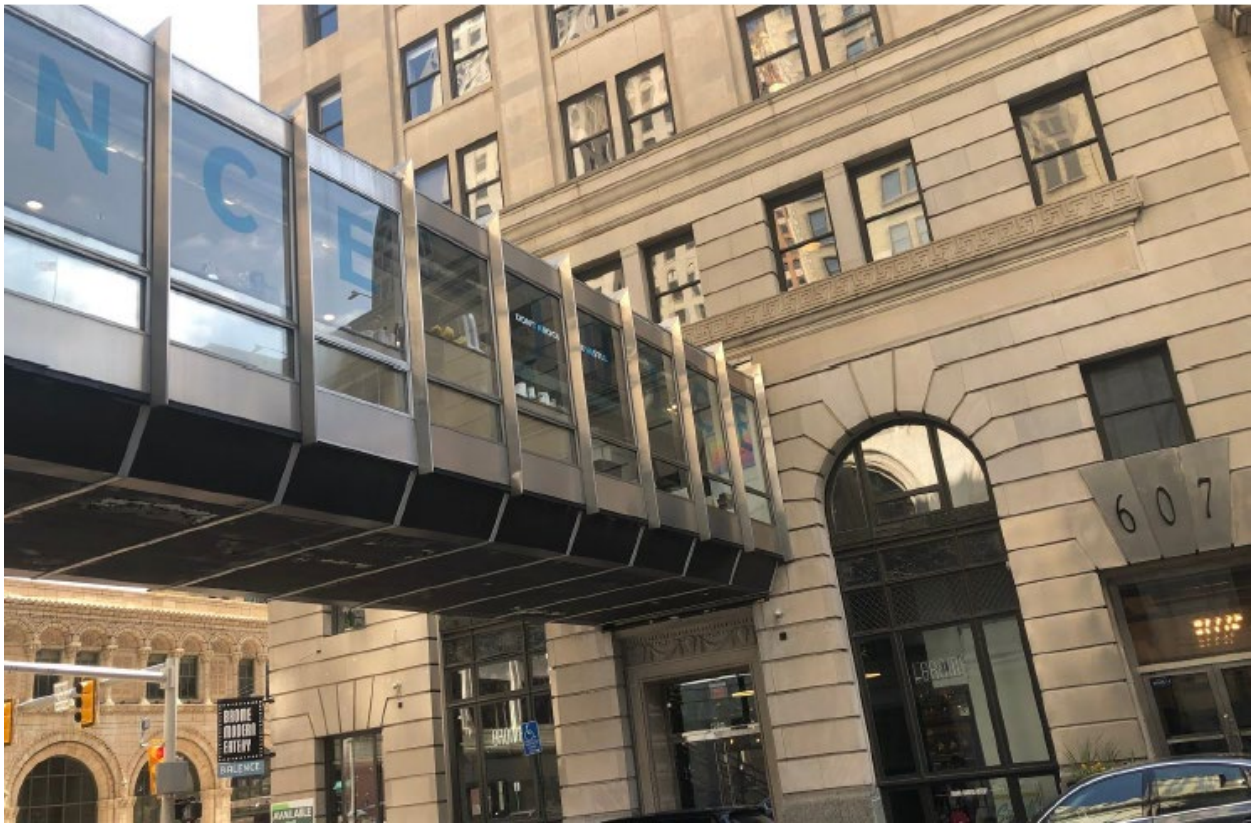
In 1962, a pedestrian bridge was built at the first floor, mezzanine level, connecting 607 Shelby to the State Savings Bank Building's (151 W. Fort Street) second story, west elevation. The bridge features a steel frame construction with glass windows. The bridge's under carriage is clad with steel panels which have been covered with a latex coating

It is staff's opinion that the bridge is a significant structure and the steel panel exterior cladding is a distinctive material that characterizes the property. As noted above, the applicant is seeking to paint a new mural at the stainless steel panels/underside of the pedestrian bridge. The work will also involve the removal of the existing latex covering at that location and priming the panels prior to the installation of the mural. However, the current application does not provide the following information:

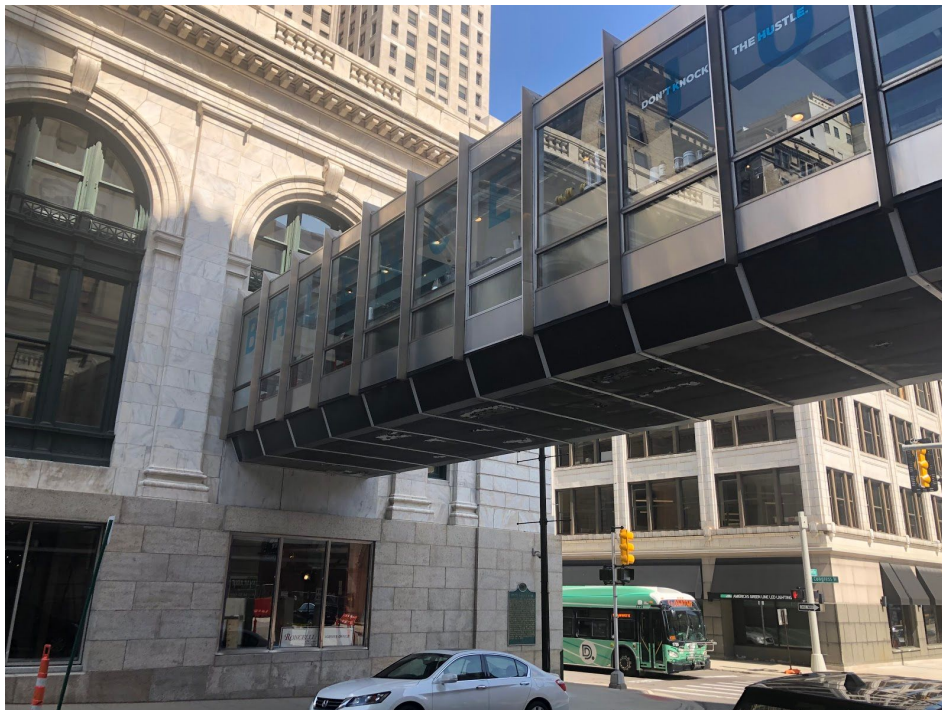
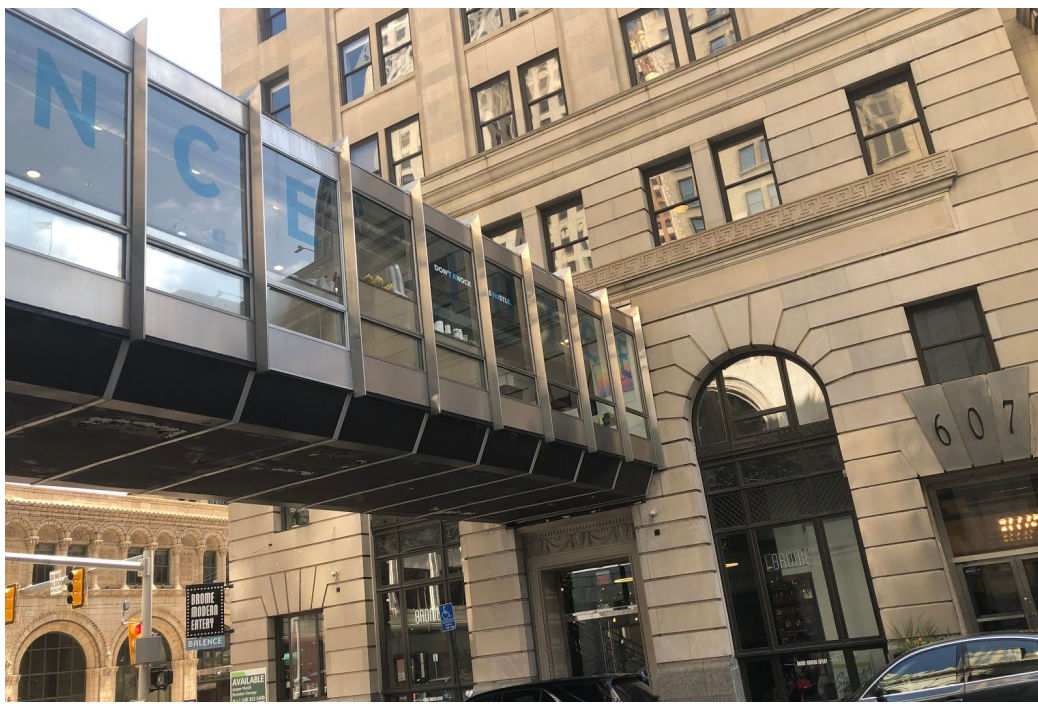
Photographs of ALL sides of existing building or site

We (Basco, owner of 607 Shelby and the Bridge in its entirety) propose removing the black latex coating and adding new waterproofing and color to the existing grid panels. The grid pattern already exists on the underside of the bridge today. This art installation is intended to not only acknowledge the architectural detail of the original design, but to amplify it as part of a historically respectful effort to add interest to the otherwise deteriorated and in poor condition underside of the bridge and activate the Shelby corridor.

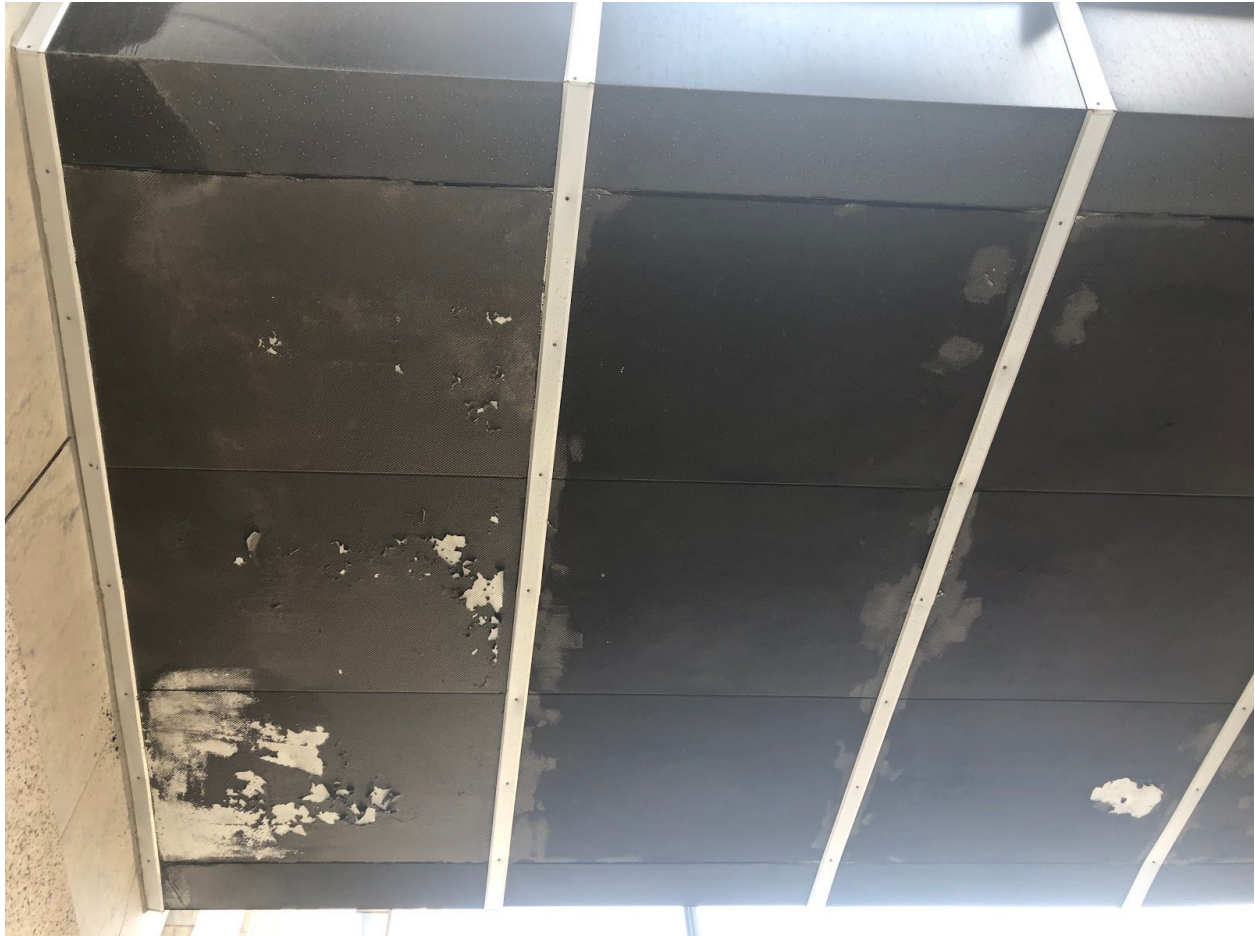
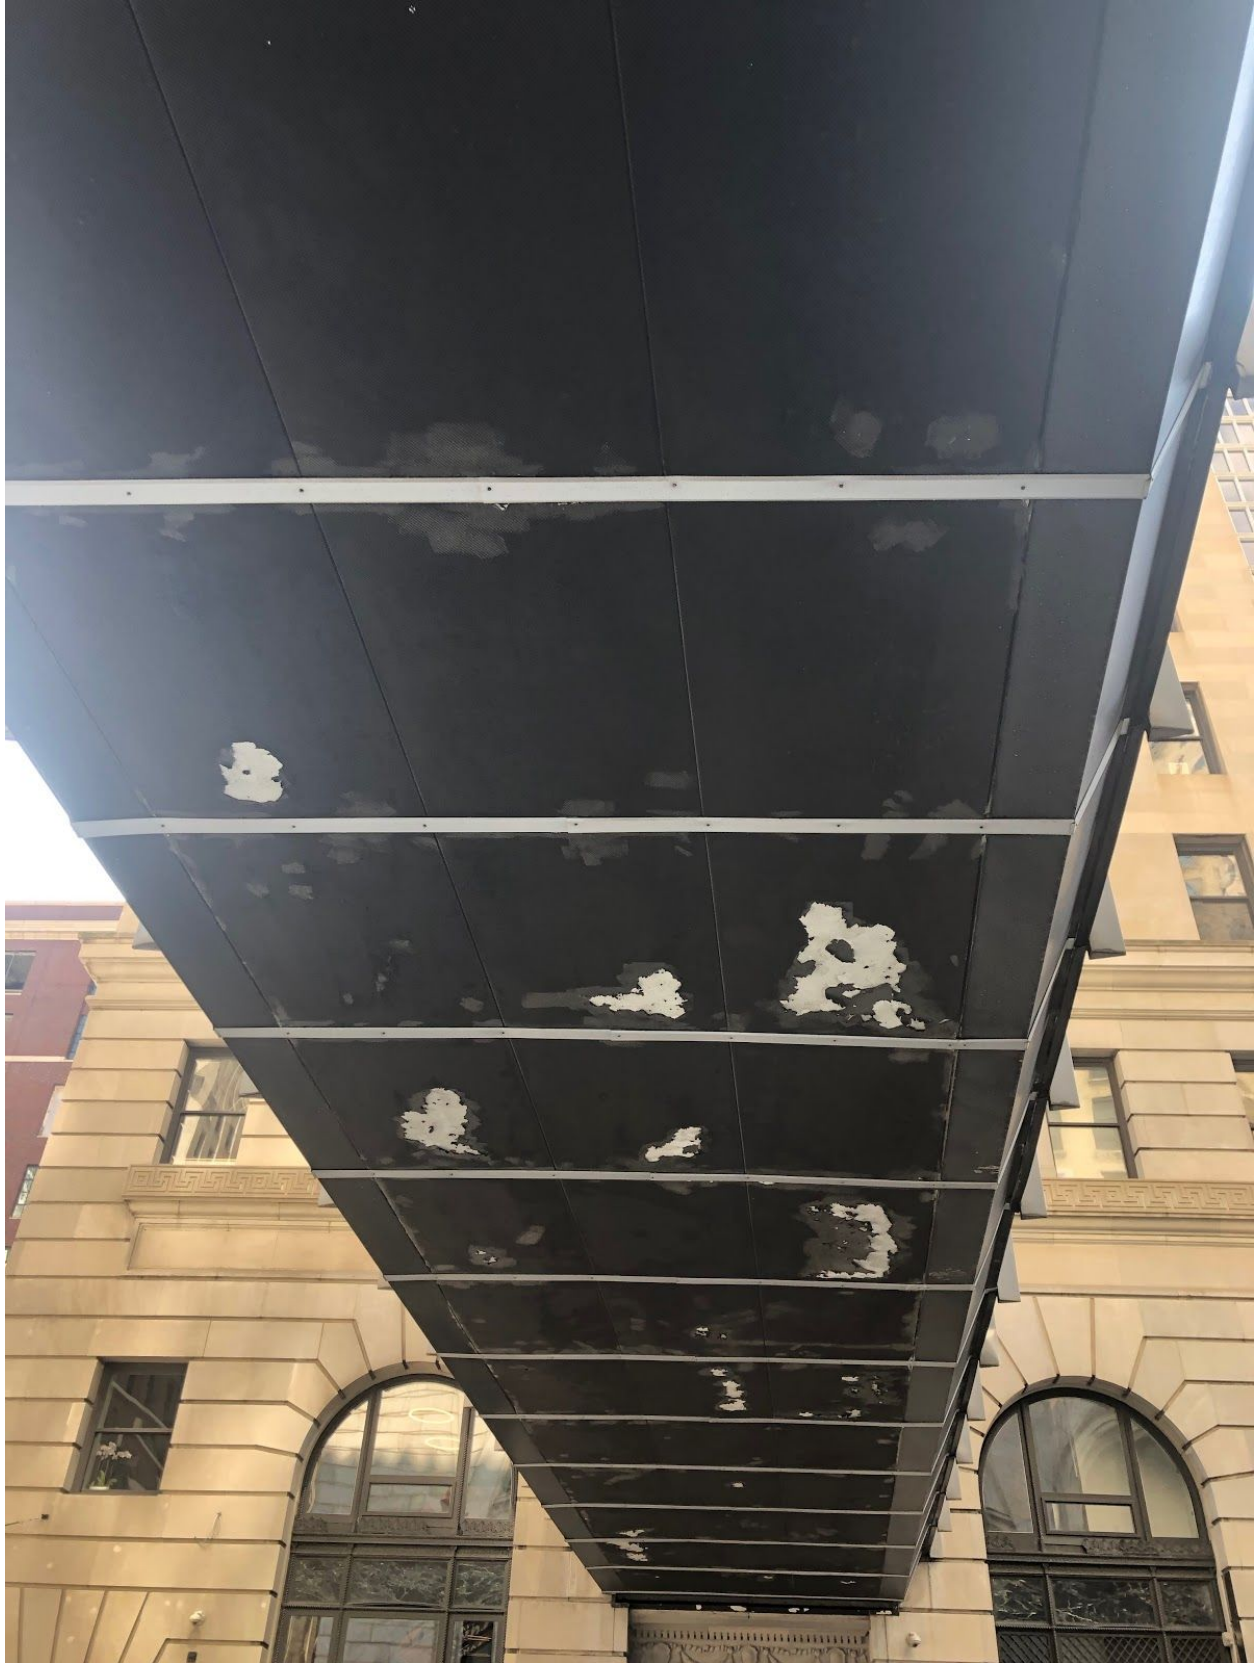
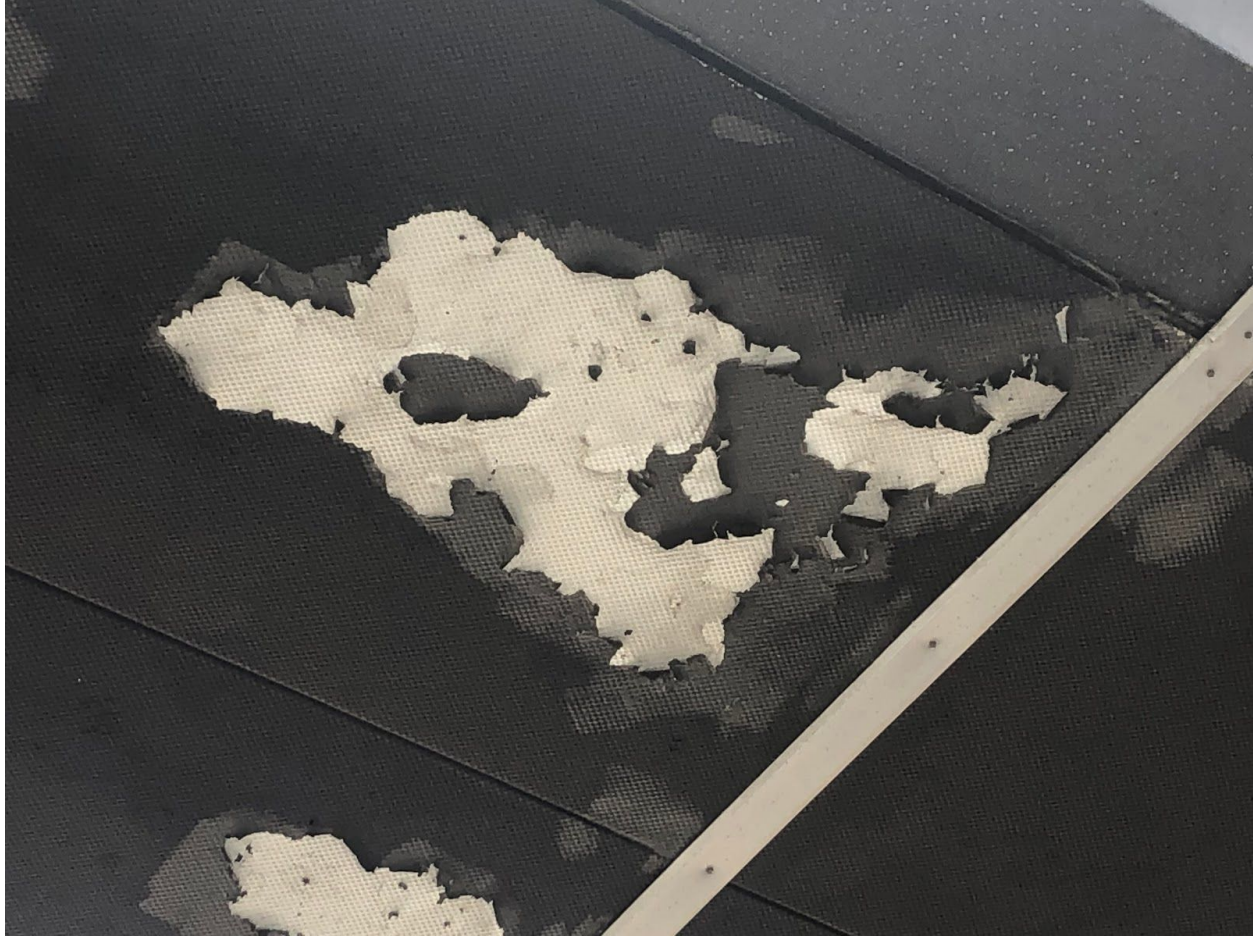
Detailed Photographs of location of proposed work (photographs to show existing condition(s), design, color, and material).

- Remove the black latex material (non original to the structure) from the undercarriage of the bridge
- Prime the area from which the black latex was removed
- Paint the the primed panels with different colored squares

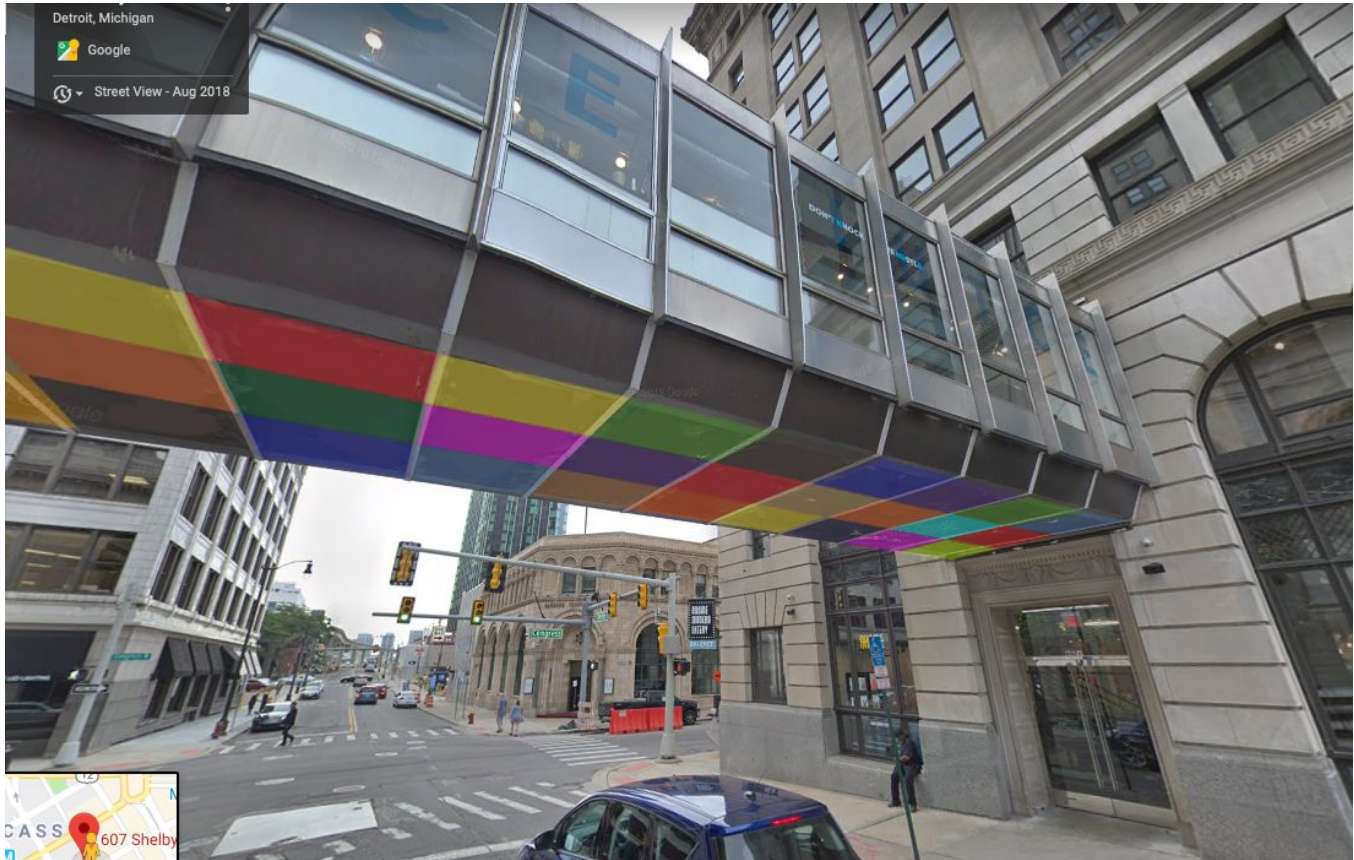
Below, please see the rendering depicting the proposed mural, which captures the general spirit of the art installation (a modernist randomized color grid).

Please note that the rendering may appear much brighter than it would actually look in real life. The underside of the bridge is constantly shaded. The rendering otherwise captures the general spirit of the proposal, but the actual order of the colors, colors actually used, and dimensions could change.

The artwork has been intentionally designed to target those standing under the bridge, and add interest without disrupting the original architecture. This is further achieved by respecting the existing grid and repetitive nature of the bridge as well leaving a consistent black border on the vertical portion of the bridge and underside creating a clean black frame around the new artwork.
