STAFF REPORT 05-13-2020 REGULAR MEETING**PREPARED BY: A. PHILLIPS****APPLICATION NUMBER: 20-6718****ADDRESS: 729 SEWARD AVENUE****HISTORIC DISTRICT: NEW CENTER AREA****APPLICANT: ANDREW JORDAN, LEWAND BUILDING COMPANIES****PROPERTY OWNER: TARA YENGLIN, 700 SEWARD DETROIT LLC****DATE OF COMPLETE APPLICATION: 04-22-2020****STAFF SITE VISIT: N/A****SCOPE: GENERAL REHABILITATION OF BUILDING INCLUDING WINDOW REPLACEMENT****EXISTING CONDITIONS**

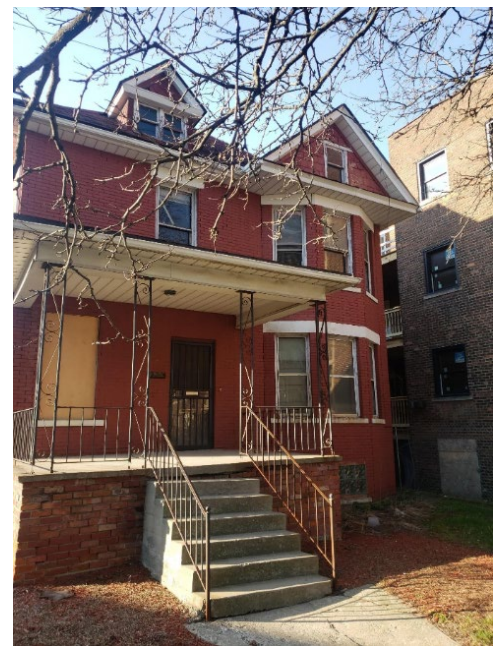
The building located at 729 Seward Avenue is a 2½-story single-family residence constructed ca. 1907. The structure is clad in red brick which is also painted red in color and features limestone and wood details as well as cedar shake. The asymmetrical façade includes a two-story bay at the right side of the elevation and a raised covered porch at the left side of the elevation which includes the main entrance to the house. The wood double-hung windows are intact. The multi-gabled roof is covered in reddish-brown asphalt shingles and features three dormers (2 at the front elevation and one at the rear elevation). The property includes a parking lot directly adjacent to the house to the east which is accessed via a curb cut onto Seward Avenue. A large garage is located behind the house at the far southwest corner of the lot.

*Applicant Photo – April, 2020***PROPOSAL**

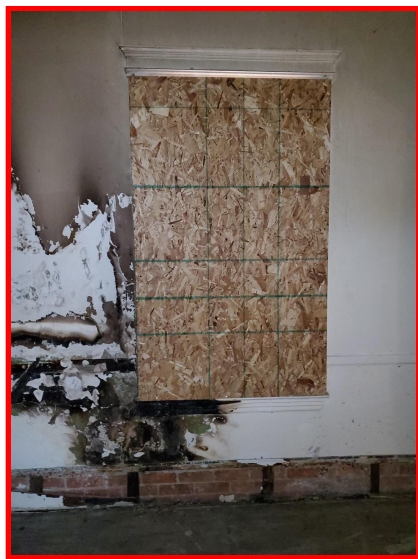
Existing Kitchen window

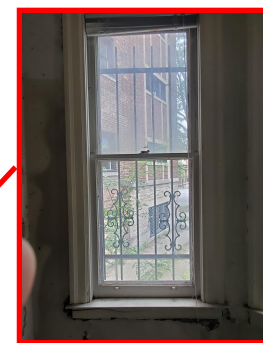
Existing Living Room windows

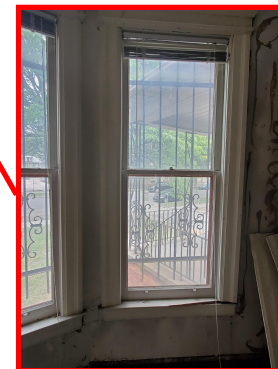
Existing Living Room window

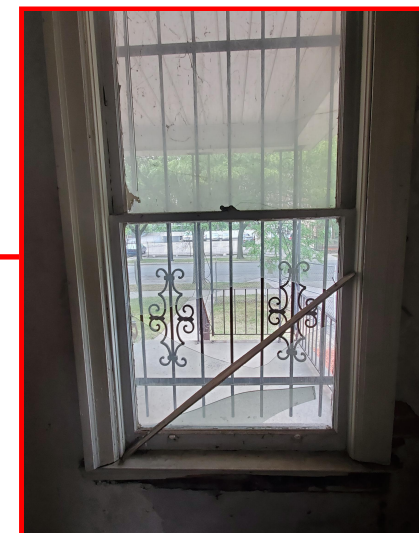
Existing Dining Room window

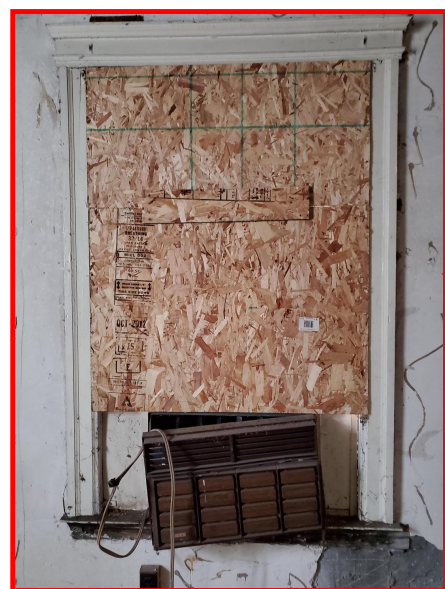
Existing Family Room window

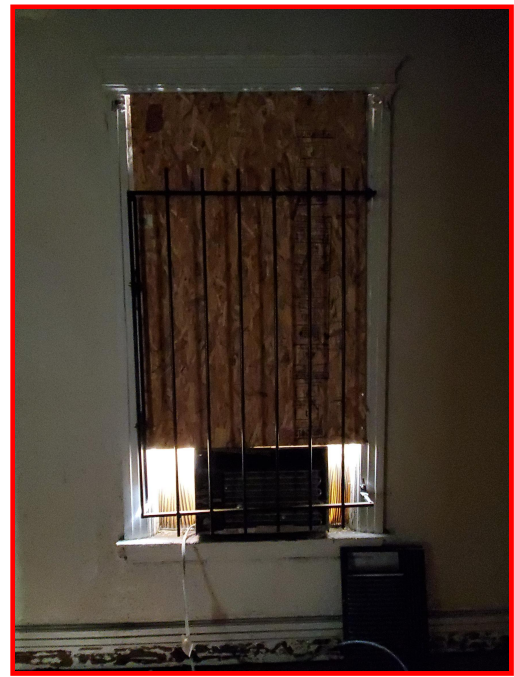
Existing Bedroom window

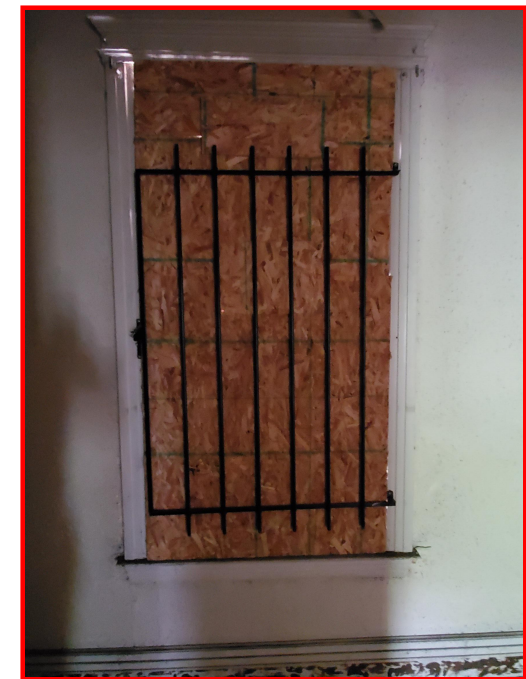
Existing Bedroom window

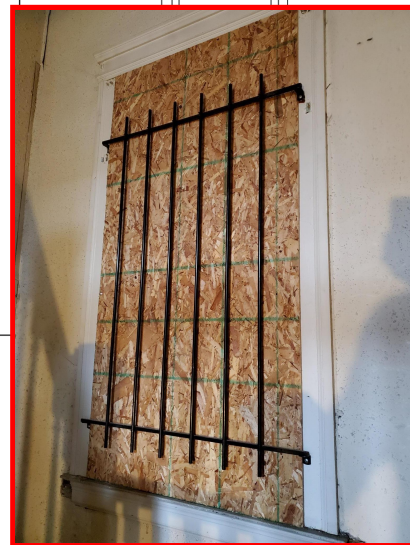
Existing Stair window

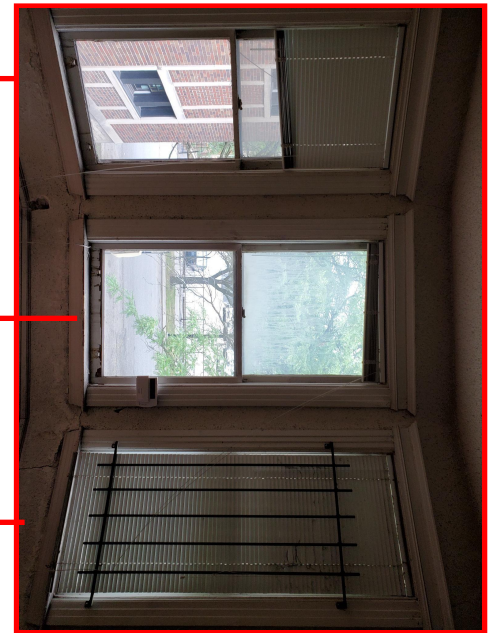
Existing Owner's Suite windows

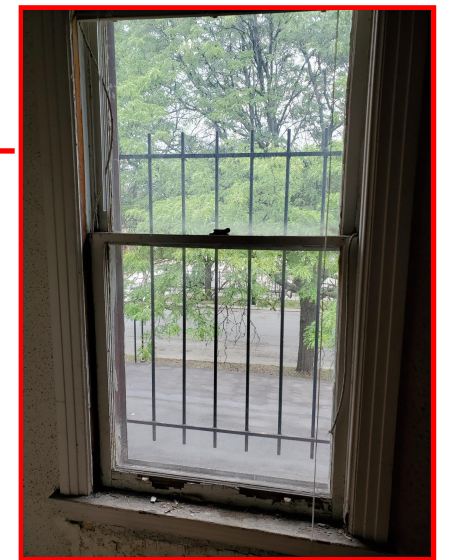
Existing Bathroom window

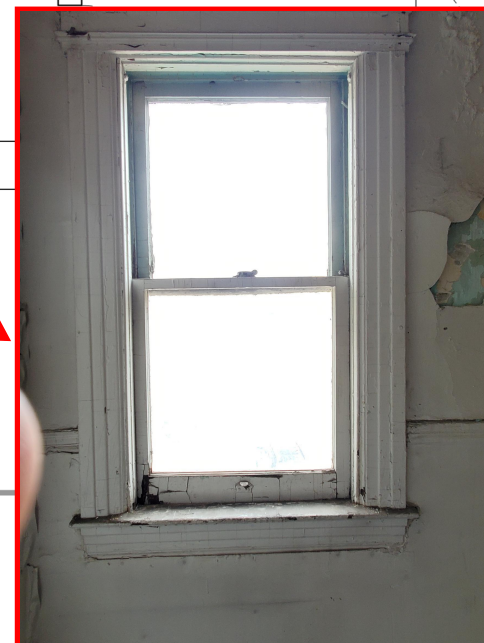
Existing Bathroom window

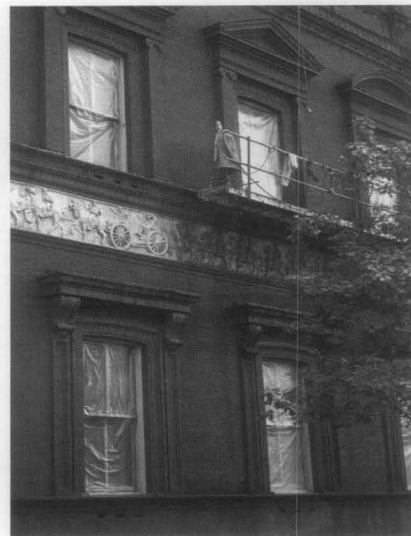
Figure 1. Low-to medium-pressure steam (hot-pressurized water washing), is being used to clean the exterior of the U.S. Tariff Commission Building, the first marble building constructed in Washington, D.C., in 1839. This method was selected by an architectural conservator as the "gentlest means possible" to clean the marble. Steam can soften heavy soiling deposits such as those on the cornice and column capitals, and facilitate easy removal. Note how these deposits have been removed from the right side of the cornice which has already been cleaned.

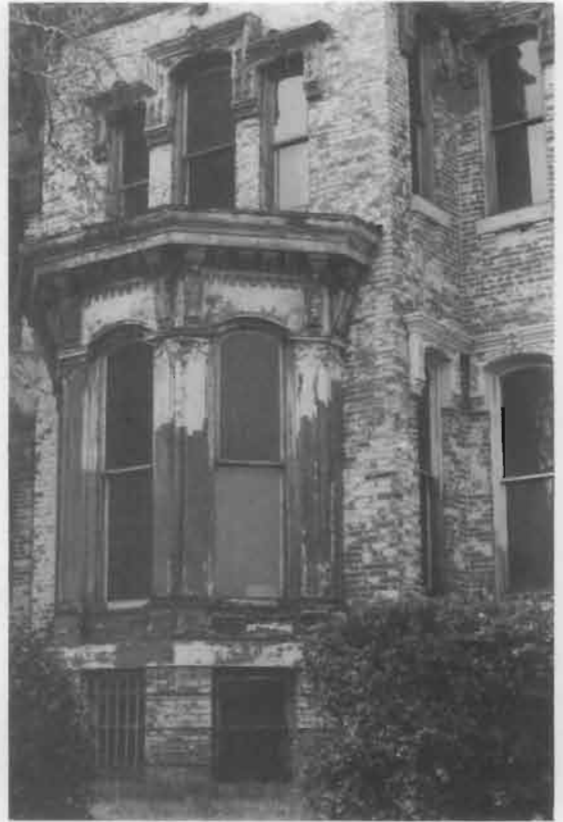
Figure 3. Know what you are cleaning. If the painted surfaces of the projecting bay window on this once elegant Second Empire brick mansion were still intact, it would not be easy to identify the beltcourse as sandstone, the windows and window frames as wood, and the cornice and all of the window hoods as pressed metal. Cleaning so many different building materials may require a variety of techniques and treatments.

Indeed, some parts of a building, particularly decorative features, may not be masonry at all (figure 3). Frequently, such features as window hoods, cornices and balustrades may be metal, such as cast iron, galvanized sheet iron or zinc. When painted, they give an intentional appearance of masonry. Some features may have been fabricated of wood, then coated with a sanded paint to give the illusion of sandstone. Thus, the need to correctly identify the type of masonry, or other non-masonry materials on a building cannot be over-emphasized when planning a cleaning project.

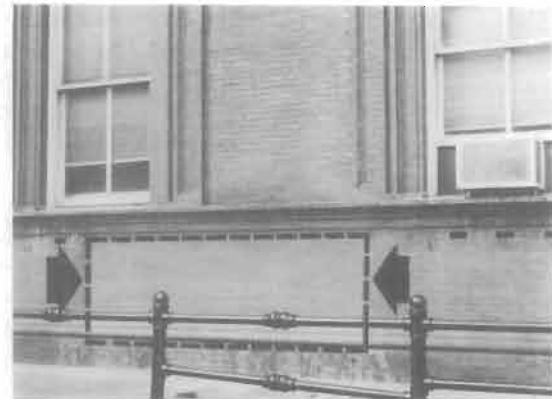
Figure 9. A test patch on brick to remove a century of dirt reveals only a slight difference in appearance between the cleaned and the uncleaned brick. The hard-baked outer skin of the brick provides a surface that is not only impervious to dirt penetration, but resists dirt accumulation. Photograph: Christina Henry

tant's careful supervision. Carefully controlled testing is probably the only reliable way to determine the best or most appropriate cleaning techniques and pressures to be used in a particular project (figures 8-9).

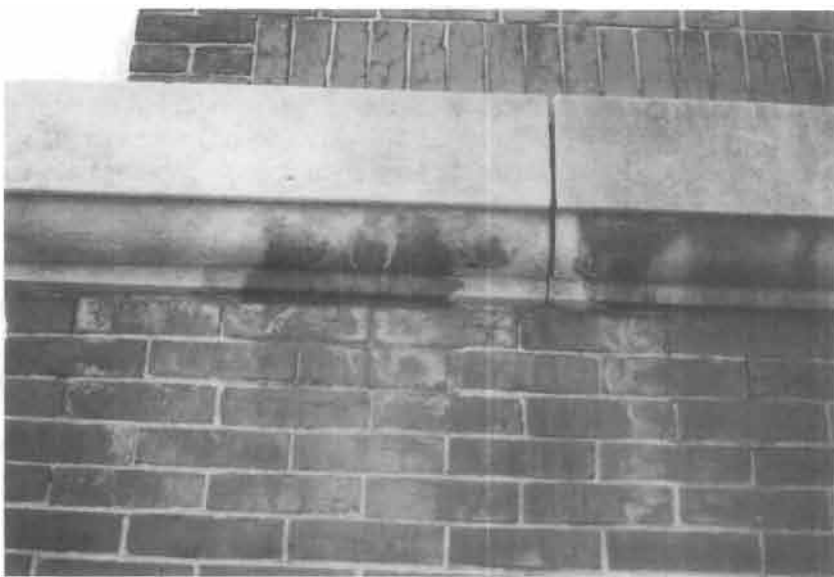
Figure 25. Excess moisture leaching out through the walls has resulted in the formation of white efflorescent salts on the brick and blackish sulfate salts on the limestone water table.

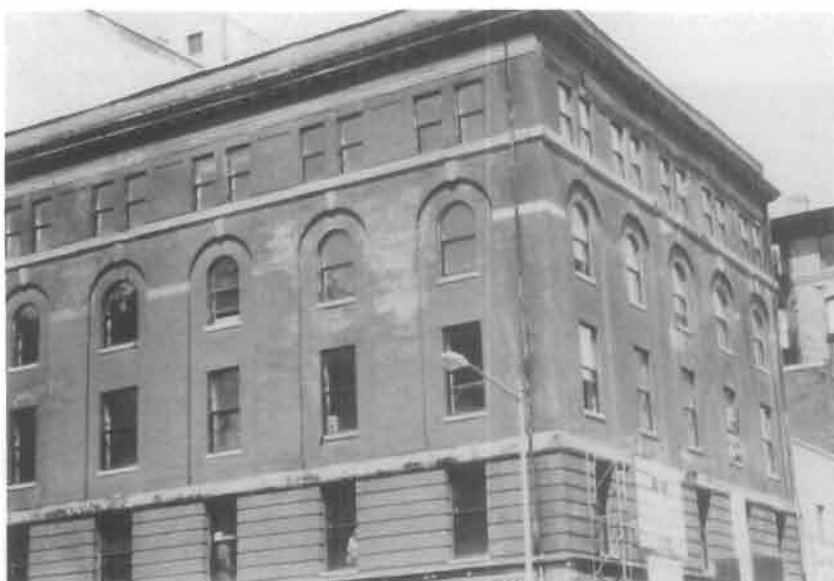
Figure 26. Efflorescent salts appearing on many of the brick piers of this turn-of-the-century building may indicate the existence of clogged interior gutters that, because they no longer function have been supplemented by an exterior rain removal system. Photograph: National Park Service

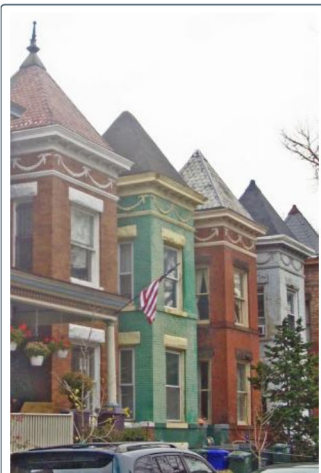
In this row of late-nineteenth century brick rowhouses, the painted brick shows signs of efflorescence (second from left) and flaking (r).
