NOTICE OF DENIAL

Application Number: HDC2025-00269

| PROJECT ADDRESS: 3928 Porter Street | | | |
| SCOPE: Replace historic wood windows. | | | |

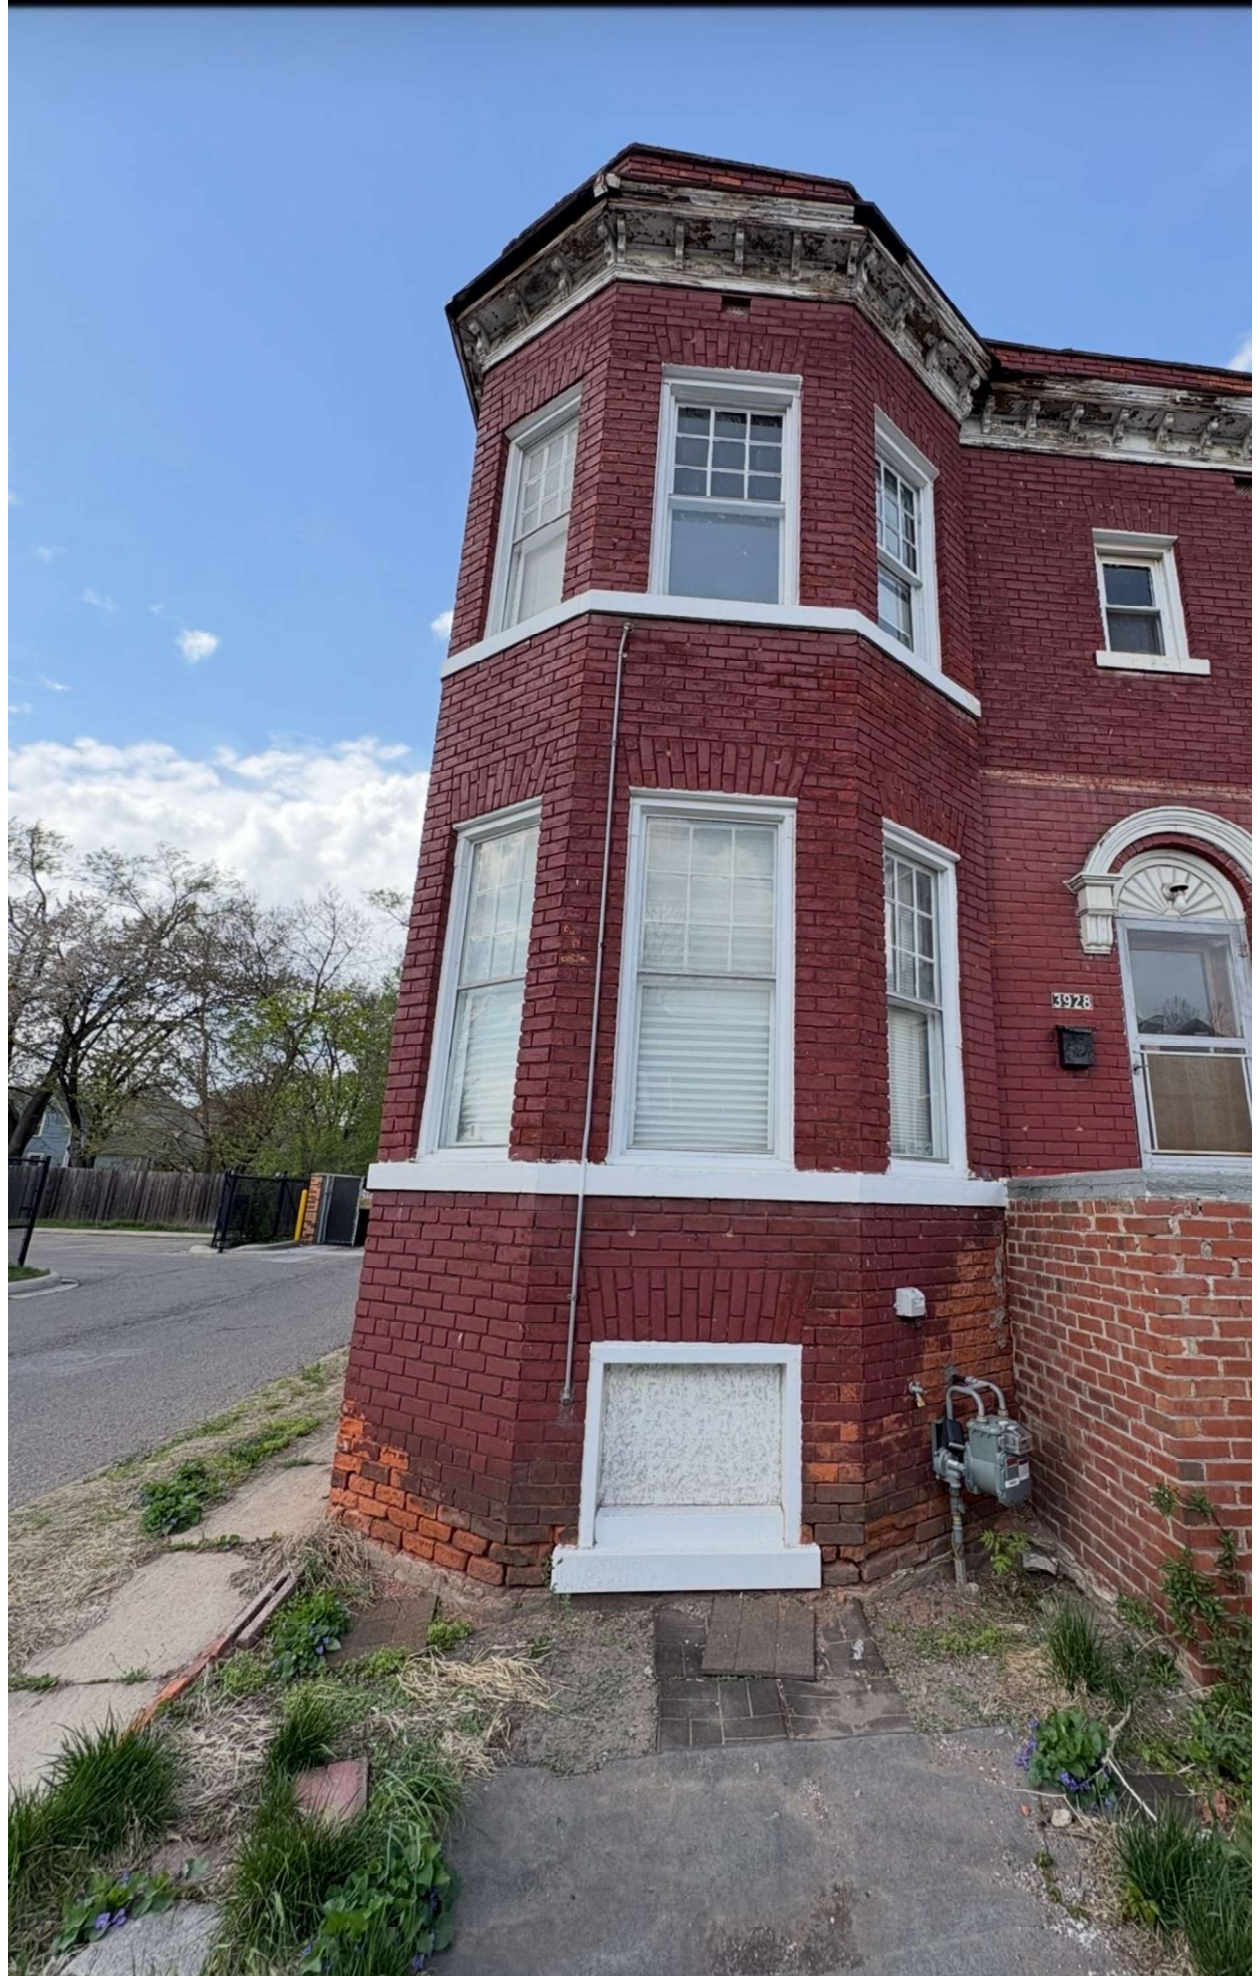
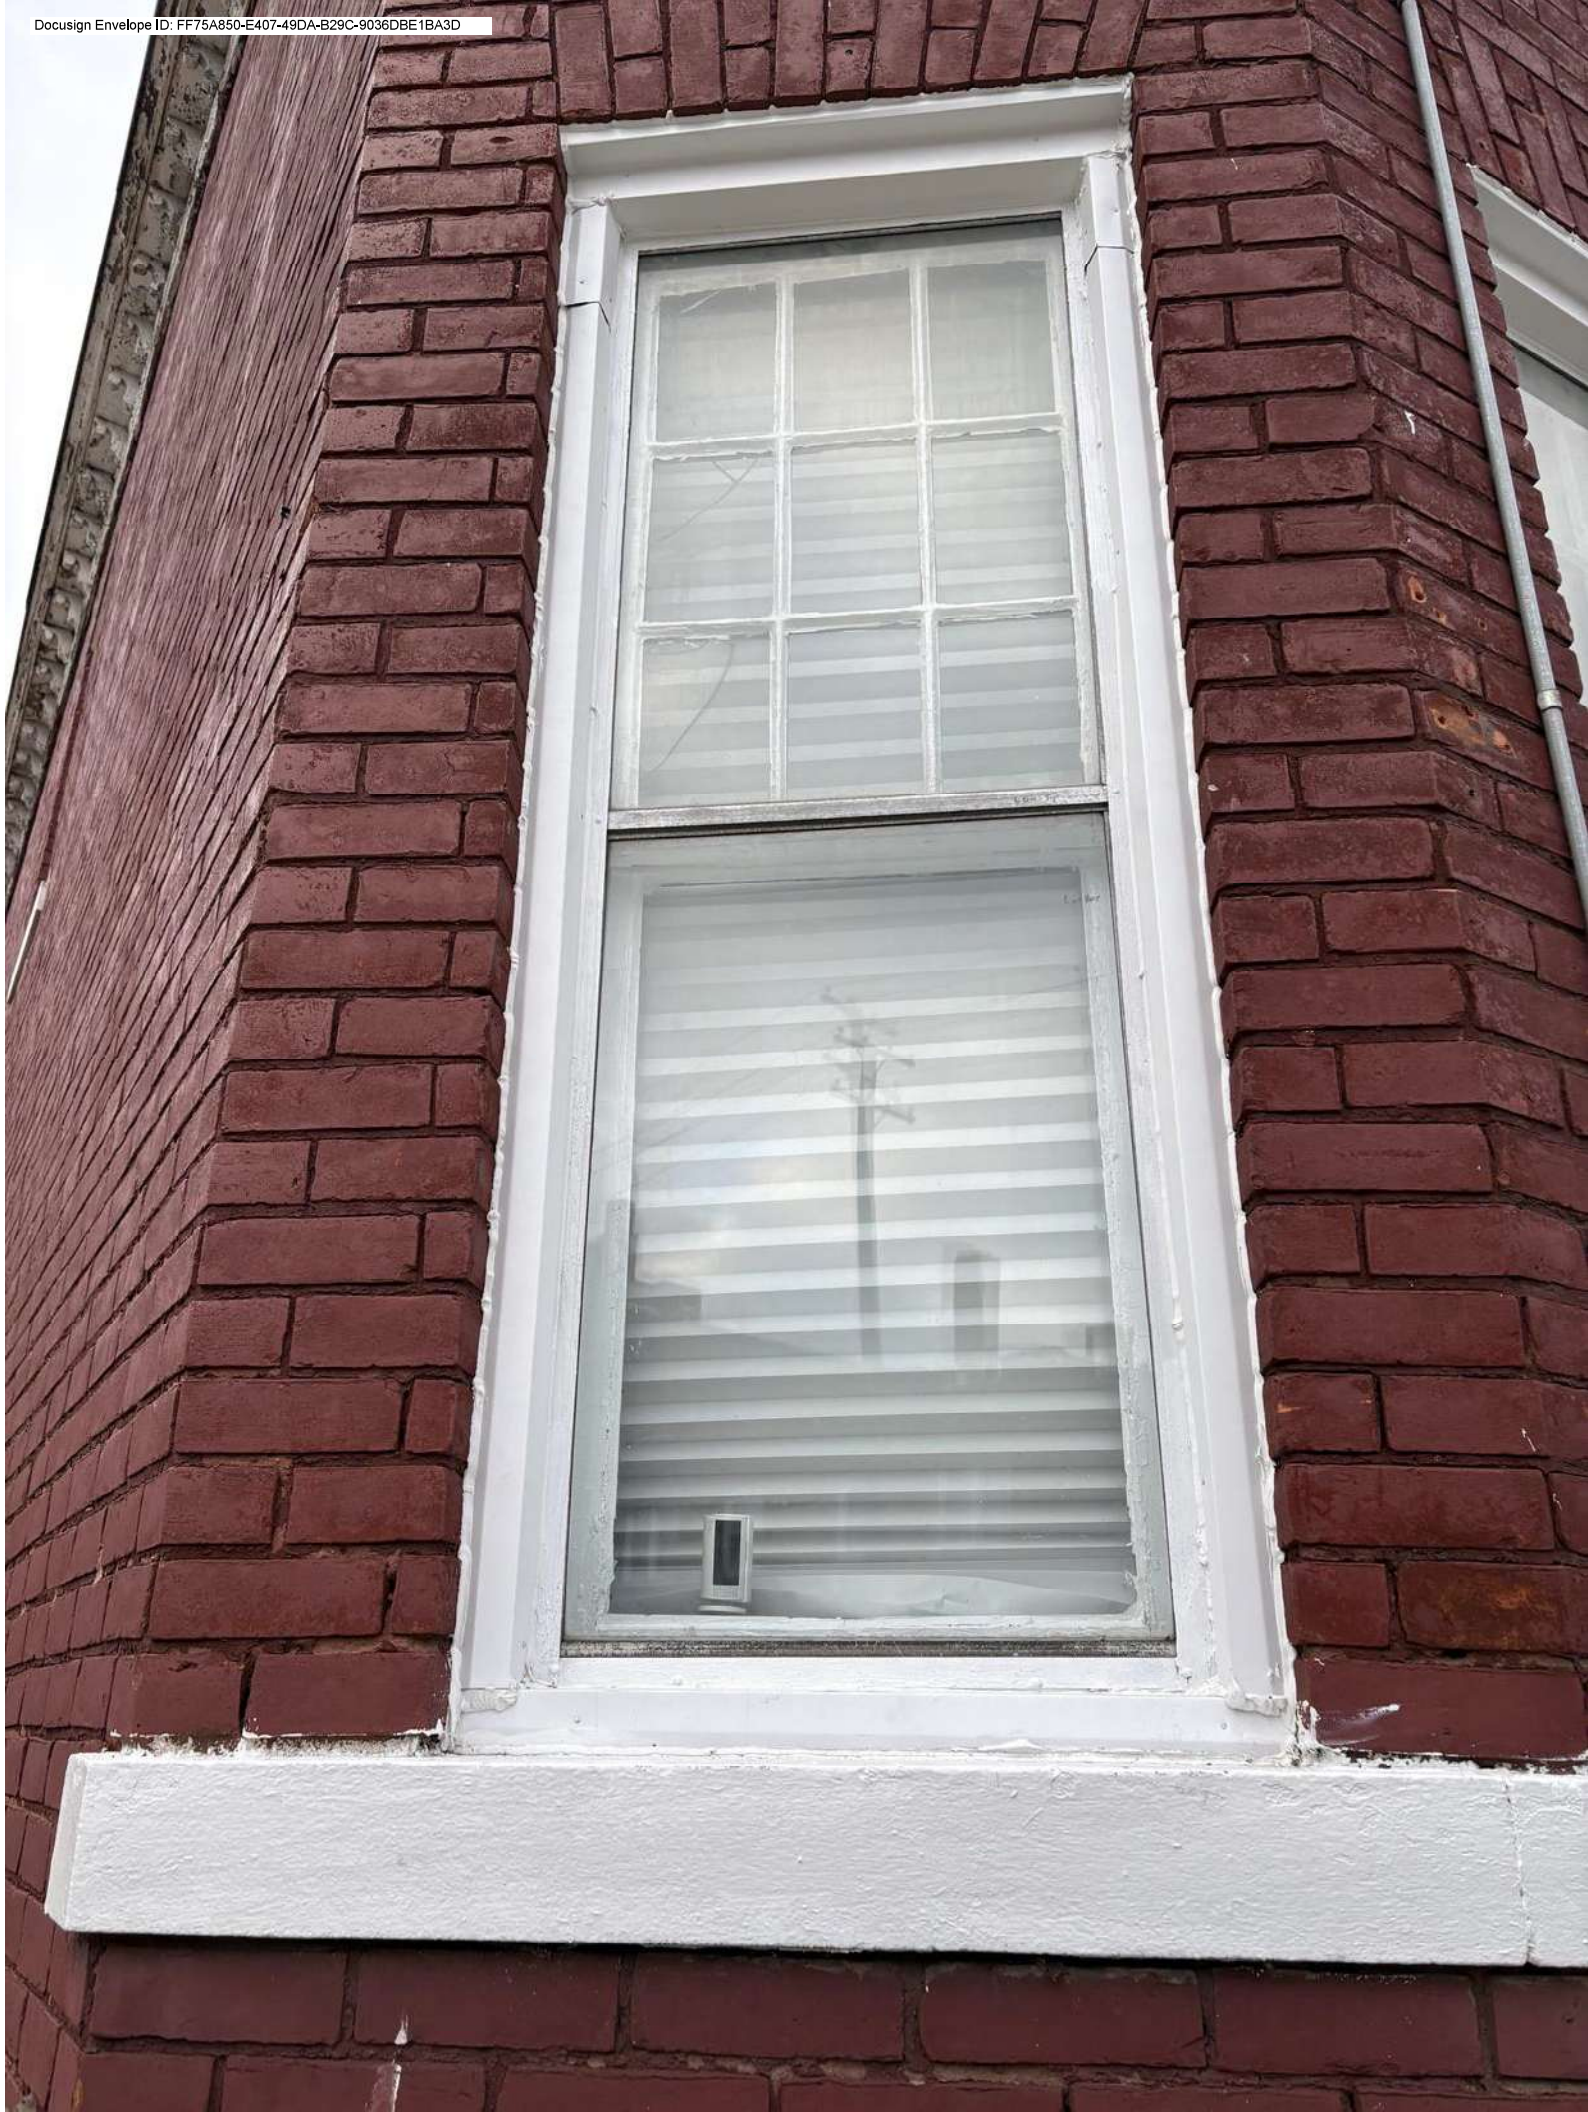
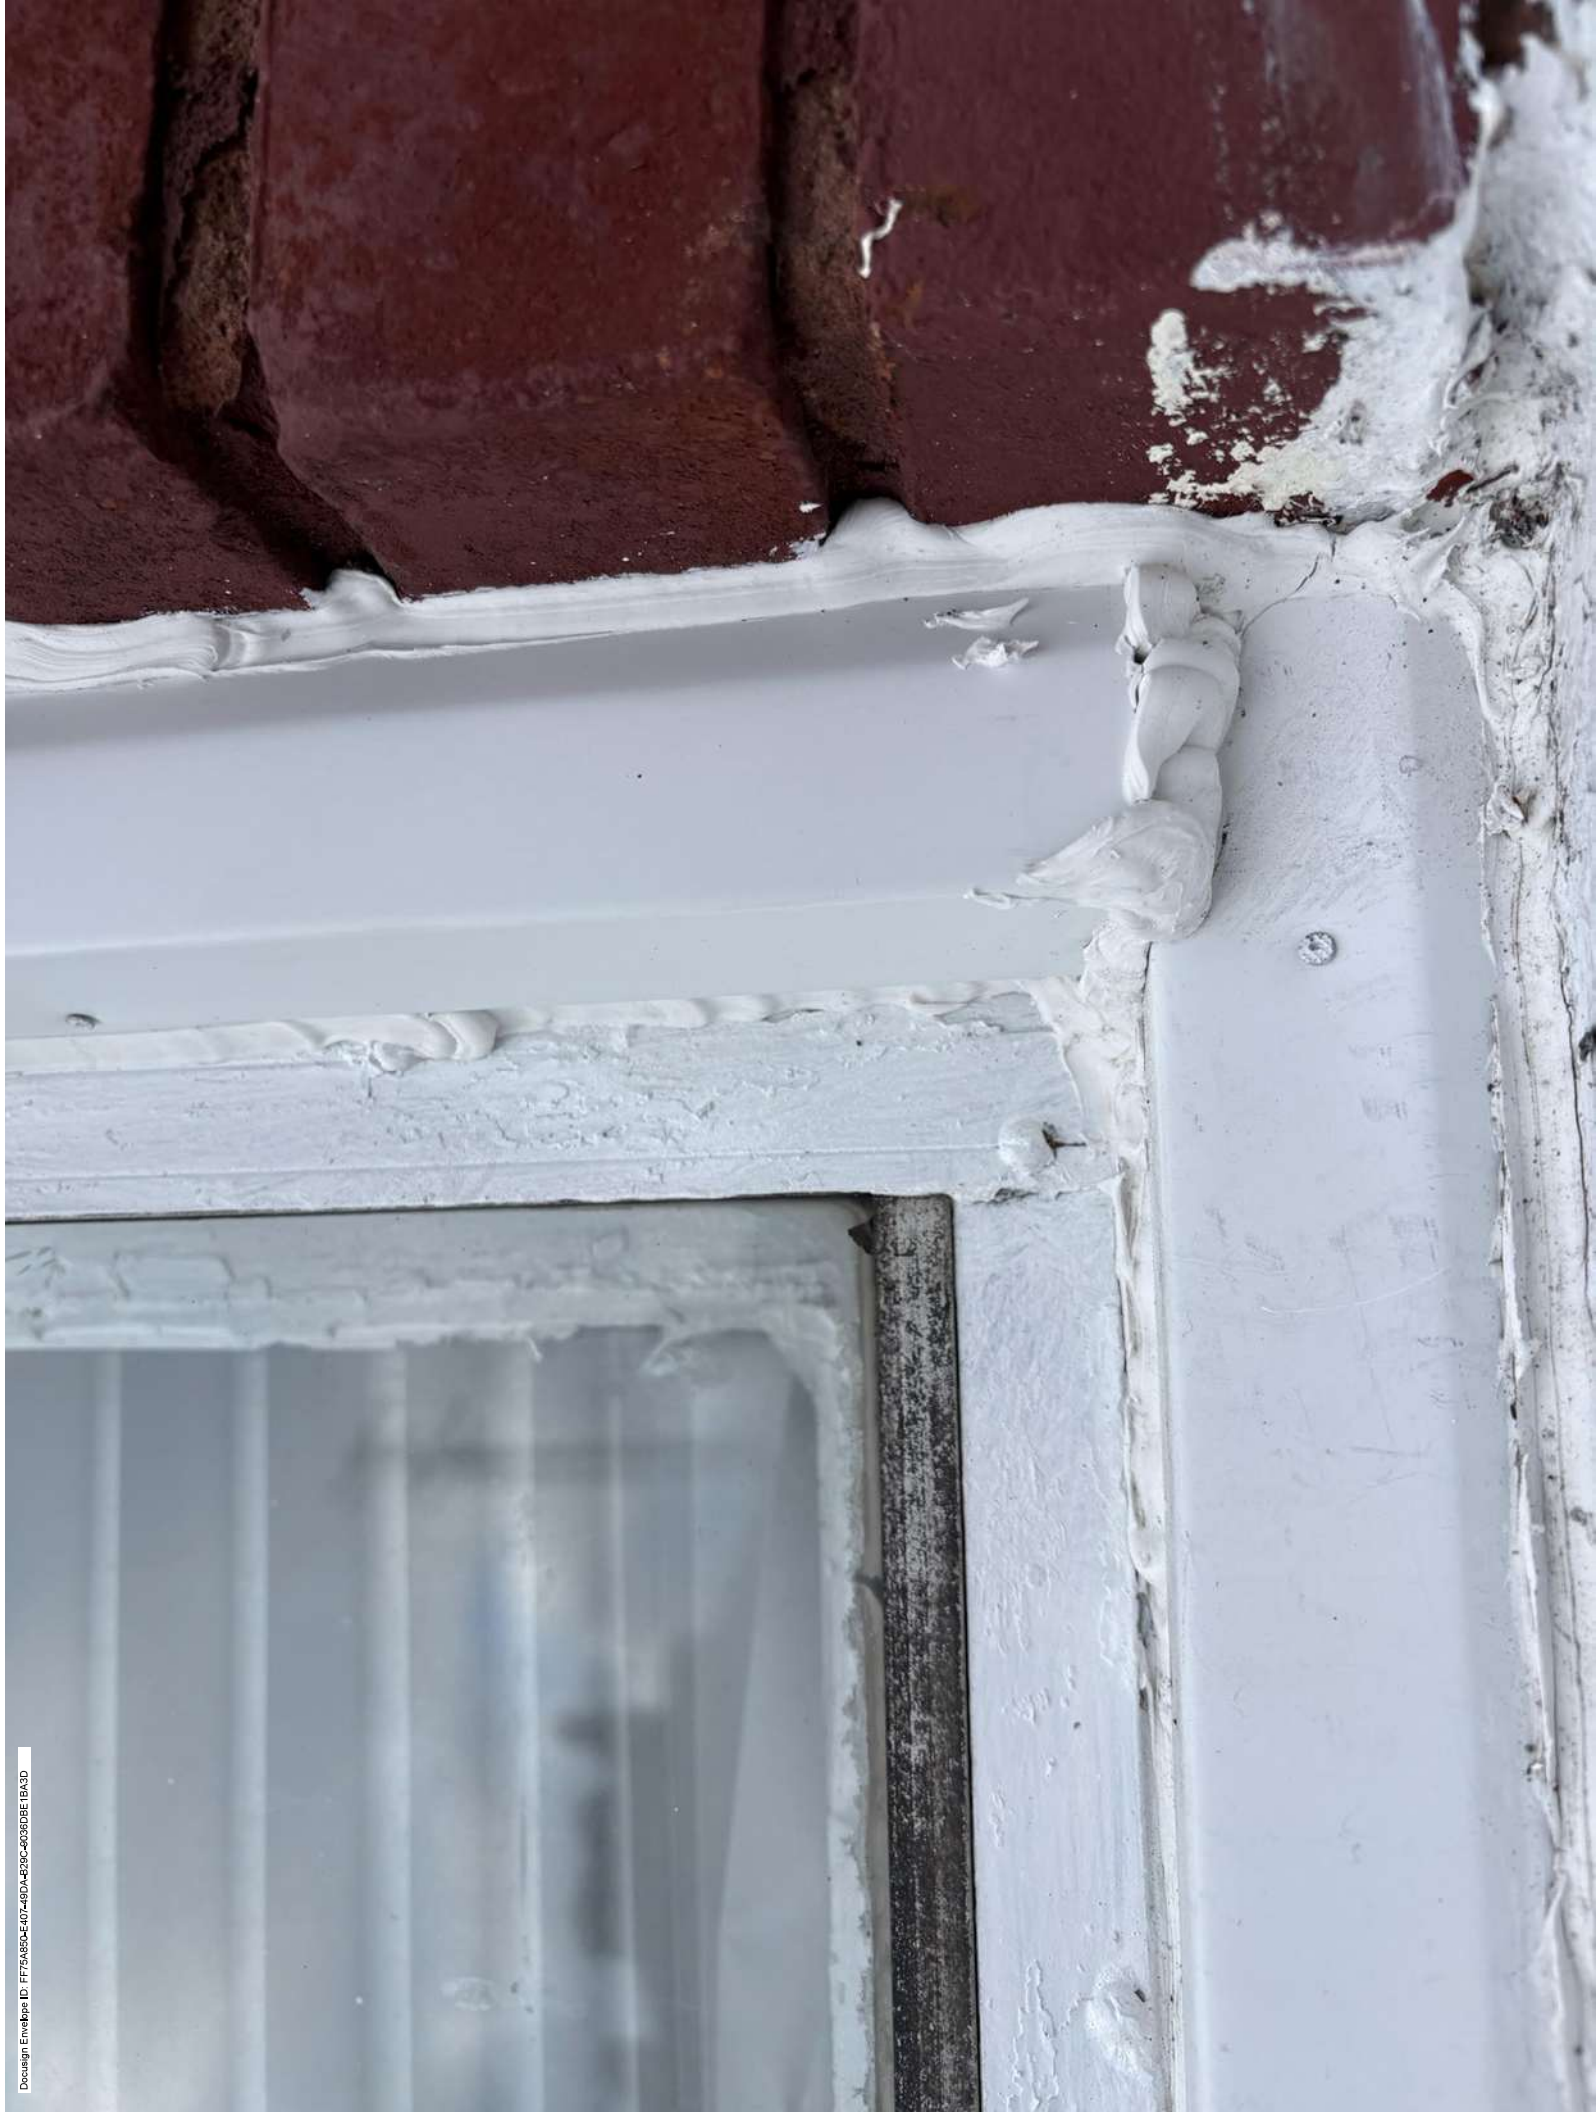
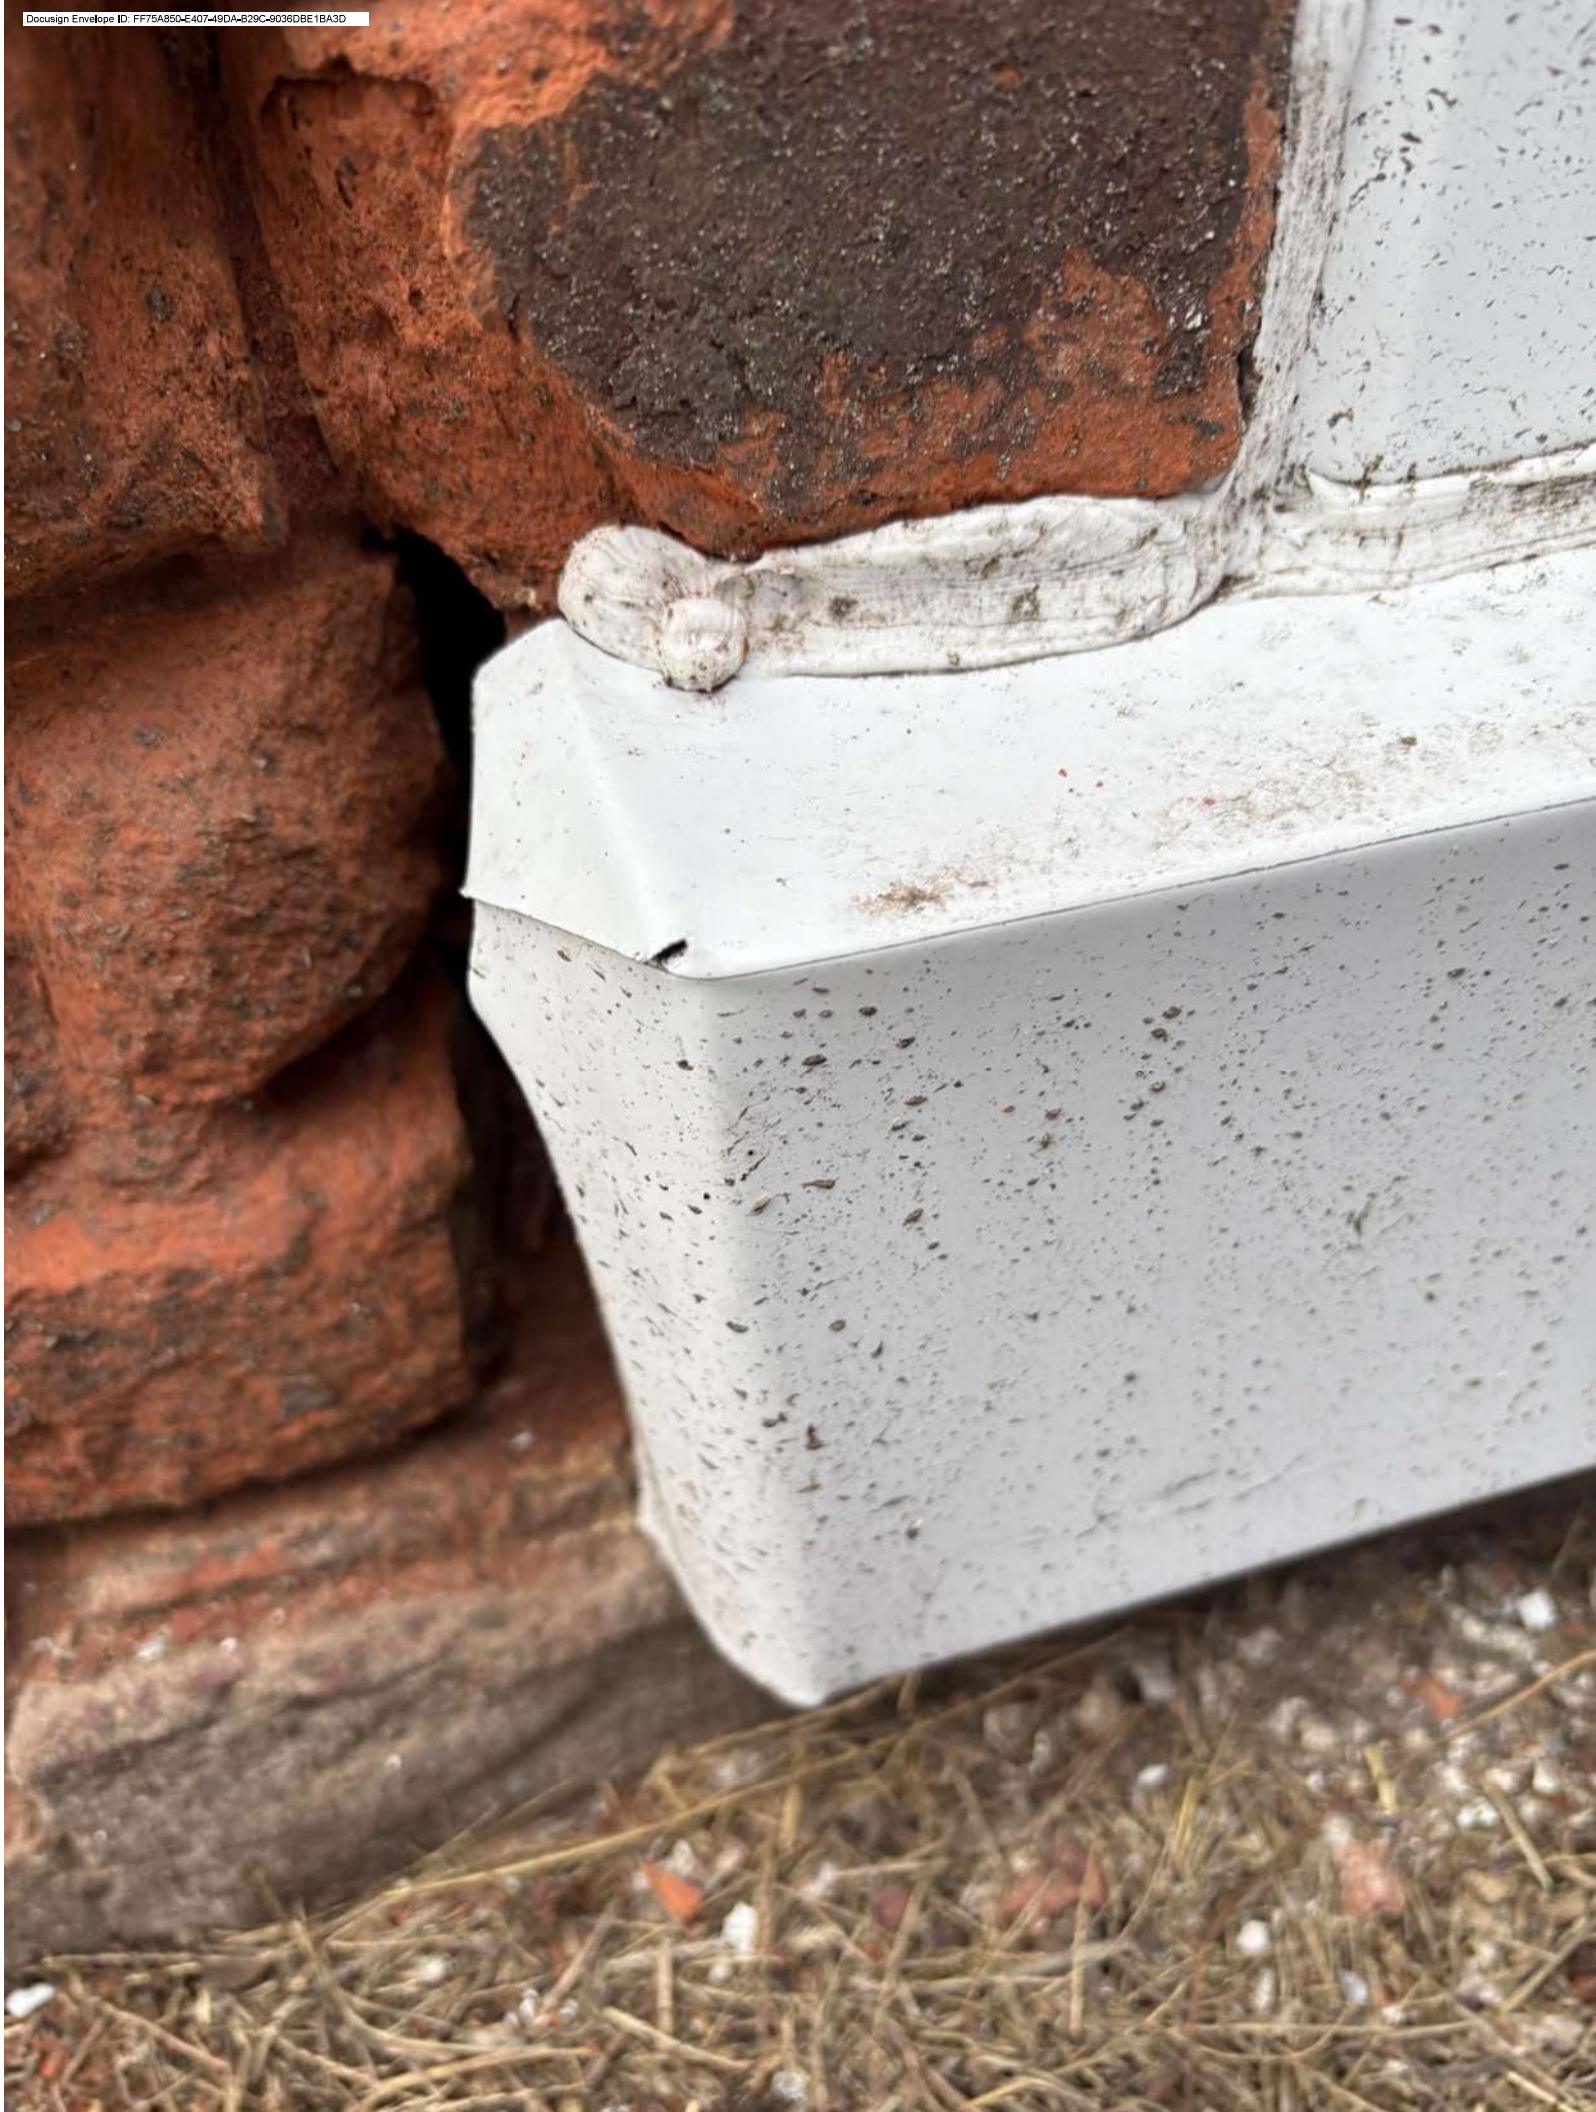
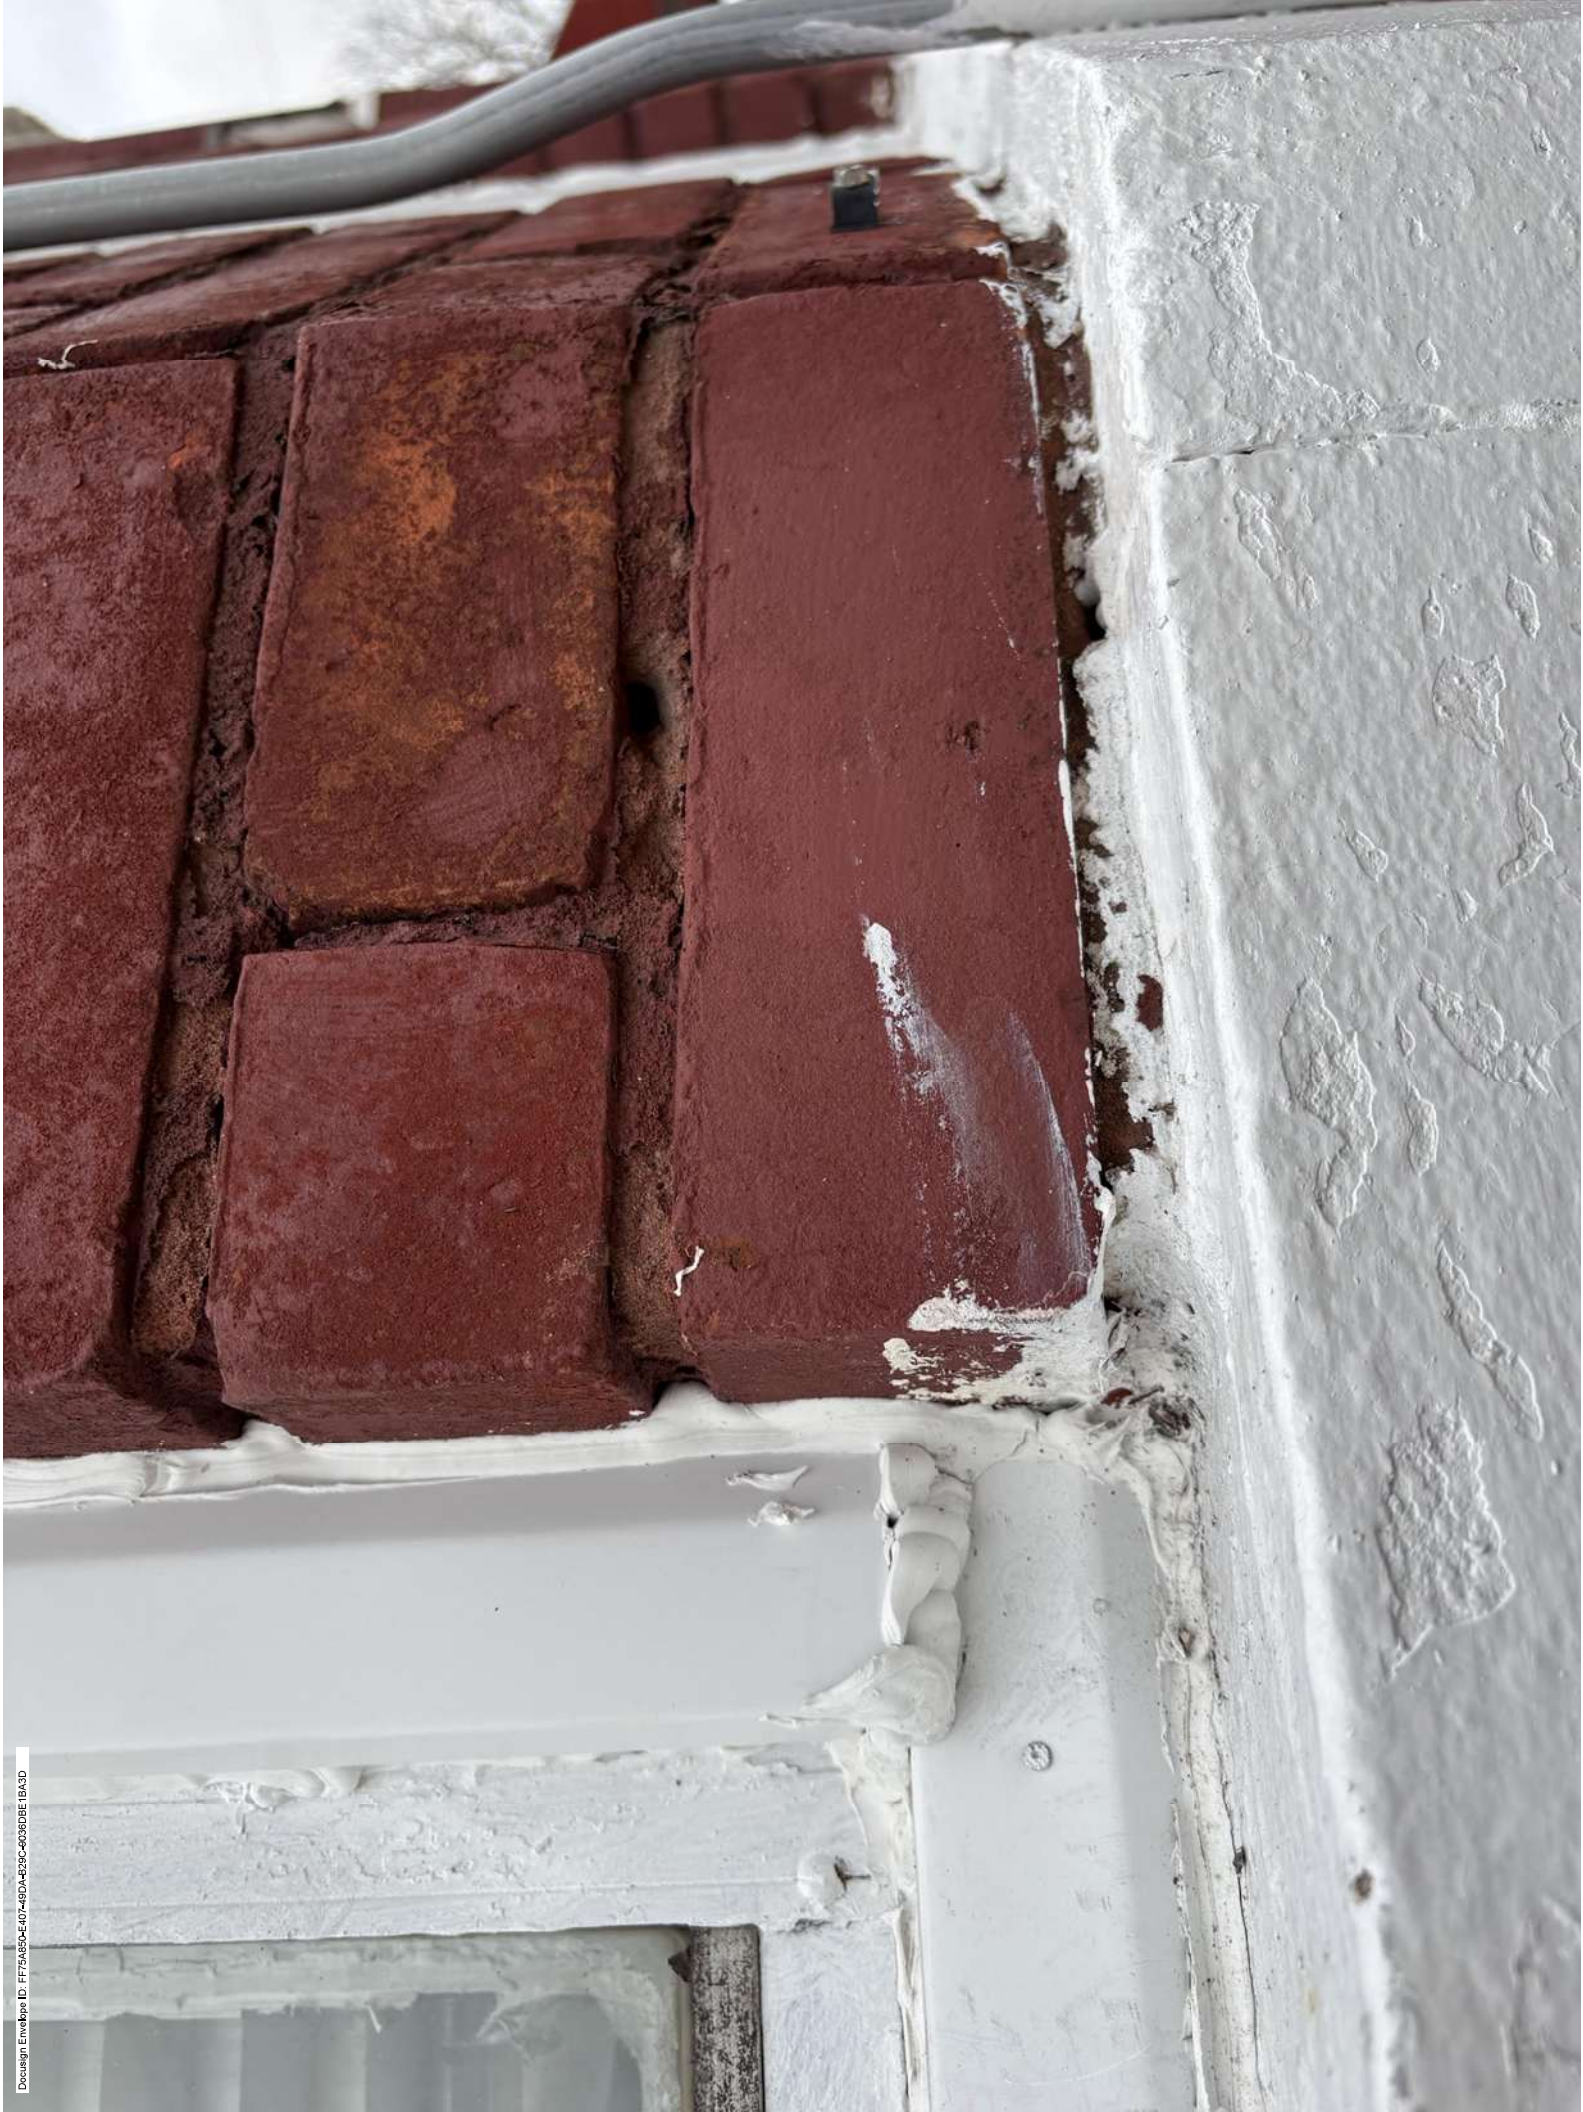
- Poor quality aluminum trim installation with many mistakes jeopardizes brick mold and window jamb.
- Polyurethane sealant/caulking was applied and is adhered tenaciously to the brick. Likely to damage mortar and leave staining upon removal.

- Sealant applied to storm windows covering screws and access points for removal of storm windows. This has effectively rendered the windows inaccessible, as many storm windows are in a non-functional condition. Broken panes in multiple sashes are now inaccessible for repair without full removal of the sash from the interior. Simply cleaning the windows is now an impossible task for the homeowner.

- Tub/Tile enamel has been applied to the windows, which is an inappropriate choice for any wood or exterior work. The workmanship of the painters is strikingly poor. Old glazing on the panes and paint on the sashes were not repaired/prepped prior to painting, creating a prohibitively difficult process to restore the window without breaking the glass. Workmanship and choice of paint demonstrate a clear lack of competency from the contractor.

- Excessive nails have been driven through the aluminum trim that was applied to all brick molding and exterior sills. Removal of this aluminum trim would likely damage the original wood beyond repair. Old wood rot was not remediated prior to applying aluminum, and the lack of air exposure caused by the application of aluminum will exacerbate rot issues.

- Restoration of old windows is made easier by weathering. Over many years of weathering, glazing and paint are made weak by the elements. Stripping back layers and preparing glazing are the most important steps in historic window restoration. The previous contractor's failure to adhere to this procedure has created a much more expensive, difficult, and in many ways impossible restoration process for these windows.
