**PLANNING AND
DEVELOPMENT DEPARTMENT**

SR-2 – ADVISORY STAFF REPORT (05-08-2026)

ADDRESS: 405 E. FERRY STREET

APPLICATION NUMBER: HDC2026-00200

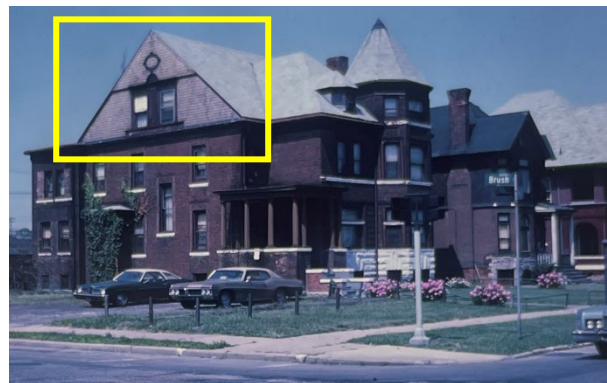
- East Ferry Avenue was designated as a historic district in 1981.
- The existing slate gable ends are a distinctive character-defining feature of the 1895 residential building.

*Designation Photo July 1981,
shows the slate tile gable end*

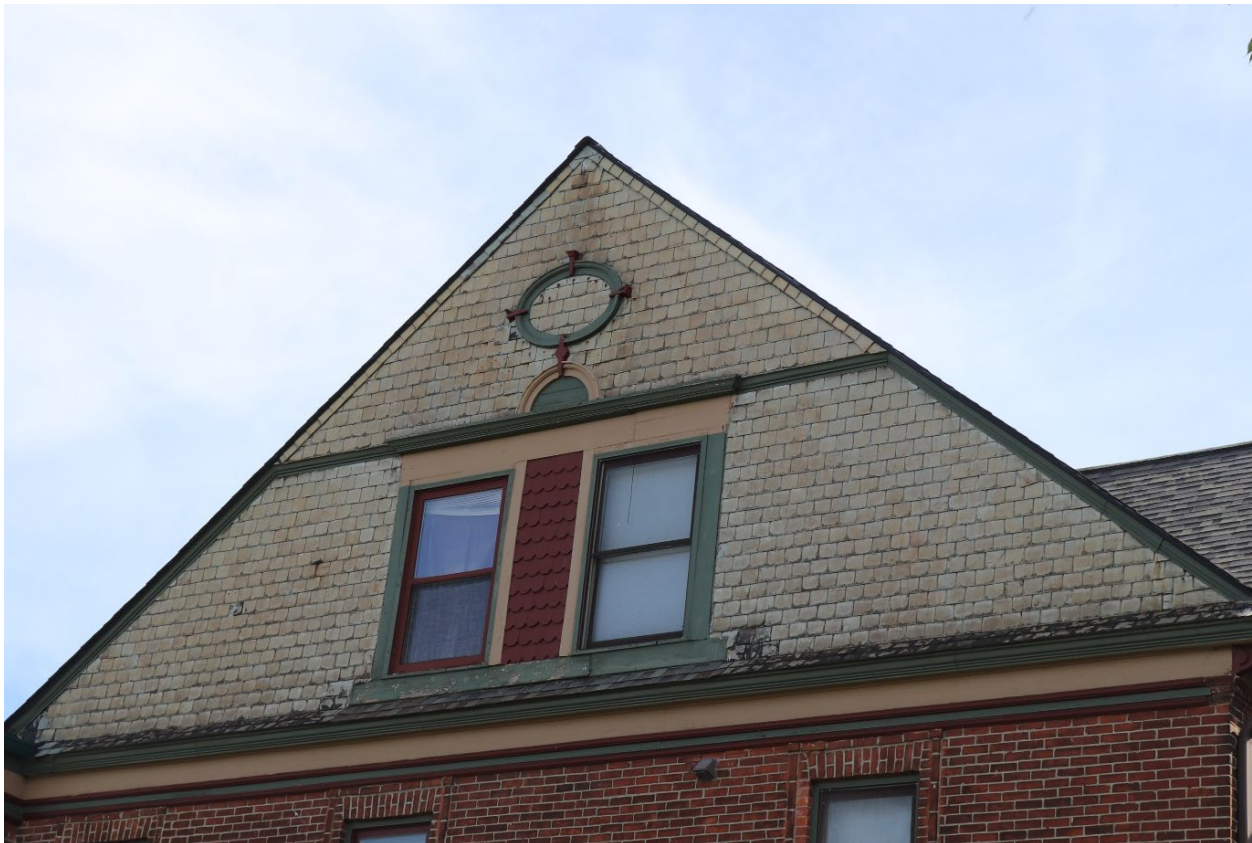
- The proposed slate tile replacement occurs at the southwest facing side and north-east facing gable ends.
- The south-west facing gable, which can be viewed from Brush Street, has experienced decay which includes rusted nails, slipping tiles, and areas that have been completely replaced (as seen at the fascia). The area below the wood window sill has been replaced with asphalt shingles. The applicant is proposing to correct this with the DaVinci Inspired slate tile as well.

- It is unclear to staff, as staff has no record of approval, when these replacement tiles were installed. Still, the gable end retains many of its original historic-age slate tiles.

South-West facing gable end, facing the Brush Street side, shows areas of deterioration, rusted nails, slipping tiles, as well as a few areas of replaced tiles (see detailed photos on next page)

- It is Staff's opinion that the existing slate tile does not appear to be deteriorated beyond feasible repair.
- Staff recommend that the slate tile gable end should be evaluated for selective repair as opposed to the full replacement of the historic-age slate tile roof.
- The National Parks Service Preservation Brief gives detailed guidelines on the repair and replacement of slate tile installations. Where possible, these repair methods should be attempted before a total replacement is conducted.

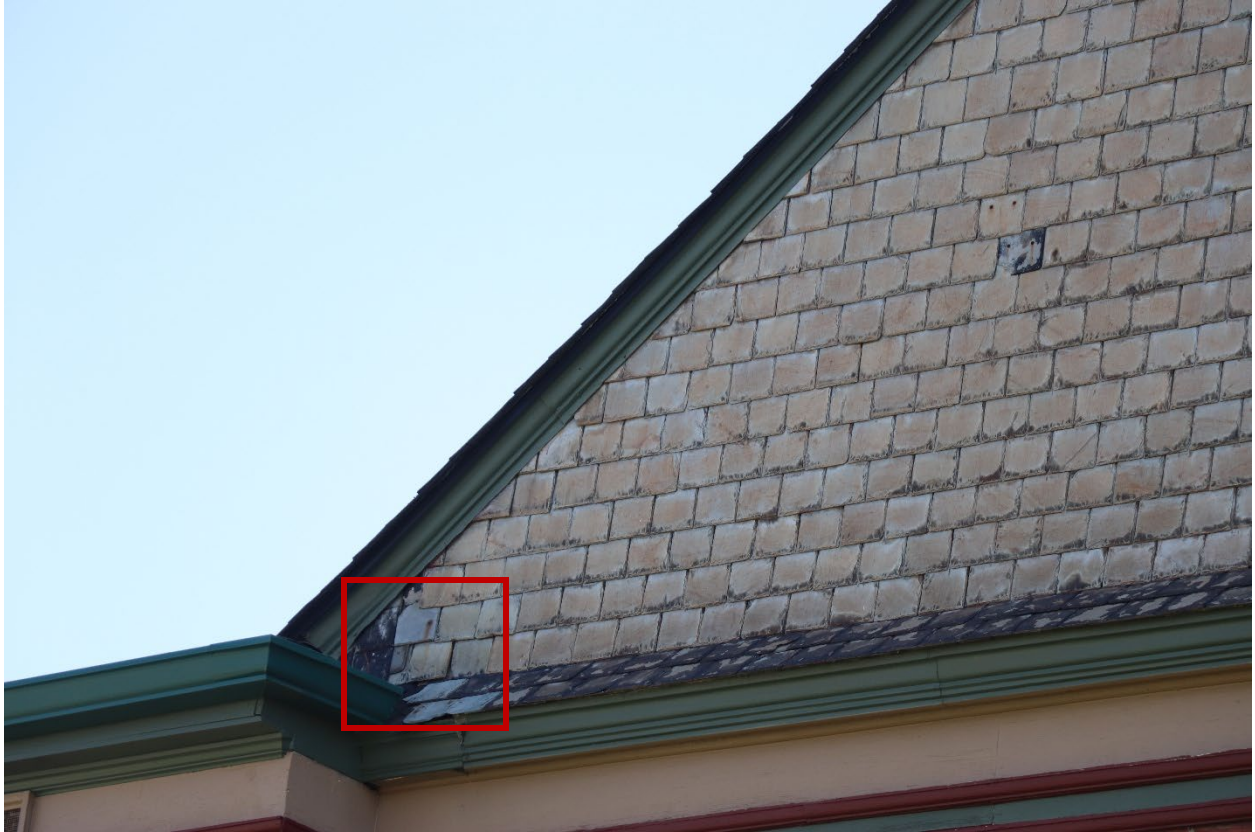
Photos taken by staff on 05/04/2026 (south-west facing gable)

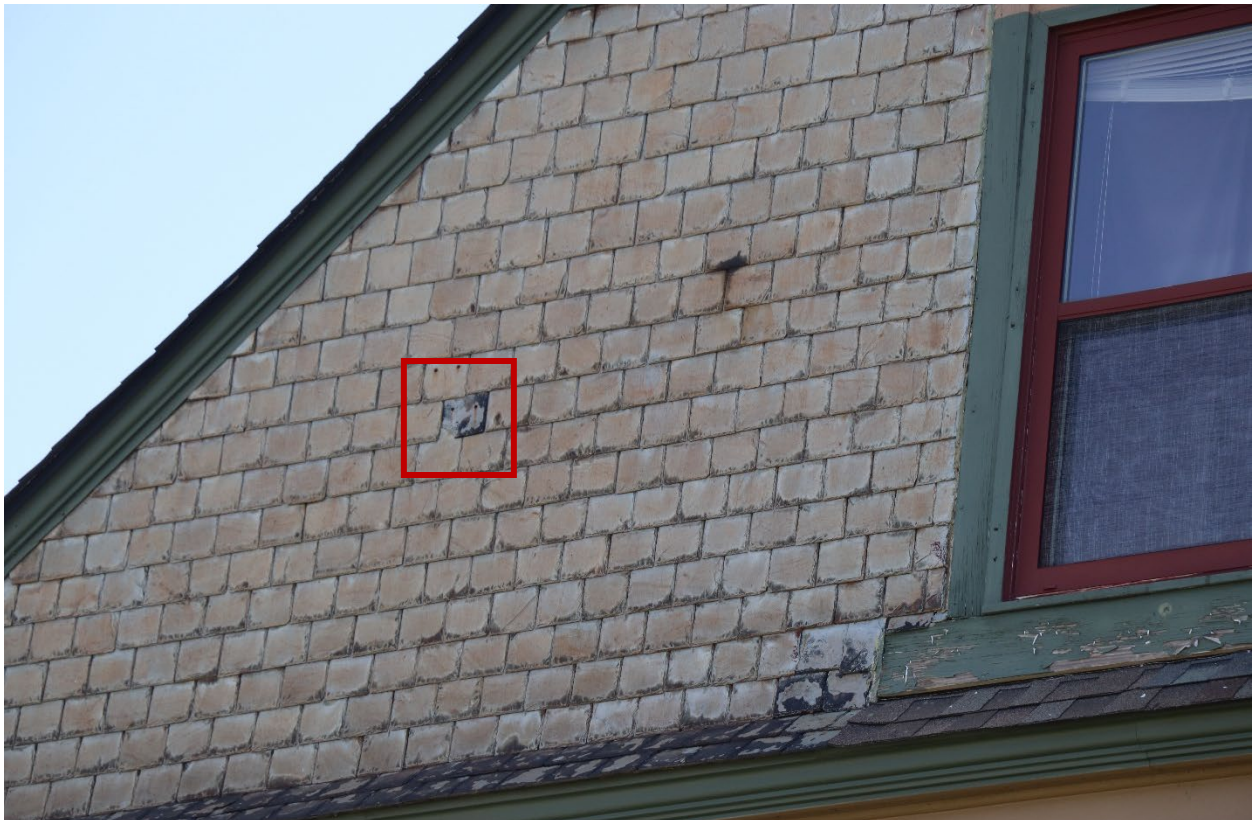
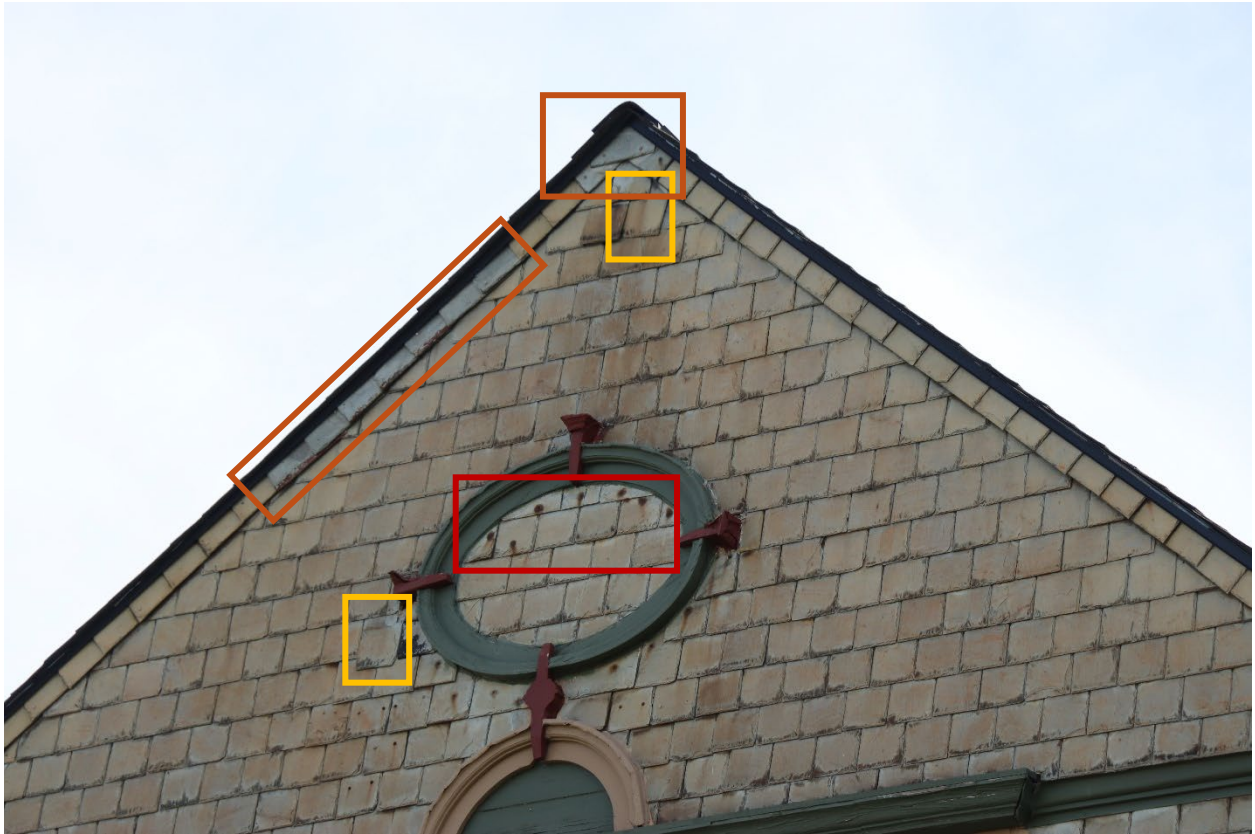
- The north-east facing gable, which faces the neighboring residential building at 411-423 East Ferry, appears to have deteriorated more than the south-west end, showing areas of missing slates which have presumably slipped and fallen. There are also select areas of replacement slate tiles which appear to contrast the existing in size and color.

Photos taken by staff on 05/04/26 (Above: south-west facing gable, Below: north-east facing gable)

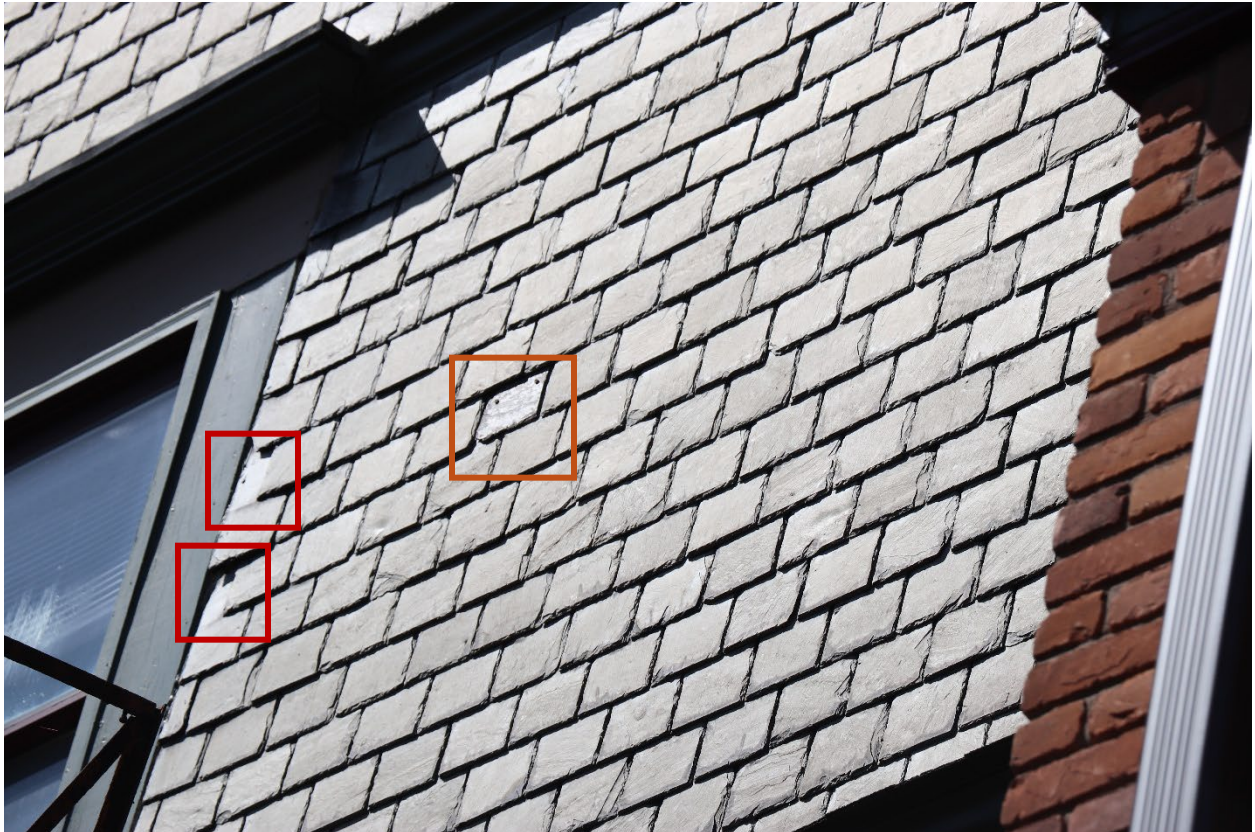
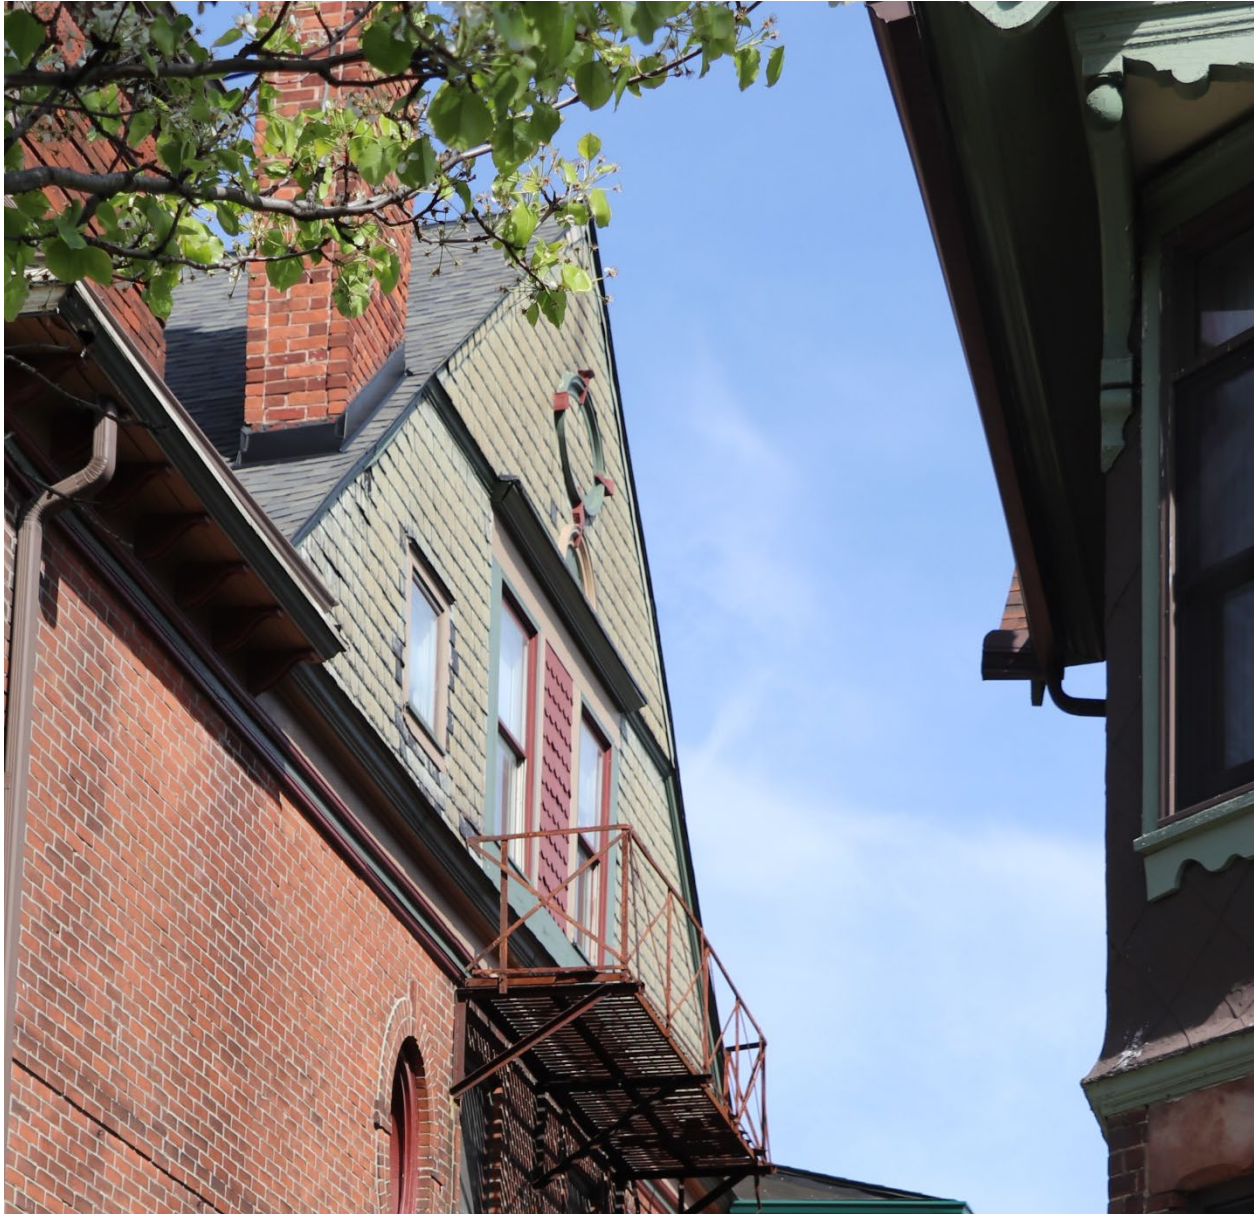
Photos taken by staff 05/04/26 (north-east facing gable end)

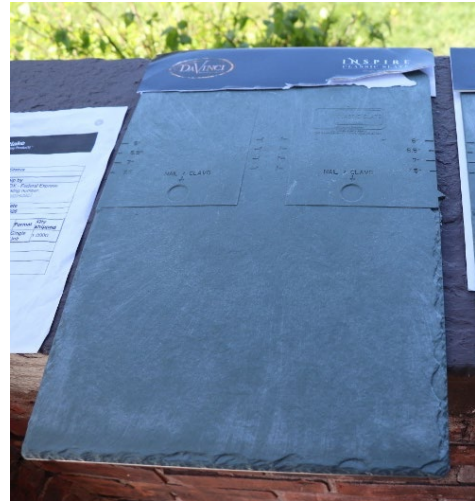
1. The existing slate tile does not appear to be deteriorated beyond repair.
2. The DaVinci Inspired slate tiles, made of a polypropylene base of product, are not a compatible replacement for a slate tile gable end roof. The replacement tiles should match the existing in size, shape, color, texture, exposure, and coursing.
 - a. Vinyl and poly-products offer a plasticity and flat/thick appearance that does not adequately match the profile/dimensionality, authenticity, and appearance of historic slate tiles.
3. No color swatch for the paint was submitted, therefore the color must be analyzed. The wood window's trim and sashes shall be finished with colors that are compatible within the Historic Districts' Color Chart System, subject to staff approval.

Image: DaVinci Inspired slate tile replacements

- However, should the Commission elect to approve the removal of the historic slate tiles, replacement tiles should match the existing in size, shape, color, texture, exposure, and coursing.
- The replacement clearly differentiates in color from the historic slate tile and creates a false sense of the historic slate tile.
- Per the National Parks Service Preservation Brief Guidelines for *The Repair, Replacement, and Maintenance of Historic Slate Roofs*:

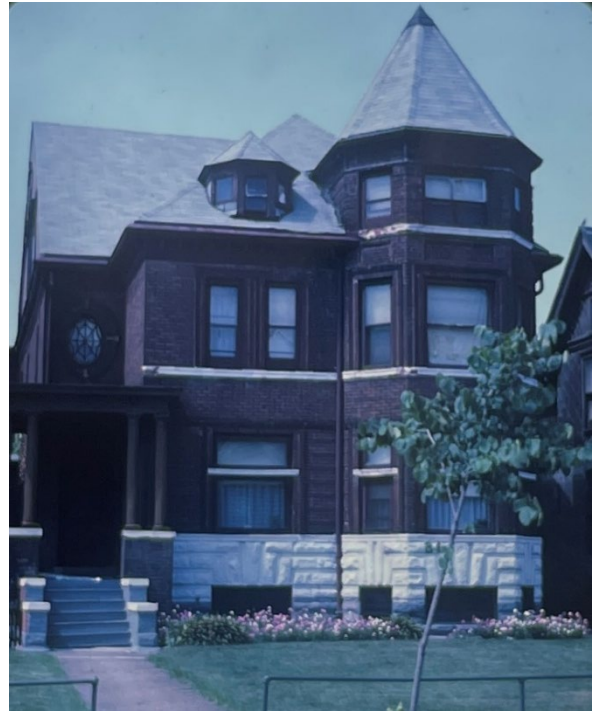
- Based on the designation photo from 1981 (*image on the right*), it is unclear to staff what the window trim and sash colors may have been at designation.
- 405 East Ferry, which was built in the Queen Anne/ Colonial revival style, must adhere to the HDC Color Chart System B.
- While a paint color sample has not been provided for the “emerald” color, the wood window paint colors should follow the table (shown below).
- Other colors off the chart can be approved by staff. No color swatch for the paint was submitted, therefore the color must be analyzed.
- Staff recommend the color B:11 Grayish Olive Green at the window trim, which may be close to the applicant’s desired color.

1. The wood window's trim and sashes shall be finished with colors that are compatible within the Historic Districts' Color Chart System, subject to staff approval.
