STAFF REPORT: 10-13-21 MEETING

APPLICATION NUMBER: 21-7521

ADDRESS: 19355 PARKSIDE

SCOPE: WINDOW REPLACEMENT

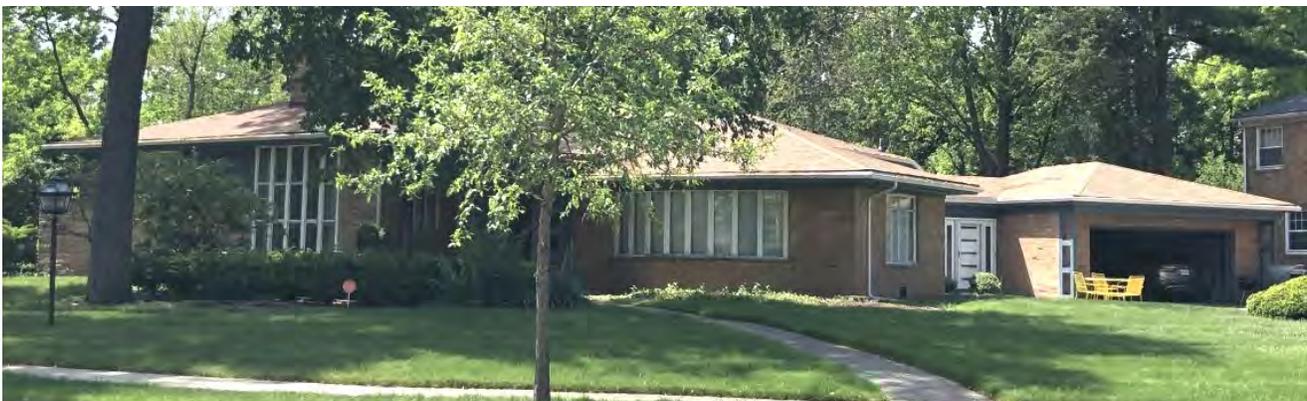
Looking northwest from Parkside at front and east elevation. HDC staff photo, May 20, 2021 (HDC photos on following two pages).

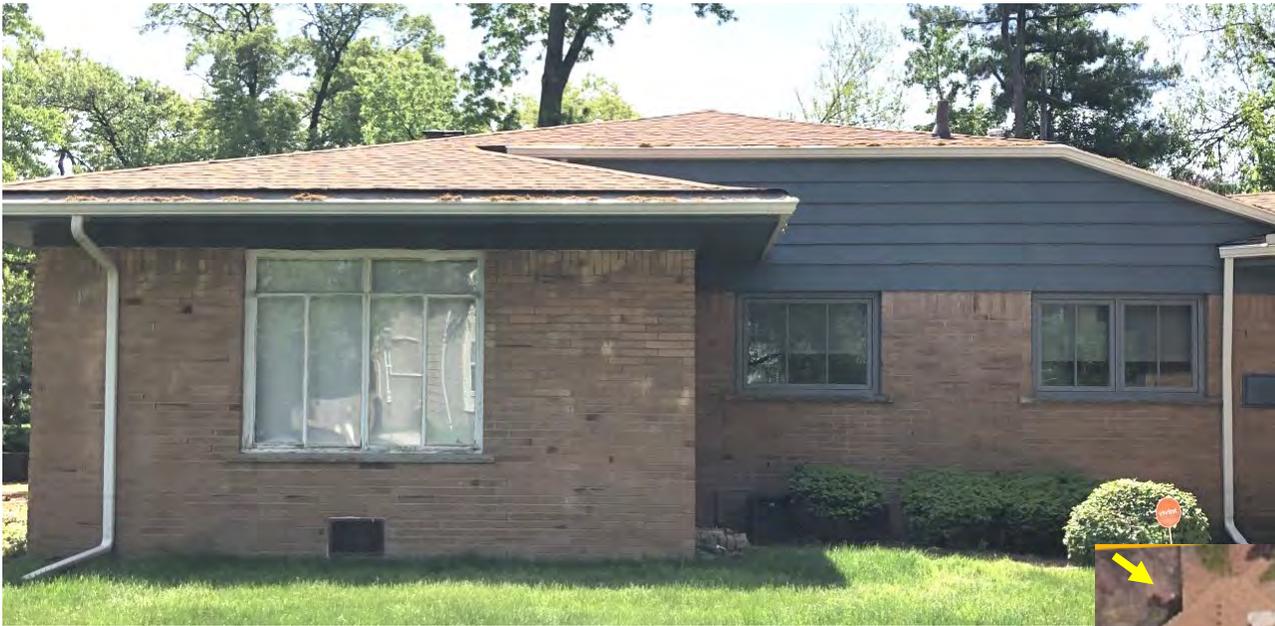
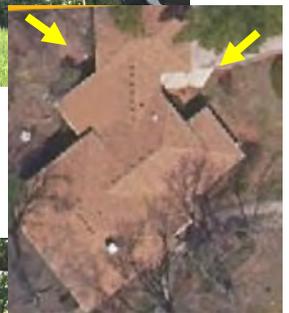
Walking counterclockwise around the property, the side elevation is broken into two different planes.

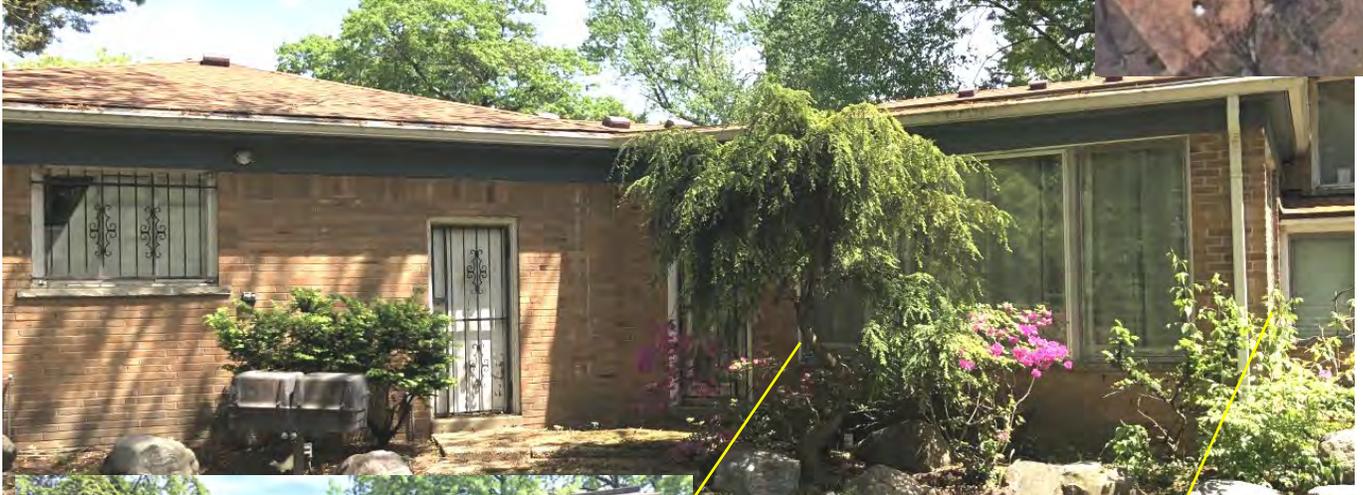
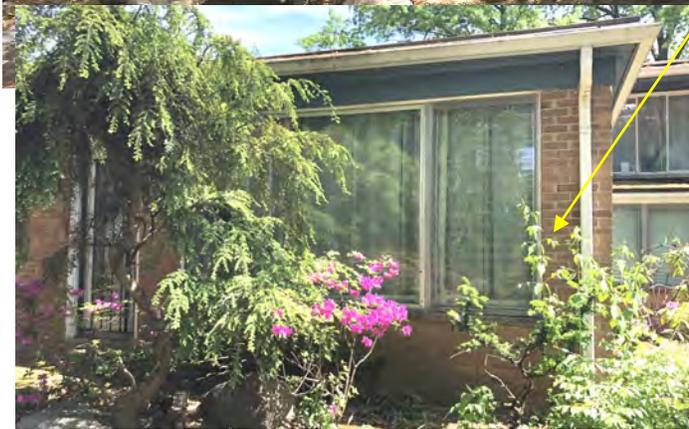
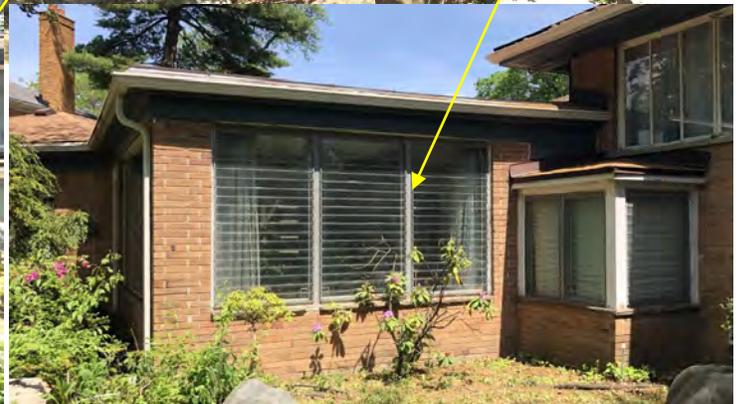
Shown below is the rear elevation. The garage wall includes the high silled window and single door; a sunroom is to the right. The rear window opening on the sunroom has a central fixed clear glass window with flanking jalousie windows. The side wall has three mullioned jalousie windows.

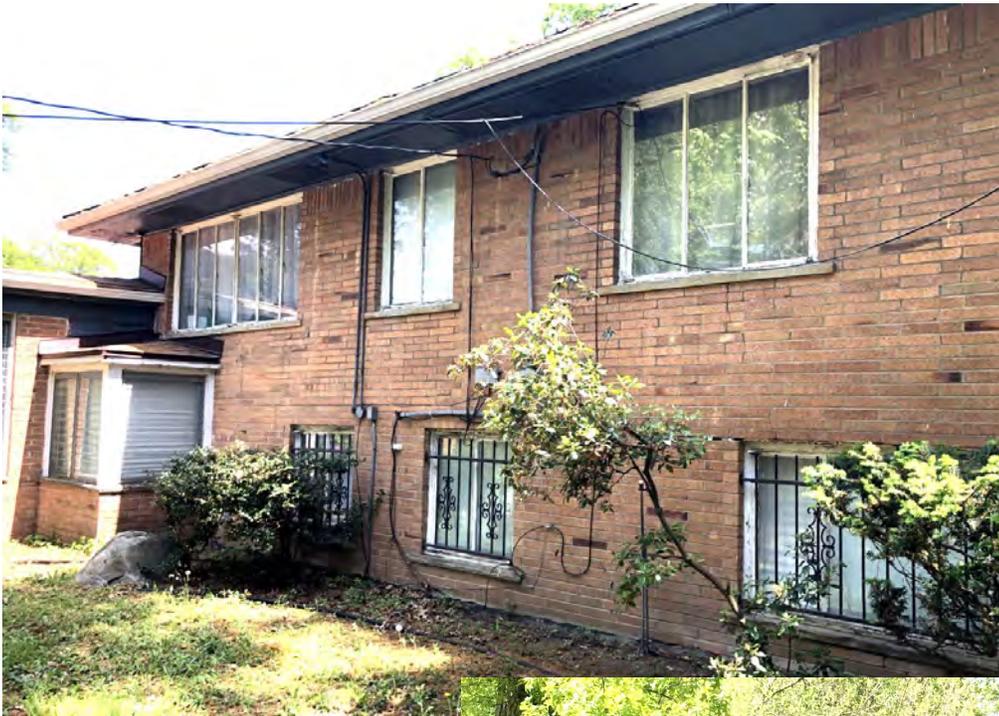
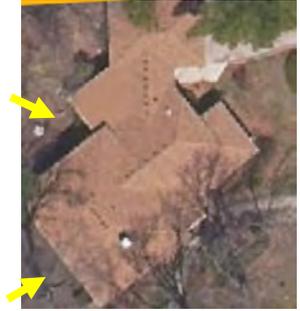
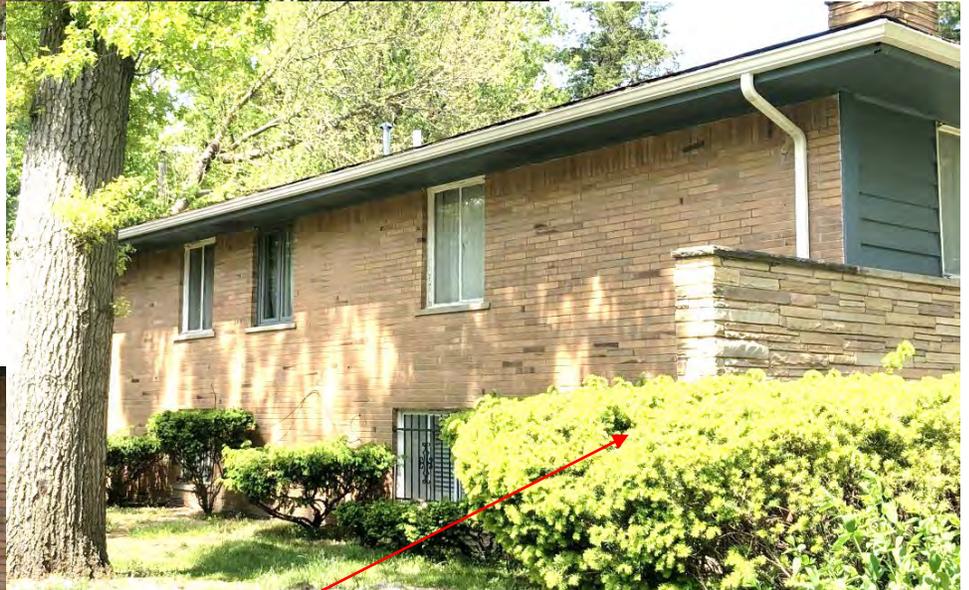
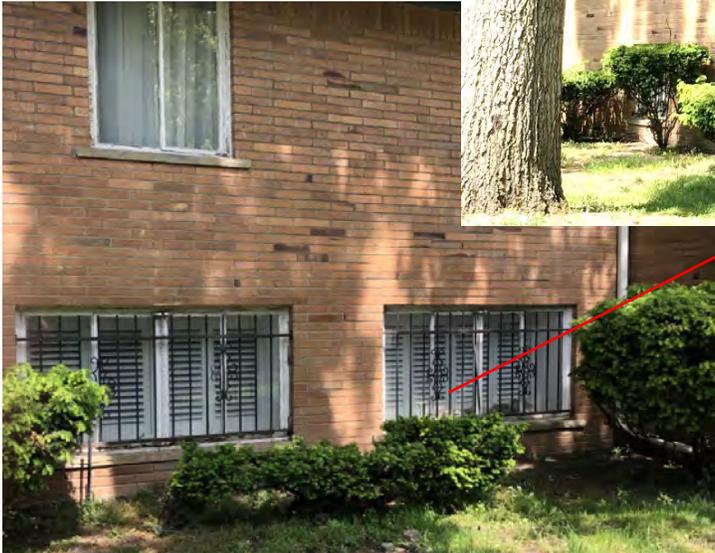
Above: Main rear elevation of the house.
Right and below: West/side elevation.

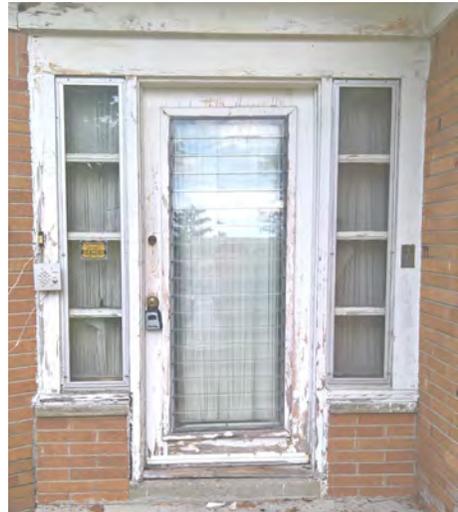
Replace the side entry door/sidelights (shown at right). Deterioration and security at this entrance were stated as the main reasons for replacement. The HDC questioned:

The Commission approved the replacement with the condition that it be finished in the color that matches the house trim (at that time, it was the recently approved blue-gray).

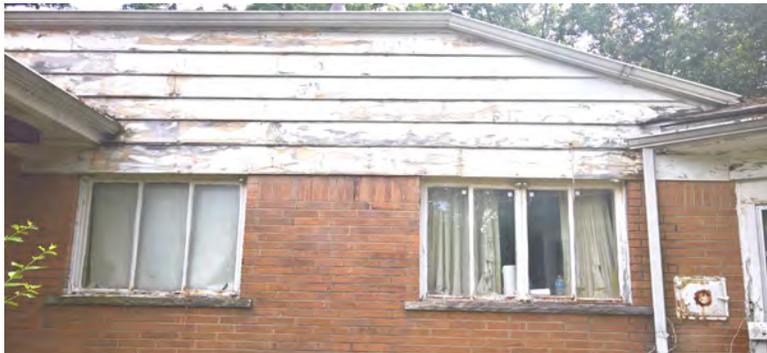
Replace the steel windows (shown below); applicant claimed they were sealed shut due to corrosion, wear, neglect and multiple layers of paint, as well as missing hardware. One repair estimate was submitted from GPH Services stating the full restoration of the two openings would cost \$6,800. Proposed replacement windows: Pella Architect Series – left opening changed to a hopper with two vertical muntin bars; right opening changed to a double casement with each glass area to have a central vertical muntin bar.

Original steel-framed window sash (casement/fix operation).

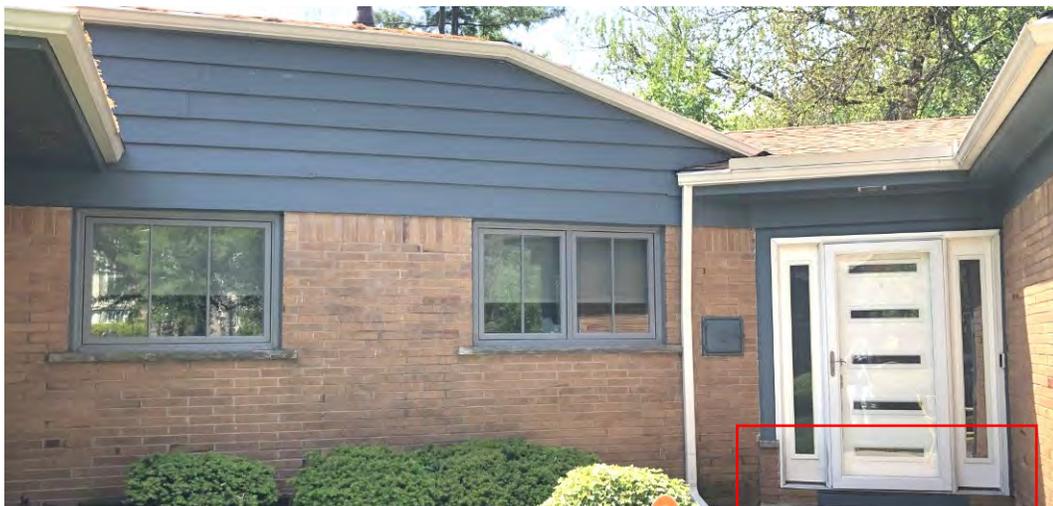
Pella replacement windows and replacement door with sidelights. (HDC staff photo, May 20, 2021). Note the replacement door doesn't fully fill the original door opening.

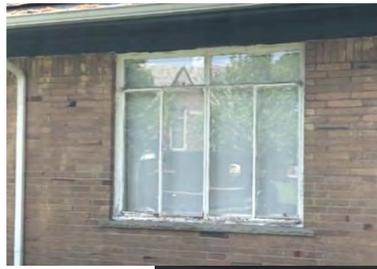
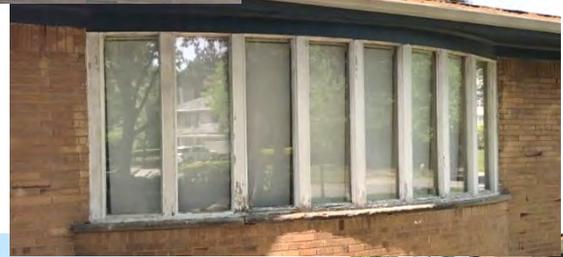
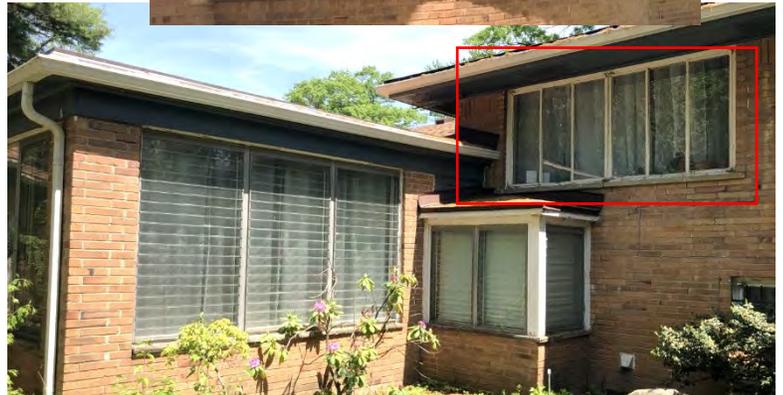
Replace steel sash double casement with transom. New windows will be two awning windows, with a “cross grill pattern” to replicate the transom/muntin bar patterns.

Replace wood fixed windows; existing wood mullions to be retained and repaired by the property owner.

Replace steel sash two mullied, three part windows (outer casements, center fixed). New windows will be two wide awning windows, each with two vertical muntin bars.

Replacement Windows: Pella Architect Series, wood, aluminum-clad units

Commission issued a COA for the proposed work due lack of economic and technical feasibility for restoration of the existing steel windows.

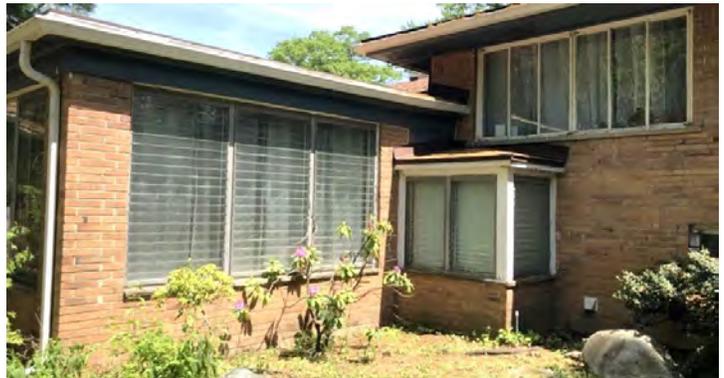
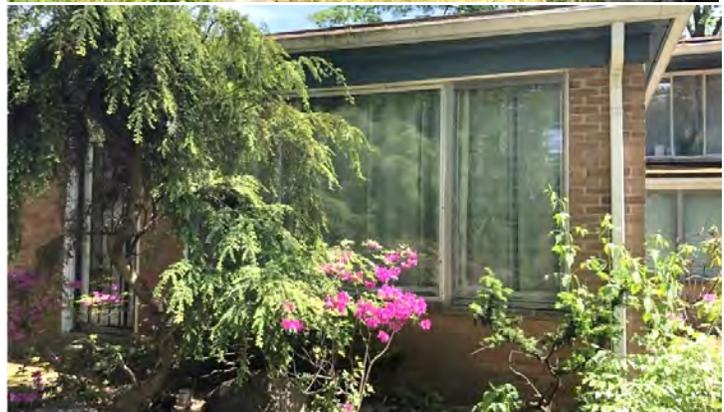
- Patented in 1901, these windows became extremely popular in the 1940s and 1950s, becoming synonymous with mid-century design.
- Original jalousie windows can offer challenges of security (slats can be removed) and maintenance/longevity (the non-airtight seals slowly allow moisture and dirt into the window's mechanisms).

- Jalousie windows fell out of favor in the late 1960s-early 1970s, likely due to rising energy costs coupled with the increasing use of residential air conditioning.

- Through some quick internet research, HDC staff identified companies that continue to make jalousie windows which include security features and stronger, more weather-resistant mechanisms. Frame options range from wood, aluminum, and PVC.

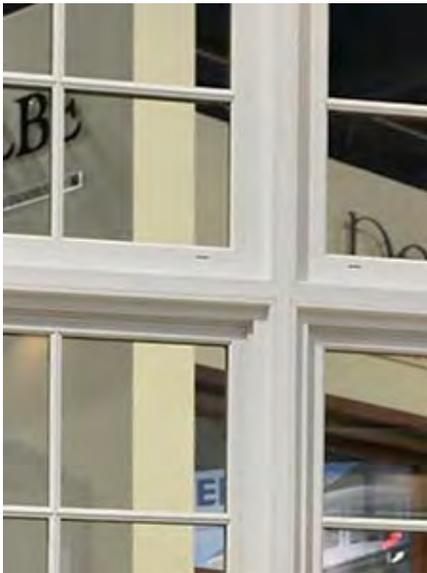
Factory-made mullions are thicker than muntins but often pale in comparison to the dimensionality of historic mullions.

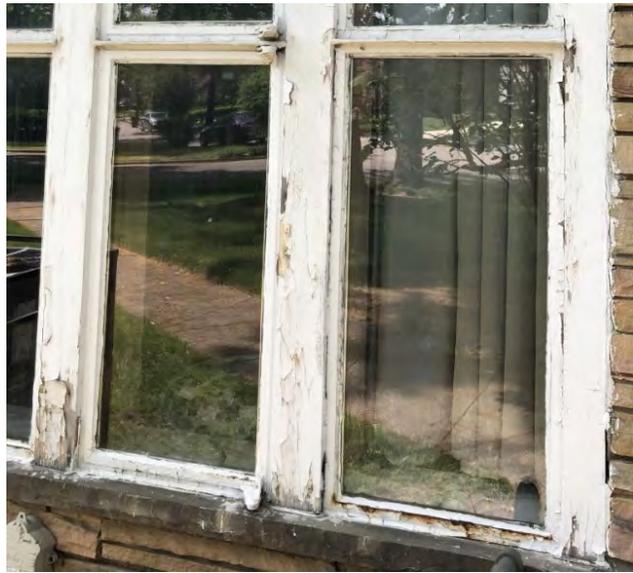
Existing mullions at 19355 Parkside display minimal detailing in keeping with the mid-century design of the house. The width of the wood mullion, in relation to the thinness of the steel sash, is a character-defining detail.

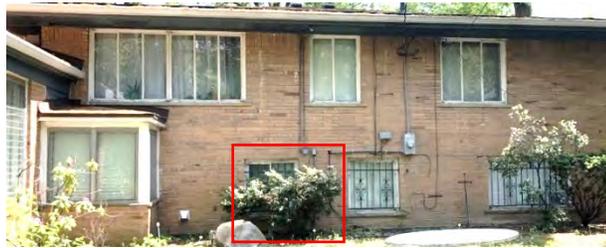
- Rear Elevation, Lower left opening: Dryer vent is proposed for the opening – staff requested catalog cut to confirm material, finish, and design of the vent.

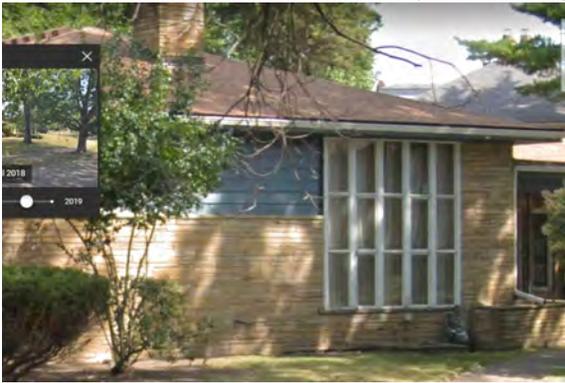
Google street view image, July 2018

- Work done without a permit/HDC review. These items are listed a notice only and aren't included with this application.
 - Generators were installed on the front elevation of the house between July 2019 and May 2019. There is no record of this installation being reviewed/approved by the HDC.

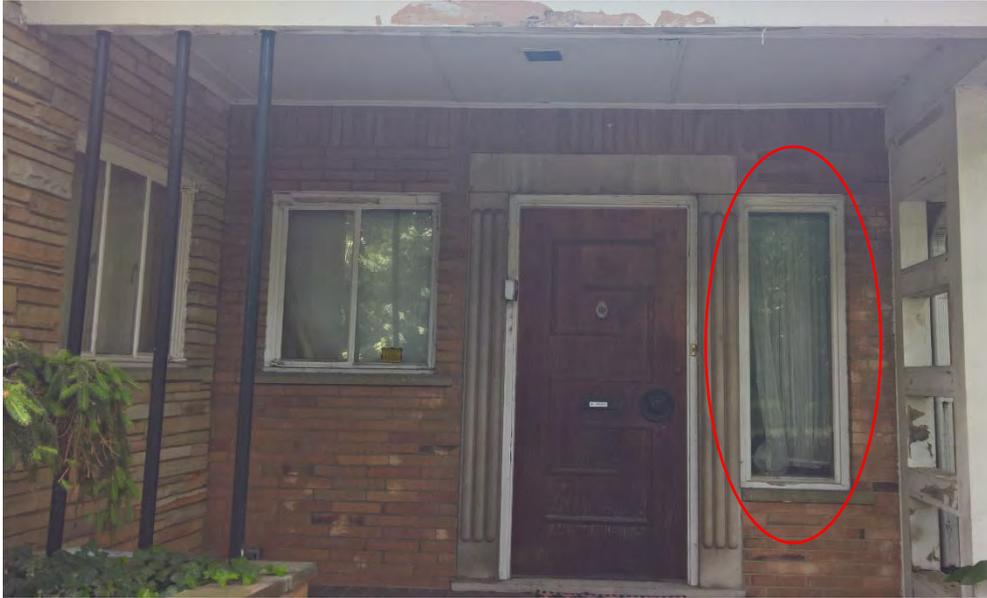
19355 Parkview – Window Replacement Overview, #21-7521

60 Front Bath: single awning with vertical muntin to replace stationery/casement unit

110 Great Room: single awning with two vertical muntins to replace two stationery/one casement unit

WINDOW TO RIGHT OF DOOR NOT INCLUDED IN APPLICATION

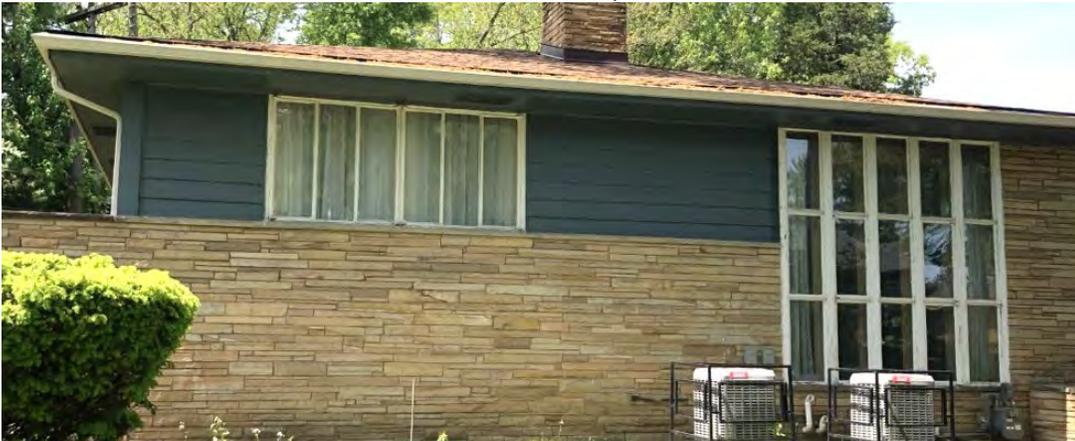
19355 Parkview – Window Replacement Overview, #21-7521

90 TOP LEFT - Master Bedroom: two awnings (each with two vertical muntins) to replace two window units (each comprises two casements flanking a central fixed sash)

Five, three-fixed window units to replace the five, three-window units (four of which are single casements, identified with stars, remaining eleven are fixed sash).

ARE MULLIONS BEING CONSTRUCTED TO MATCH THE DIMENSIONS OF THE EXISTING MULLIONS? OR IS THE ENTIRE WINDOW UNIT BEING FABRICATED IN THE FACTORY? IF THIS IS THE CASE, PLEASE PROVIDE THE DIMENSIONS AND A SECTION (SO WE CAN SEE THE PROFILE) OF THE FACTORY MULLION.

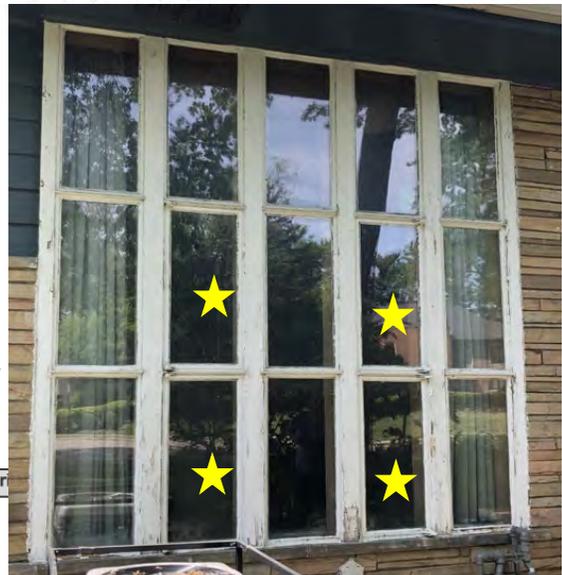
1: Fixed Frame
General Information: Interior Glazed, Factory Assembled, Standard, Clad, Pine, 5", 3 11/16"
Exterior Color / Finish: Painted, Standard Enduraclad, White
Interior Color / Finish: Primed Interior
Glass: Insulated Dual Tempered Low-E AdvancedComfort Low-E Insulating Glass Argon Non High Altitude
Grille: SDL, No Custom Grille, 7/8", Traditional (1W3H)

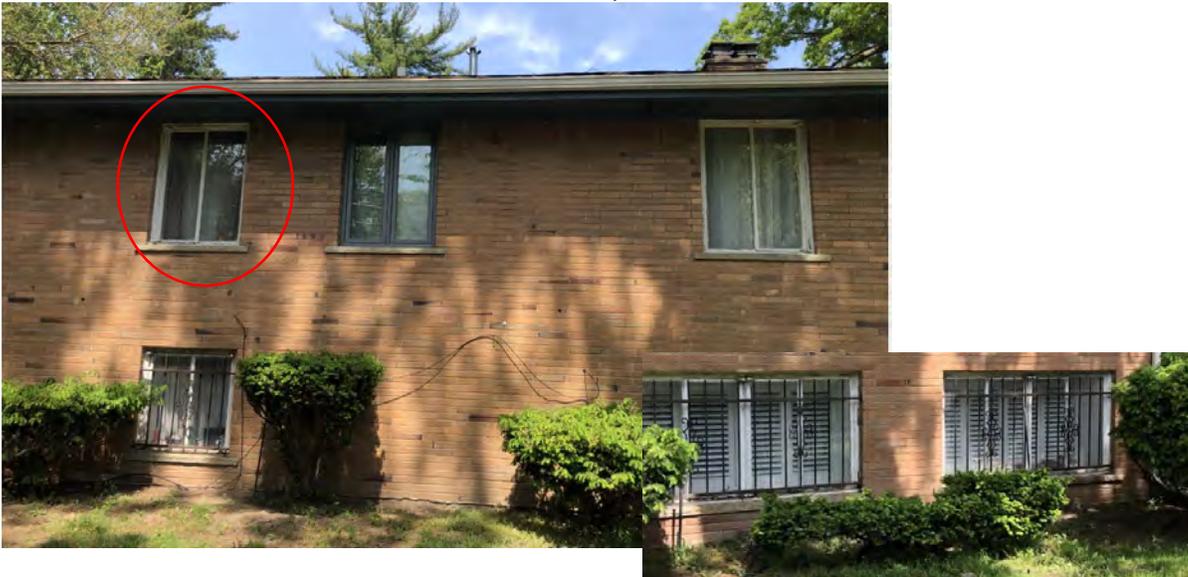
19355 Parkview – Window Replacement Overview, #21-7521

95 TOP RIGHT - single awning with vertical muntin to replace stationary/casement unit

100 TOP MIDDLE – already replaced – no COA

115 BOTTOM LEFT - single casement with vertical muntin to replace stationary/casement unit

130 & 135 BOTTOM RIGHT - single awning with four vertical muntins to replace two (mulled) stationary/casement units

TOP LEFT OPENING ON SIDE NOT INCLUDED IN APPLICATION

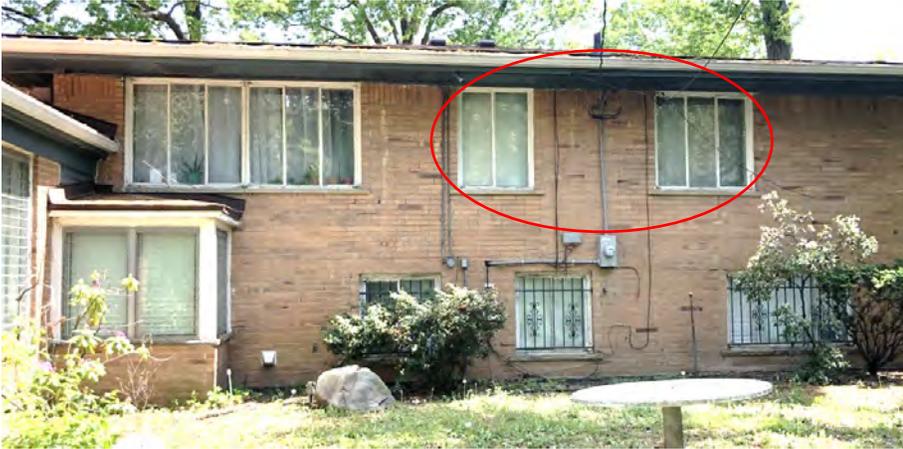
19355 Parkview – Window Replacement Overview, #21-7521

105 TOP LEFT - second floor; two (factory) mullied awning units (each with two vertical muntins) to replace two window units (each comprised of two casements flanking a central fixed sash)

125 BOTTOM MIDDLE - bath; single awning with vertical muntin to replace one stationery/casement unit

120 BOTTOM RIGHT - three opening (center fixed with flanking casements) unit to replace a three opening unit (center fixed with flanking casements)

140 BOTTOM LEFT – one stationery/casement unit to be replaced with laundry vent
NEED CATALOG CUT TO CONFIRM DESIGN AND FINISH

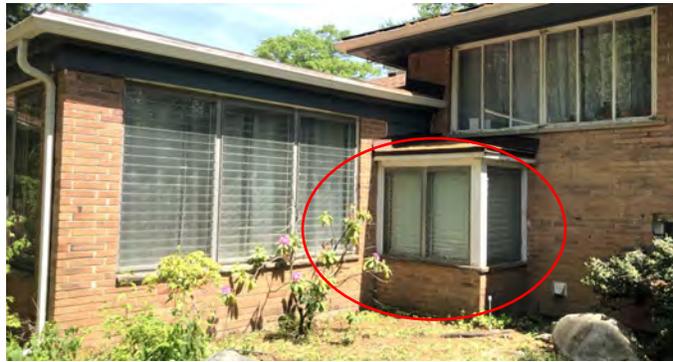
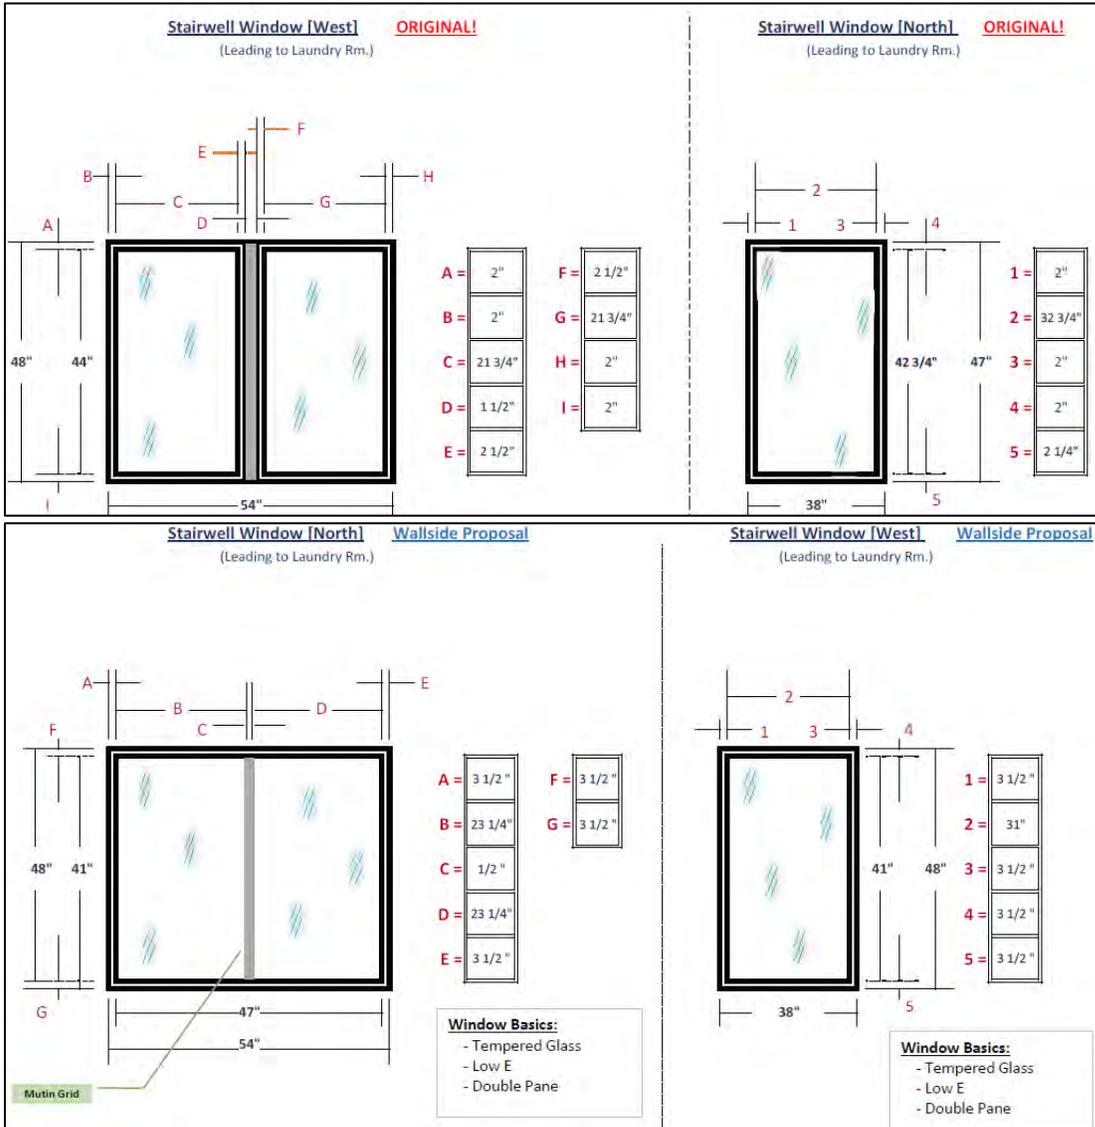
BW 1 & 2 - Stairs

Existing	New	Difference
Vertical Sash (Stile)	2"	3 1/2"	75% increase
Horizontal Sash (Rail)	2"	3 1/2"	75% increase
Mullion	1 1/2"	1/2"	The 1 1/2" wide structural mullion will be replaced with a 1/2" wide between-the-glass muntin.

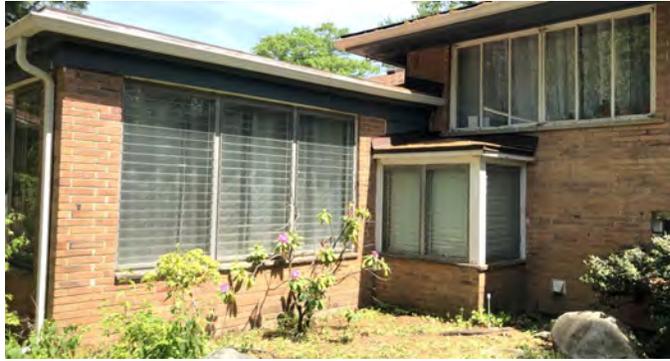
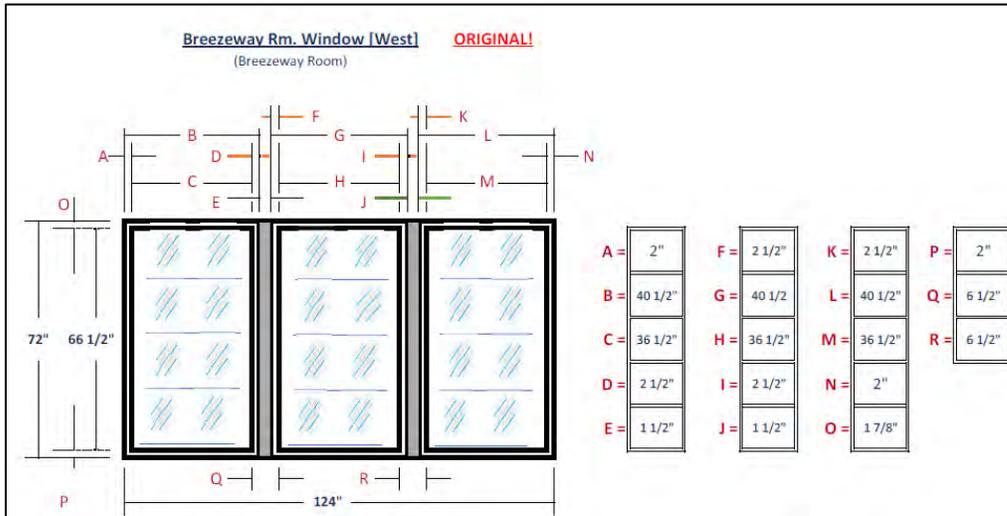
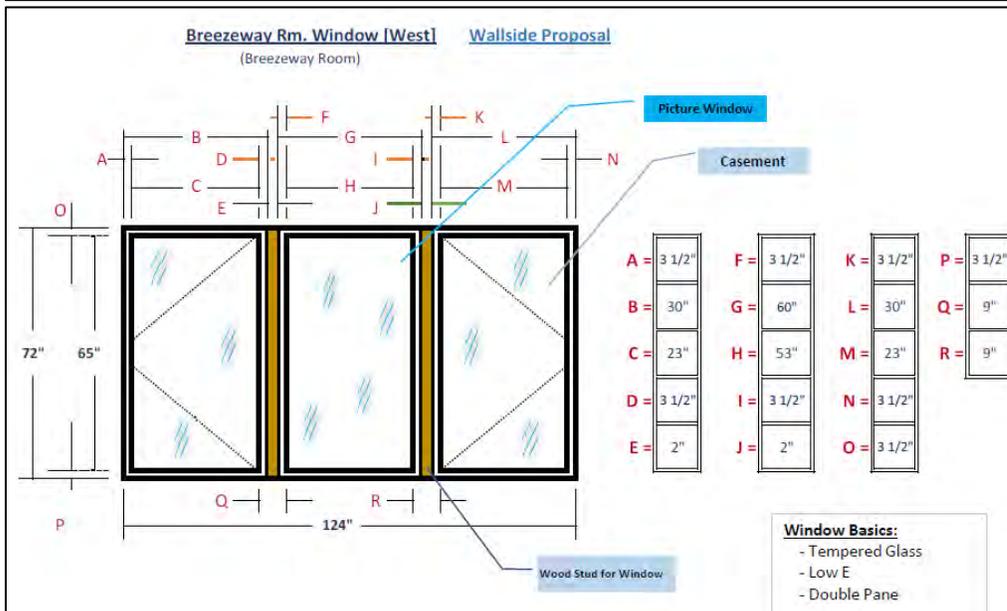
BW3 – West triple opening

<u>Existing</u>	<u>New</u>	<u>Difference</u>
Exterior Vertical Sash (Stile)	2"	3 1/2"	75% Increase
Interior Vertical Sash (Stile)	2 1/2"	3 1/2"	40% Increase
Top Horizontal Sash (Rail)	1 7/8"	3 1/2"	75% Increase
Bottom Horizontal Sash (Rail)	2"	3 1/2"	75% Increase

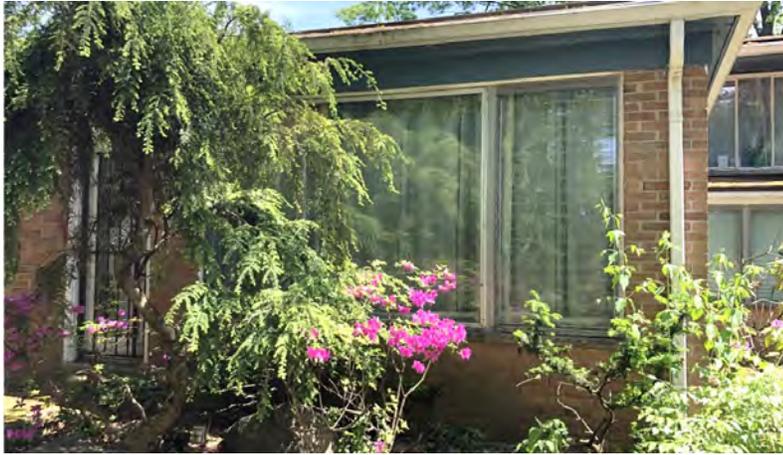
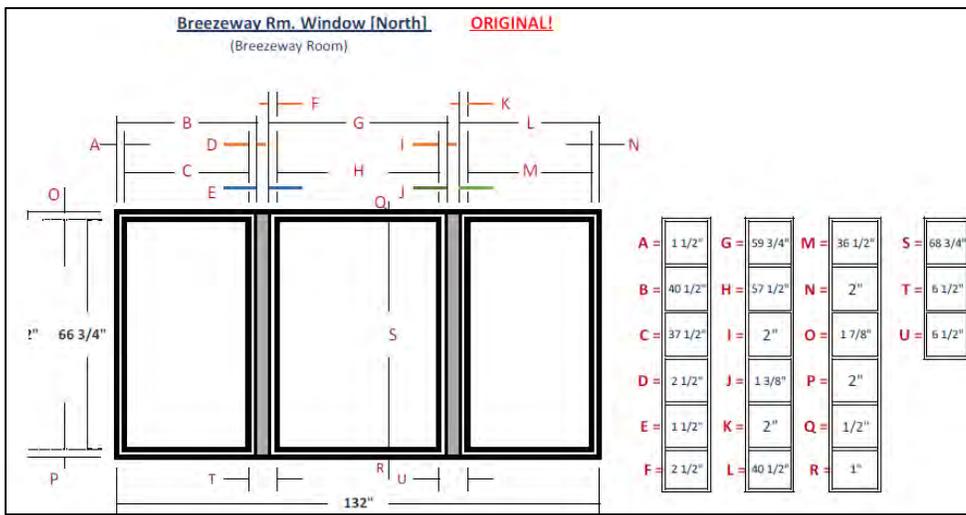
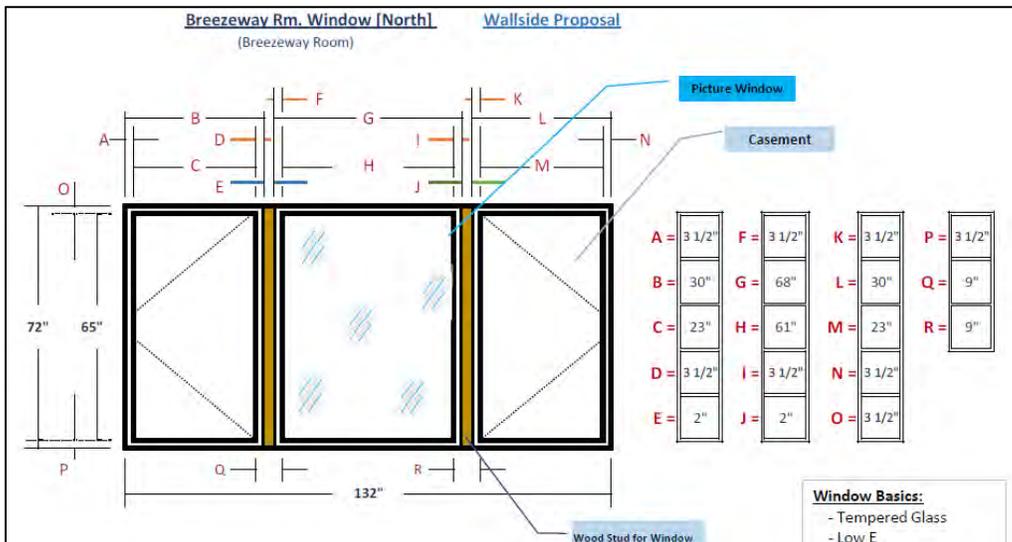
BW4 – North Triple opening (center picture)

Existing	New	Difference
Exterior Vertical Sash (Stile)	1 1/2"	3 1/2"	133% Increase
Interior Vertical Sash (Stile)	2 1/2"	3 1/2"	40 % Increase
Top Horizontal Sash (Rail)	1 7/8"	3 1/2"	75 % Increase
Bottom Horizontal Sash (Rail)	2"	3 1/2"	75 % Increase

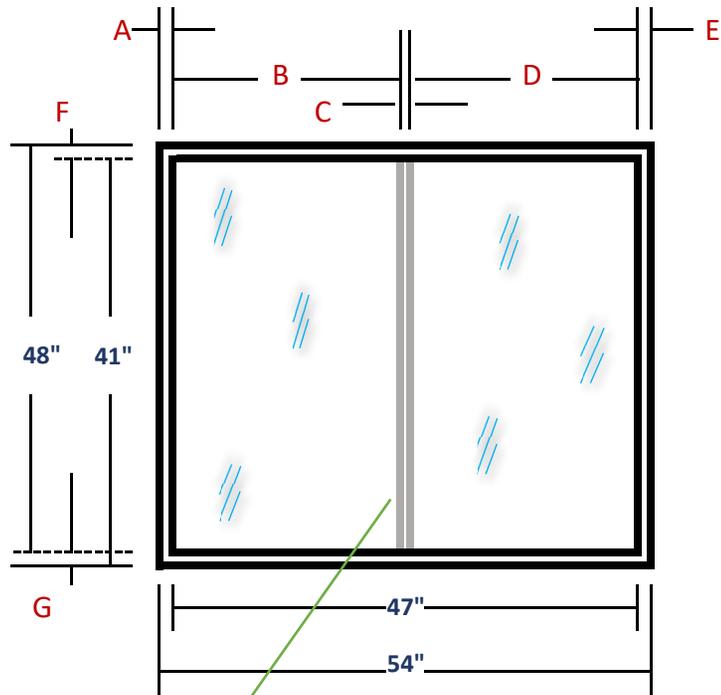
Stairwell Window [North] **Wallside Proposal**
 (Leading to Laundry Rm.)

A =	3 1/2 "	F =	3 1/2 "
B =	23 1/4"	G =	3 1/2 "
C =	1/2 "		
D =	23 1/4"		
E =	3 1/2 "

Window Basics:
 - Tempered Glass
 - Low E
 - Double Pane

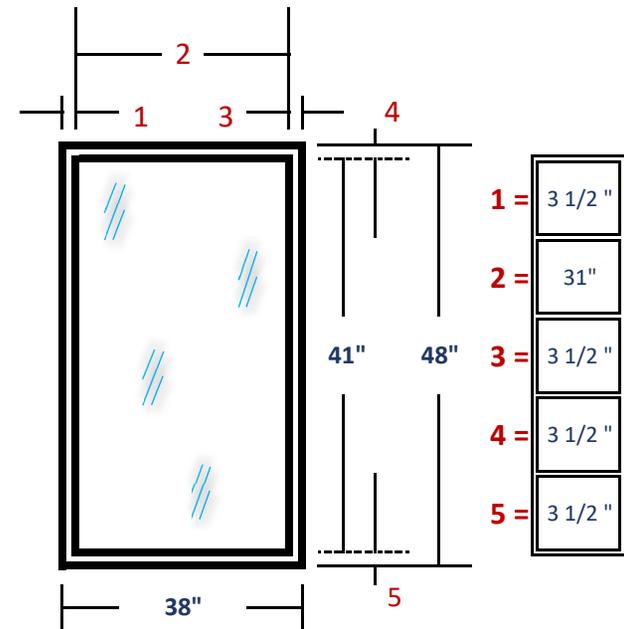
Stairwell Window [West] **Wallside Proposal**
 (Leading to Laundry Rm.)

1 =	3 1/2 "
2 =	31"
3 =	3 1/2 "
4 =	3 1/2 "
5 =	3 1/2 "

Window Basics:
 - Tempered Glass
 - Low E
 - Double Pane

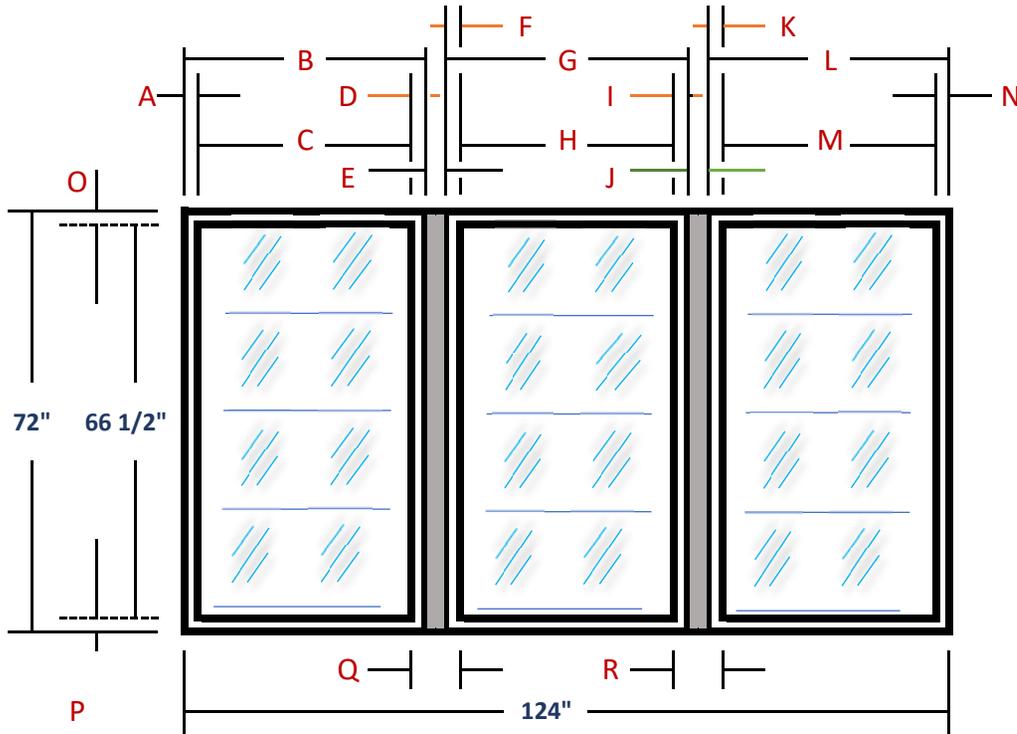
A =	2"
B =	40 1/2"
C =	36 1/2"
D =	2 1/2"
E =	1 1/2"

F =	2 1/2"
G =	40 1/2"
H =	36 1/2"
I =	2 1/2"
J =	1 1/2"

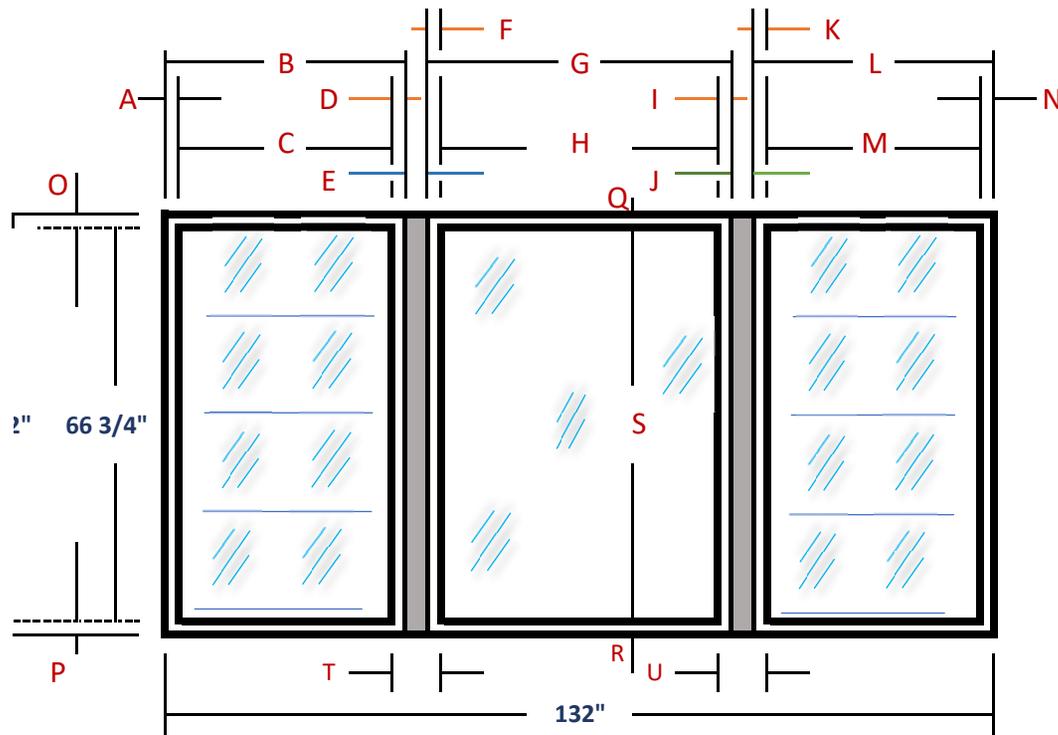
A = 1 1/2"	G = 59 3/4"	M = 36 1/2"	S = 68 3/4"
B = 40 1/2"	H = 57 1/2"	N = 2"	T = 6 1/2"
C = 37 1/2"	I = 2"	O = 1 7/8"	U = 6 1/2"
D = 2 1/2"	J = 1 3/8"	P = 2"	
E = 1 1/2"	K = 2"	Q = 1/2"	
F = 2 1/2"	L = 40 1/2"	R = 1"

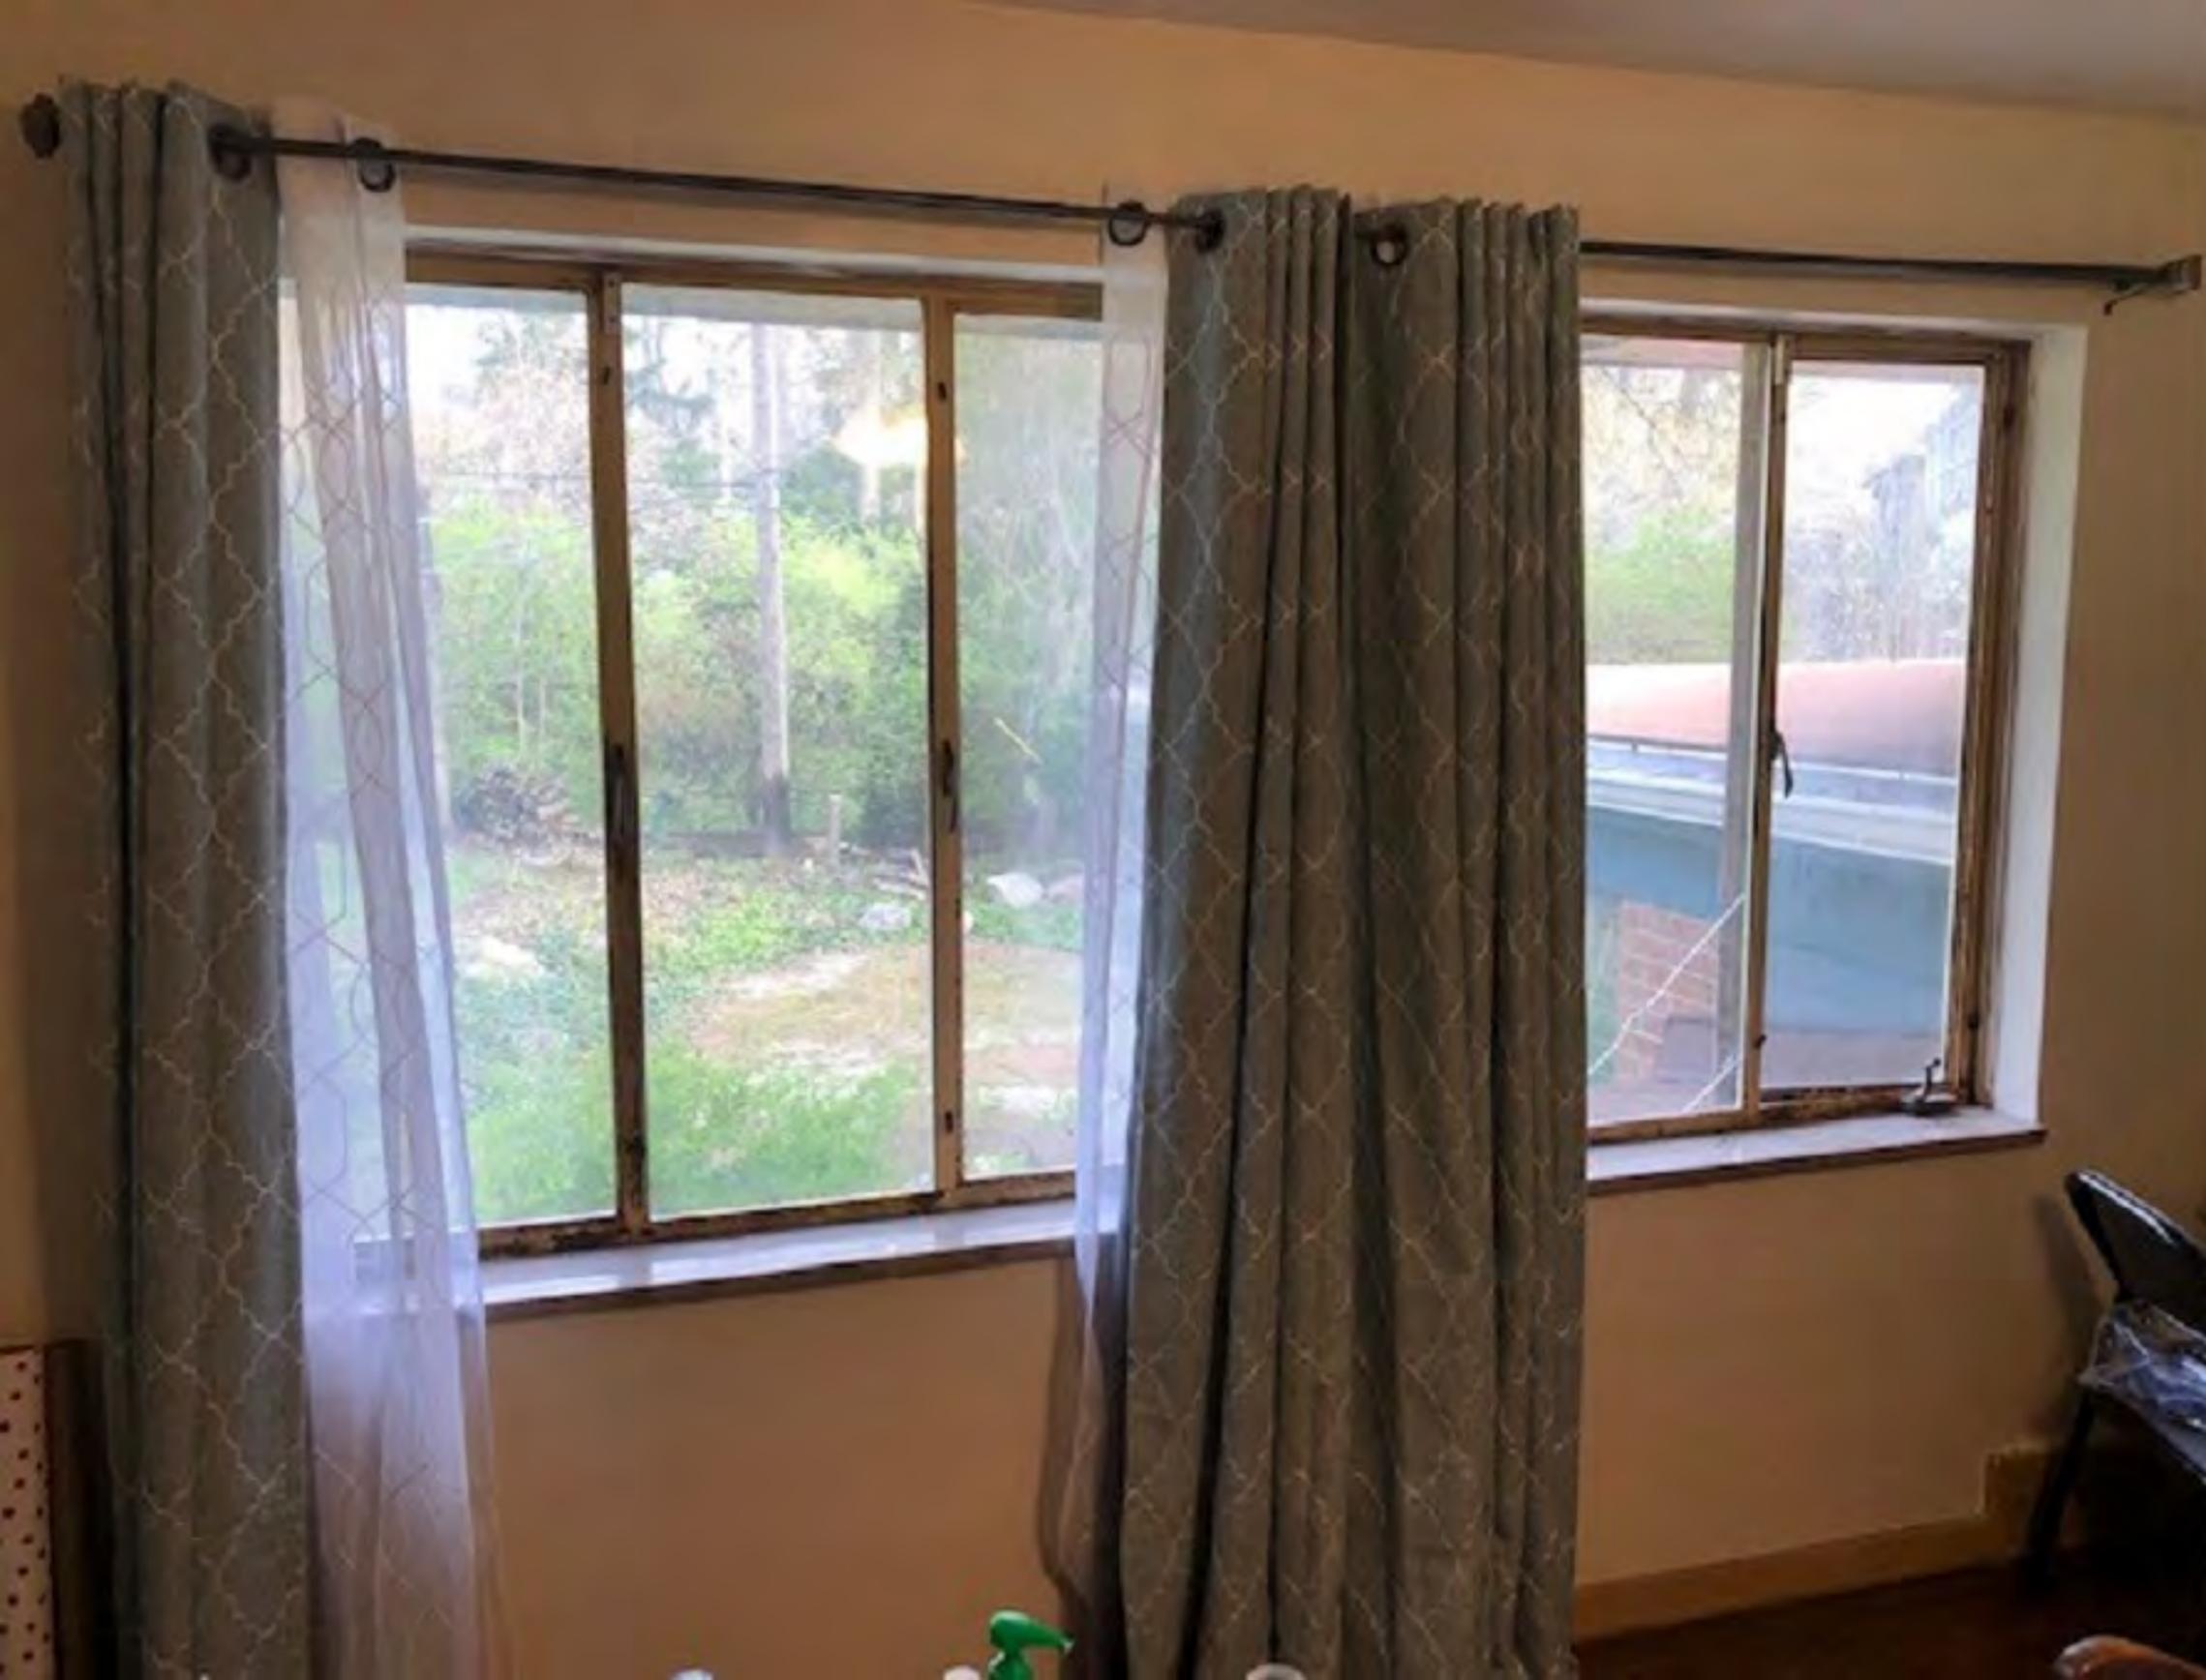
#60, back of house
steel casements removal, rusting
hard to operate.
