STAFF REPORT: 10-13-21 MEETING

APPLICATION NUMBER: 21-7521

ADDRESS: 19355 PARKSIDE

SCOPE: WINDOW REPLACEMENT

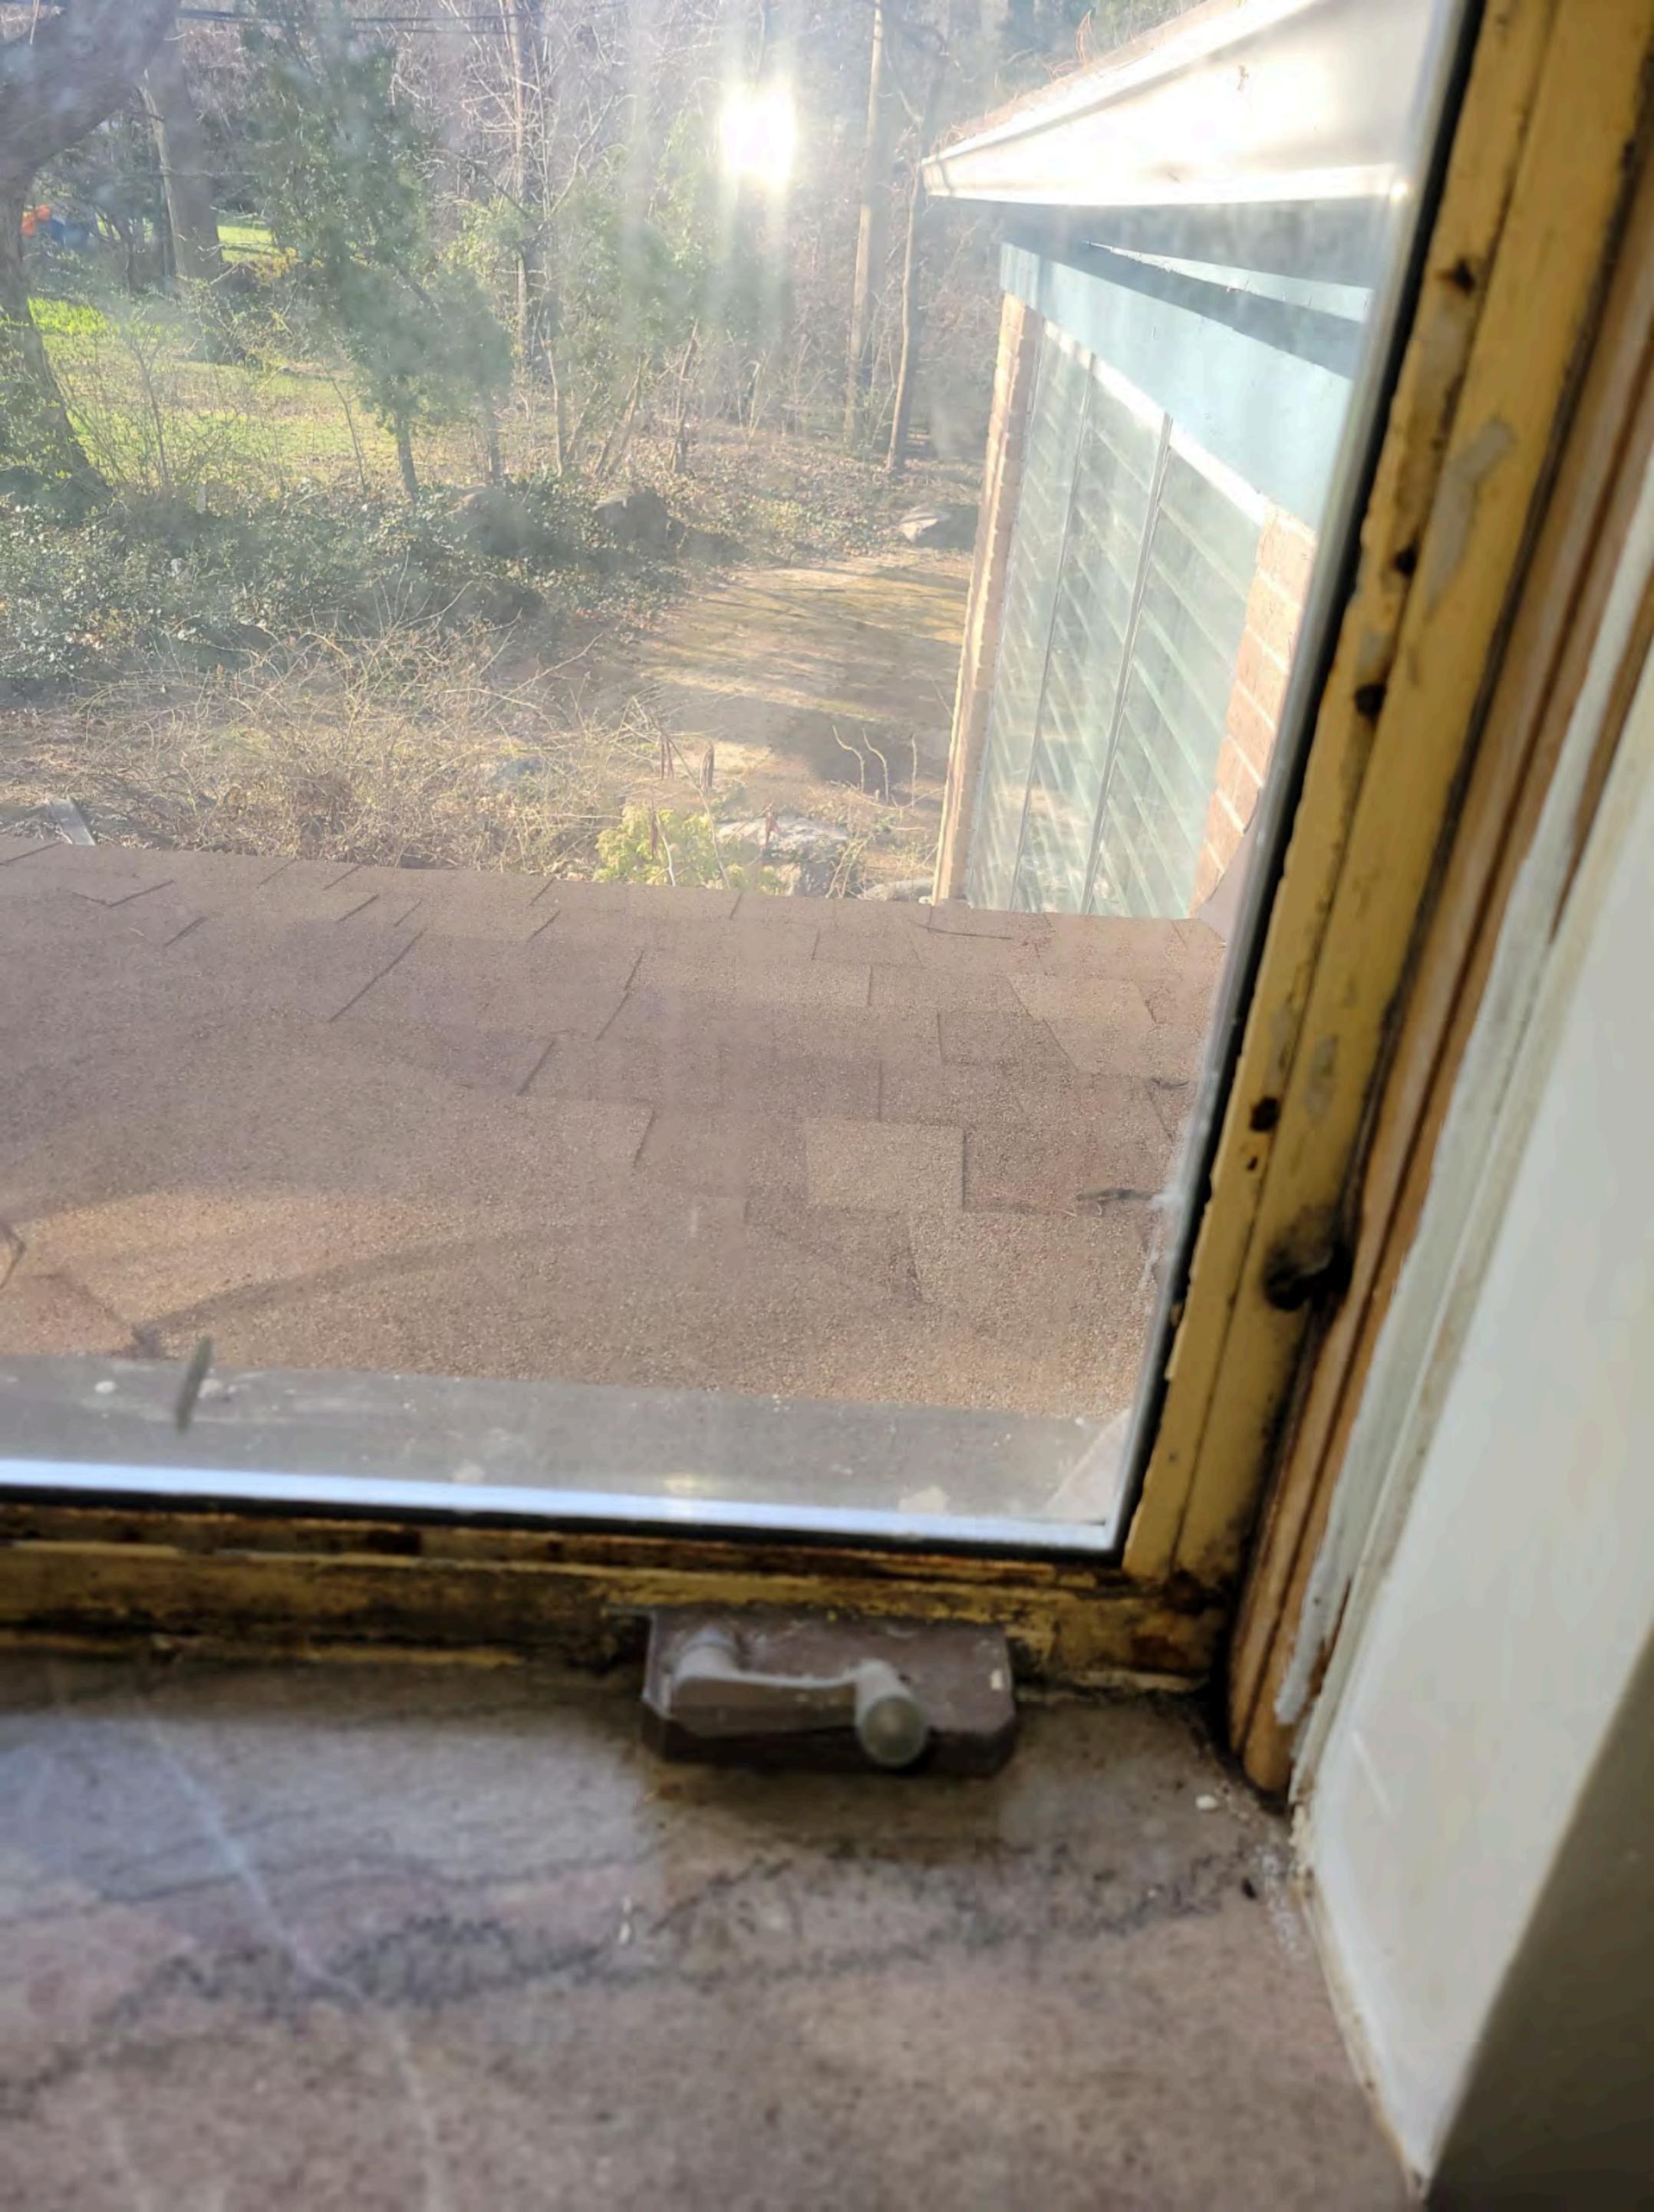
#60, back of house
steel casements removal, rusting
hard to operate.

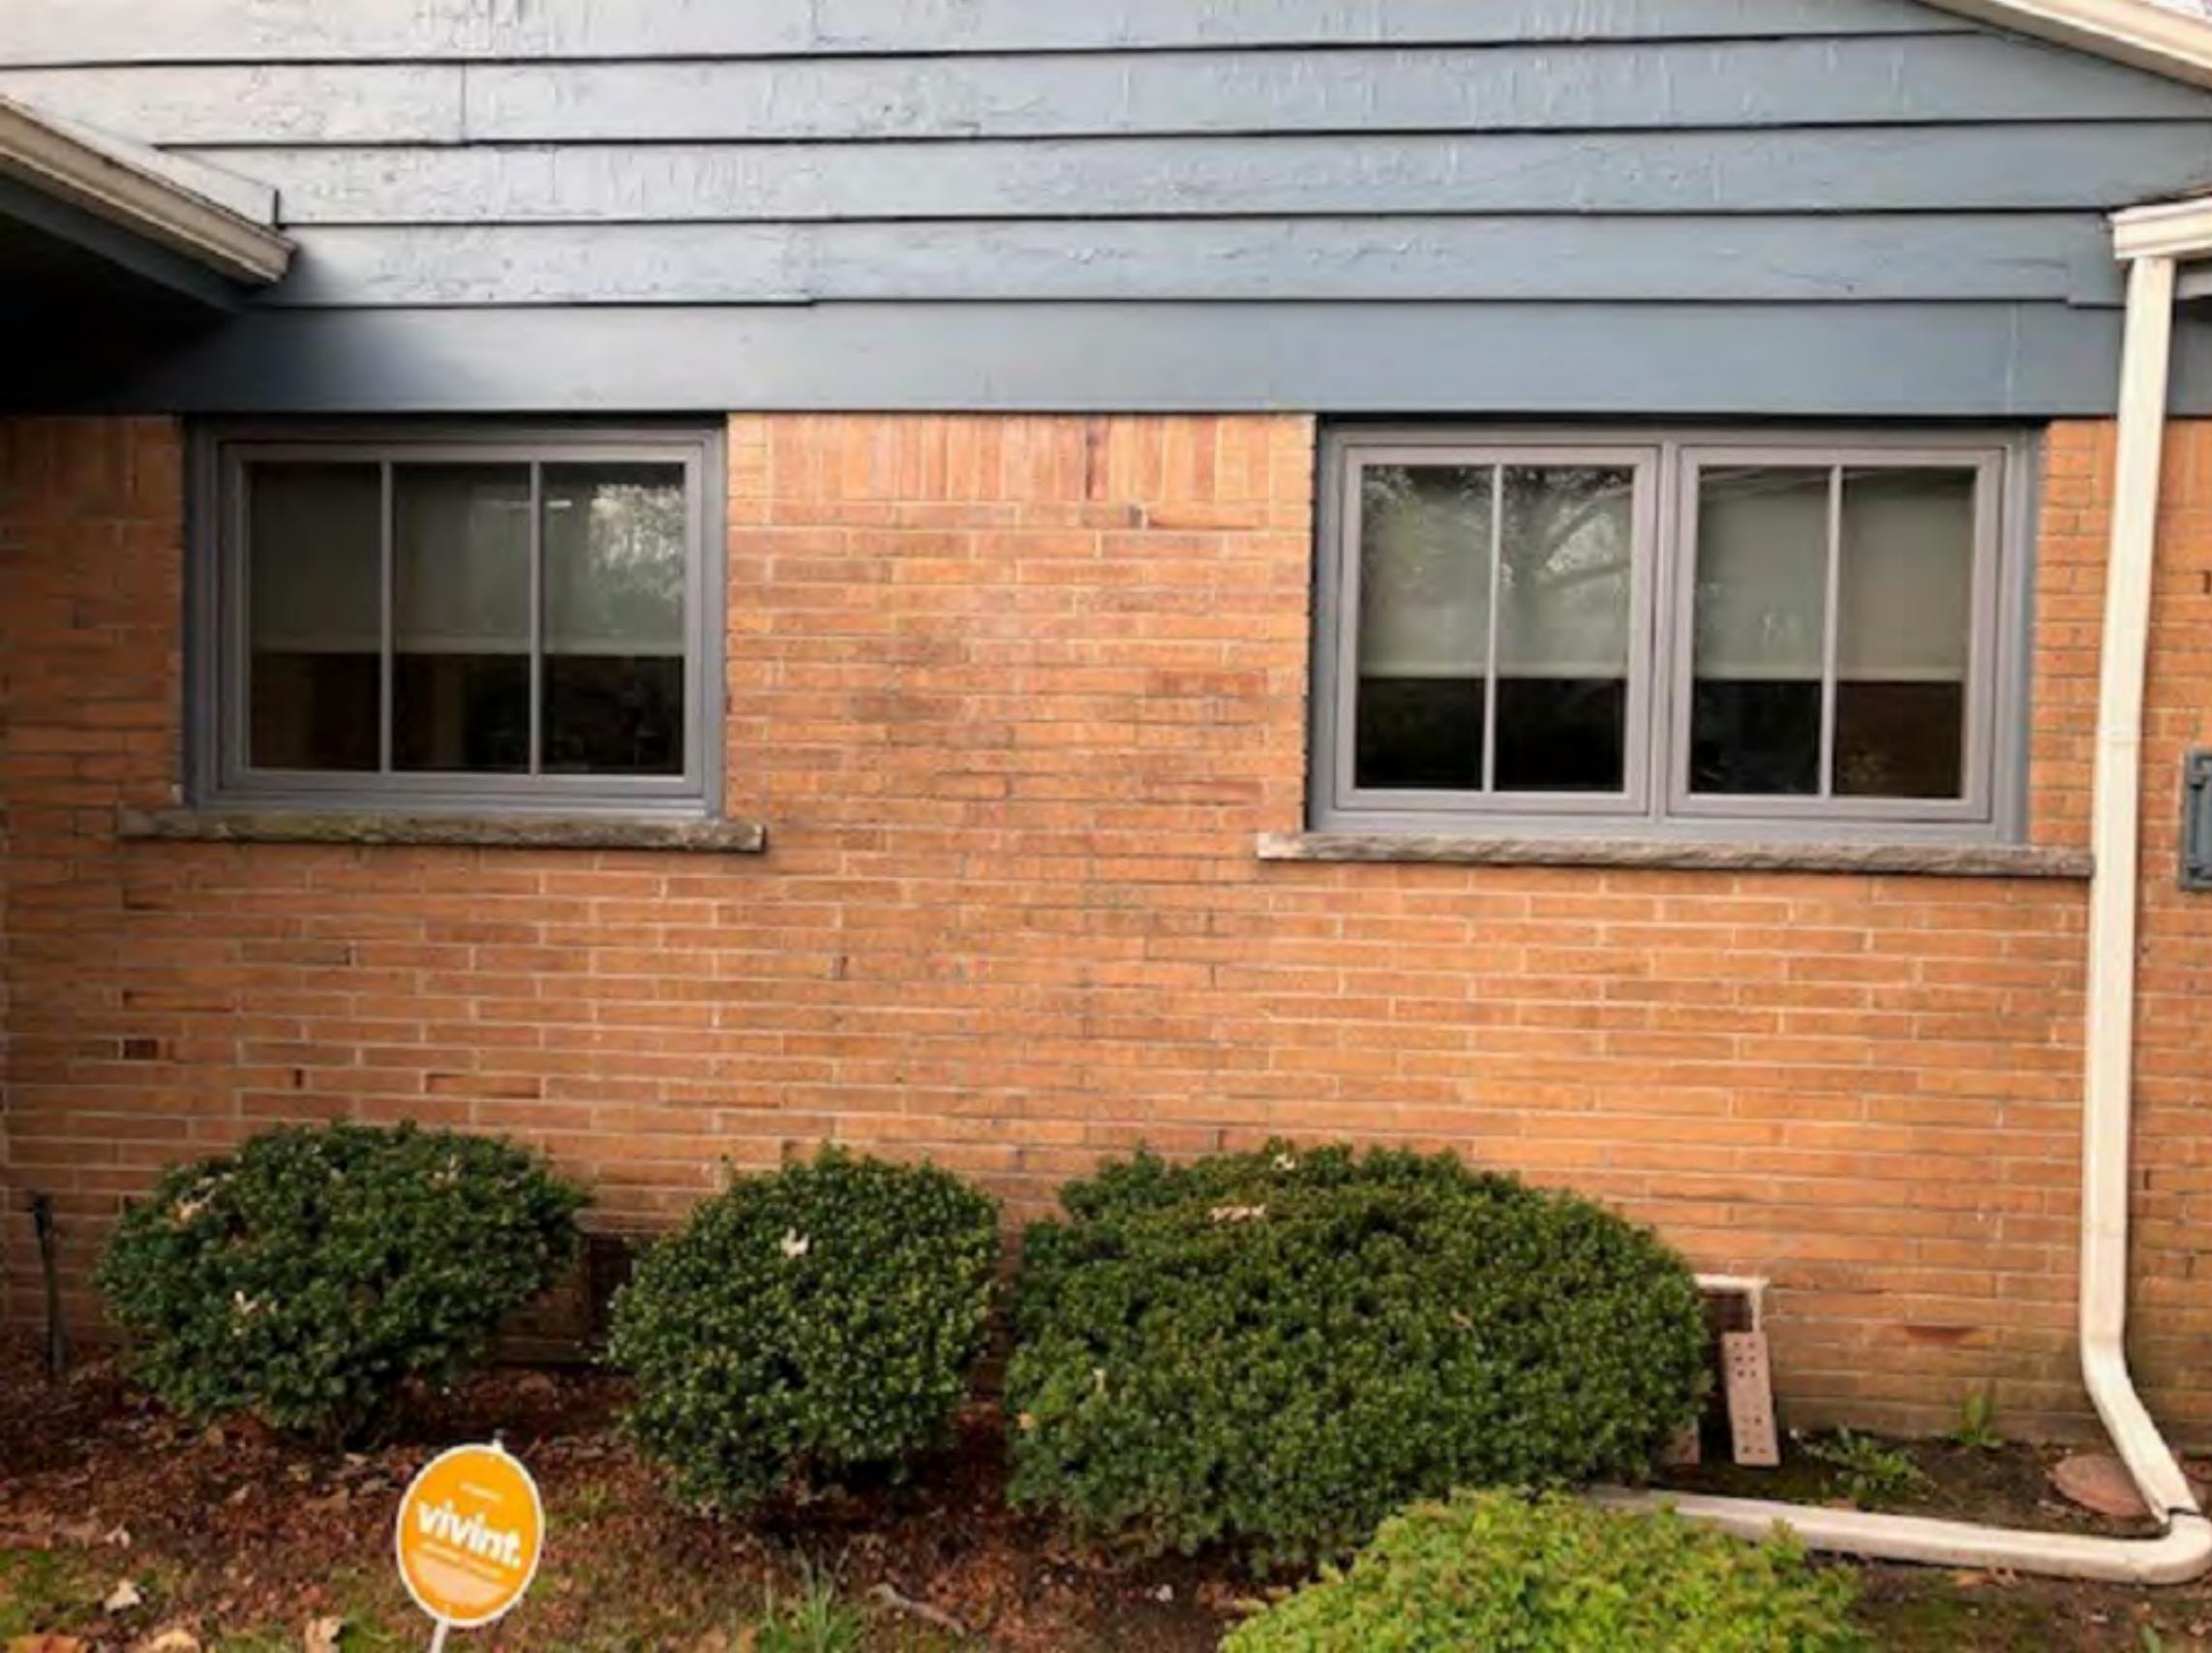
redo the alum trim in pella
white per h/o. labor added.
side of house
