STAFF REPORT: FEBRUARY 9, 2022 MEETING PREPARED BY: A. DYE

APPLICATION NUMBER: 22-7670

ADDRESS: 686 SELDEN

SCOPE: REPLACE VINYL WINDOWS WITH NEW VINYL WINDOWS (on sides and rear of building)

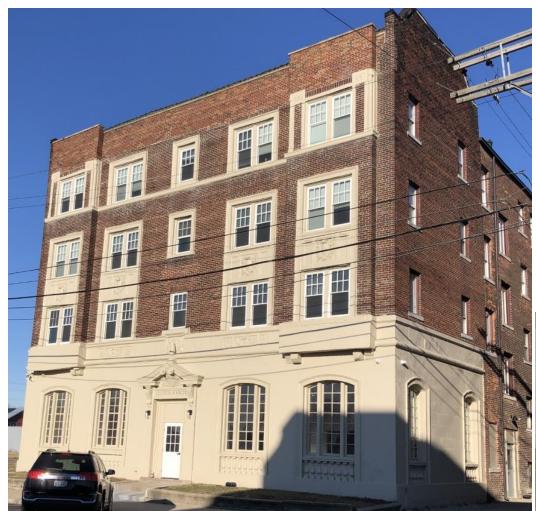
Sanborn Map, Vol. 2, 1921 – 1950

Erected ca. 1924, Selden Manor is located at 686 Selden, on the north side of the street between Second and Third Avenues. The four-story masonry structure was erected to the lot lines, with the exception of the small setback at the rear elevation. The front elevation retains some of its classical revival detailing, including the tile roof. The contrasting-colored brick denotes where the cornice and small balcony between the center second and third floor windows were removed, and only a few original corbels remain below the extending walls at the second floor. As shown on the Sanborn map, the block on which 686 Selden sits was filled with structures, helping to obscure the now-exposed west elevation

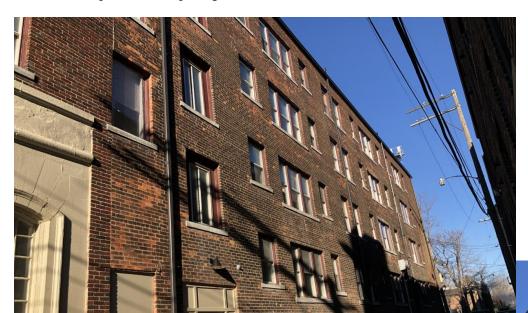
Above: East elevation / Right: West elevation HDC staff photos, January 2022

The first-floor exterior was likely faced with limestone and wraps around both sides of the building, covering the lower portion of the walls closest to Selden. The remaining side walls and rear wall are faced entirely with brick; the only ornament consists of the window openings with stone sills, marking them as secondary elevations. The alleys to the east and north, and the three alcoves within the west elevation, allowed for an abundance of windows comprised of single, double, and triple window openings.

Vinyl windows were in place on all elevations prior to 2009 (per Google street view) and at the time of local district designation in 2011. Vinyl windows of varying operation (double-hung and casement) remain in place on the non-primary sides and rear elevations. Furthermore, as shown on the adjacent west elevation photo, the operation of existing window units is not consistent within similarly sized/located window openings.

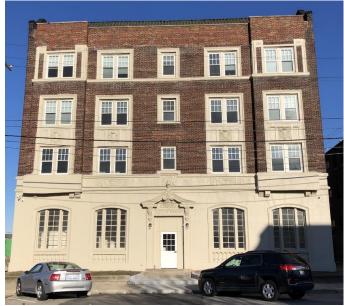
HDC staff photo, January 2022

The windows on the front elevation are Wojan-m1500 series, and are white, aluminum framed double-hung units with a simulated divided light pattern of six-over-one (matching the historic window pattern -- COA #21-7216). Other projects approved in 2021 included a new front door as well as the restoration (including the east elevation reopening) of the first-floor wood windows.

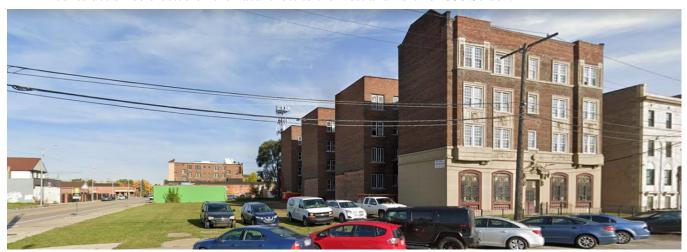
Google street view, October 2020. This photo not only reinforces the location of the building on this block, it also shows the vinyl windows and first floor window alterations that were in place at time of district designation.

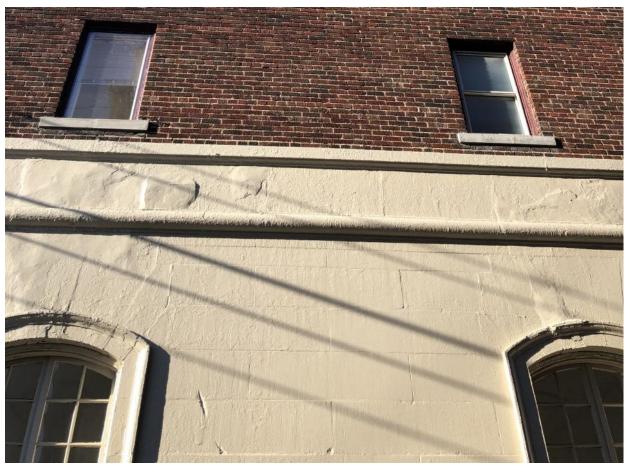
In this January 2022 HDC staff photo, poor repair/patching work was completed and then covered with a coating that minimizes the stone block pattern (which is now only noticeable up close), and obliterates the contrasting beveled stone detail above the arched window. This surface treatment was in place at time of district designation.

- Prior to district designation, the limestone block and associated architectural ornament was covered with an unidentified material that obscures the block pattern as well as covering, or smoothing out, other small details. This treatment has created a monolithic, stucco-like appearance to this area of the exterior. It is staff's opinion the white framed windows offer a contrast to the front elevation which helps to offset the visual heaviness created by the current wall coating application.

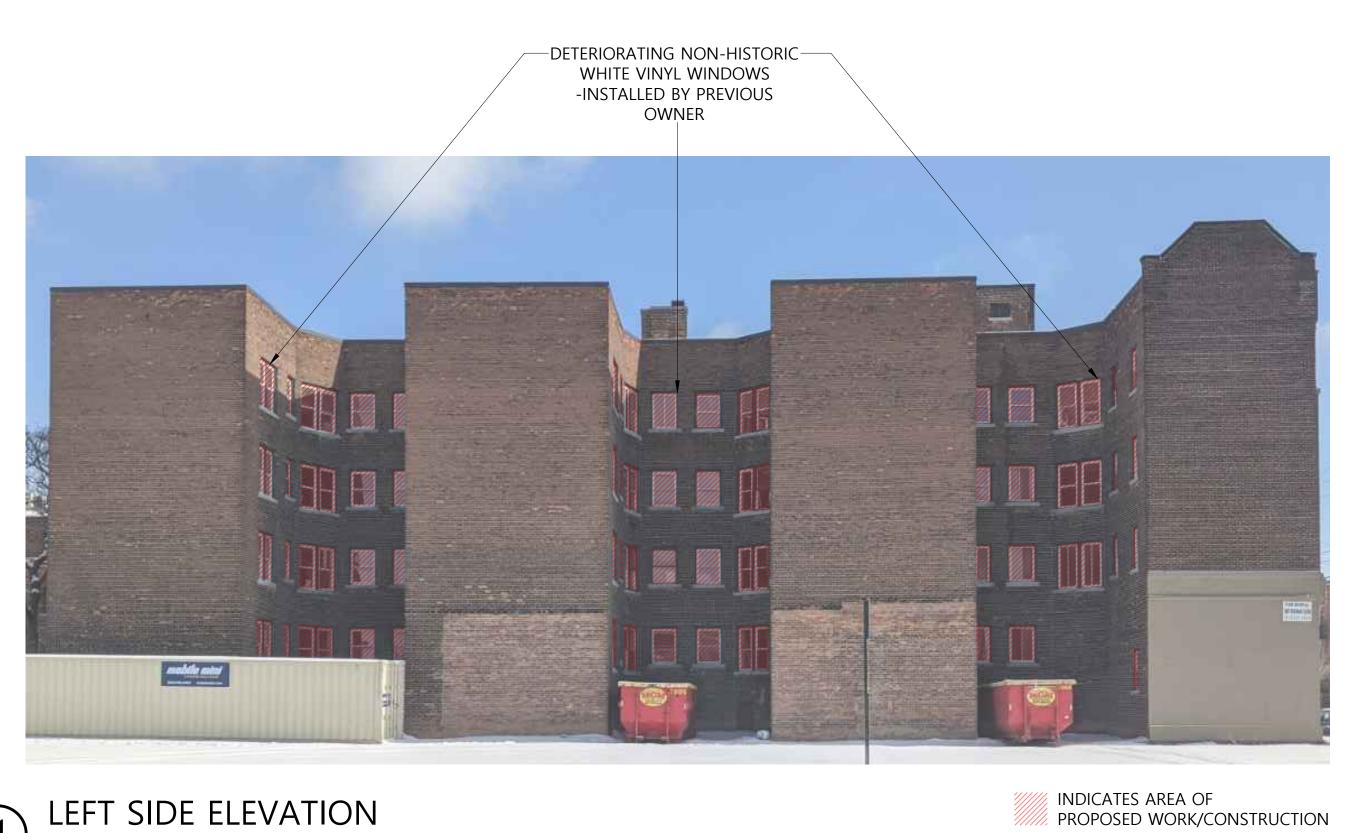
SITE PLAN

• THE ORIGINAL WINDOWS ON THE LEFT, REAR AND RIGHT ELEVATIONS HAVE BEEN REPLACED WITH NON-HISTORIC WHITE VINYL WINDOWS BY THE PREVIOUS OWNER

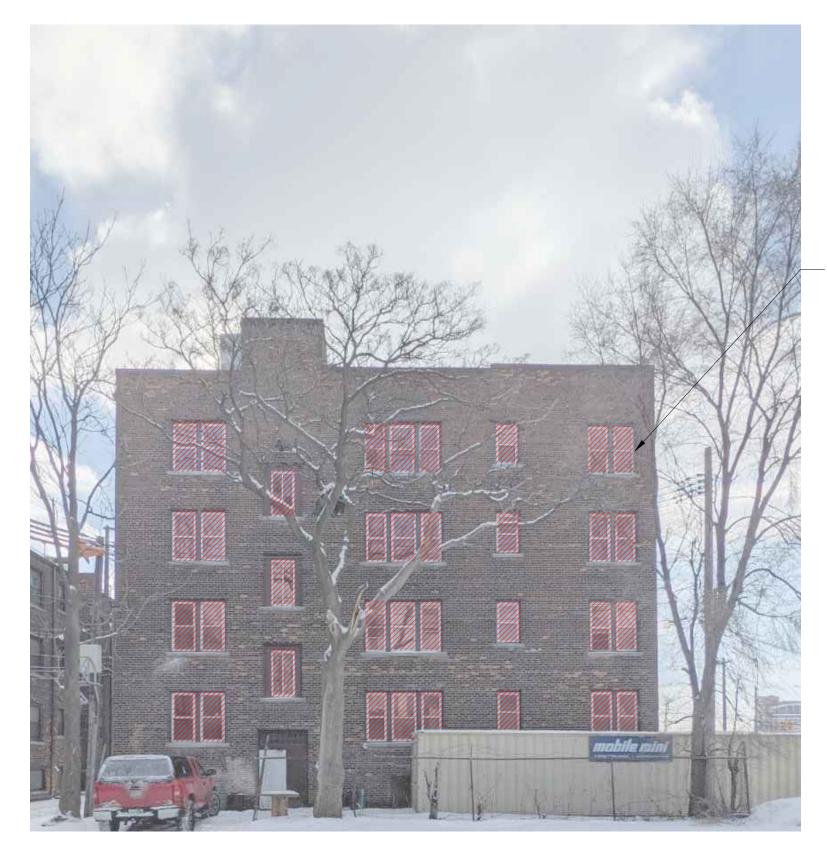
RIGHT FRONT SIDE ELEVATION

DETERIORATING NON-HISTORIC
WHITE VINYL WINDOWS
-INSTALLED BY PREVIOUS
OWNER

• REMOVE DETERIORATING NON-HISTORIC WHITE VINYL WINDOWS ON LEFT, REAR AND RIGHT ELEVATIONS AND REPLACE THEM WITH A MORE HISTORICALLY ACCURATE DOUBLE HUNG WHITE VINYL WINDOWS

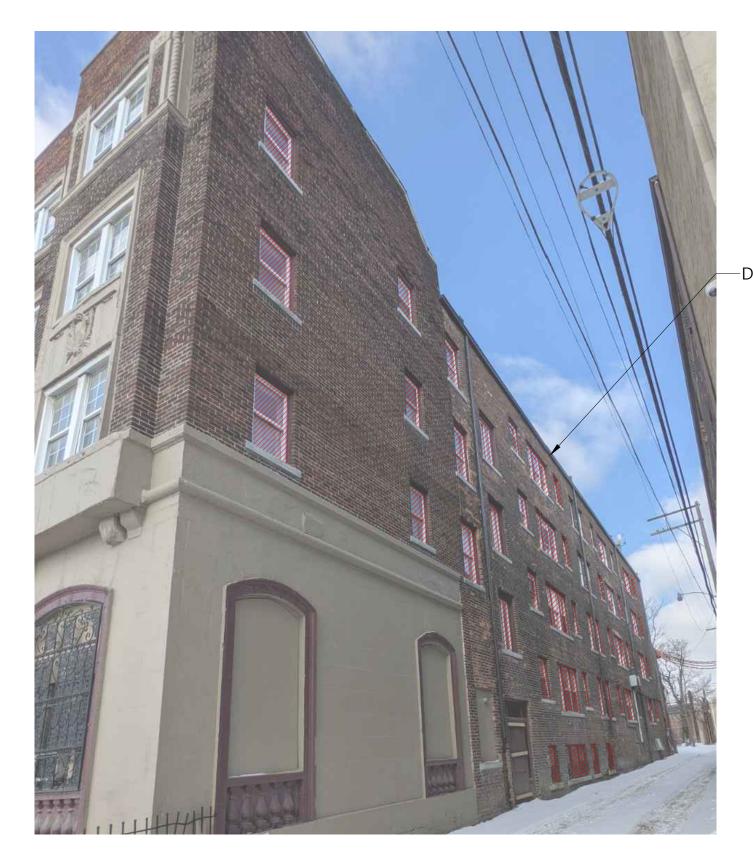
RIGHT REAR SIDE ELEVATION

—Deteriorating non-Historic— White Vinyl Windows -Installed by Previous Owner

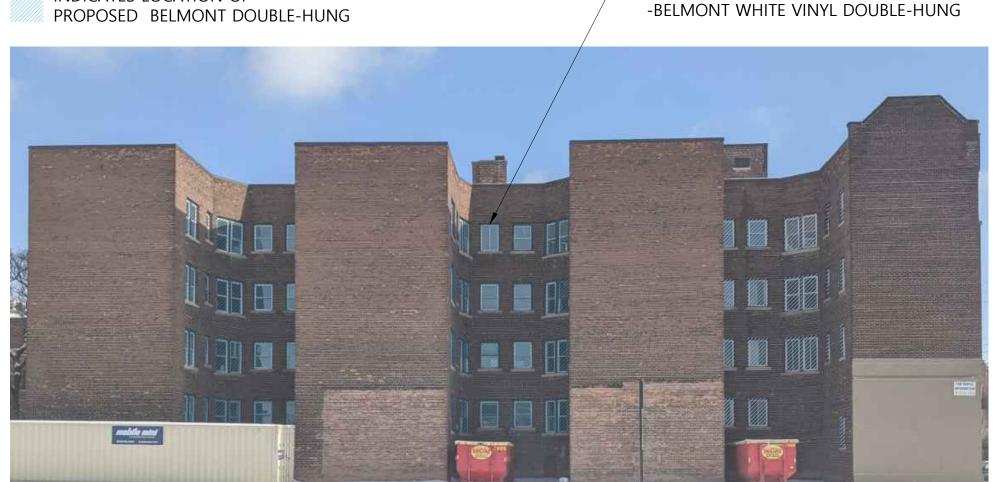
LEFT SIDE ELEVATION

PROPOSED LOCATION FOR A MORE HISTORICALLY -PROPOSED LOCATION FOR A MORE HISTORICALLY ACCURATE DOUBLE HUNG WINDOW -BELMONT WHITE VINYL DOUBLE-HUNG

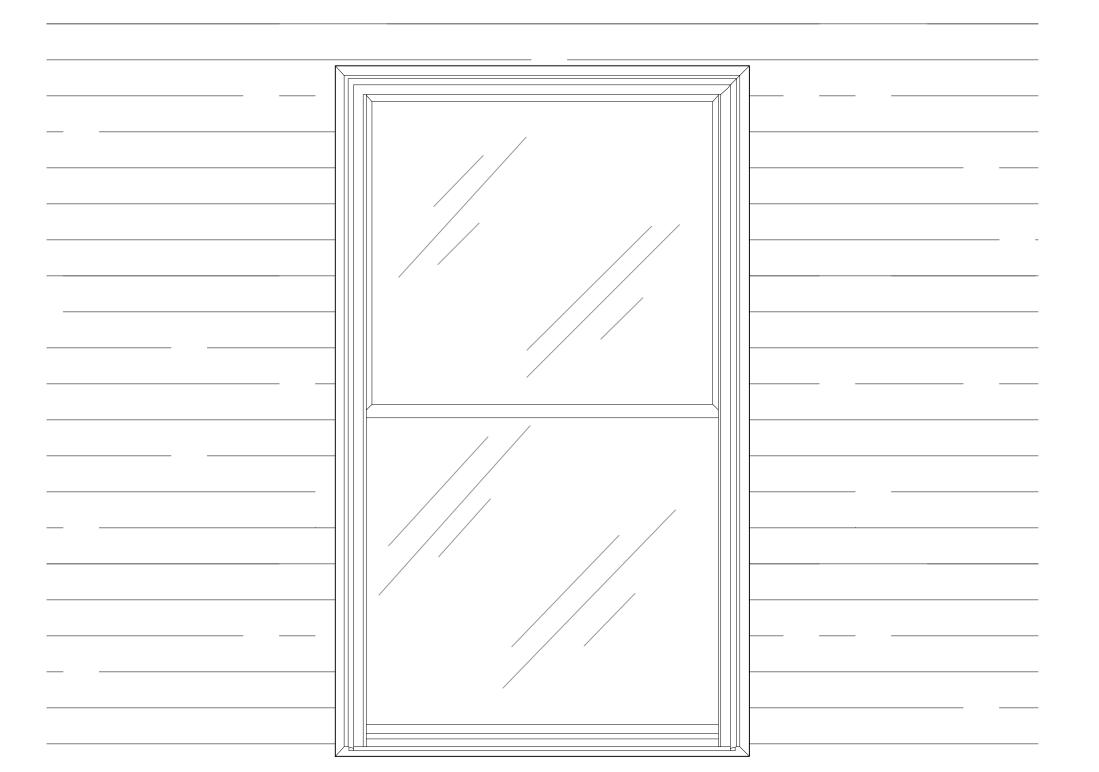
REAR ELEVATION

-Proposed Location for a more historically—

ACCURATE DOUBLE HUNG WINDOW
