STAFF REPORT: MAY 11, 2022 MEETING PREPARED BY: J. ROSS

APPLICATION NUMBER: #22-7819 ADDRESS: 259 W. GRAND BOULEVARD HISTORIC DISTRICT: HUBBARD FARMS

SCOPE OF WORK: REPLACE EXISTING VINYL AND WOOD WINDOWS WITH NEW

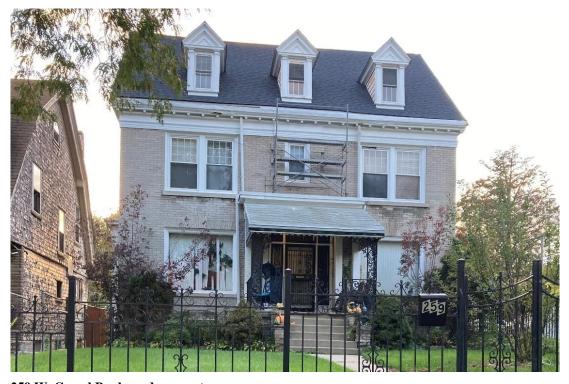
The building located at 259 W. Grand Boulevard is a two-story, single-family dwelling that is located in the Hubbard Farms Historic District. The building is topped with a side-gabled roof which displays three front-gabled dormers at the front elevation roof surface. The exterior walls are clad with a light buff brick. All windows, with the exception of the two picture windows at the front elevation, first story, are non-historic vinyl units. Specifically, the vinyl windows at the front elevation are 12/1 and 6/1 units at the second story (girds between the glass), and 6/3 units at the dormers (grids between the glass). Windows at the side and rear elevation are typically 1/1 vinyl units. The windows at the front elevation, first story are fixed wood picture windows. A glass block window is also located north elevation, second story. The dormer windows retain their historic wood pilasters/trim. The front, side, and rear elevation windows also retain their original wood trim/brickmould.

259 W. Grand Boulevard, current appearance

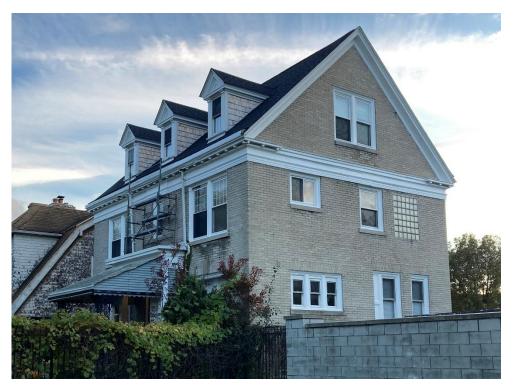
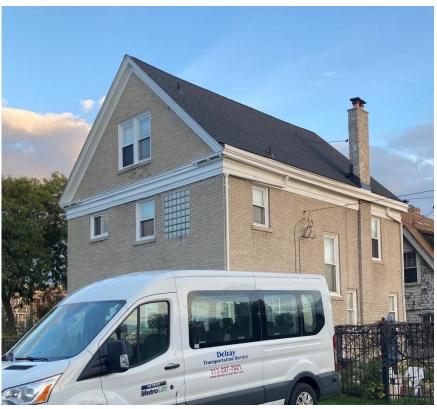
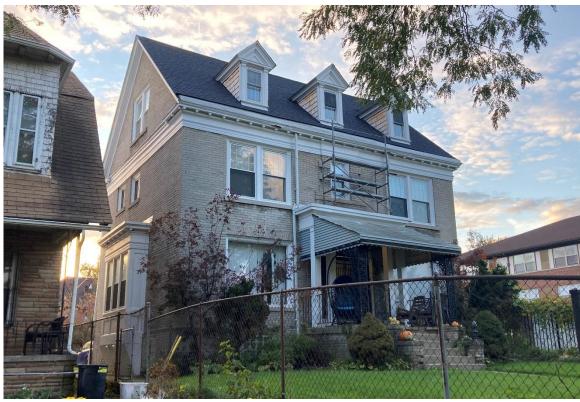
259 W. Grand, current appearance
