**STAFF REPORT:** 11/16/22 REGULAR MEETING

**APPLICATION NUMBER:** 22-8092

**ADDRESS:** 740 VAN DYKE

**SCOPE:** DEMOLISH GARAGE, DEMOLISH REAR ADDITION, ALTER REAR ELEVATION

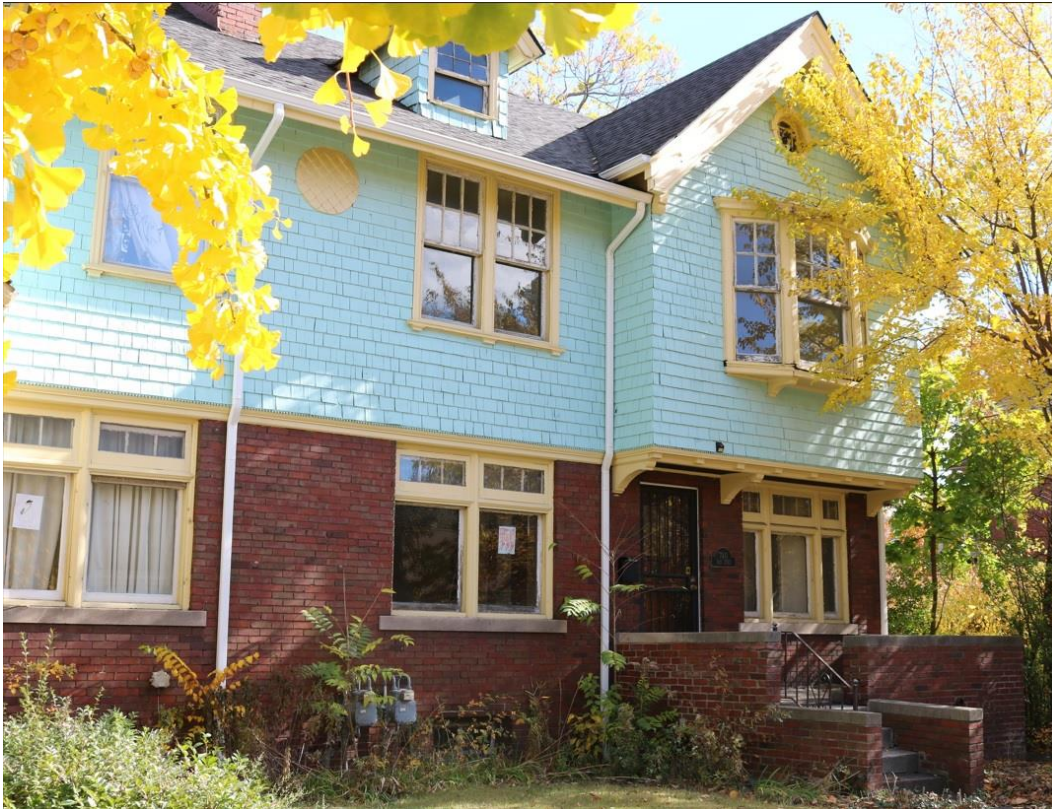
The property at 740 Van Dyke is an attached single-family townhouse (sharing a common wall with another townhouse to the north). The building is two-and-a-half stories, brick- and shingle-sided, built in 1909 and displaying Arts and Crafts elements. It faces west onto the street. Items subject to this application are on the rear (east) of the house, and include an enclosed addition and a detached garage.

*November 2022 photo by staff.*

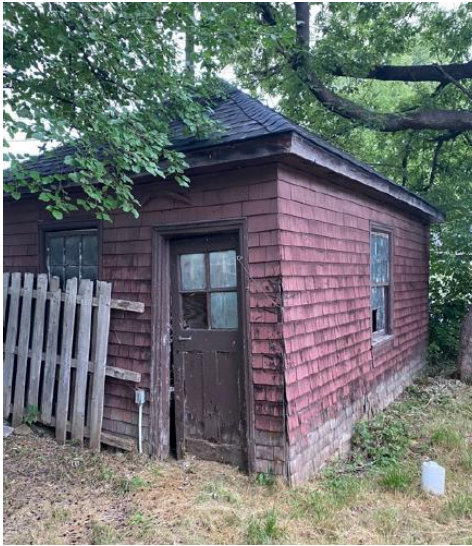
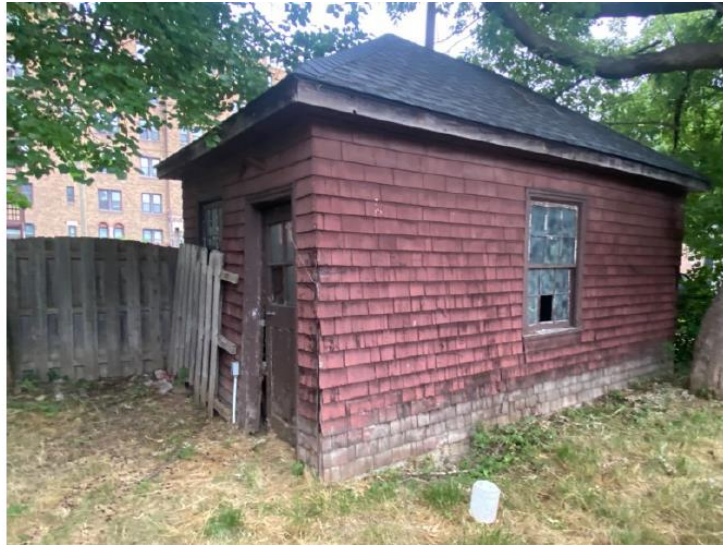
The application proposes to demolish a single-bay garage in the rear yard. The application states that the garage is in “poor” condition with “noticeable structural slab defects. Door and window frames at the exterior are splitting

away from each and the foundation itself is sinking in a few places.” The application also states that “the framing and the foundation of the garage have failed ... the structure has noticeably sunk into the ground ... inside the garage the concrete slab on grade has completely caved inward.”

*Garage proposed for demolition. Photos from application.*

methodology.”<sup>2</sup> Staff suggests that stabilization or repair of the garage foundation and framing, though potentially more expensive than demolition, is still feasible (perhaps even more feasible due to the relatively small size of the garage). Therefore, staff recommends denial of the garage demolition.

Staff recommends that the Commission issue a *Denial* of the proposed demolition as it does not meet the Secretary of the Interior’s Standards for Rehabilitation, in particular:

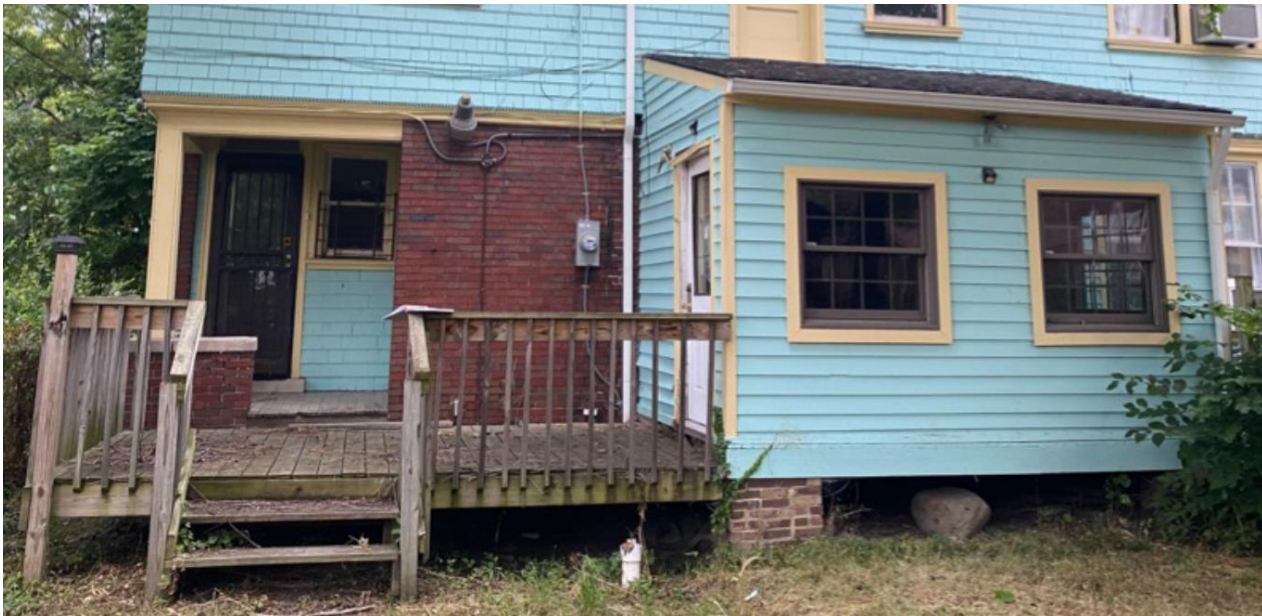
The application seeks to demolish an addition. The applicant states that the addition is “fairly recently built” and is of poor quality, “not properly sealed and insulated,” and “not conducive to tempered habitable space.” This addition is integrated with a wood deck which is also proposed for demolition. (Staff’s assessment of the addition is given below.)

*Addition and deck proposed for demolition. Photo from application.*

Staff recommends that the Commission issue a *Certificate of Appropriateness* for the remaining work items as they meet the Secretary of the Interior’s Standards for Rehabilitation, with the following conditions:

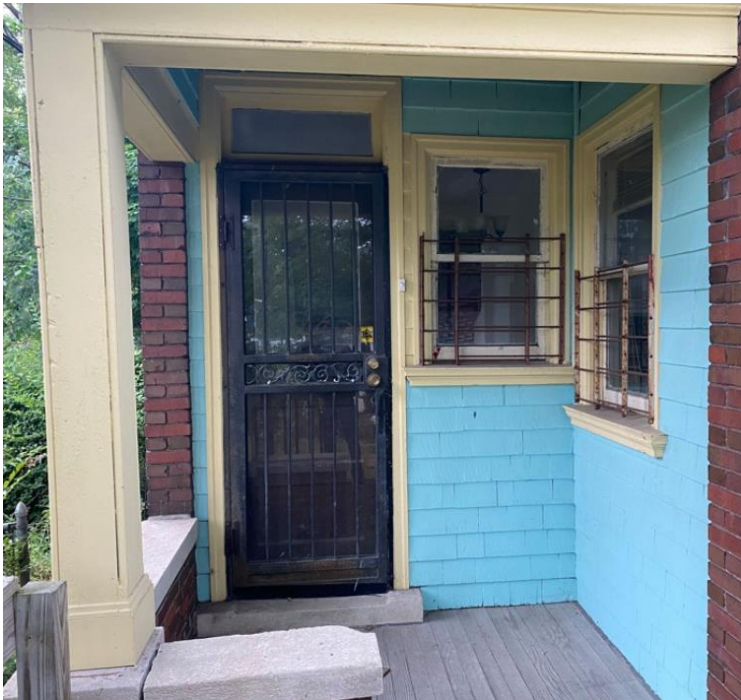
Also proposed is the elimination of a door opening on the rear (east) elevation.

*Rear door proposed for elimination. Photo from application.*

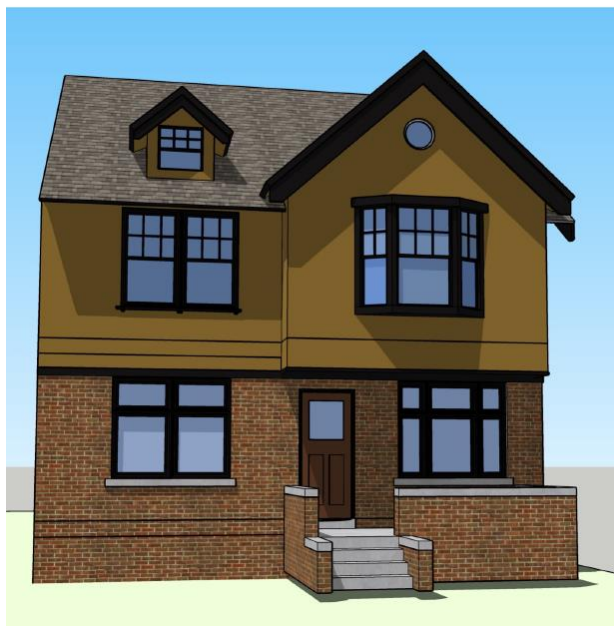
- Body color, B2 Dark Yellow
- Trim color, B19 Black

*Rendering of proposed paint colors. Image from application.*

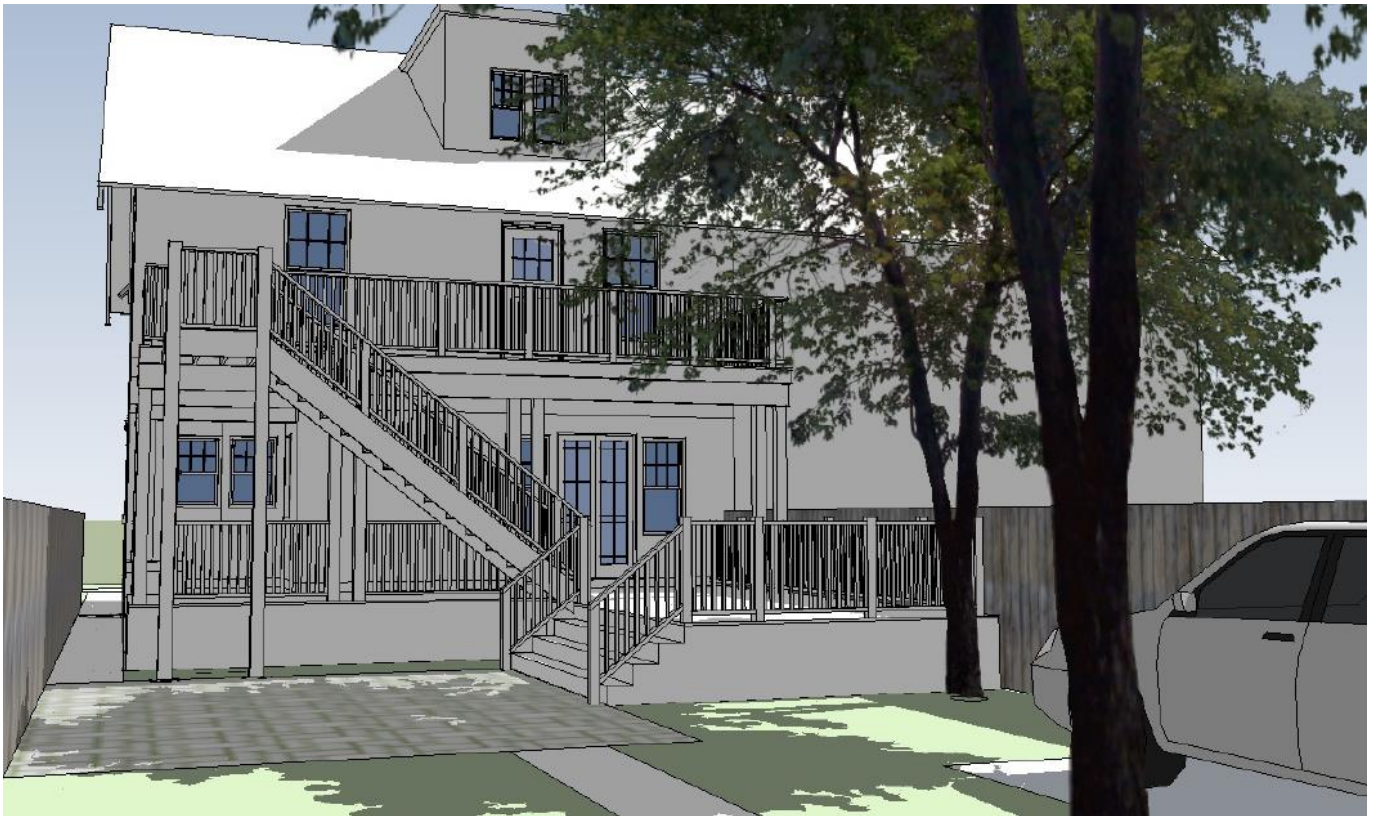
*Rendering of rear of house with all proposed work items shown. Image from application.*

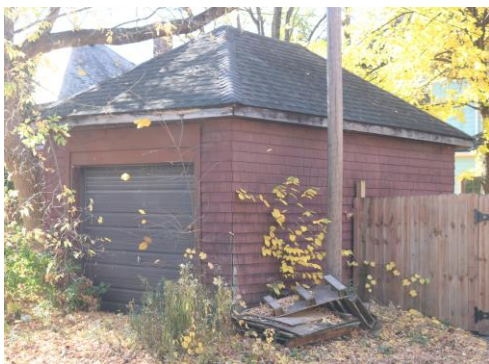
*October 2022 staff photo showing non-historic garage door.*
