STAFF REPORT: FEBRUARY 8, 2023 REGULAR MEETING

APPLICATION NUMBER: 23-8919

ADDRESS: 1505 CHICAGO

SCOPE: REPLACE FASCIA, GUTTERS, REBUILD PORCH

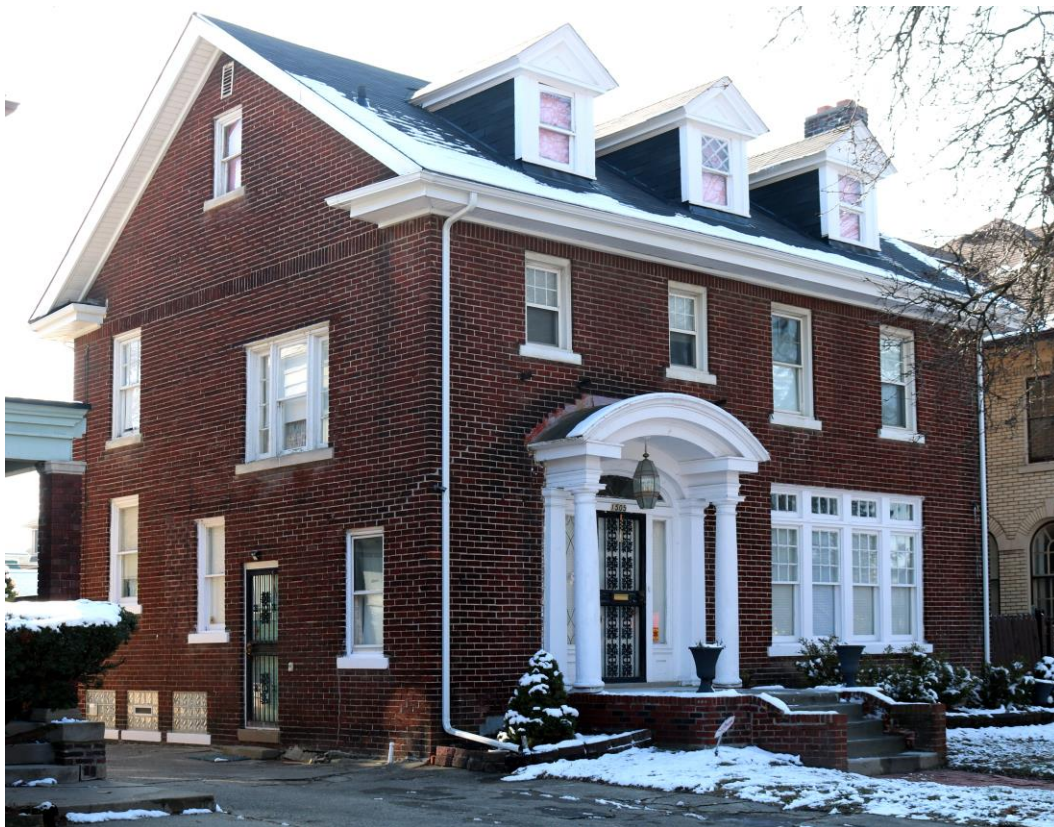
1505 Chicago Boulevard is a two-and-a-half story, red-brown brick, Colonial Revival house, built c. 1916-1918. It faces north onto its street in the Boston-Edison Historic District. Prominent features include a projecting entry portico with simplified Classical columns and entablature and a curved pediment, wide eaves with returns, gabled dormers, and subdivided or mullioned windows of various configurations on all elevations. The historic massing and details remain intact but the building has seen a few alterations: some windows have been replaced, fascia and soffit work (subject of this application) has been completed, and the projecting front porch (also subject of this application) was modified with brick, likely sometime in the 1980s.

January 2023 site visit photo by staff.

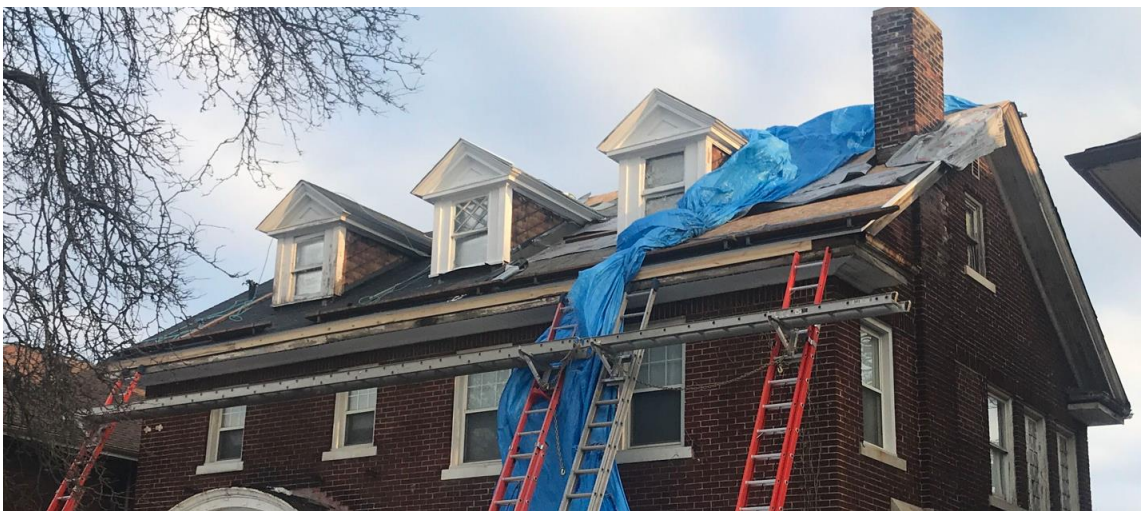
Work in progress. 2021 photo by staff.

- Staff photos from 2021, though taken from a distance, appear to show significant deterioration in these areas, such as rusted gutters and rotted wood. Staff suggests that these elements may have deteriorated beyond feasible repair. These conditions are also stated in the application.

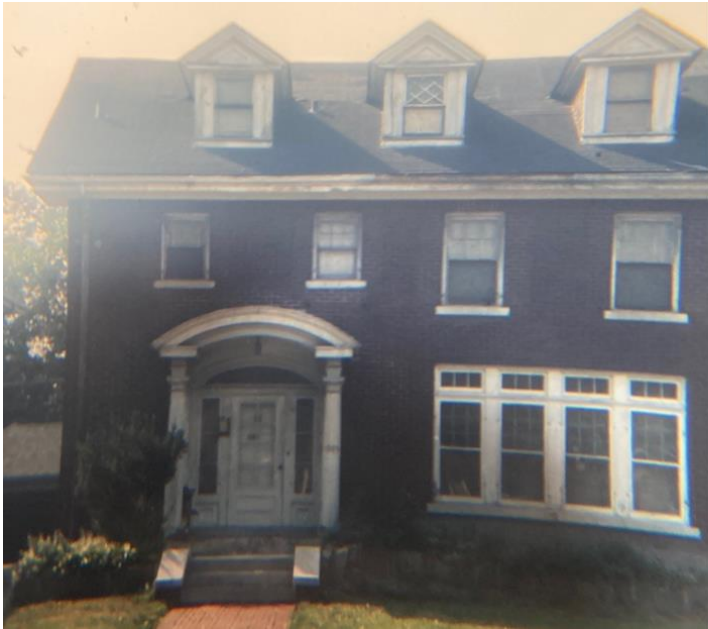
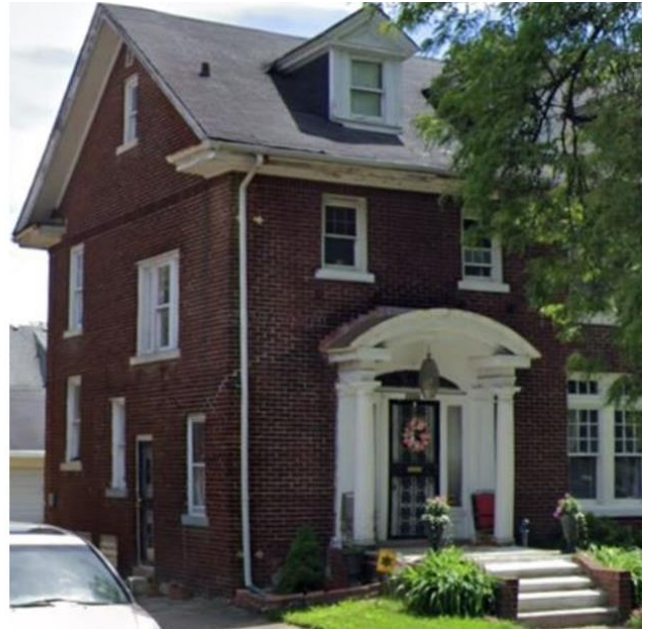
Left: The house in 1974. Historic Designation Advisory Board photo. Right: The house in 2019. Google Street View.

- The roof shingles are an appropriate texture and color for the style and district.
- The dormer walls can be seen as wood shingles in a 1974 photo; they were replaced with asphalt shingles sometime prior to 2019 (see above photos).

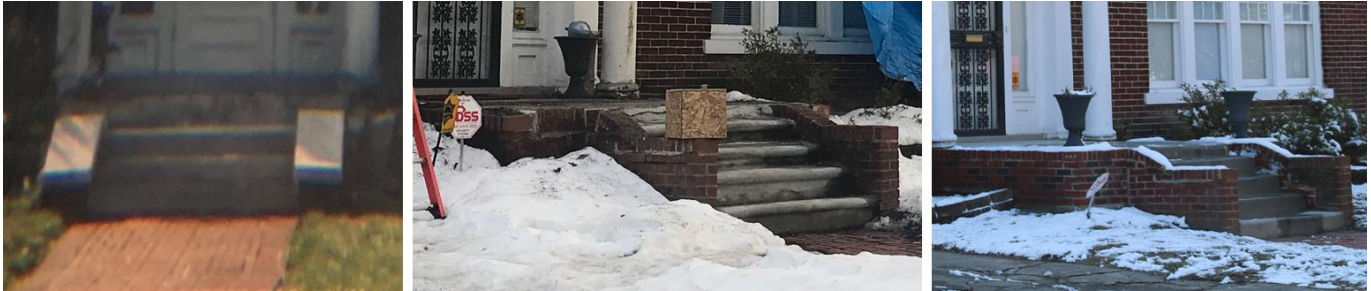
- Staff has determined that the front porch is not an original or historic feature of the building. A 1974 photo, taken at the time the Boston-Edison Historic District was established, shows a slightly different configuration. Undated photos in the Historic District Commission property files show the porch was completely demolished, likely sometime in the later 1970s. It was subsequently replaced with a new porch of generally similar materials and spatial qualities, but with an additional concrete step and heightened brick wingwalls without a concrete cap.

- The current proposal is to rebuild the porch in the same configuration. The work appears to already be completed. The applicant states in emails dated February 2, 2022 (included as a component of the application) that the historic columns were retained, “60%” of bricks were reused, and Quickcrete mortar mix was used.

- Staff confirms from a site visit that the new bricks match the old in color and texture.
- Quickcrete mortar mix is a type N product and is appropriate for the location.

Left to right: The front porch deck in 1974, 2019, and 2023.

- Staff suggests that although the materials, orientation, and massing of the front porch are an important character-defining feature of the house, the exact design of the wingwalls are not; therefore, repairing and rebuilding the most recent version of the porch (rather than replicating the pre-1980s porch based on photographic evidence) is appropriate.
