STAFF REPORT: 2/8/2023 MEETING

APPLICATION NUMBER: #23-8212

ADDRESS: 450 AMSTERDAM

SCOPE OF WORK: DEMOLISH ADDITION AND REHABILITATE BUILDING

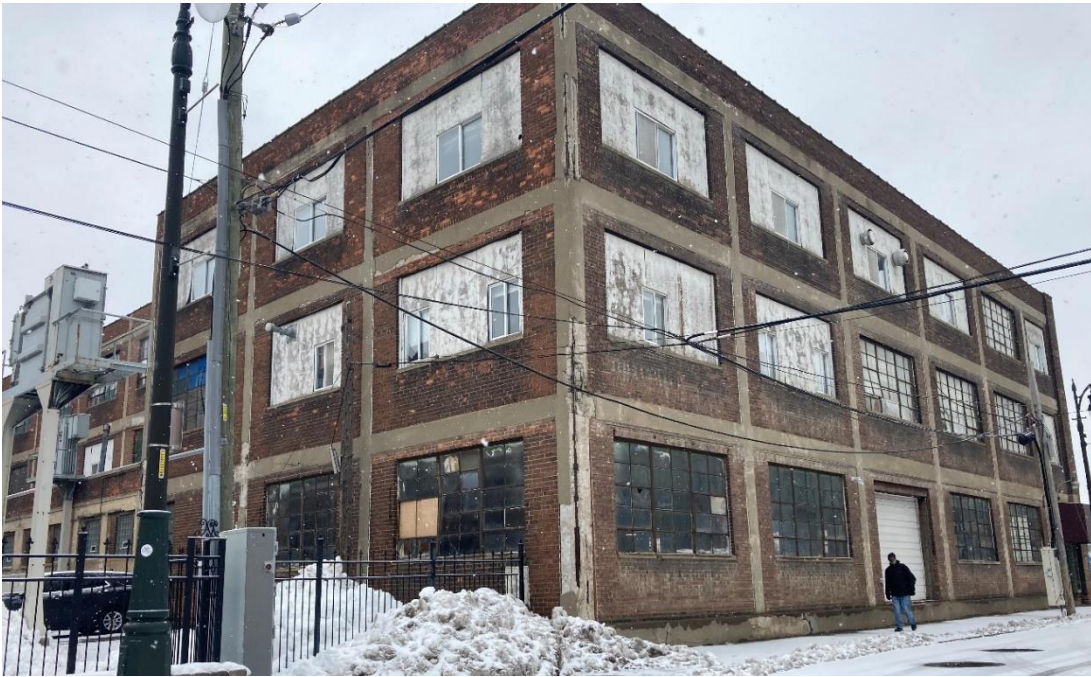
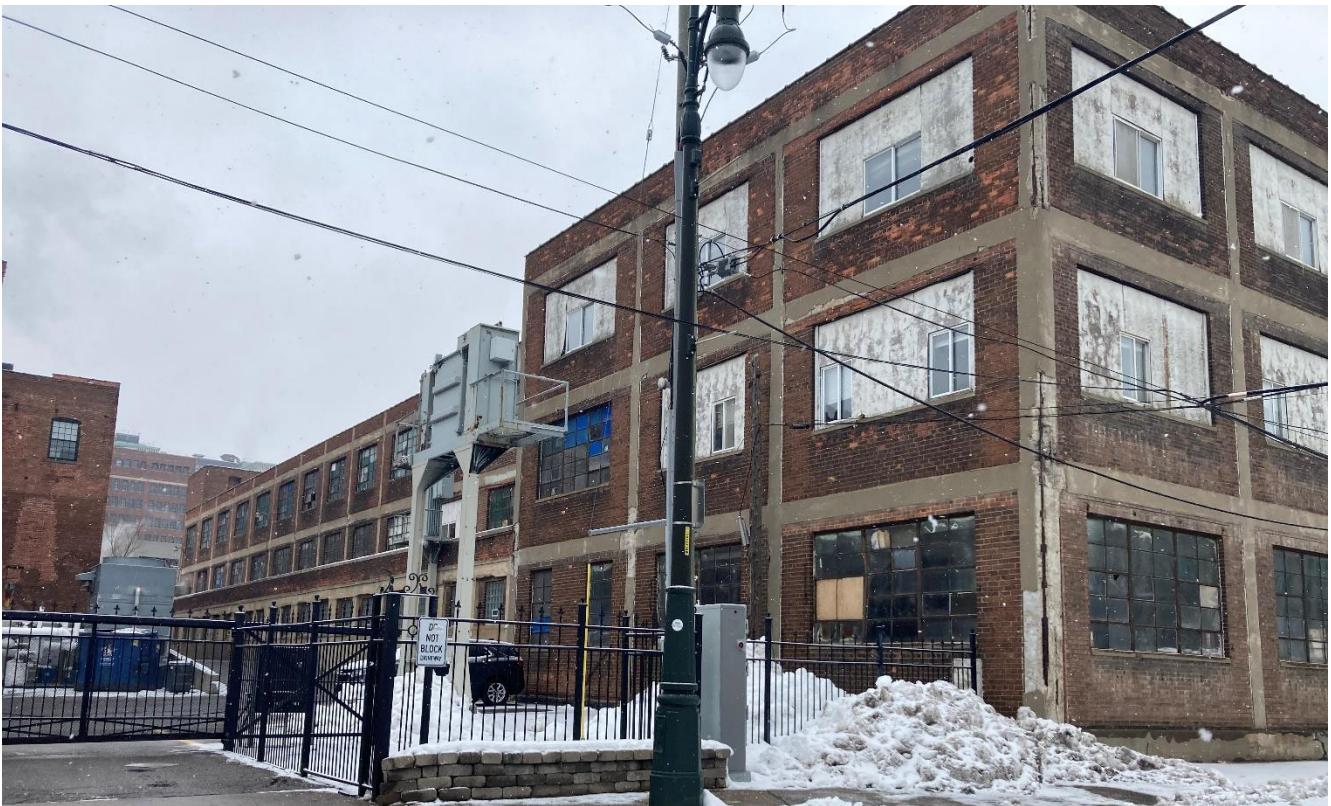
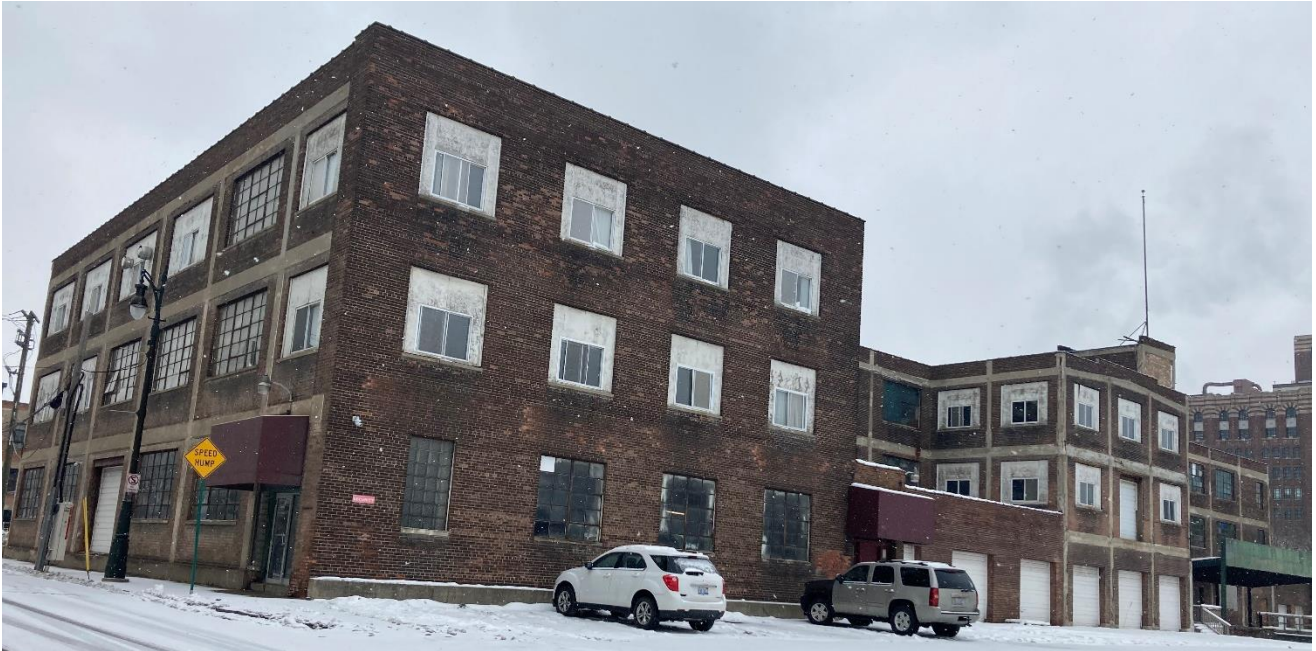
The building is three stories in height (with one-story wings at the east and north elevations) and was constructed with reinforced concrete and brick. The rear, one-story addition was erected with concrete masonry units. The building features a six-bay wide, four-bay deep main mass which faces south on Amsterdam Avenue. To the north of the main mass, the building steps in two bays at the east elevation and one bay at the west elevation forming the building's T-plan. The roof is flat. Exterior walls are primarily brick, although concrete is present at the rear one-story addition's north and west elevations, at the first story at the west elevation, and at stories two and three of the west elevation's stair tower. Many of the fenestration openings retain historic-age steel windows. Some window openings have been infilled with glassblock (mainly at the west elevation, first story). Still other window openings include non-historic vinyl sliding windows with masonry infill/surrounds. The primary entrance, which is located at the south elevation is a non-historic aluminum storefront door with aluminum and glassblock sidelites. A non-historic awning shelters this entrance. Other entrances are non-historic steel overhead doors and non-historic hinged single doors. A loading dock which includes a masonry dock and a steel-frame canopy is located at the building's northeastern corner.

450 Amsterdam, current appearance (staff photos, 1/30/2023)

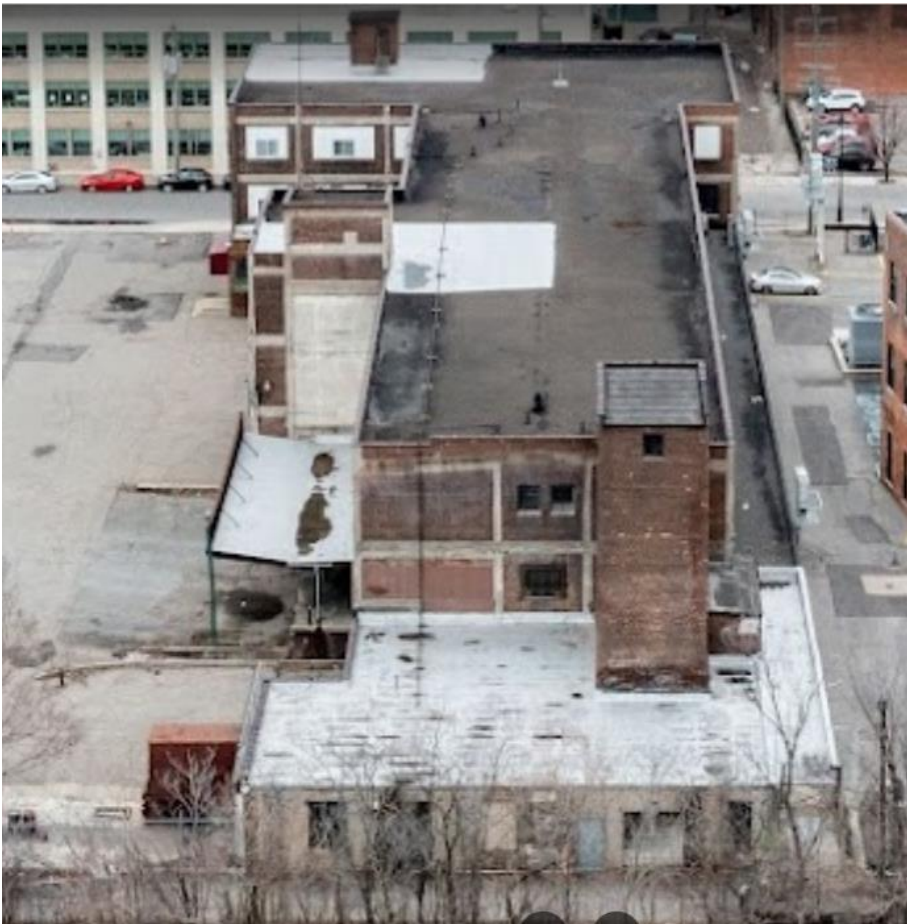
Google aerial facing south showing rear one-story addition, 2022

- At rear, one-story addition/block, rebuild wall with new brick per elevation drawings (sample of new brick not provided)

- The application proposes to rebuild the rear wall of the north elevation, one-story rear wing. However, the submission has not included a photo of the type/style/finish color, etc of the new masonry. As this wall at the rear elevation of a non-original addition and faces towards existing railroad tracks/outside of the district, staff has no issue with rebuilding the wall as long as the treatment is compatible with the building's historic character.

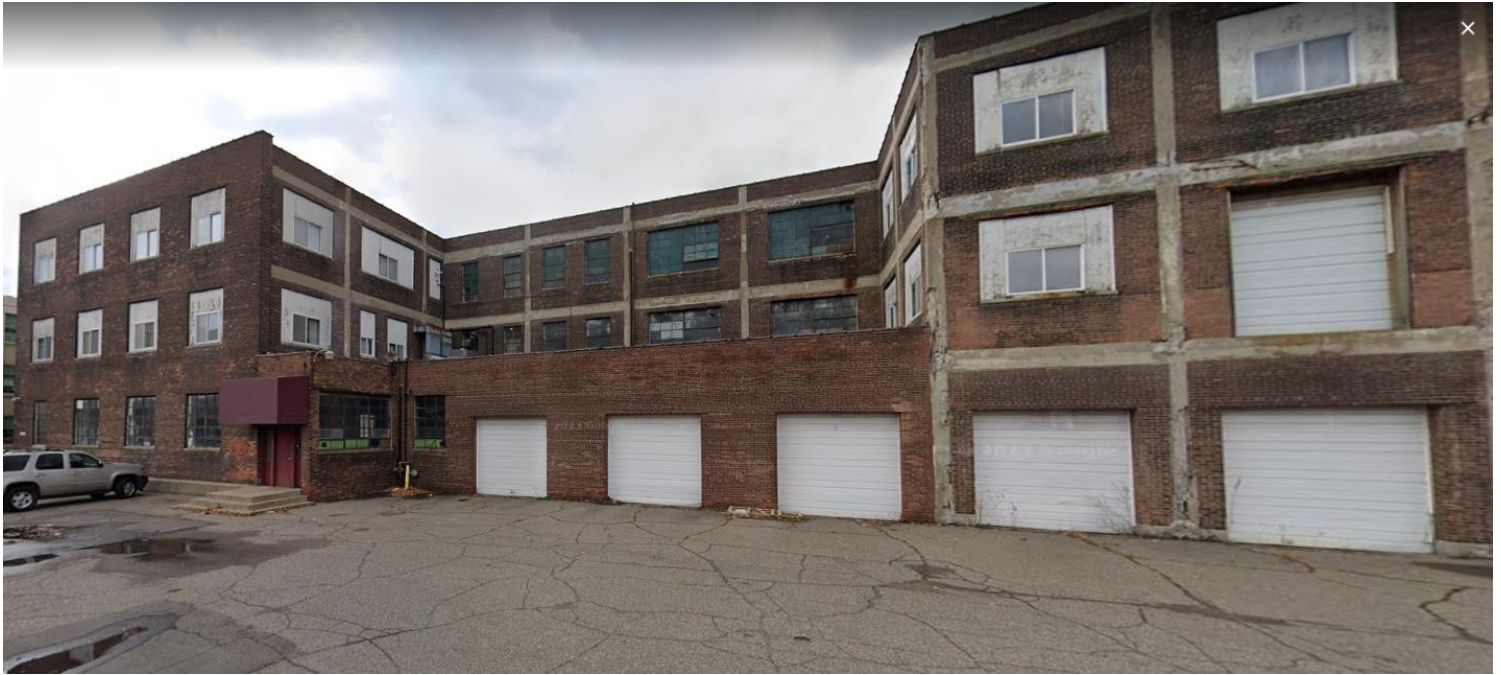
Google Streetview, facing southwest showing east elevation, one-story addition

- Demolish the one-story, masonry wing
- Demolish metal canopy which is located at the loading dock
- At southernmost bay, first story, install a new aluminum canopy with rigid tiebacks over a new entry door

- It is staff's opinion that this building's primary architectural significance is associated with the fact that it remains as one of the city's earliest erected reinforced concrete buildings although the east elevation one-story addition and loading dock canopy are historic-age, they are not associated with the building's original construction or its historic significance and are therefore not distinctive character-defining features of the building. Rather, these elements detract from the expression of the reinforced concrete structure at the building's east elevation. Staff supports the removal of these elements.

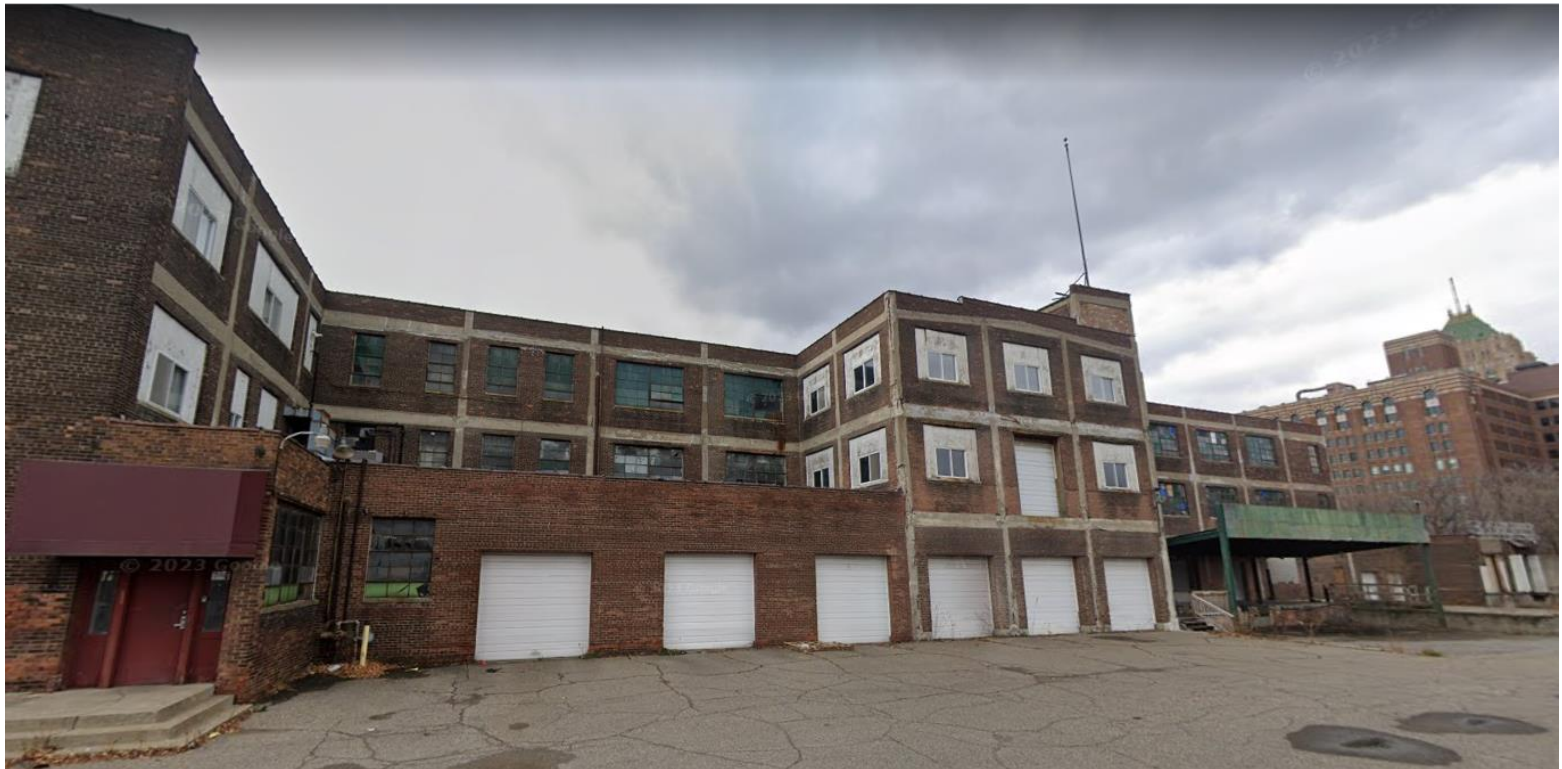
Google Streetview, facing northwest showing east elevation, one-story addition and loading dock canopy

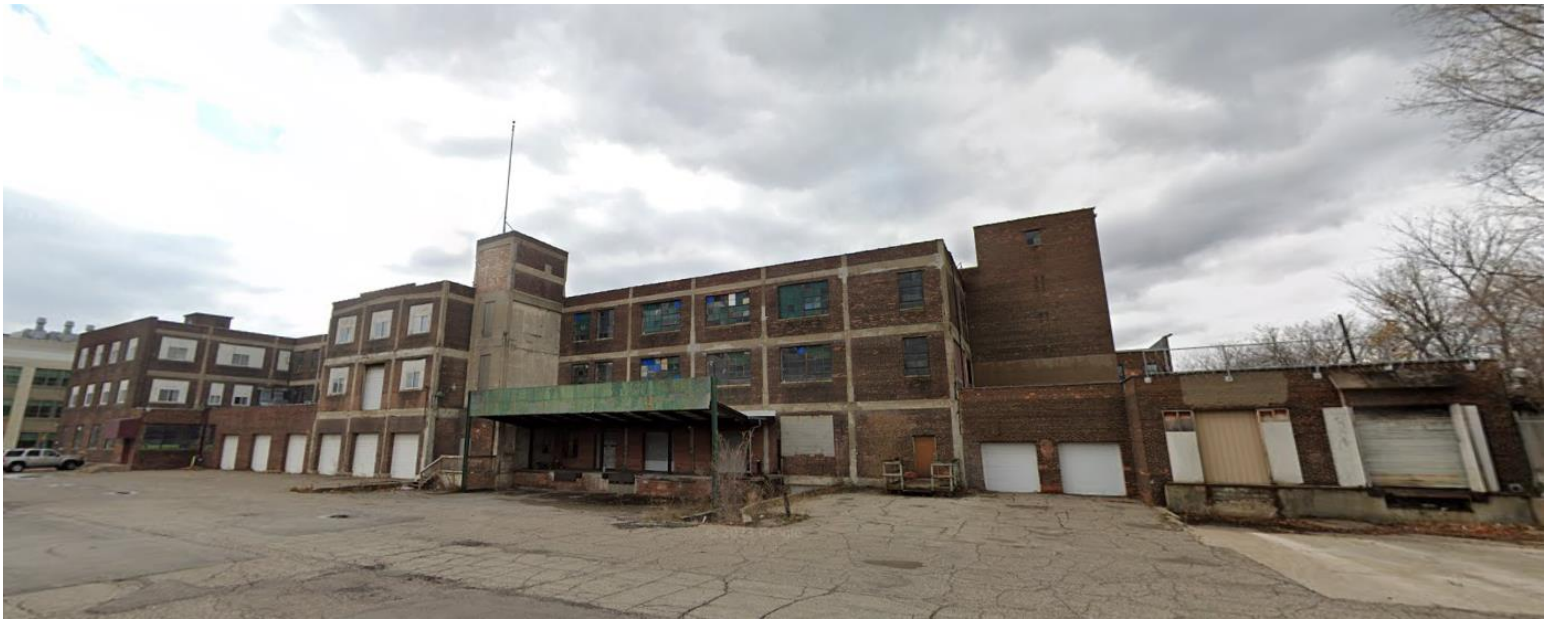
Google Streetview, facing southwest showing east elevation, one-story addition, loading dock canopy, and rear one-story addition

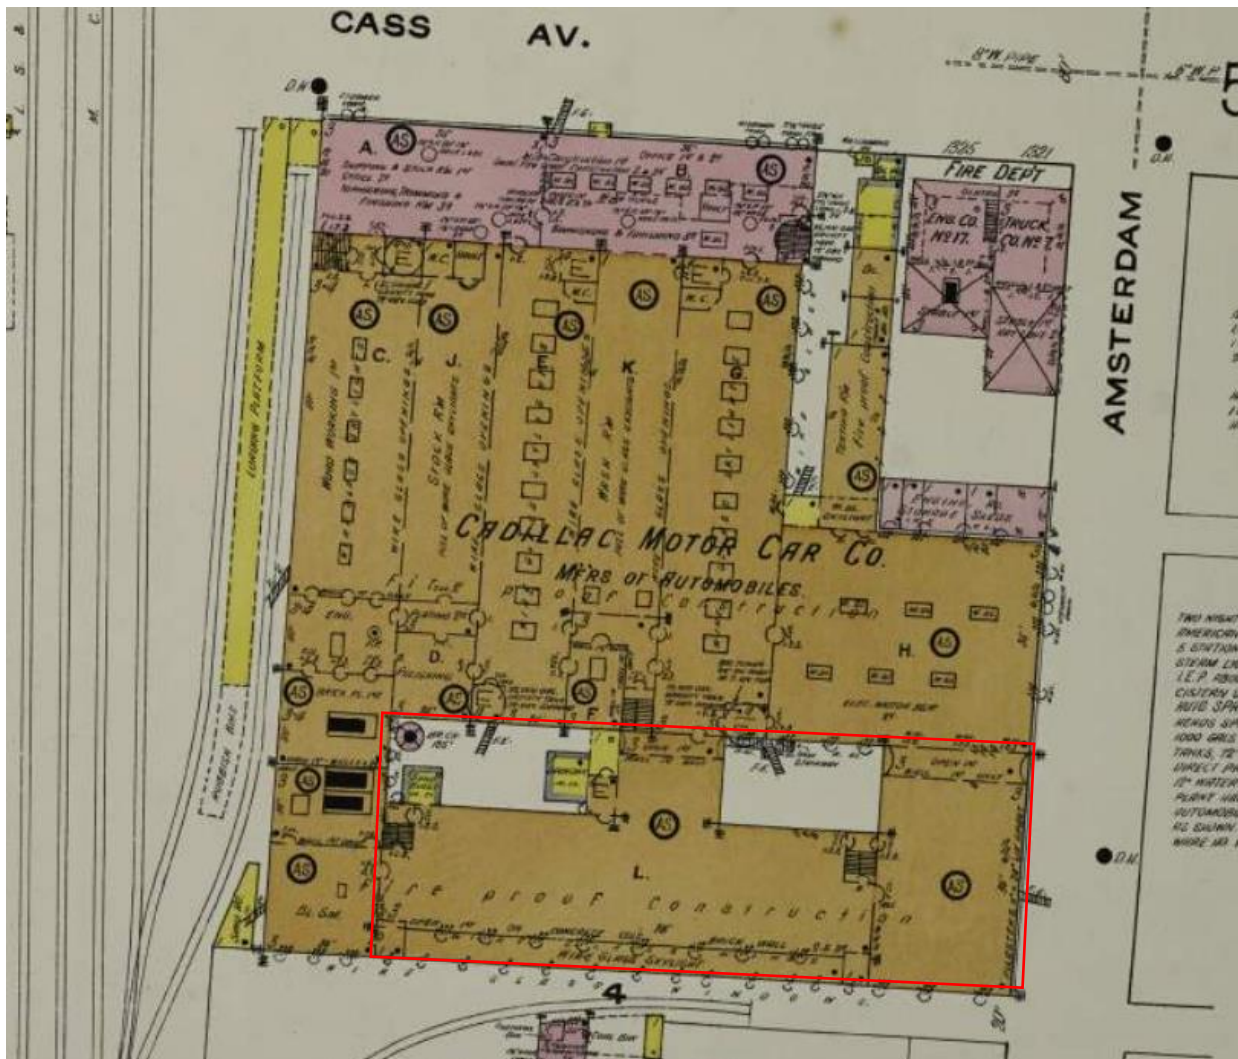
- As noted above, the building was originally erected in 1905 to serve as the Cadillac Motor Car Company Assembly Plant. See the below 1910 Sanborn Fire Insurance map which depicts the footprint of the original complex. In 1945, per the below Sanborn Fire Insurance map, much of the original plant had been demolished and the east elevation one-story addition and loading dock and the north elevation, one-story addition had been added. It also appears that the first story at the west elevation had been modified during the 1945 rehabilitation.

Sanborn Fire insurance Map, 1910 showing original footprint with existing portion outlined in red

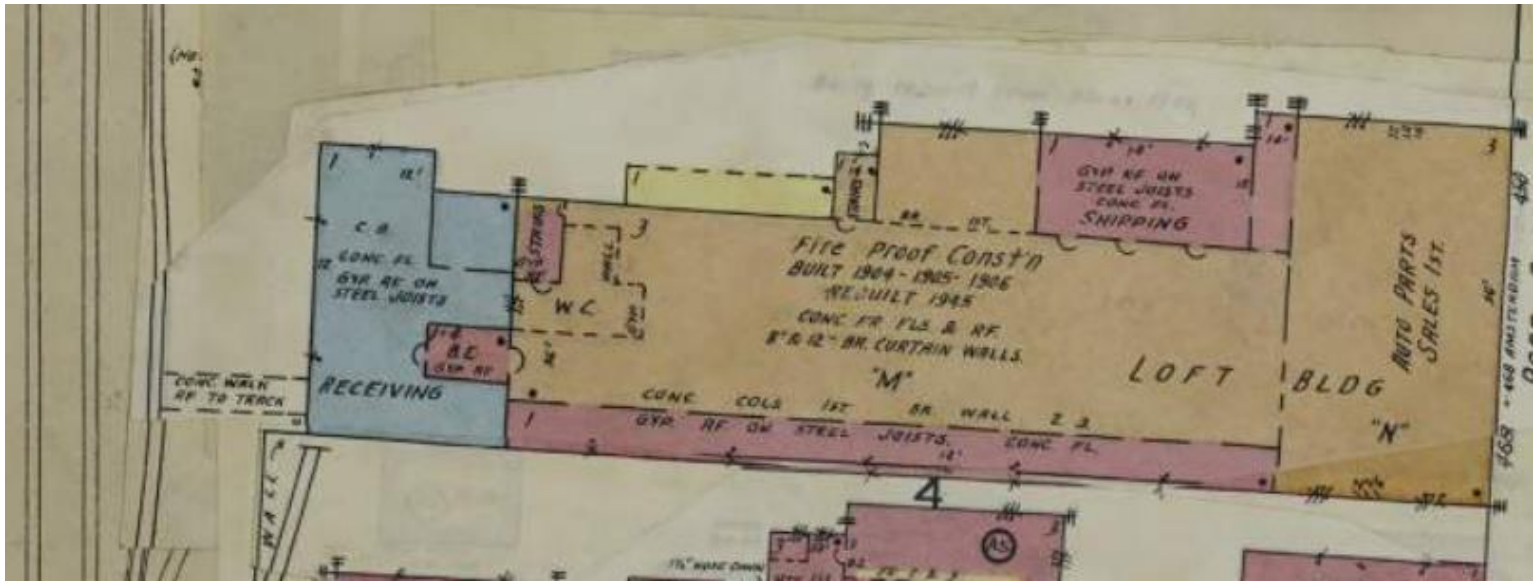
Sanborn Fire Insurance Map, 1951 showing current footprint

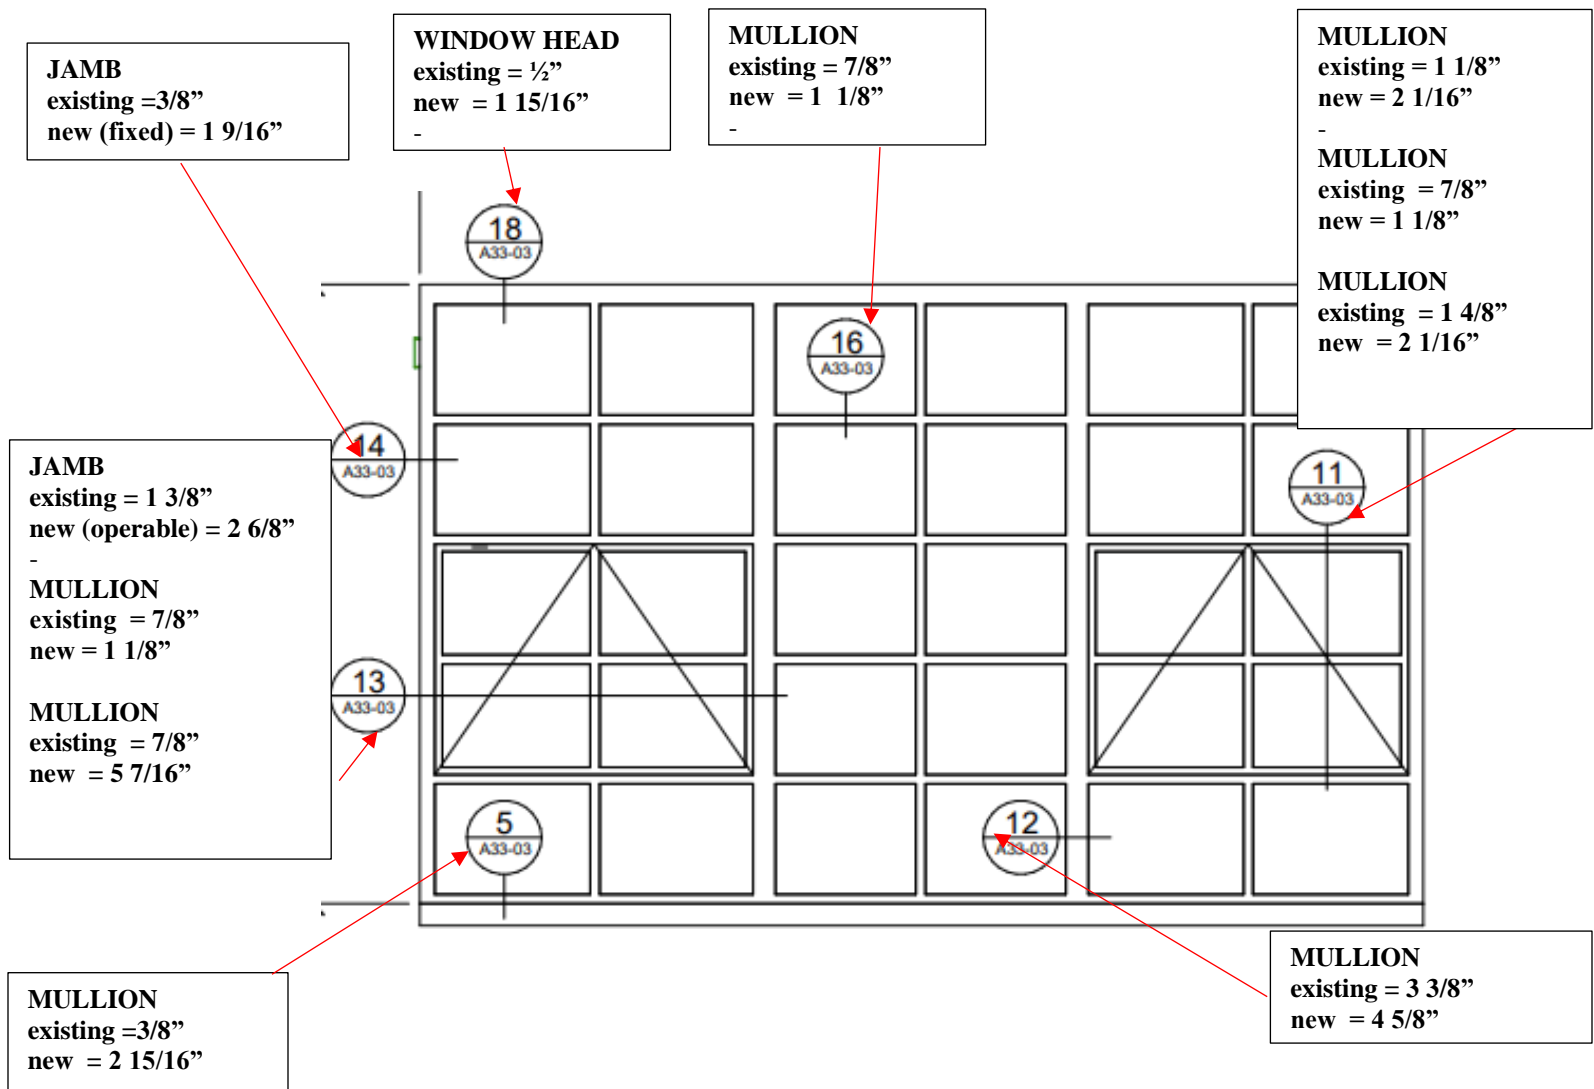
- The applicant has provided a good amount of photos of the steel windows which are proposed for replacement, and it does appear that they all display deterioration/corrosion to varying degrees. The windows likely can be repaired, but such work could not be undertaken in situ/would require their removal. Although no quote for repair has been provided in the current application, staff does acknowledge that the cost to repair the remaining steel sash will likely not be feasible due to the large number of units, their level of deterioration, the necessity to replace the existing sills and lintels, and the historic windows' method of installation.

- Please see the below graphic which provides a comparison of the typical details of the existing historic steel windows versus the proposed new aluminum windows. Note that at every detail of the new windows presents wider/thicker dimension and profile due to the properties of the material from which the units are made and the double-pane glazing/thickness of the glass panes. However, staff does note that new steel sash is not a readily available and economically feasible product for a rehab project of the current scale. Also, the proposed new window product has been successfully employed as a reasonable replacement for steel sash in similar projects which involve the adaptive reuse of former industrial buildings

- The size of the window openings shall be consistent/regular at the building elevations that are visible from the public right-of-way (front and side elevations)
- HDC staff shall be afforded the opportunity to review and approve the final detail drawings and brick sample for the proposed rear/north elevation reconstruction. Should staff determine that the work item does not meet the SOI Standards, the item will be submitted to the Commission for review at a future meeting
- The applicant shall provide staff with the outstanding product cut sheets for the new single hinged doors which are proposed for installation at the side elevations
