STAFF REPORT: 7/12/2023 REGULAR MEETING

ADDRESS: 19435 CANTERBURY

APPLICATION NO: #23-8437

SCOPE: INSTALL SECURITY CAMERAS ON POLE IN FRONT YARD

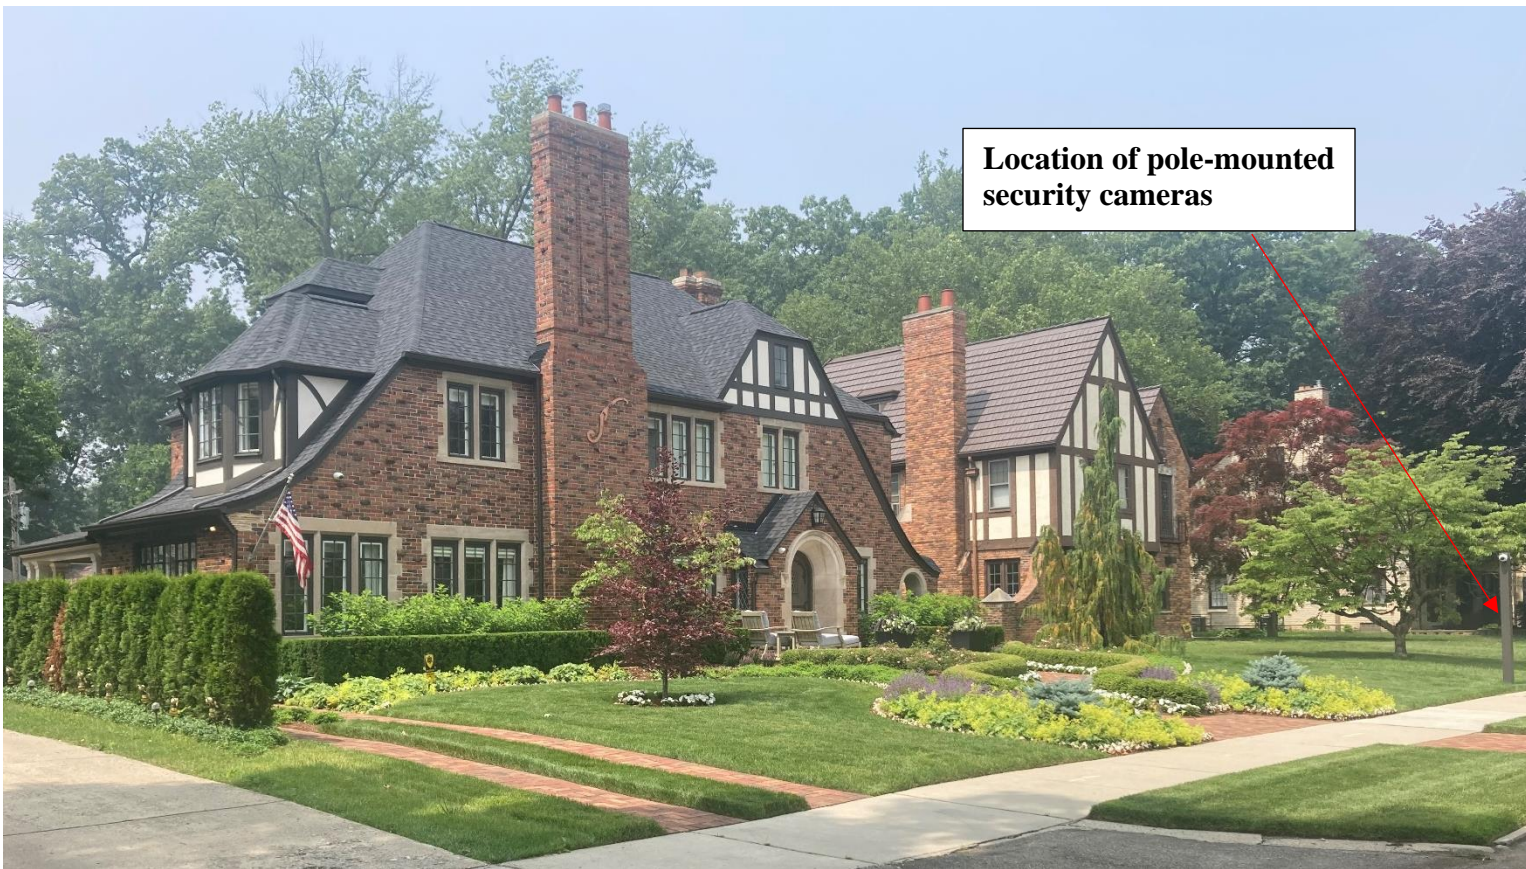
Location of pole-mounted security cameras

19435 Canterbury, current appearance. Photo taken by staff, 6/30/2023

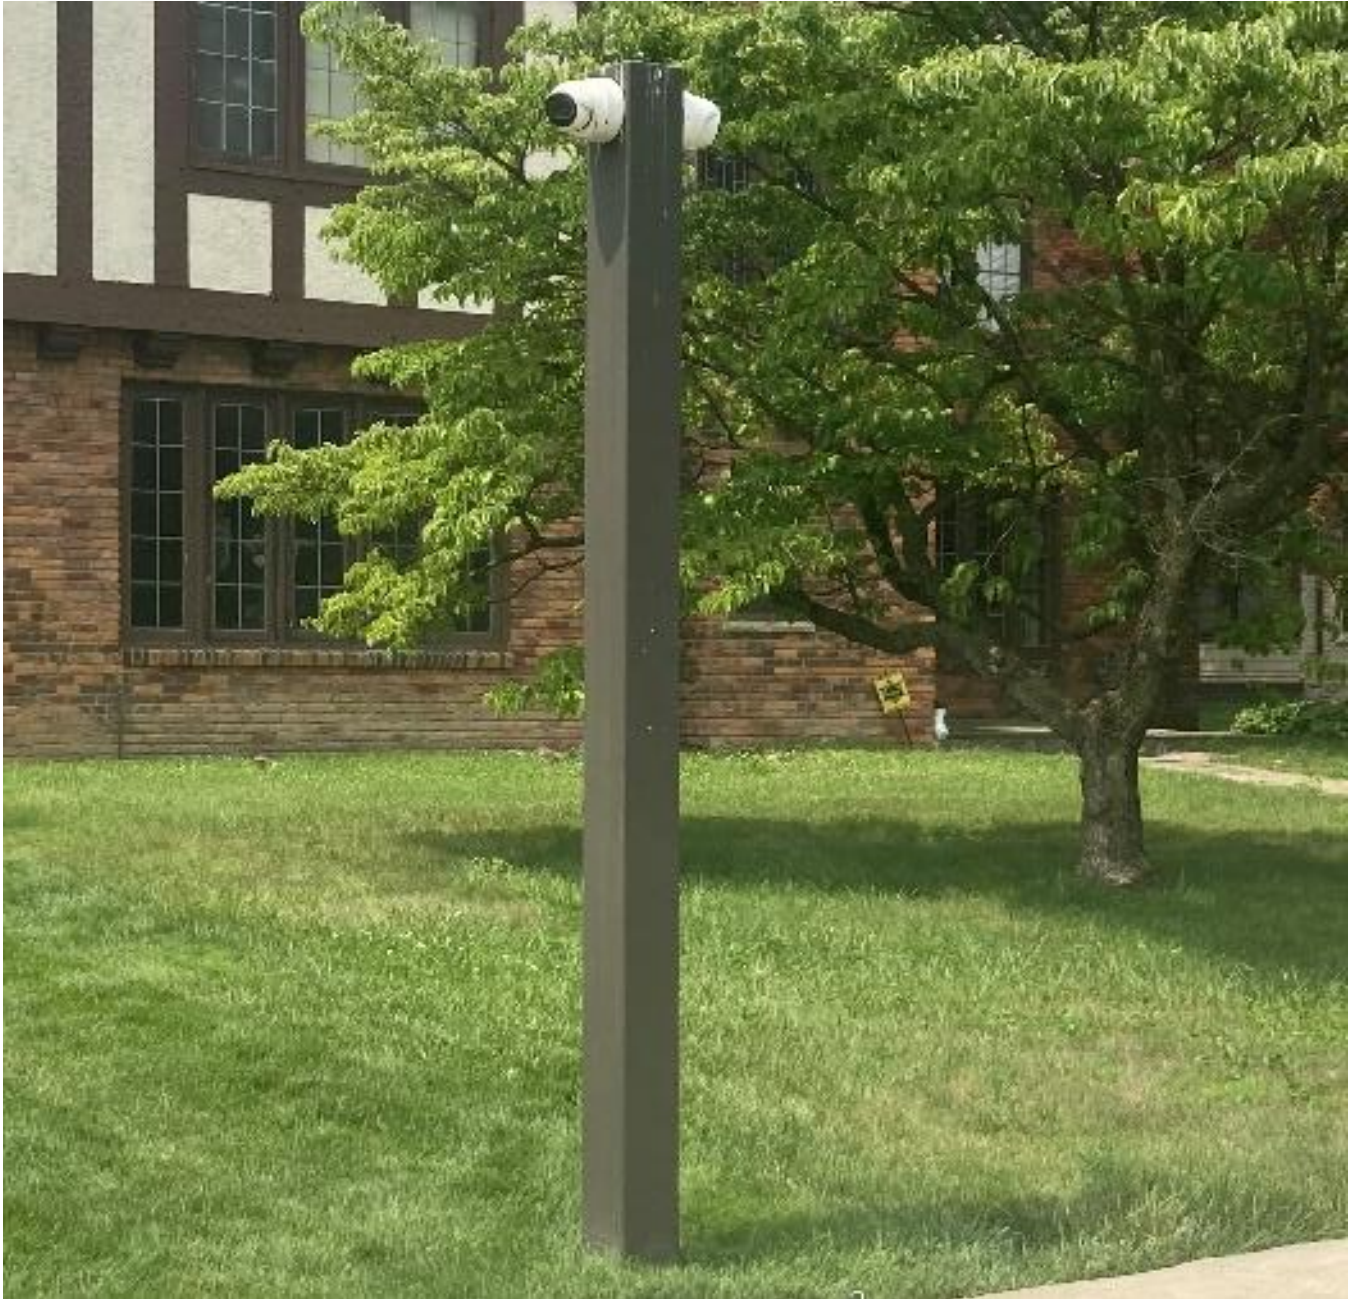
With the current application, the property owner is seeking the Commission's approval to install a pole with mounted security cameras within the property's front yard, adjacent to the sidewalk. Please note that this work has been completed without HDC approval (see the below).

19435 Canterbury, current appearance. Photo taken by staff, 6/30/2023

- The area visible from the public right-of-way within the vicinity of 19435 Cambridge (street bed, berm area, and front yards) is devoid of modern, utilitarian intrusions such as stoplights, utility poles, pole mounted security cameras, utilitarian-style light poles, etc. The current/proposed pole-mounted security camera installation is an anomaly within the neighborhood and presents an appearance that is highly incompatible with the historic character of 19345 Canterbury and its surrounds due to its location, scale, and utilitarian appearance.

- The Commission’s *Security and Lighting Guidelines* emphasize the installation of security cameras “within the site/yard in a manner that will not call undue attention to itself.” The current installation is highly visible due to its scale, location, and utilitarian nature.
